HY623/251

**Stenhouse Mill Lane
Bridge**

**Principal Inspection
Report**

July 2018

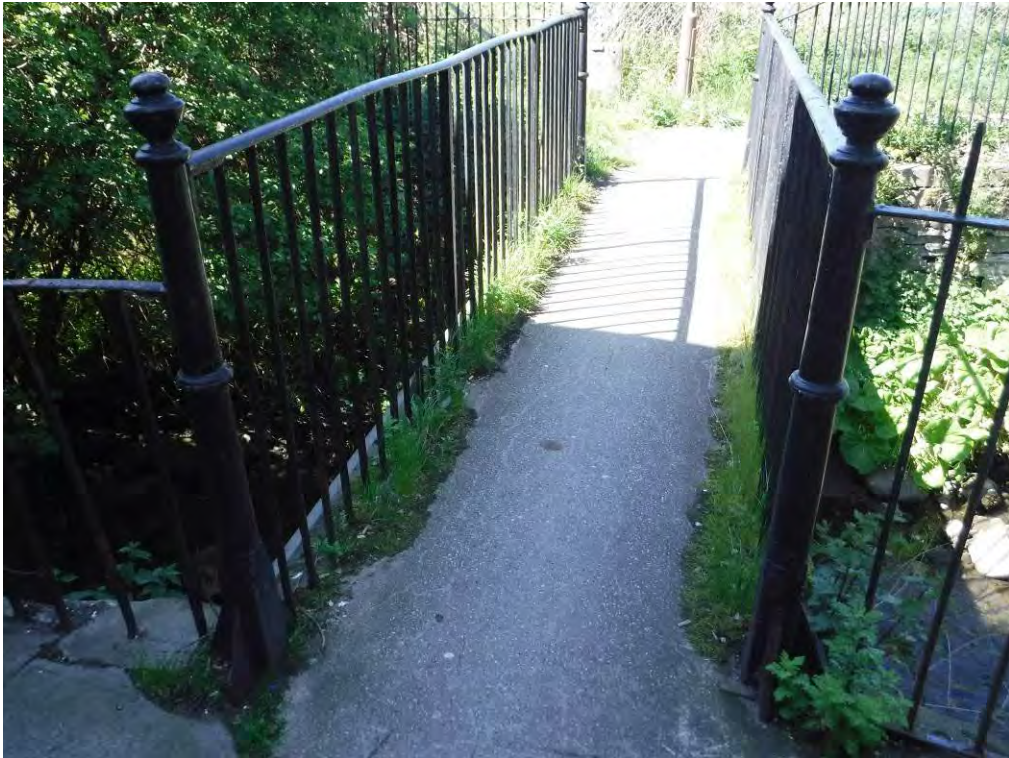
Photograph 3: View over bridge looking north

- Generally in fair condition.
- Odd areas of minor cracking to the footway surface (Photograph 3).
- 100mm band of minor vegetation along the deck edges along the full span (Photograph 3).

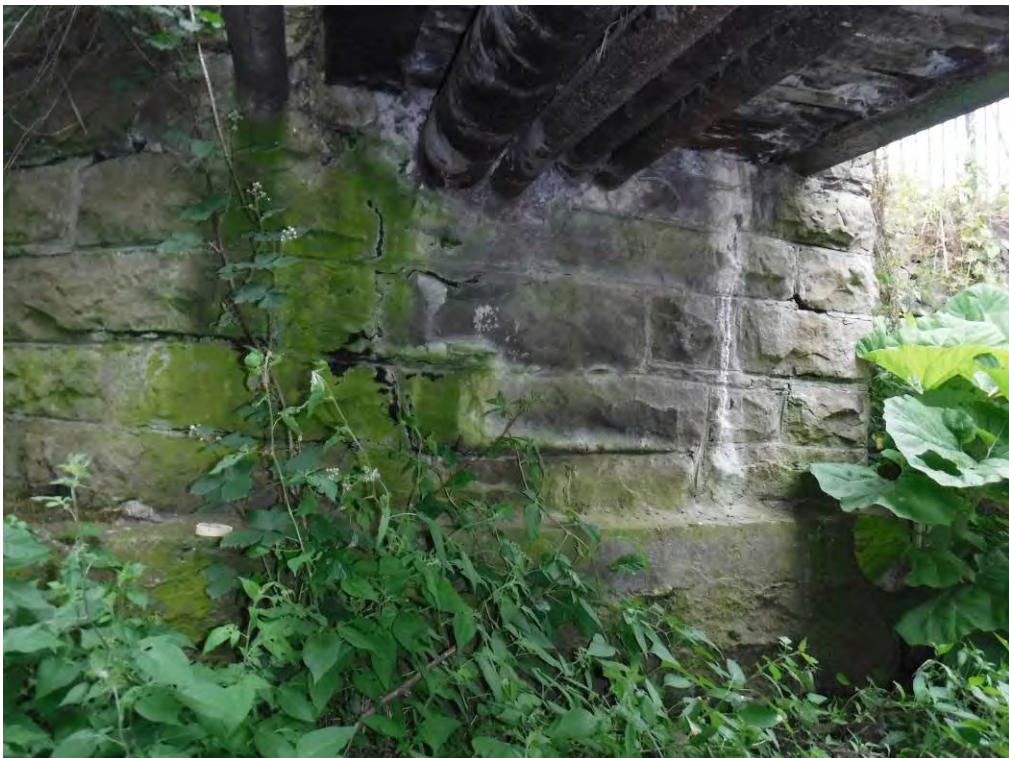
Photograph 8: North abutment

The foundations at the north abutment were in good condition with no observable defects (Photograph 8).

- Fair condition.
- 40% loss of pointing, particularly concentrated at the east side of the abutment (Photograph 8).
- Cracked infill concrete surrounding the service pipes at support (Photograph 29).
- 150mm wide band of leachate staining originating from the deck soffit to the abutment face (Photograph 30).

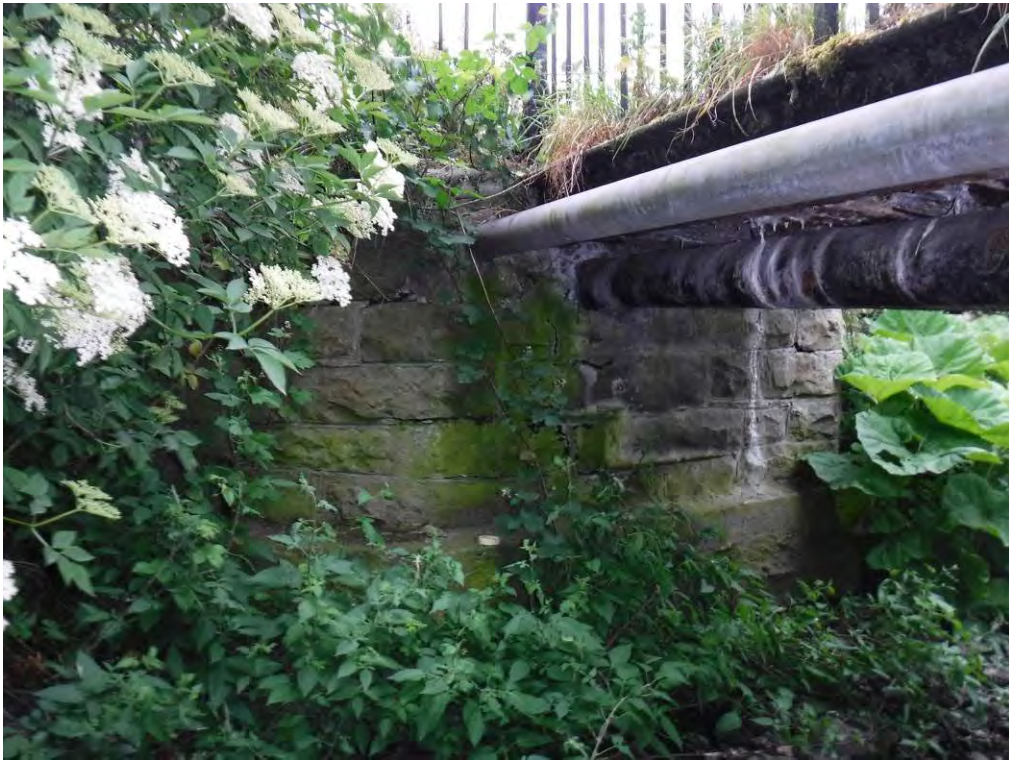
Photograph 9: North-west wingwall

- Fair condition.
- 75% obscured by overgrown vegetation (Photograph 9).

- Blast clean metallic elements comprising the superstructure and reapply metallic paint system.
- Repair service pipe bracket bolted connection with deck soffit.
- Remove overgrown vegetation obscuring 2No. wingwalls.

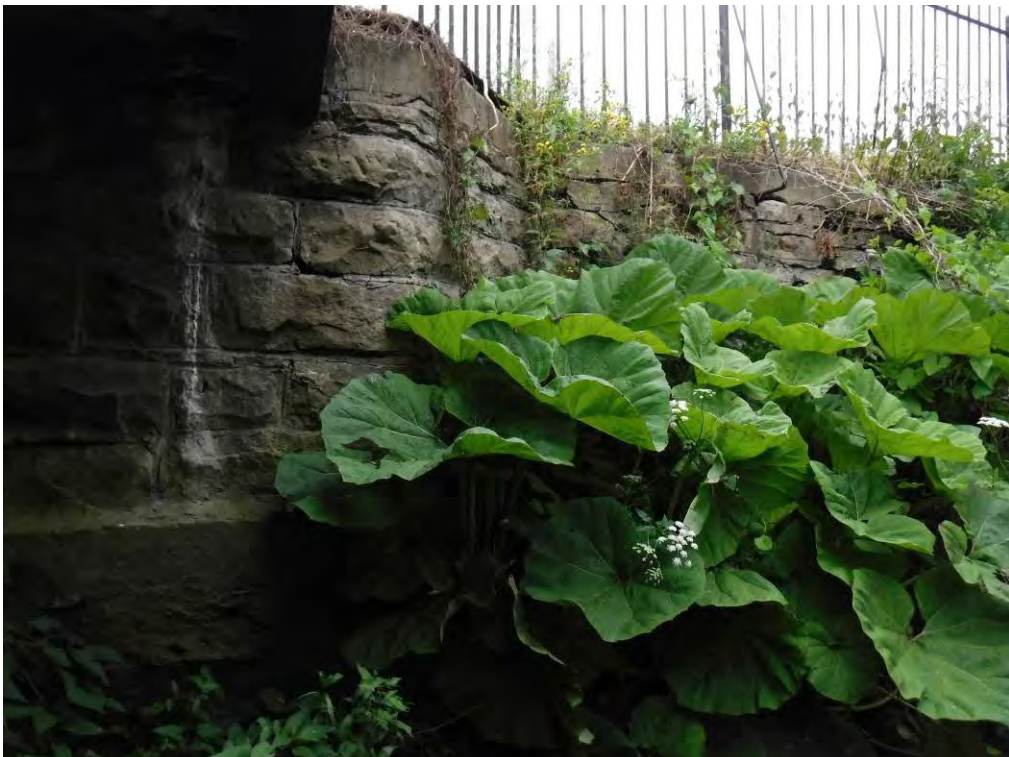
Photograph 10: North-east wingwall

- Fair condition.
- 50% obscured by overgrown vegetation (Photograph 10).
- 50% loss of pointing.

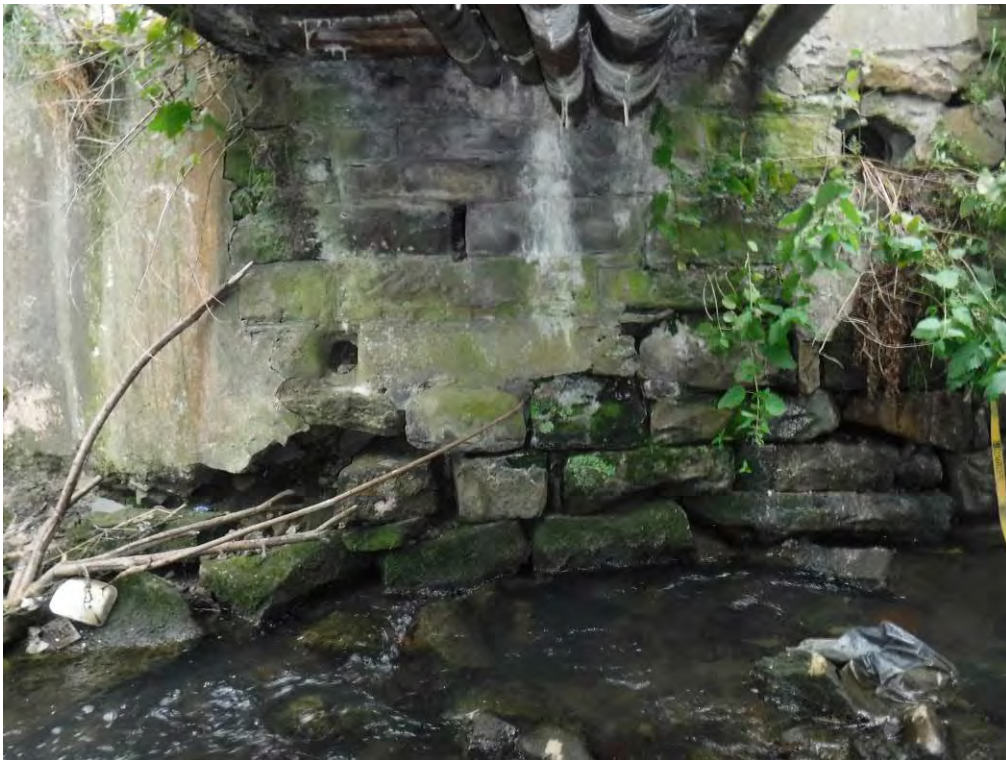
Photograph 11: South abutment

- Poor condition as the abutment has been undermined.
- 1400mm x 600mm area of missing masonry at the base of the abutment. Several masonry stones have been dislodged into the river bed (Photograph 11 and Photograph 31 - Photograph 32).
- Cracked concrete infill surrounding the service pipes and leachate staining beneath to the masonry abutment face (Photograph 33).
- 5mm separation between abutment and south-east masonry wingwall (Photograph 34).
- Moderate vegetation growth from the bearing area of the east main girder (Photograph 24).

- Fair condition.
- 1No. weep pipe at the south-west wingwall is misaligned with the outlet at the wingwall face (Photograph 35).
- An open head joint weep hole at the south abutment/south-west wingwall was observed to discharge sewage directly into the watercourse which is an environmental concern (Photograph 36).
- Drainage pipe weep hole at south abutment appears unblocked (Photograph 11).

- Repair undermined section of south abutment and dislodged stone at the south-west wingwall.

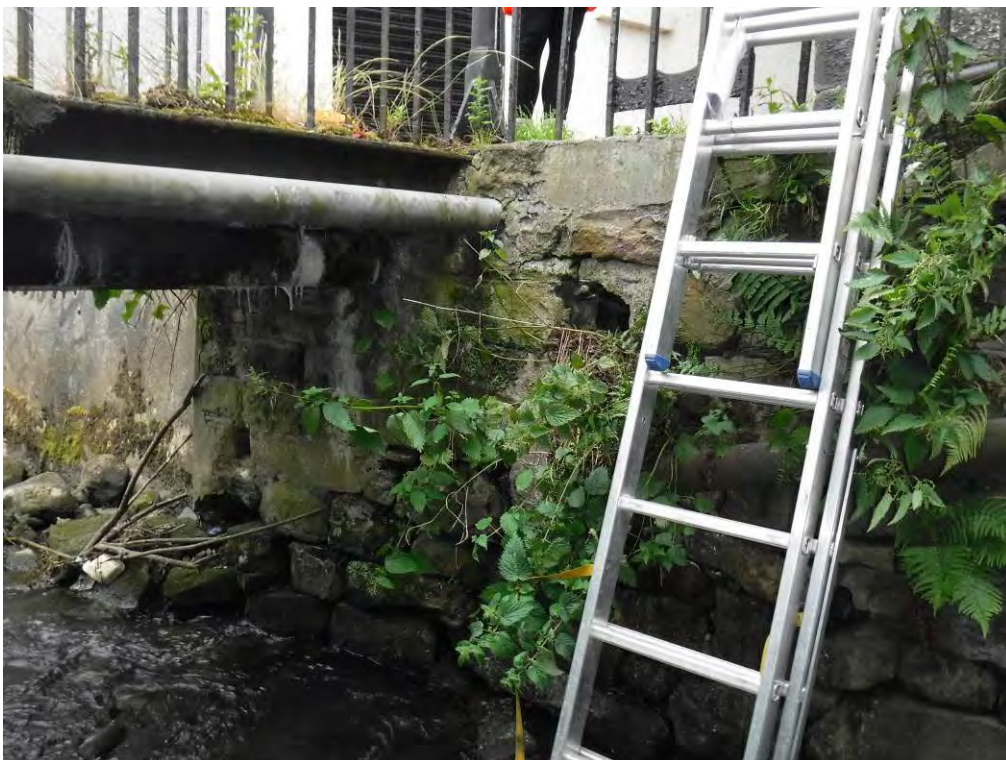
Photograph 12: South-west wingwall

- Fair condition (Photograph 12).
- Dislodged stone at base of wingwall (Photograph 38).

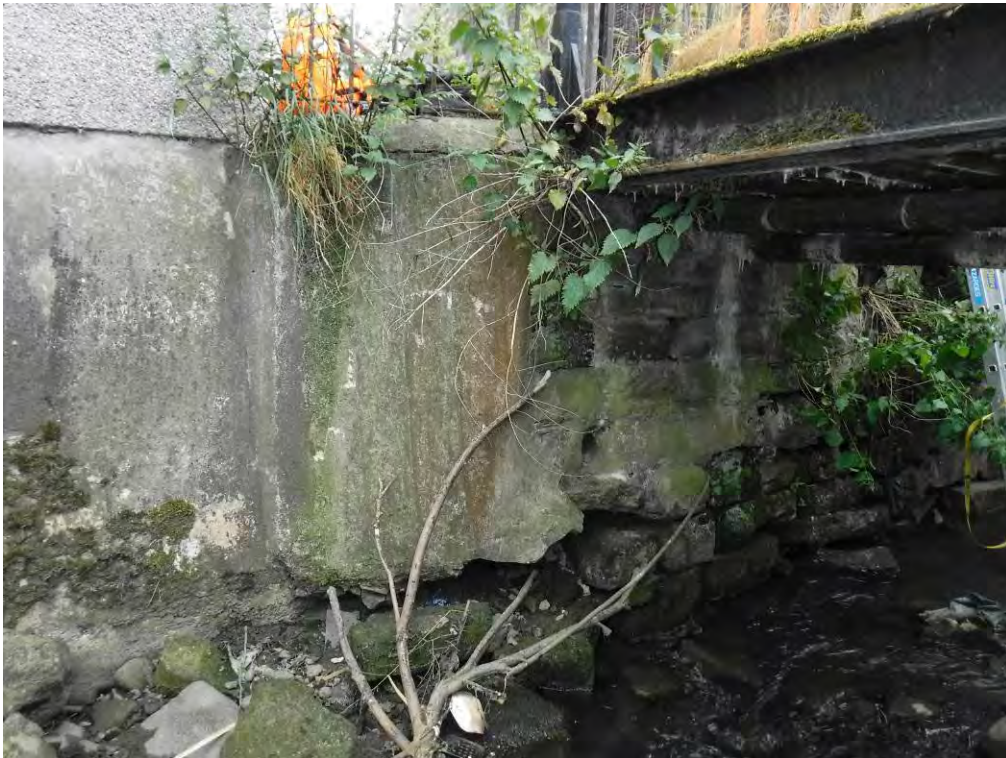
Photograph 13: South-east wingwall

- Fair condition (Photograph 13).
- 5mm separation between concrete wingwall and masonry abutment (Photograph 34).

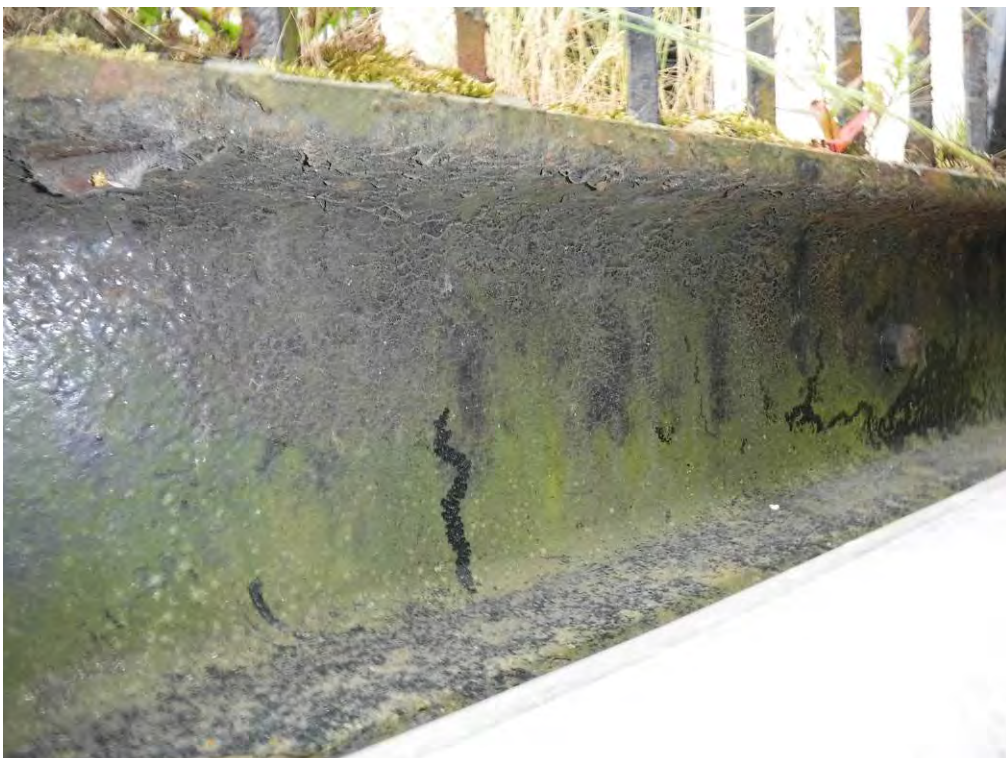
- Fair condition.
- The metallic paint system at the top flange, upper surface of the bottom flange and outer face of the web is typically intact with minor chips and cracks (Photograph 14).
- Typically 1mm historical pitting section loss identified to the outer face of the web, underside of the top flange outstand and upper face of the bottom flange outstand throughout (Photograph 15).
- 50 to 80mm wide band of paint loss, surface corrosion and leachate staining/stalactites along the inner edge of the bottom flange soffit along the full span (Photograph 16 and Photograph 17).

Photograph 14: Typical condition of west main girder outer face (looking south). Paint system in fair condition with chips and minor cracks

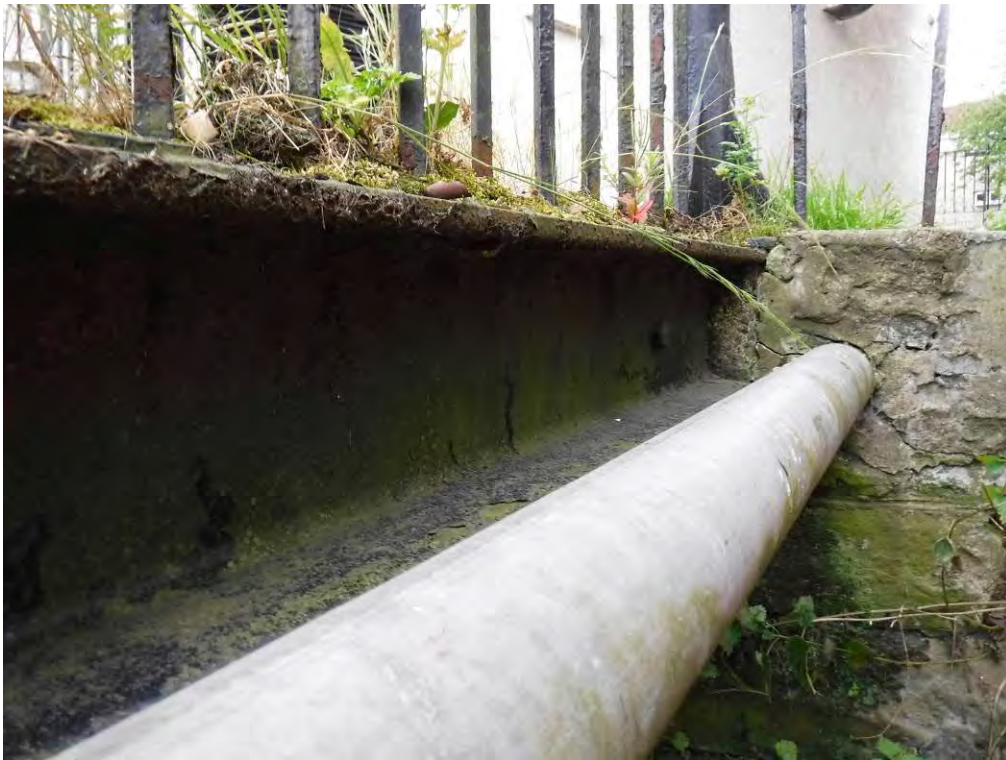
Photograph 15: West main girder outer face (looking south). 1mm section loss typical

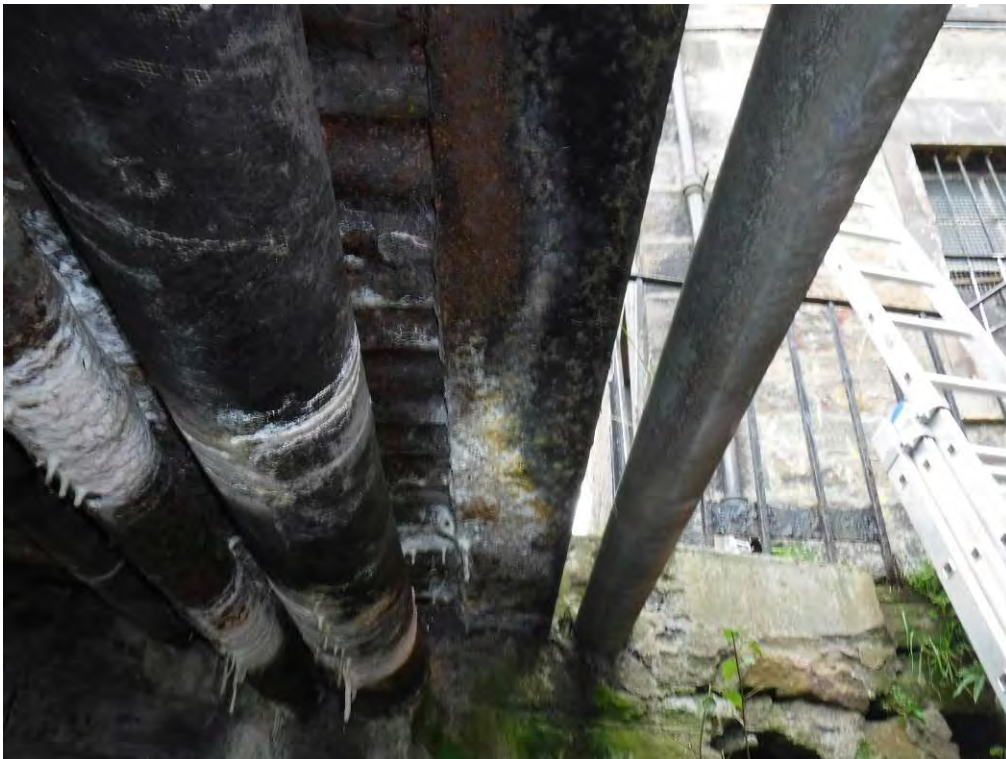
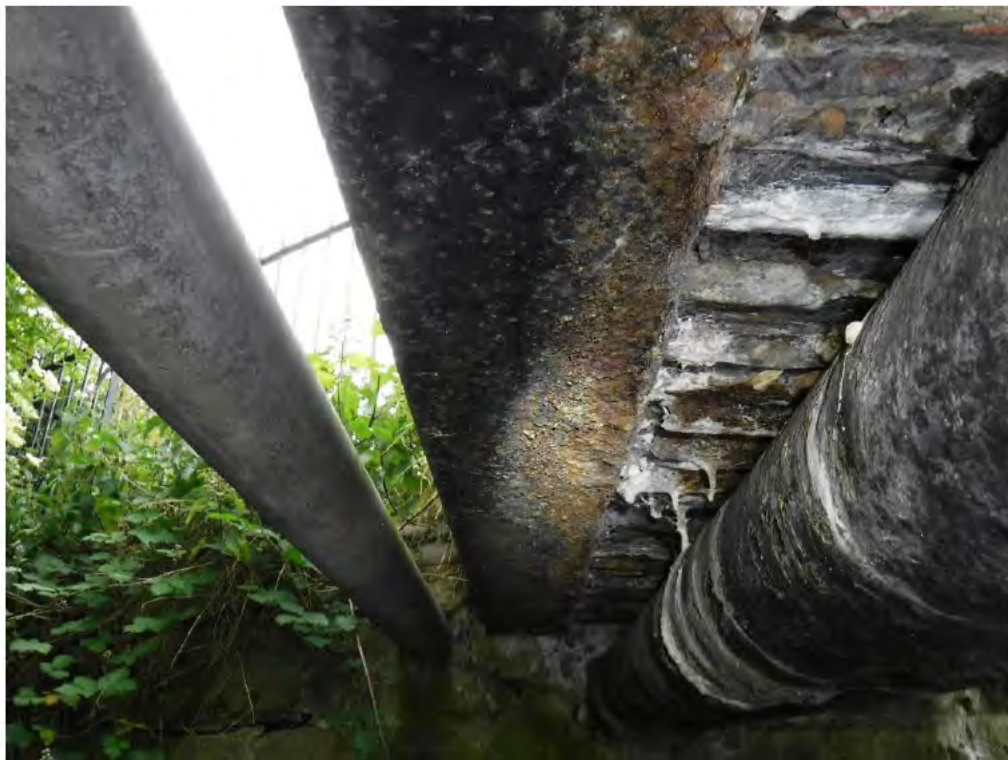
- Typically 2mm historical pitting section loss to the full width of the soffit of the bottom flange (Photograph 16 and Photograph 17).
- Isolated 150mm length of delamination across 130mm width of the bottom flange soffit from the south abutment (Photograph 18).
- The inner face of the girder could not be accessed and was not examined.

Photograph 16: Soffit of west main girder looking south. 50-80mm wide band of paint loss, surface corrosion and leachate staining. 2mm section loss typical

Photograph 17: Soffit of west main girder looking north. 50-80mm wide band of paint loss, surface corrosion and leachate staining. 2mm section loss typical

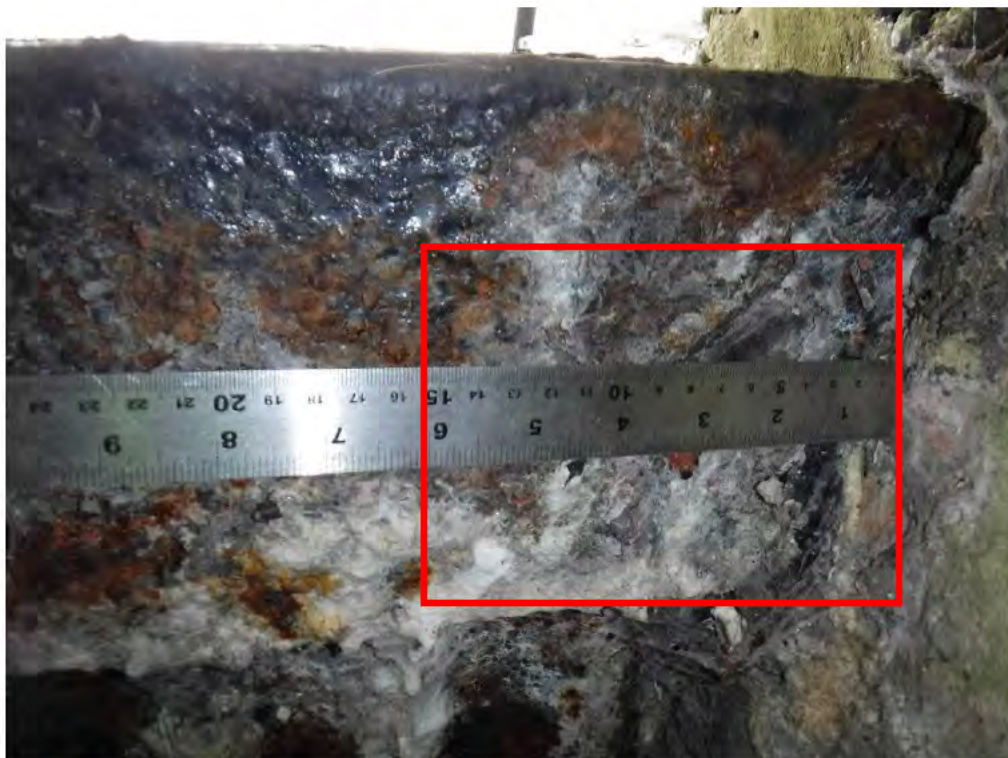
Photograph 18: 150x130mm area of delamination to west main girder adjacent to south support

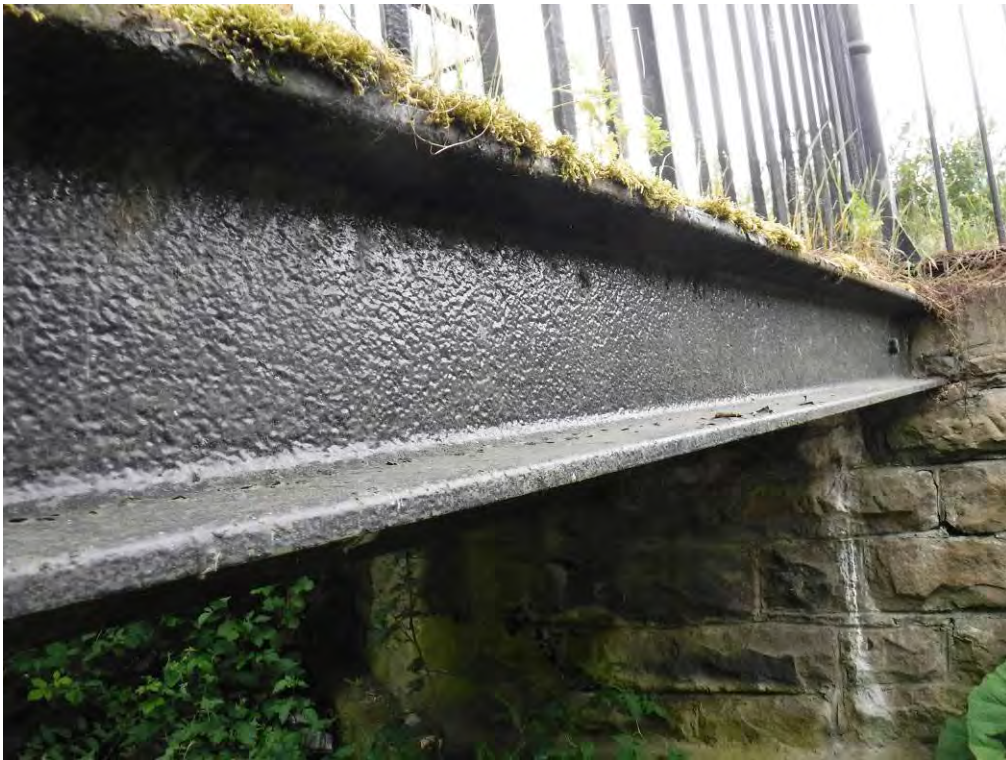
- Fair condition.
- The metallic paint system at the top flange, upper surface of the bottom flange and outer face of the web is typically intact with minor chips and cracks (Photograph 19).

- Typically 2mm historical pitting section loss identified to the outer face of the web, 1mm underside of the top flange outstand and upper face of the bottom flange outstand (Photograph 19).

Photograph 19: East main girder outer face looking north. Typical 1-2mm historical pitting section loss

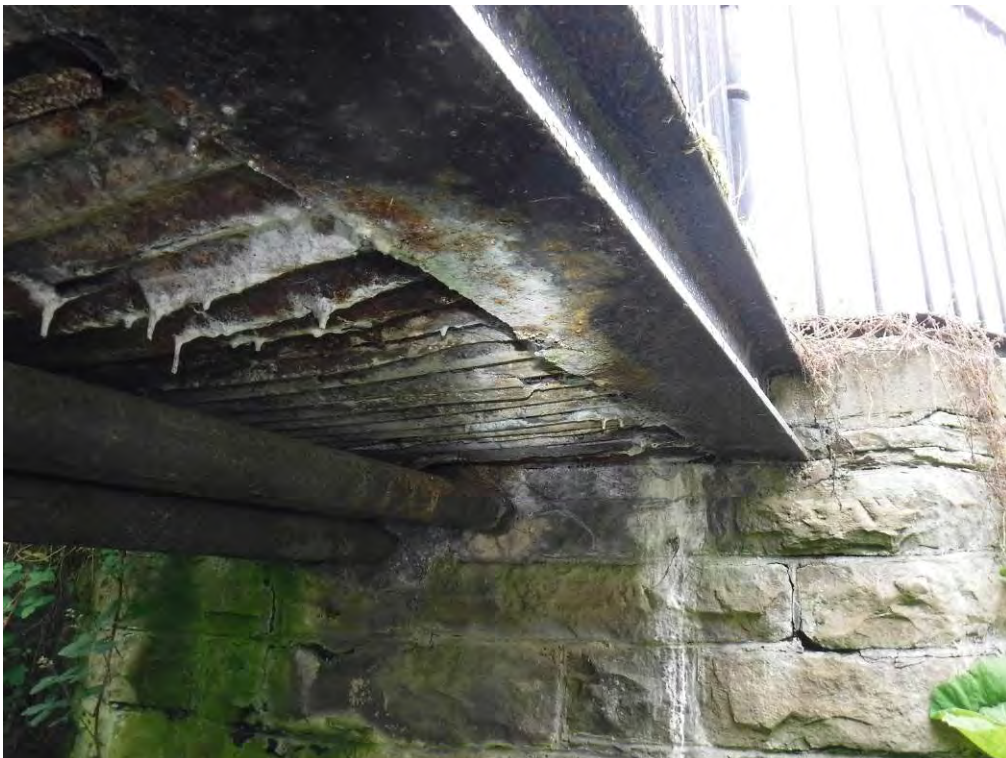
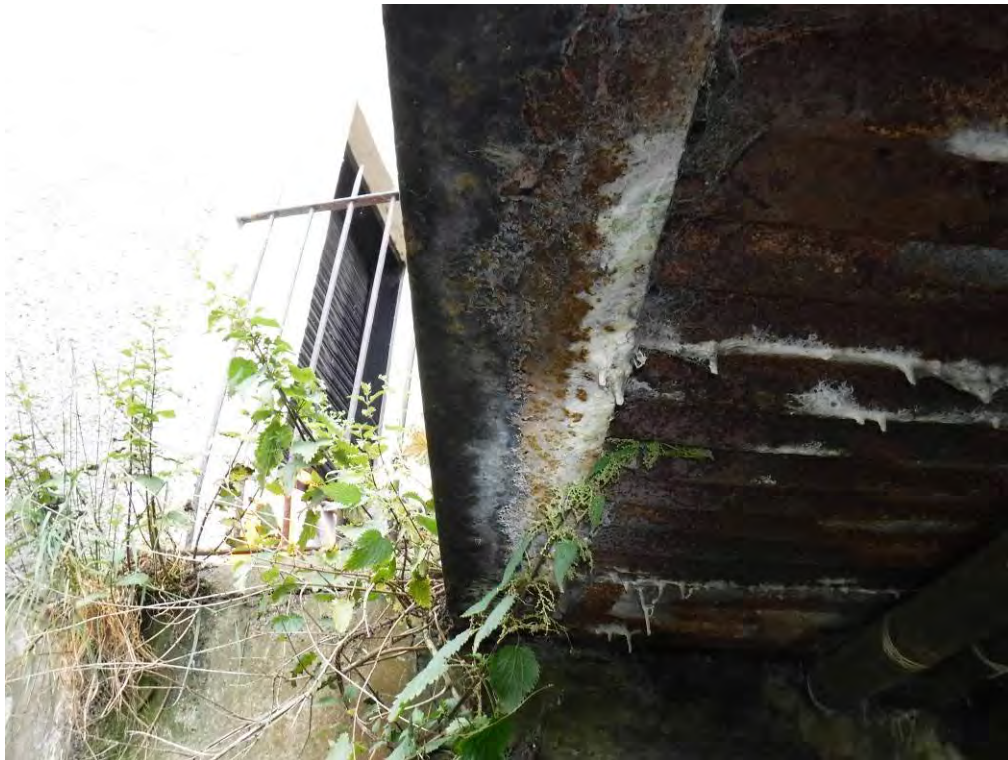
- 50 to 80mm wide band of paint loss, surface corrosion and leachate staining/stalactites along the inner edge of the bottom flange soffit along the full span. 1mm section loss to the full width of the flange soffit throughout (Photograph 20 and Photograph 21).

Photograph 20: Soffit of east main girder looking north. 50-80mm band of paint loss, surface corrosion and leachate across full span. 1mm section loss typical

Photograph 21: Soffit of east main girder looking south. 50-80mm band of paint loss, surface corrosion and leachate across full span. 1mm section loss typical to full flange width

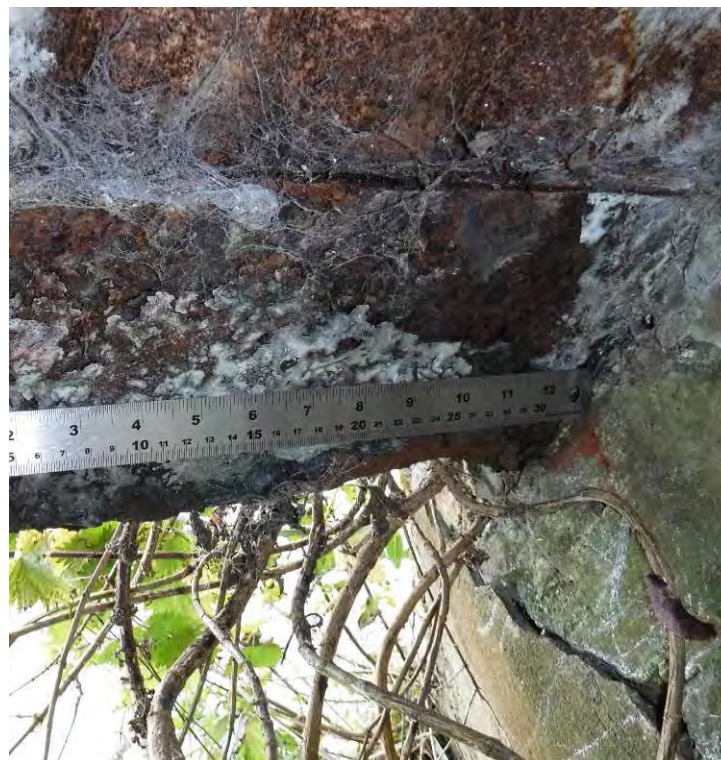
- Isolated 300mm length of delamination and 2mm pitting section loss across the full width of the bottom flange soffit from the south abutment (Photograph 22).

Photograph 22: East main girder - Isolated 300mm length of delamination and 2mm pitting section loss across the full width of the bottom flange soffit from the south abutment

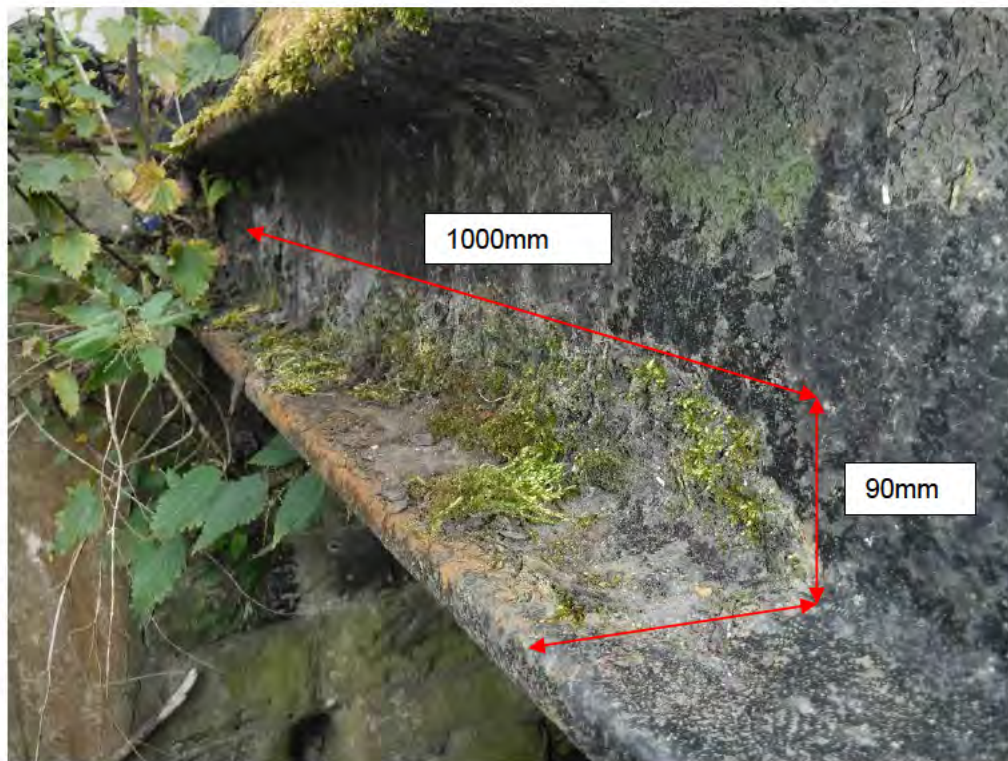
Photograph 23: East main girder - 4mm section loss to 1000x90mm area along upper surface of bottom flange and web

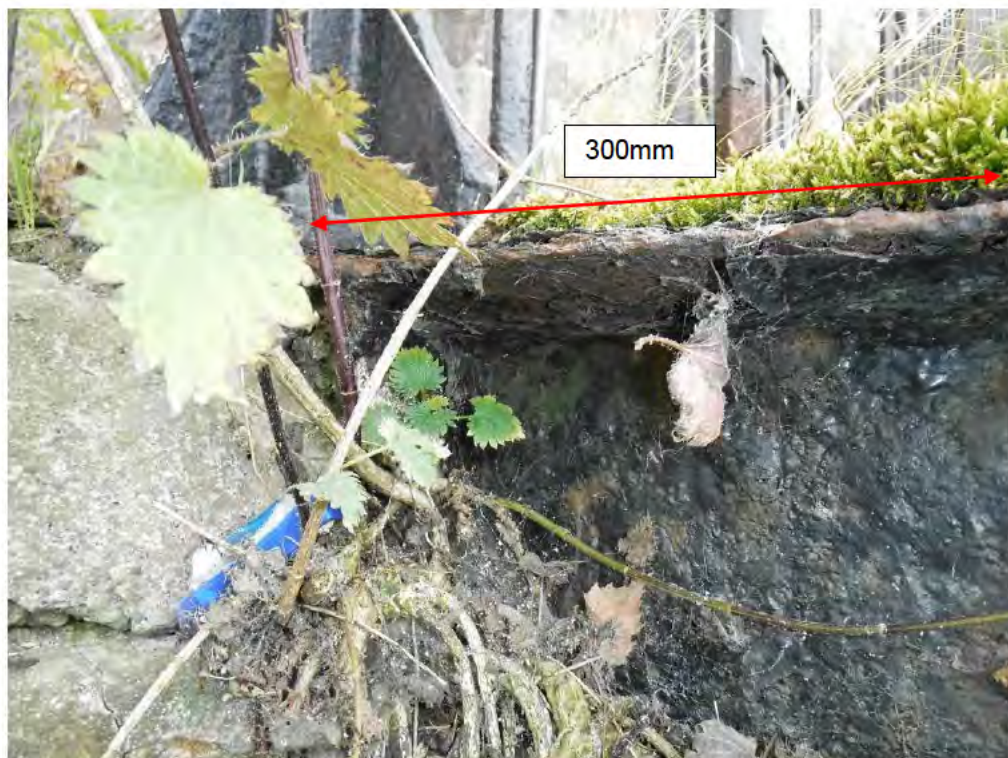
- Knife edge corrosion with a typical residual thickness of 6mm to the outer edge of the top flange outstand along a length of 300mm from the south support (Photograph 24).

Photograph 24: East main girder at south support – Knife edge corrosion to top flange outstand. 6mm residual thickness

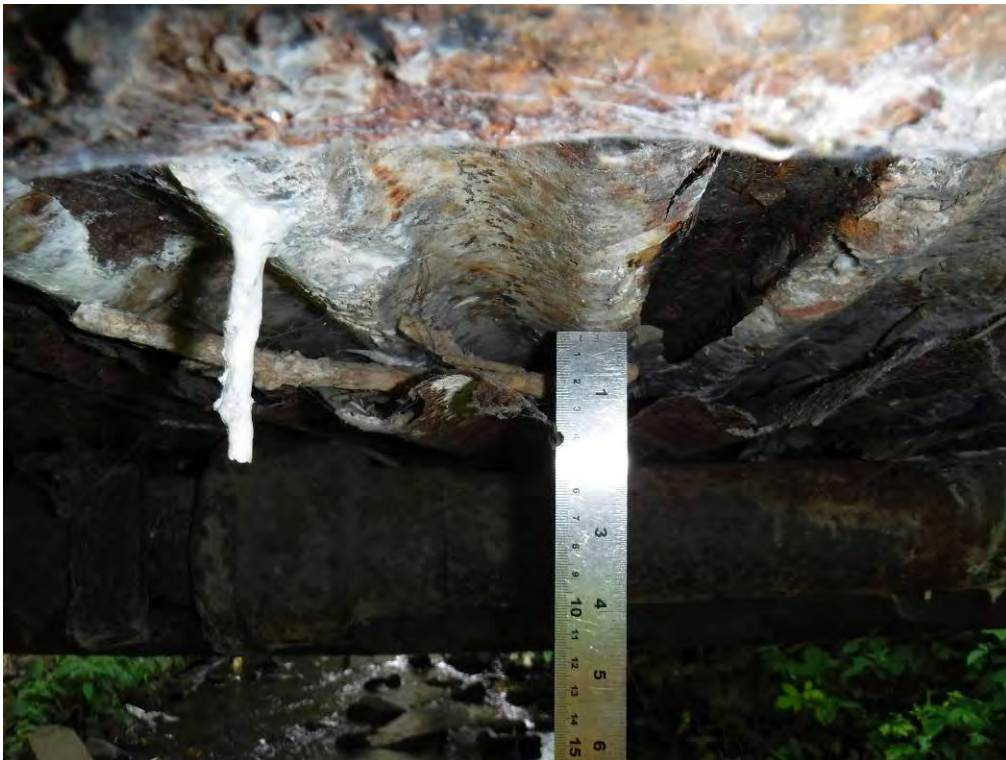
- Poor condition.
- Widespread breakdown of metallic paint system, corrosion throughout and leachate staining/deposits to approximately 30-40% of the deck area. Water ingress is clearly an issue and appears to be the primary cause of the defects identified (Photograph 6 to Photograph 7).
- Widespread delamination and heavy section losses throughout. Several large sections of deck have delaminated and separated from the parent steel and are hanging loose from the deck soffit. (Photograph 25 to Photograph 28). The residual thickness of the remaining deck section could not be identified.

Photograph 25: Delaminated section of deck separated from soffit, 40mm displacement

- Consider feasibility study to investigate repair/replacement of the heavily corroded and delaminated trough deck. Consider installing effective waterproofing system in conjunction with any repair works carried out.
- Report discharge of sewage into watercourse to SEPA from open headed weep joint at south-west wingwall.

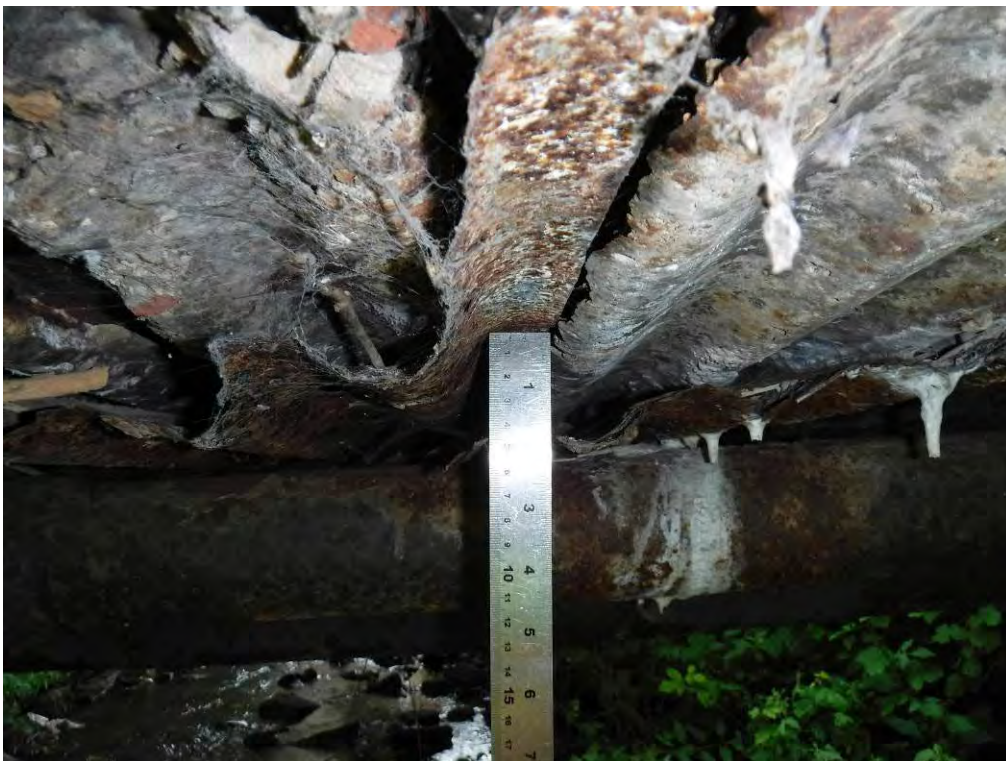
Photograph 26: Delaminated section of deck separated from soffit, 50mm displacement

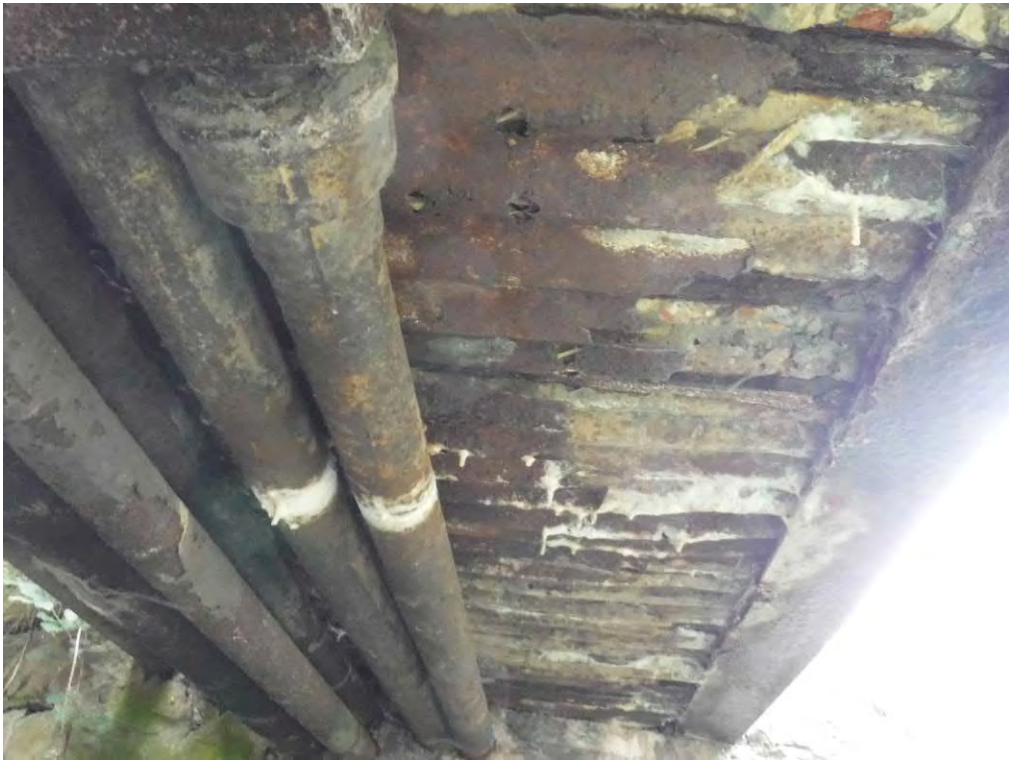
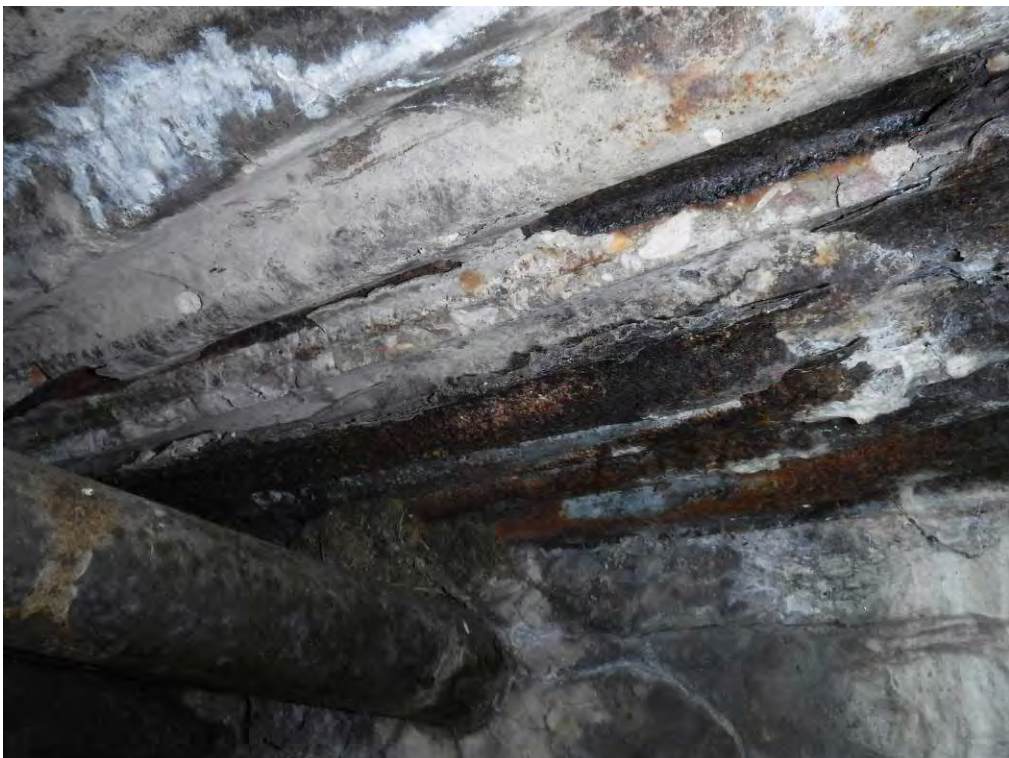
The waterproofing, if present, is buried and was not inspected. Water ingress is clearly a widespread problem as exhibited by the poor condition of the trough deck.

Photograph 27: Trough deck in poor condition. Widespread corrosion and delamination

Photograph 28: Trough deck in poor condition. Widespread corrosion and delamination

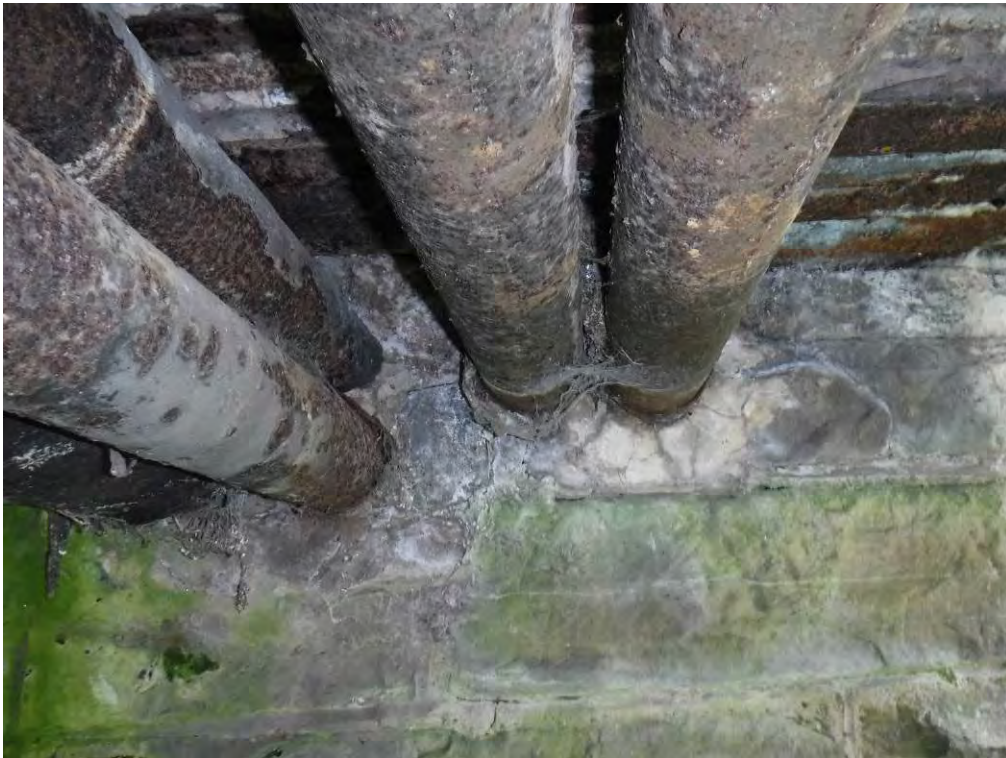
Photograph 29: North abutment – cracked concrete infill surrounding service pipes

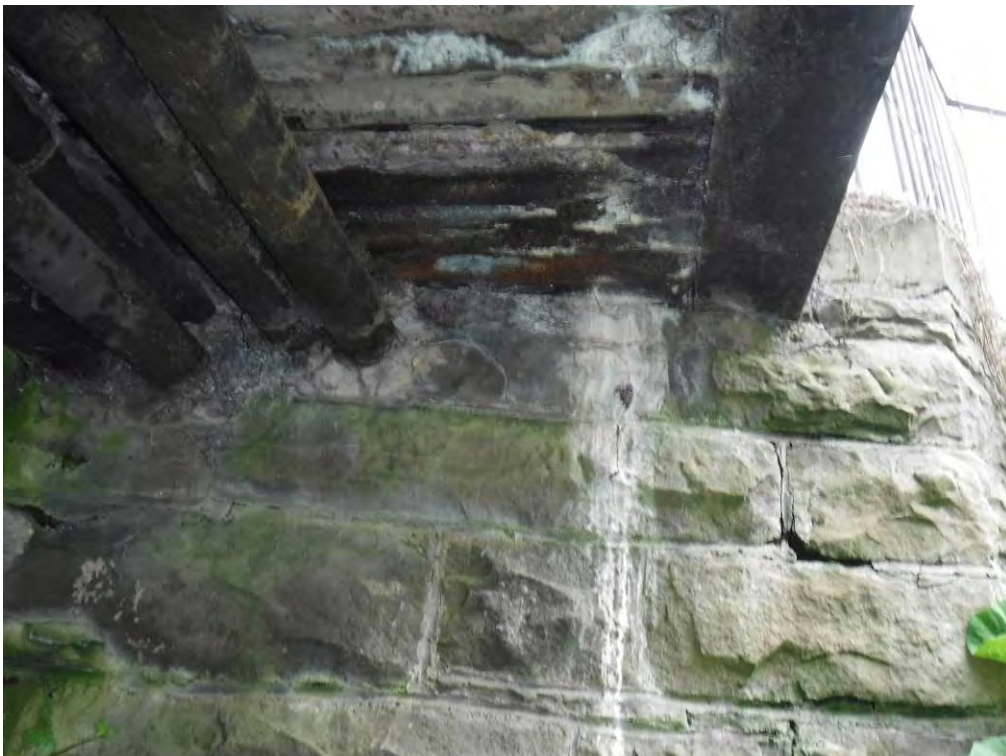
Photograph 30: Leachate staining to north abutment

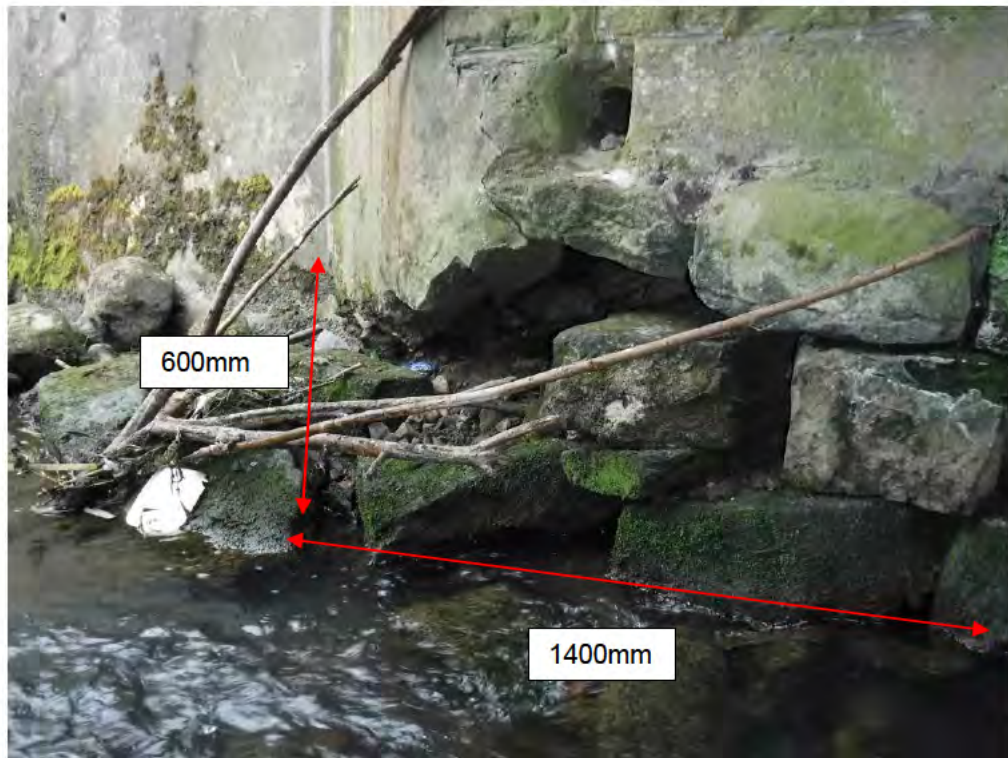
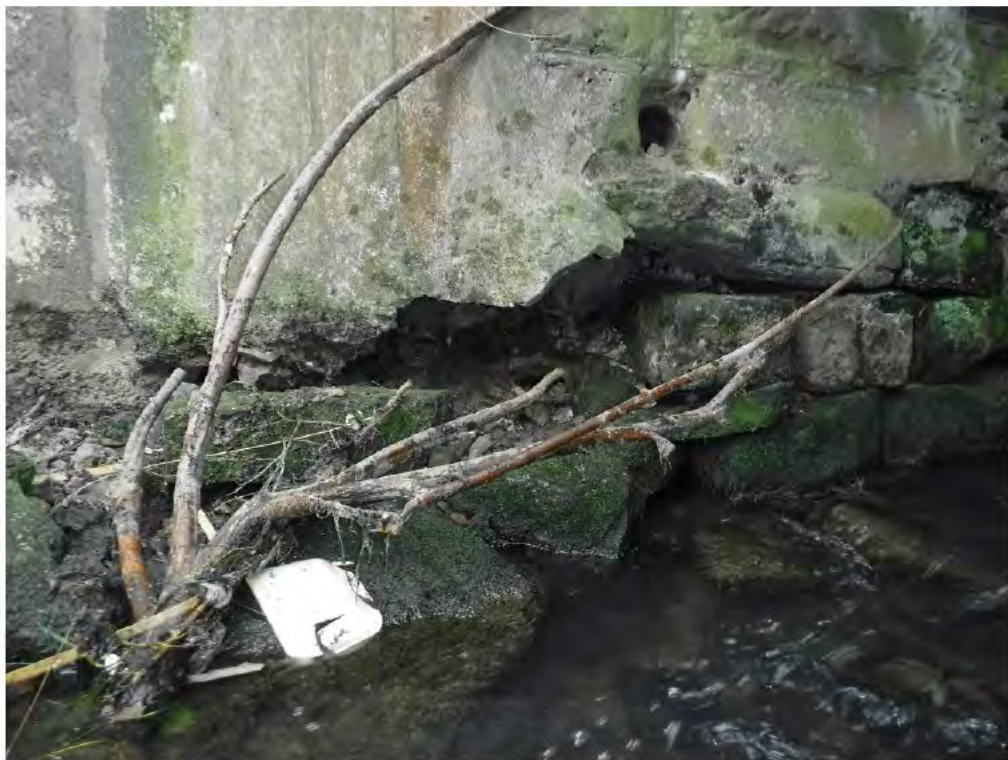
The substructure was found to be in fair condition with the exception of the south abutment which has been undermined and has a significant area of missing stone at the base of the abutment which requires repair.

Photograph 31: South abutment – base undermined and large area of missing and dislodged masonry

Photograph 32: South abutment – base undermined and a large area of missing and dislodged masonry

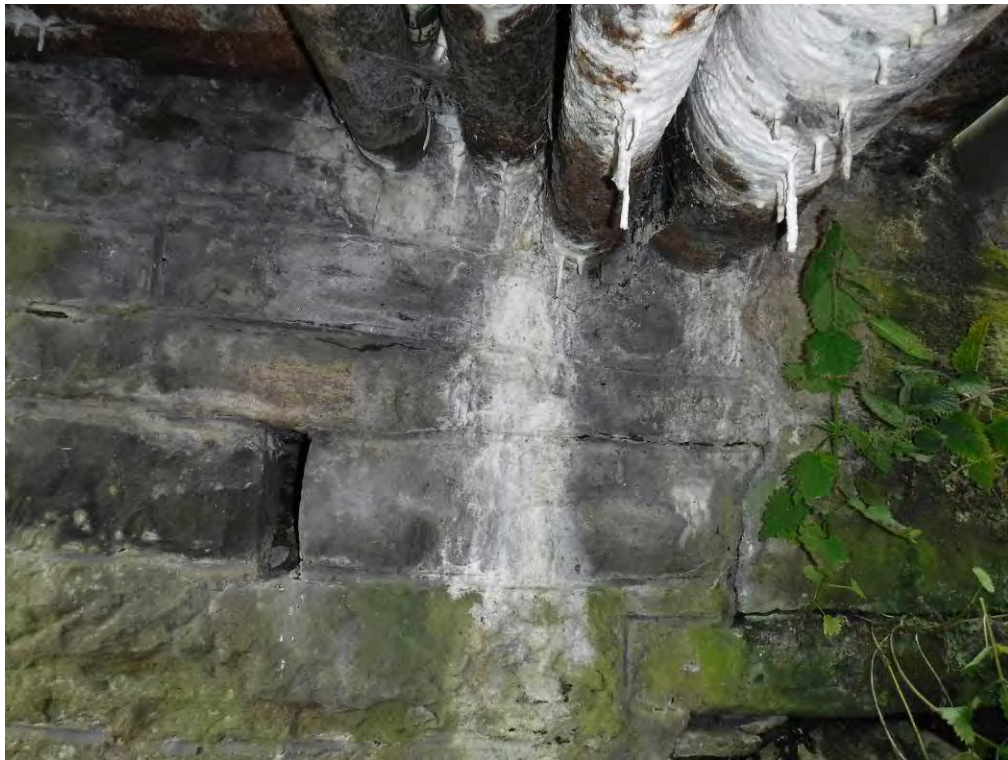
Photograph 33: South abutment - Cracked concrete infill surrounding the service pipes and leachate staining beneath to the masonry abutment face
