HY623/251

**Stenhouse Mill Lane
Bridge**

**Principal Inspection
Report**

July 2018

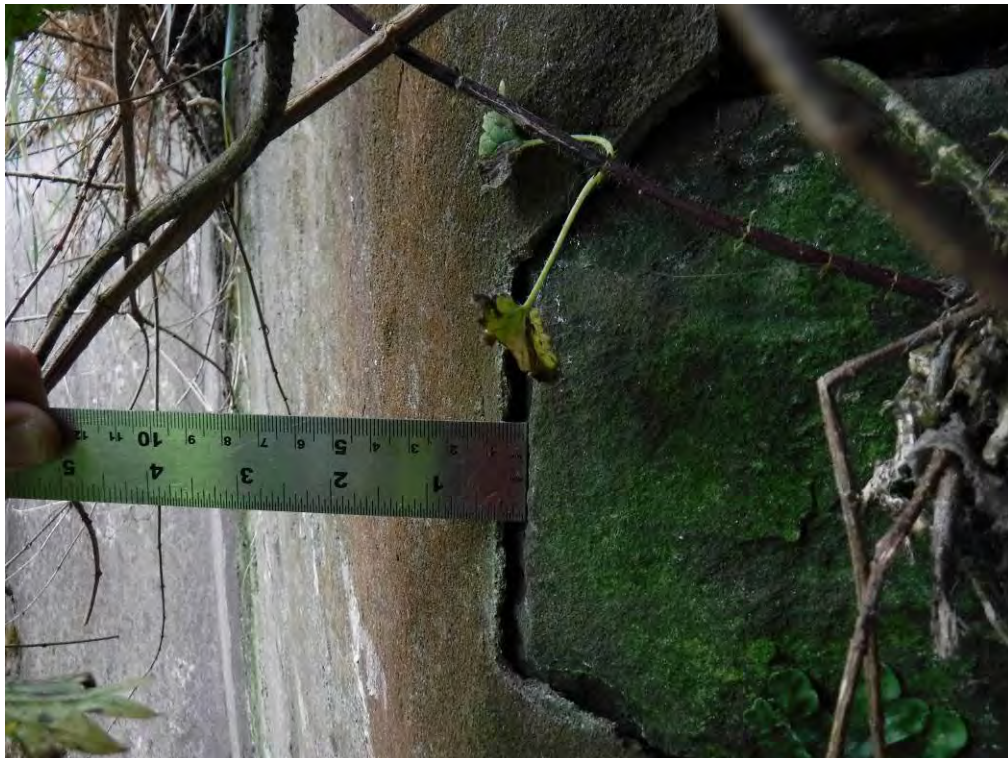
- Fair condition (Photograph 13).
- 5mm separation between concrete wingwall and masonry abutment (Photograph 34).

Photograph 34: 5mm separation between south abutment and south-east wingwall

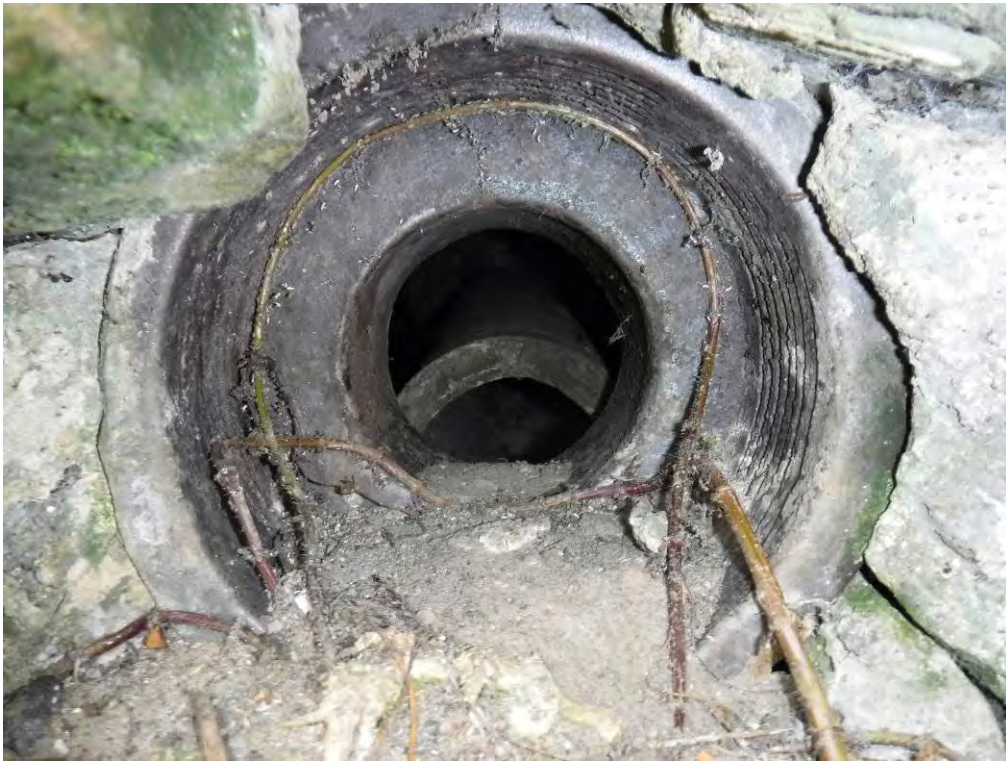
- Fair condition.
- 1No. weep pipe at the south-west wingwall is misaligned with the outlet at the wingwall face (Photograph 35).
- An open head joint weep hole at the south abutment/south-west wingwall was observed to discharge sewage directly into the watercourse which is an environmental concern (Photograph 36).
- Drainage pipe weep hole at south abutment appears unblocked (Photograph 11).

Photograph 35: South-west wingwall – weep pipe misaligned with outlet

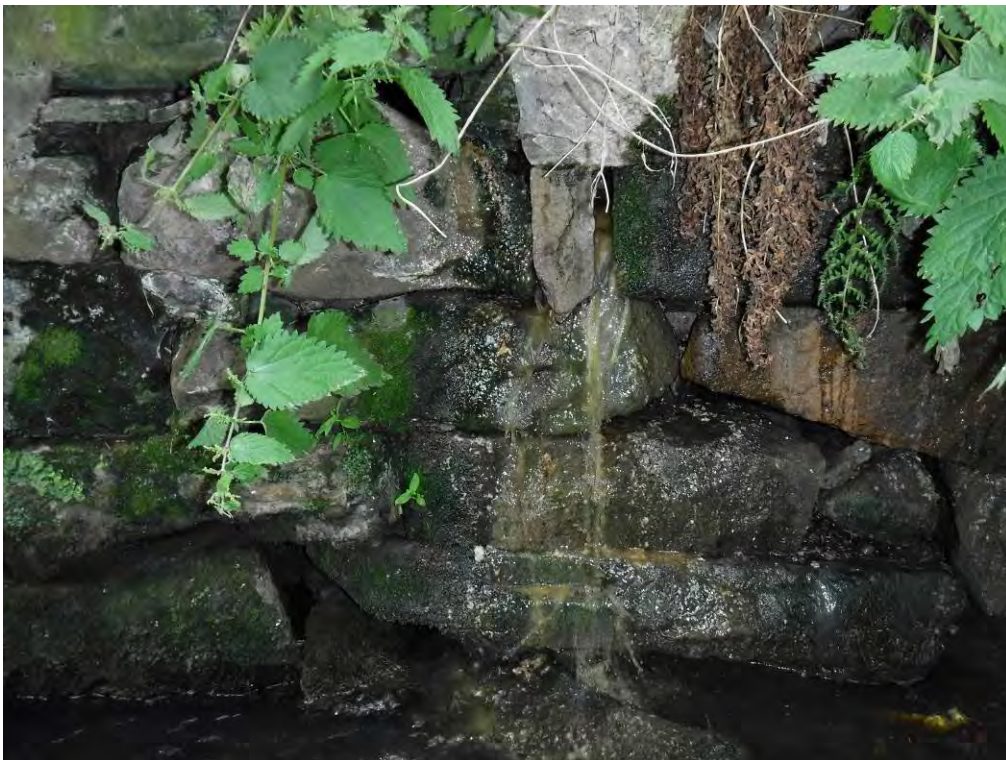
Photograph 36: South-west wingwall – open headed joint weep hole discharging sewage directly into Murray burn watercourse

- Consider feasibility study to investigate repair/replacement of the heavily corroded and delaminated trough deck. Consider installing effective waterproofing system in conjunction with any repair works carried out.
- Report discharge of sewage into watercourse to SEPA from open headed weep joint at south-west wingwall.

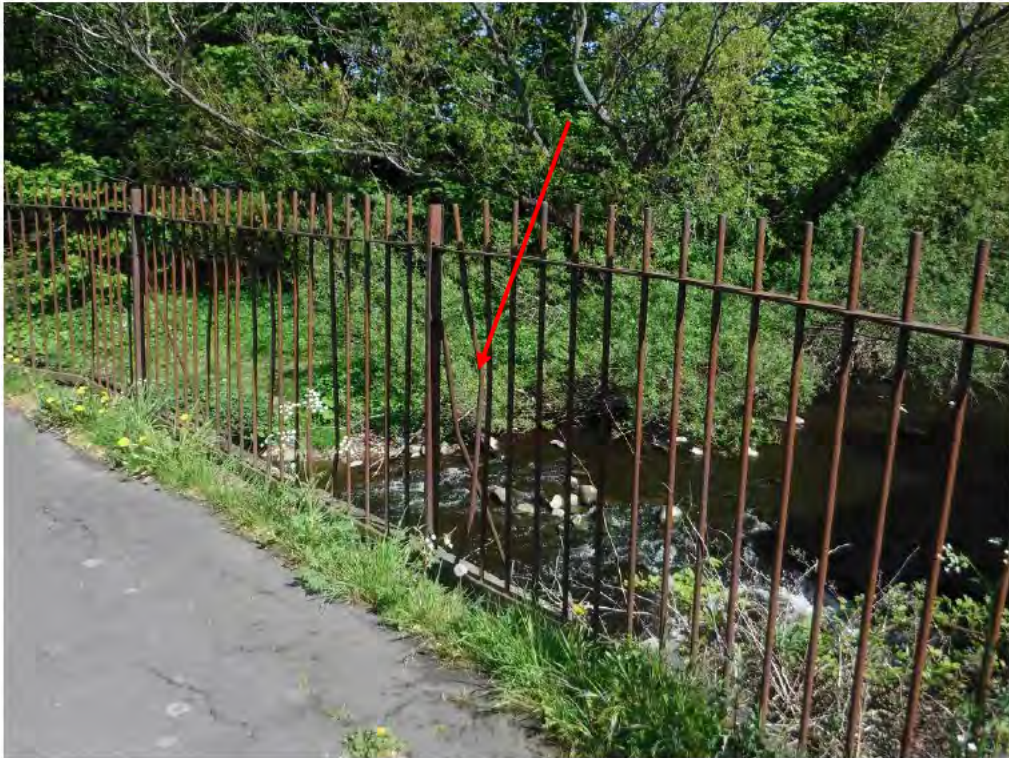
- The parapets and approach fences are generally in fair condition.
- The metallic paint system is generally intact with normal weathering except at the north-east approach fence where the paint system has broken down along 60-70% of its length
- 2No. railings at the north-east approach fence have buckled out of shape (Photograph 37).

Photograph 37: North-east approach fence – paint system broken down and 2No buckled railings

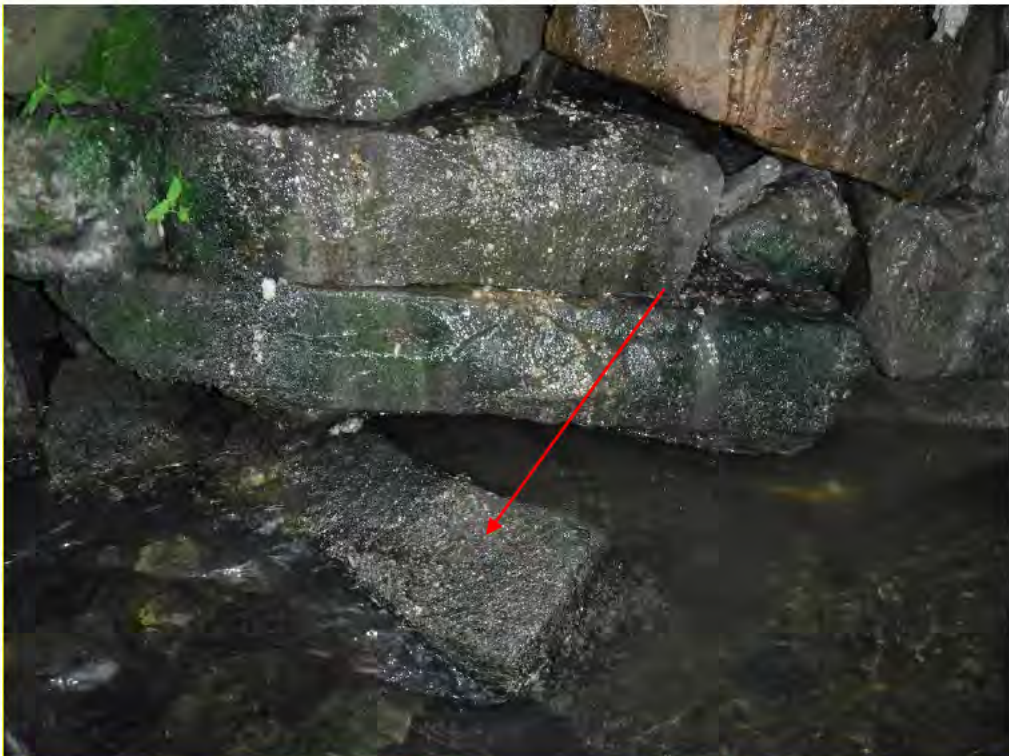
- Fair condition (Photograph 12).
- Dislodged stone at base of wingwall (Photograph 38).

Photograph 38: South-west wingwall – dislodged stone at base

- Repair undermined section of south abutment and dislodged stone at the south-west wingwall.

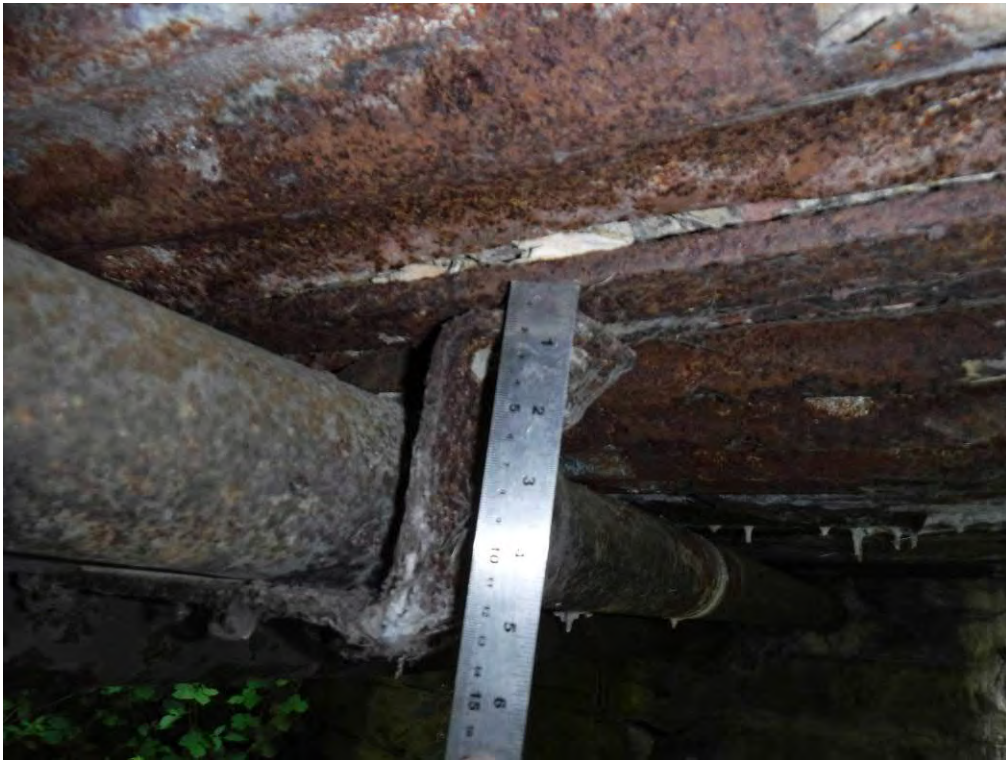
Photograph 39: Service pipe bracket connection – dropped by 10mm. Not loose to touch

- Blast clean metallic elements comprising the superstructure and reapply metallic paint system.
- Repair service pipe bracket bolted connection with deck soffit.
- Remove overgrown vegetation obscuring 2No. wingwalls.
