Survey for Edinburgh Council - Preservation

10 Rutherford Drive, Edinburgh,
EH16 6AX

Survey Report

Firstcall Reference: JOB-24133

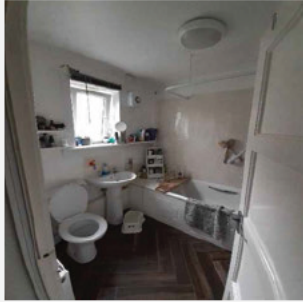
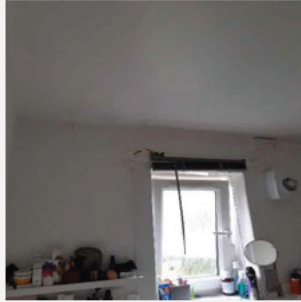
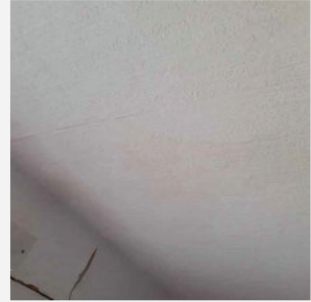
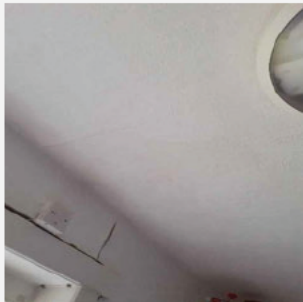
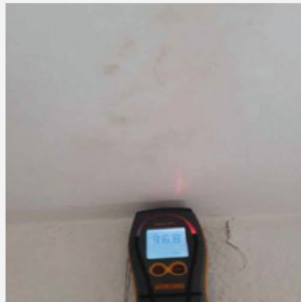
On entry was shown to front facing Bathroom, visible water staining to ceiling and high level walls, peeling paper, due to readings this is an active leak as ceiling and high level walls are saturated

With use of a moisture meter readings were taken to ceilings and walls and sourced elevated readings with bathroom only

Recommend CECs one operatives carry out necessary repairs above prior to any internal works being undertaken

- Blue grit and plaster B+K ceilings
- Full decoration to B+K
- Minor electrics for access
- Removal of pulley fittings (grinder)

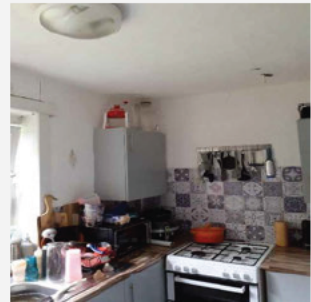
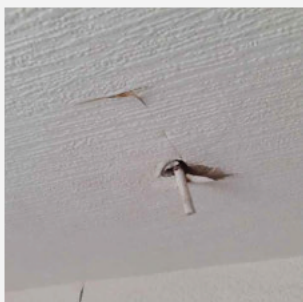
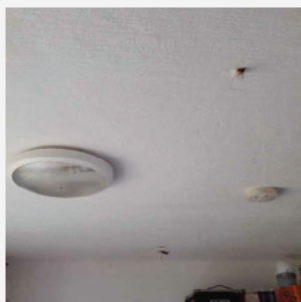
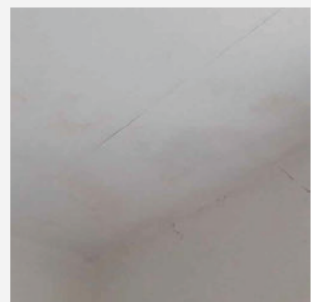
Rear facing Kitchen too has water staining and peeling paper to ceiling following a historic leak tenant advised, was also advised pulley was taken down and fittings were left in ceiling

It was also noted that there is no environment within Kitchen would recommend installing a glazed extractor due to layout
