EDINBURGH TRAM YORK PLACE TO NEWHAVEN

STAGE 2 Road Safety Audit – DESIGNERS RESPONSE

PROJECT				ORIGIN			VOLUME			LEVEL		TYPE		ROLE	NUMBER				REV		
E	T	Y	N	S	E	F	X	X	X	0	3	R	P	D	0	0	0	1	P	0	4

April 2021

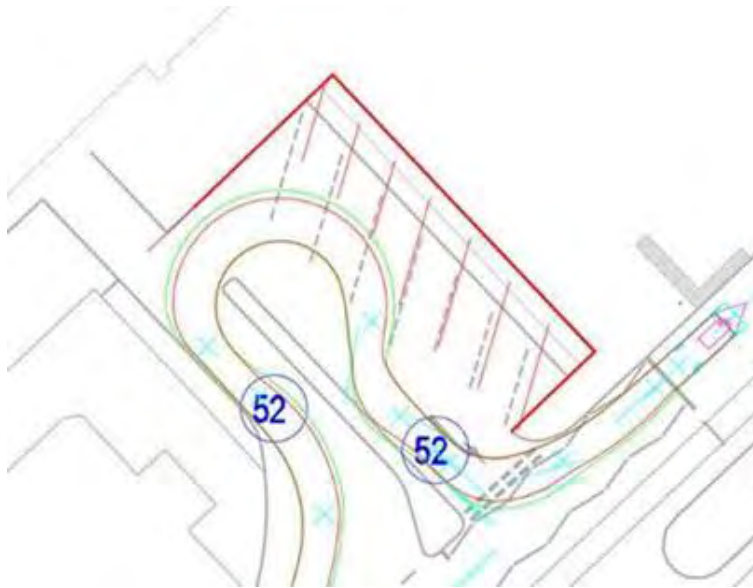
Figure 1 - Ocean Terminal Taxi Rank

Swept path drawings have not been provided to the Audit Team. From the plans provided, it is unclear whether there is sufficient space for a vehicle to safely manoeuvre in this area without overhanging a footway or undertaking an unsafe manoeuvre.

The designer assumes the comment is the stage 1 and stage 2 RSA in relation to a taxi rank positioned to the east of the Ocean Terminal western carpark entrance. The designer has reviewed the swept path and confirm that the existing arrangement will be amended to accommodate the swept path requirements for the taxi rank see Figure 1.

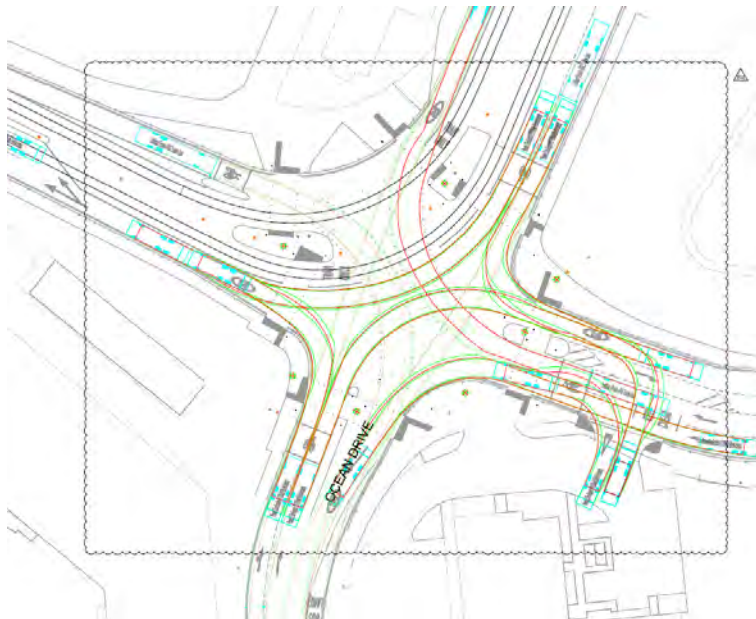
Figure 2 - Swept Path Junction 5 Melrose Drive/Ocean Drive

It is recommended that swept path analyses are undertaken of a large vehicle carrying out the turning movements at this junction, and that the design is modified as necessary to ensure all turning movements can be safely accommodated.

Swept path information provided to the RSA team demonstrating manoeuvrability of vehicles at the junction. Refer to ETYN-SEF-XXX-12DR-H-1306_P02 see Figure 2

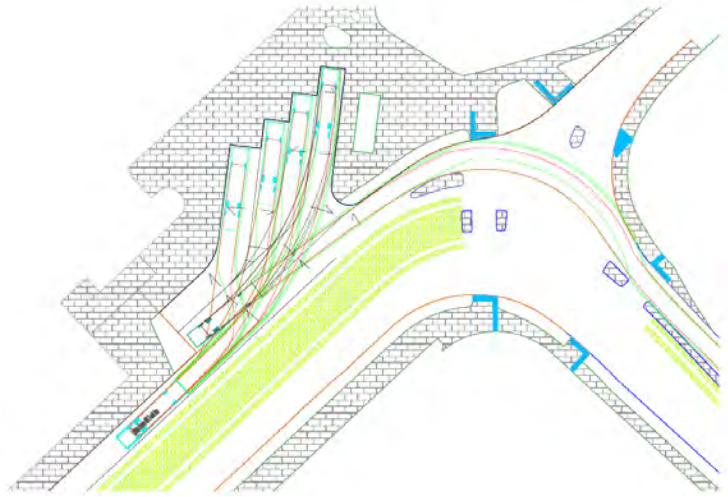
Figure 4 - Ocean Terminal Bus Facility Swept Path

Swept path drawings have not been provided to the Audit Team. From the plans provided, it is unclear whether there is sufficient space for a vehicle to safely manoeuvre in this area without entering the carriageway or undertaking an unsafe manoeuvre.

The swept path analysis undertaken for the Ocean Terminal Bus facility indicates sufficient width to allow vehicles to access and egress the Ocean Terminal bus facility. See Figure 4

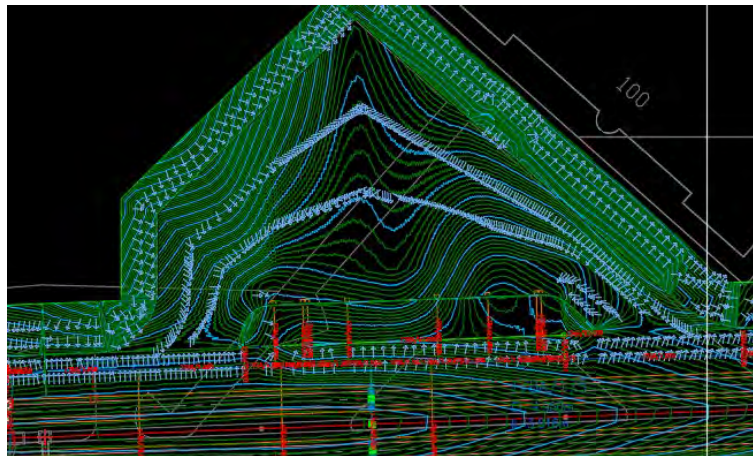
Figure 6 - Forth Ports Drop-Off Area Contours

The observed photograph included in the stage 2 road safety audit report is a picture off the existing Forth Ports drop off layout and not the proposed works.

However the existing layout of the Forth Ports drop off is to be altered such that the hardstanding area will drain from the building towards Melrose Drive Figure 6. New gullies are located on the hardstanding side of the shared footway/cycleway providing a positive drainage connection to the new carrier drain in Melrose Drive.

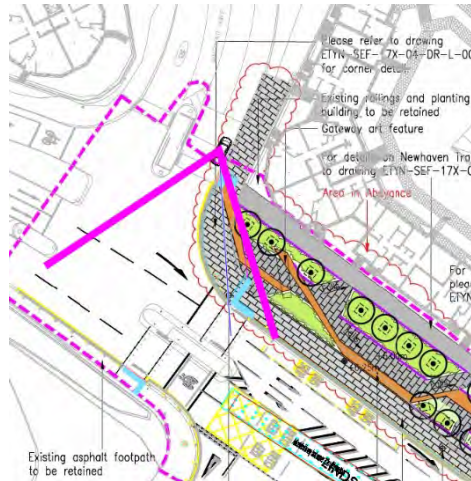
Figure 8 - visibility envelope at Sandpiper Drive junction

No visibility issue has been found for the vehicles turning left to Lindsay Road once the vehicle has advanced over the cycle box. From the stop line the trees are within the visibility splay however the

trees specified there will have a clear stem of 2m as a minimum with the canopy above that being a compact and uniform shape reducing significantly the obstruction to visibility. The building on the left is not blocking the visibility envelope.

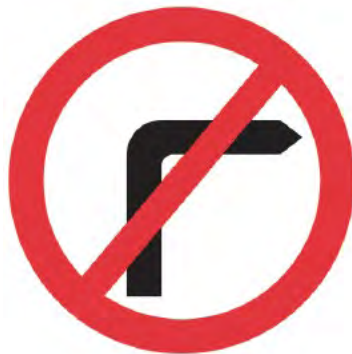
Figure 10 - No right turn for vehicular traffic

There is a risk of motorised road users undertaking unsafe manoeuvres across the tram tracks resulting in side-swipe collisions.

This movement is prohibited by the use of a 'No Right Turn' sign to Diagram 612

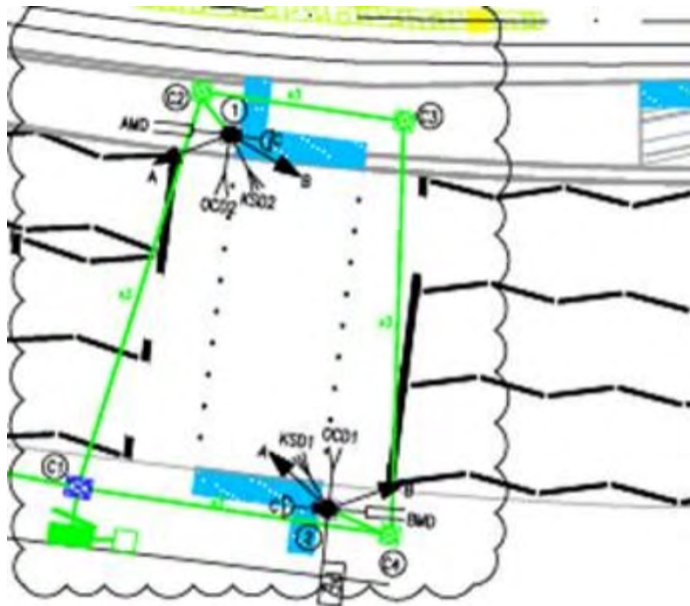
Figure 11 - Lindsay Road Pedestrian Crossing

From the plans provided, it appears that no secondary traffic signals are proposed at the signalised pedestrian crossing on Lindsay Road. With two lanes of traffic approaching the signals, there is a possibility that the primary signal head and / or duplicate primary could be obscured by large vehicles. There is also a risk that a signal head could fail, meaning that approaching drivers / riders may not be able to see a signal head on approach to the crossing.

Secondary signals have been added to the design. See Figure 11
