Wall Name: Marchfield Road Lane				Wall/No: 22-41		
						_
Map Ref:	E: 320791	N: 675122	Single Span Structure	Letter delivered to private owner	No	
Inspection Date	18/01/2023	Inspector Name		Category Rating	P2	
All above ground elements inspected: YES			Photographs? YES	Inspection Weather Conditions: Overcast		
Location Plan

## Inspection Summary - Include wall description and defects

Marchfield Road Lane. Masonry retaining wall retaining Hillhouse Road with the wall running along the perimeter of the garden of Marchfield Road Lane flats.

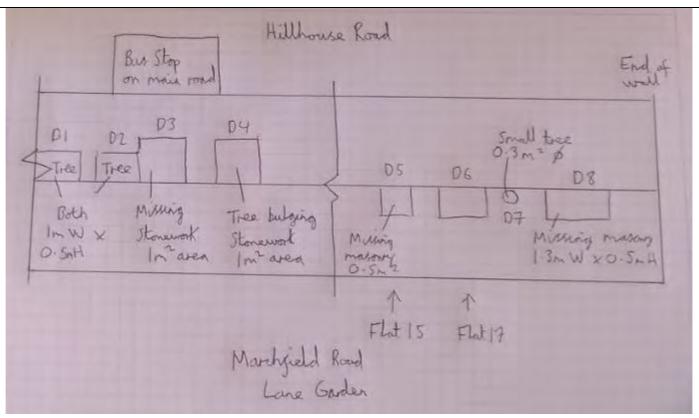
Figure 2: Defects Sketch

8no. defects present across two sections of wall. The defects are tree growths and missing masonry.

- Remove trees and roots from wall as required.
- Replace any masonry dislodged by removing trees masonry to be treated.
- Infill any missing masonry.
- Reuse masonry where possible.
- Ownership to be confirmed.

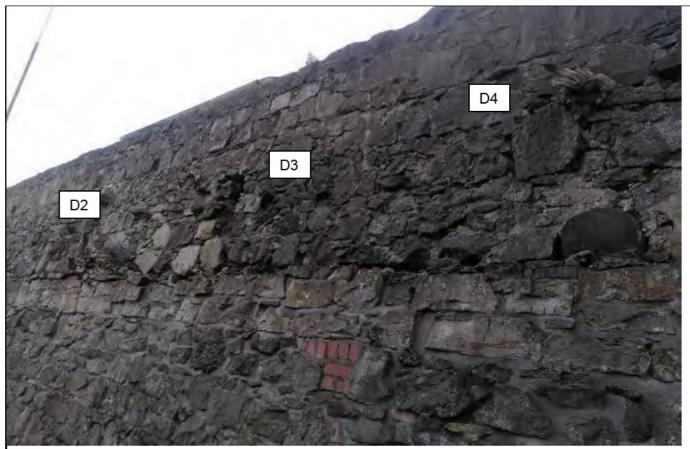
Defect 2 – Tree growth (1m wide x 0.5m high)

Defect 3 – Missing stonework (1m2 area)

Defect 4 – Tree growth leading to bulging stonework (1m2 area)

Figure 3: Defects 2, 3 and 4

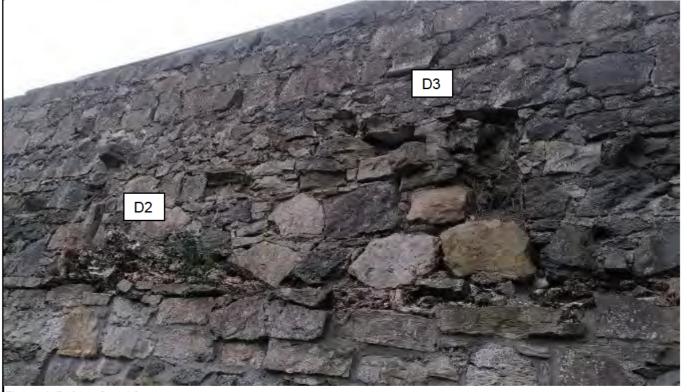
Figure 4: Defects 2 and 3

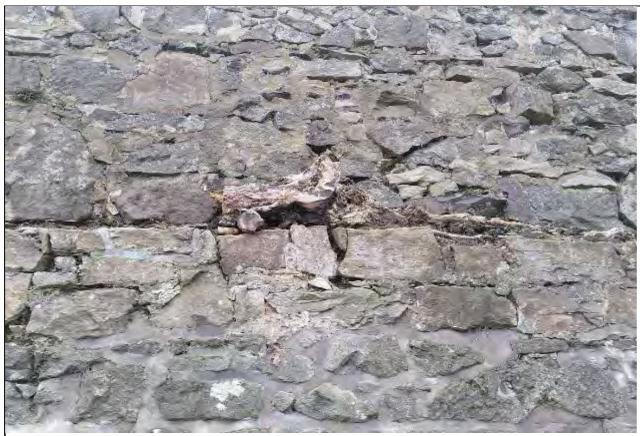
Defect 1 – Tree growth (1m wide x 0.5m high)

Figure 5: Defect 1

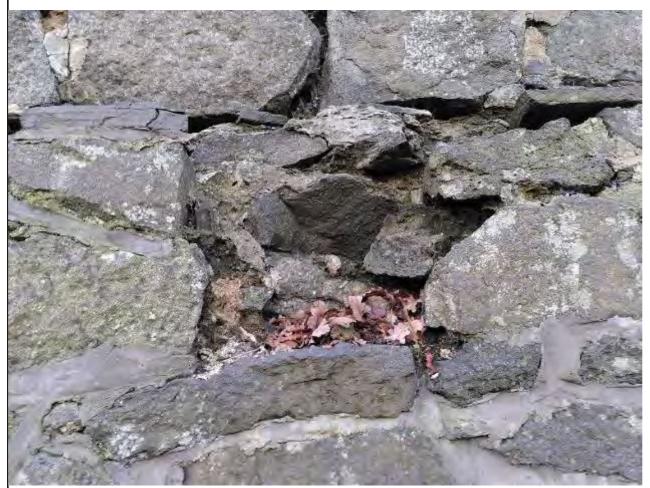
Defect 5 – Missing masonry (0.5m2 area)

Figure 6: Defect 5

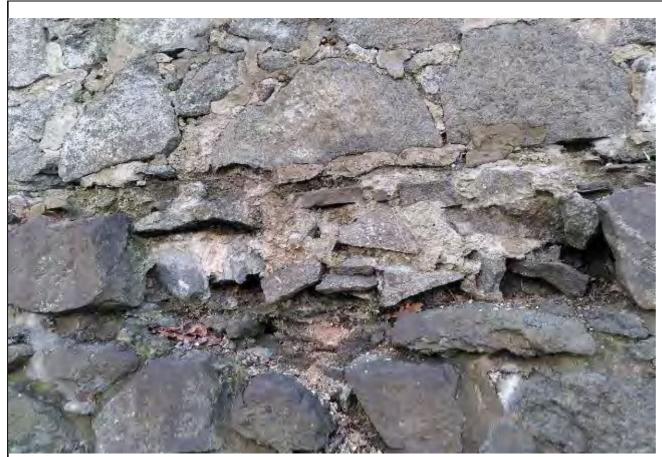
Defect 6 – Missing masonry (1.3m wide x 0.5m high)

Figure 7: Defect 6

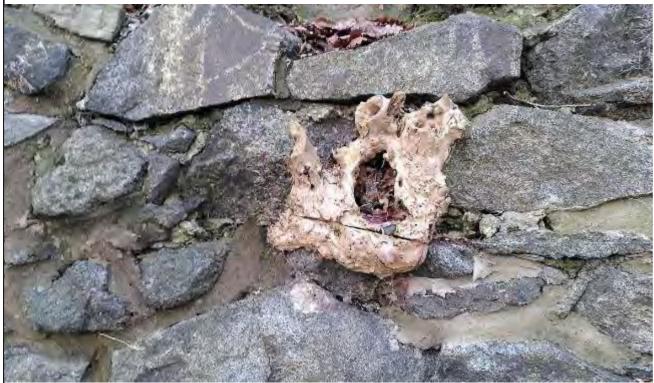
Defect 7 – Tree growth (0.3m2 area)

Figure 8: Defect 7

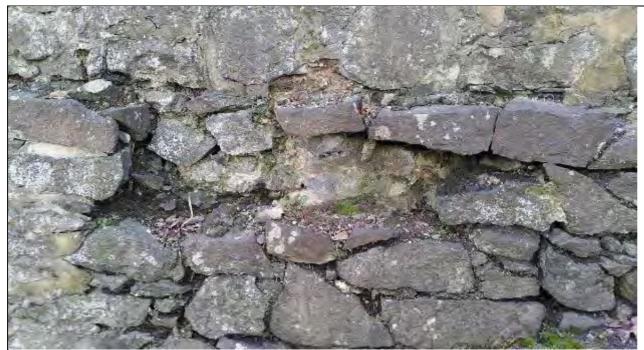
Defect 8 – Missing masonry (1.3m wide x 0.5m high)

Figure 9: Defect 8
