ASBESTOS SURVEY

KIRK BRAE RECREATION GROUND, 1 DOUBLE HEDGES ROAD, EDINBURGH

| Survey No : | CEC/329 |

REPORT OF ASBESTOS SURVEY OF KIRK BRAE RECREATION GROUND, 1
DOUBLE HEDGES ROAD, EDINBURGH

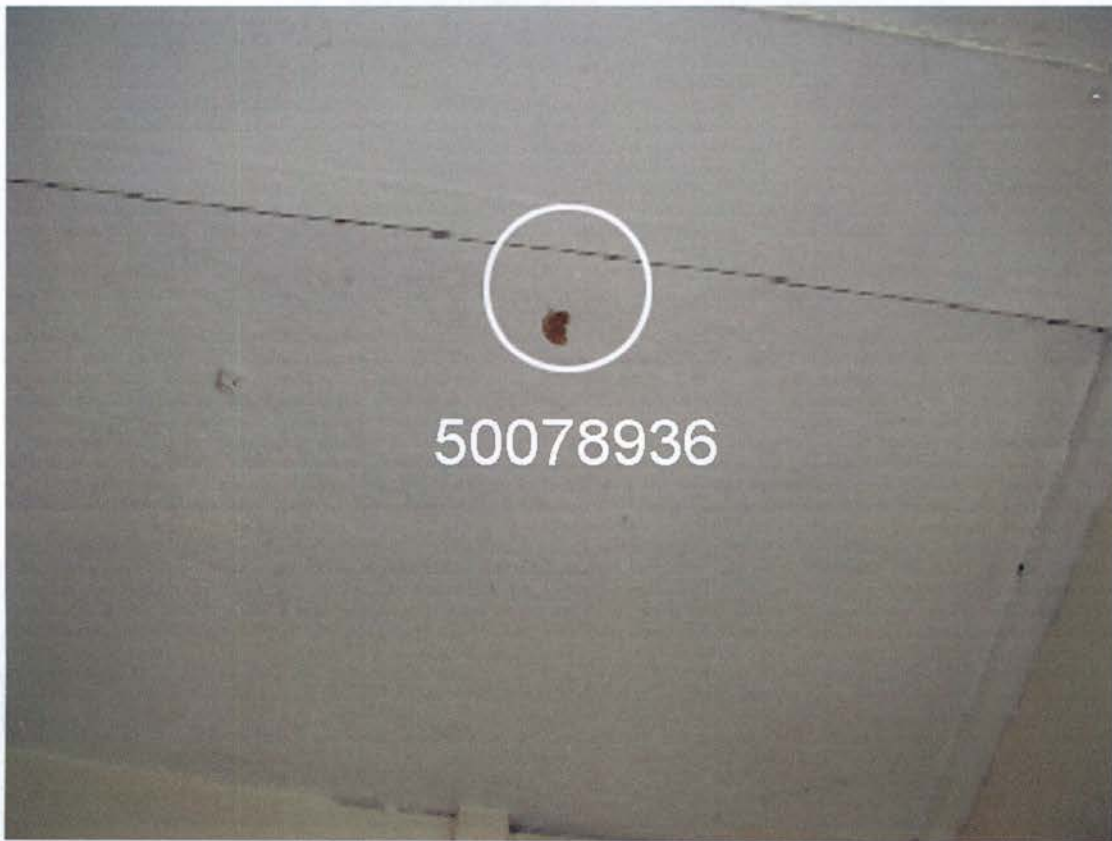
| LAB REF NO | SAMPLE NO | LOCATION CODE(SEE FIGS) | LOCATION | SAMPLE DESCRIPTION | ASBESTOS TYPE | ESTIMATED PROPORTION OF ASBESTOS |
|---|---|---|---|---|---|--|
| 78936 | KS1 | K2 | Staff area | Vegetable fibre tiles | Not detected | - |

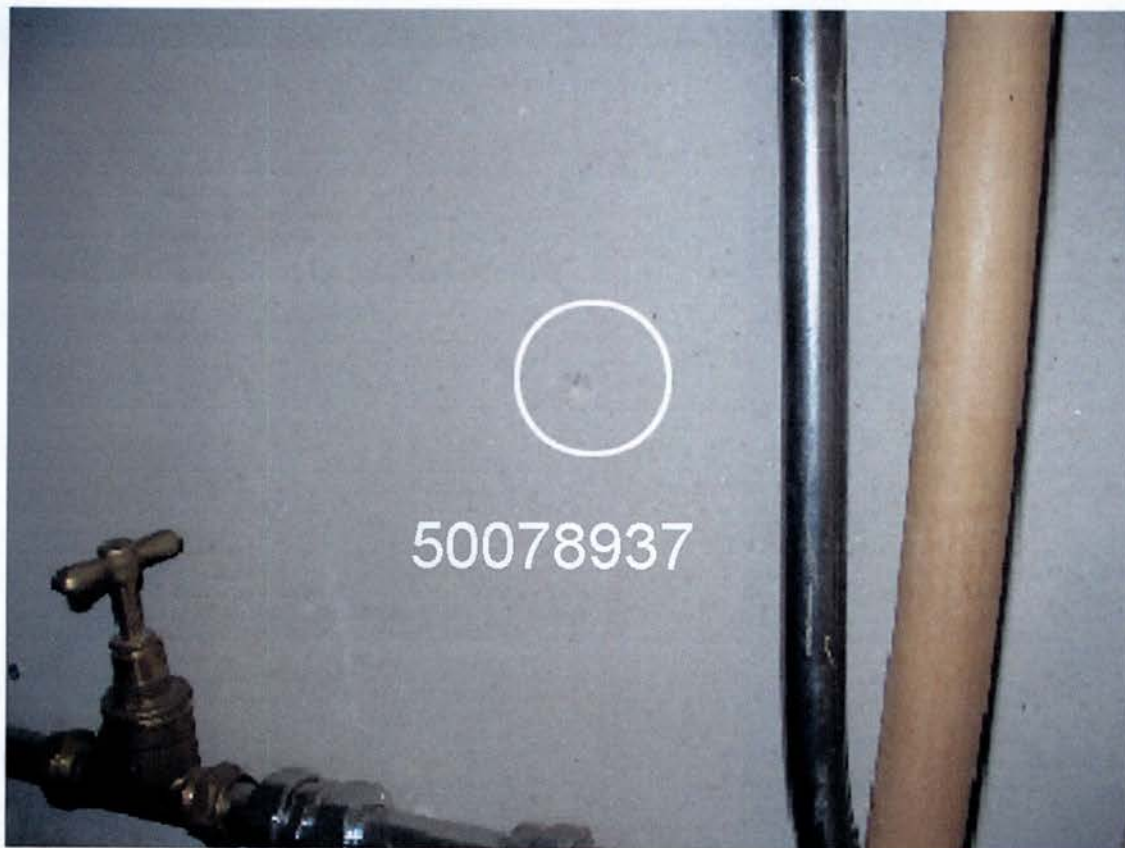
| LAB REF NO | SAMPLE NO | LOCATION CODE(SEE FIGS) | LOCATION | SAMPLE DESCRIPTION | ASBESTOS TYPE | ESTIMATED PROPORTION OF ASBESTOS |
|---|---|---|---|---|---|--|
| 78937 | KS2 | K5 | Changing room | Cement board wall panelling | Not detected | - |

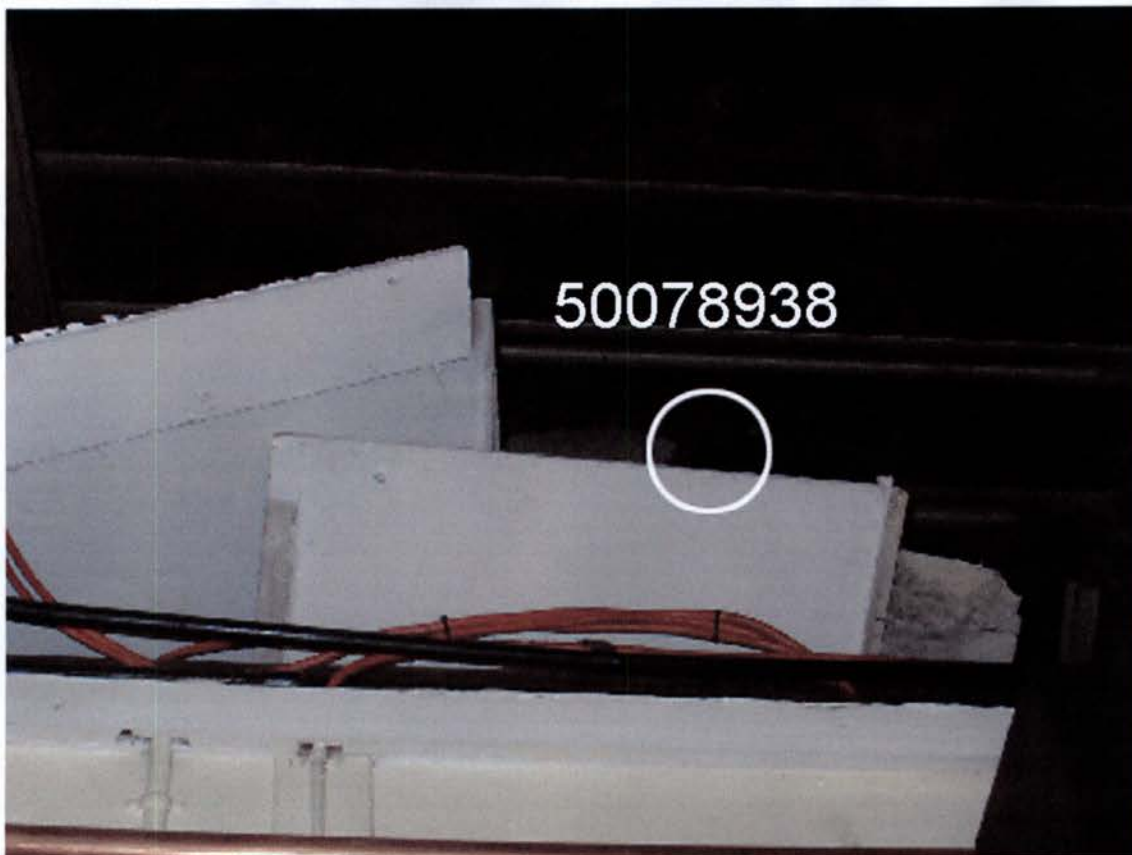
| LAB REF NO | SAMPLE NO | LOCATION CODE(SEE FIGS) | LOCATION | SAMPLE DESCRIPTION | ASBESTOS TYPE | ESTIMATED PROPORTION OF ASBESTOS |
|---|---|---|---|---|---|--|
| 78938 | KS3 | K2 | Staff area | Cement board | Not detected | - |

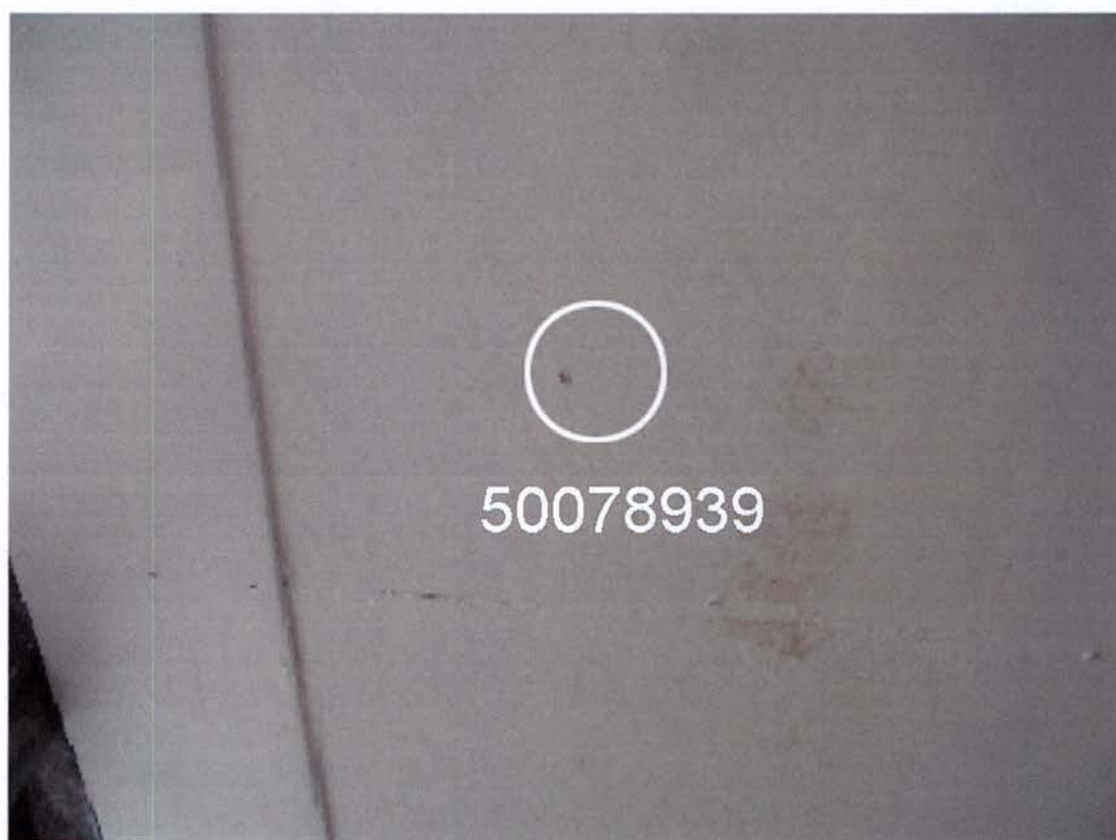
| LAB REF NO | SAMPLE NO | LOCATION CODE(SEE FIGS) | LOCATION | SAMPLE DESCRIPTION | ASBESTOS TYPE | ESTIMATED PROPORTION OF ASBESTOS |
|---|---|---|---|---|---|--|
| 78939 | KS4 | K7 | External toilets | Ceiling material | Not detected | - |
