**Westfield Court & Alexander Drive,
EH11 2RJ**

Structural Condition Report

Project title: Westfield Court & Alexander Drive, EH11 2RJ

Document number: E20511-WRD-XX-XX-RP-S-00001

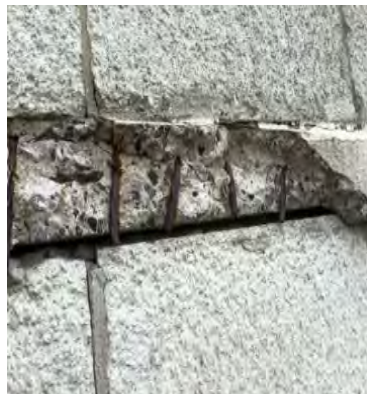
The string courses and horizontal ledges throughout the façade exhibit widespread deterioration. Numerous areas display concrete spalling, with extensive exposure of embedded reinforcement. The exposed rebar in these locations is heavily corroded, indicating prolonged ingress of moisture and loss of passivation. Additionally, there are numerous linear and transverse cracks present, ranging in length from 10mm up to approximately 1000mm. These defects are dispersed across all elevations, suggesting systemic degradation consistent with age-related wear and environmental exposure.

Spalling and exposed rebar on the string course

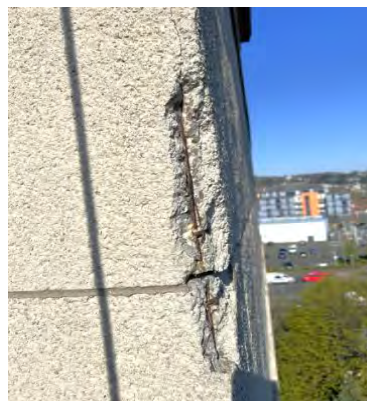
Based on visual inspection and tap testing, the majority of Orlit panels did not exhibit movement and show no immediate risk of detachment. Approximately 10% of the panels show signs of distress, including surface cracking and localised spalling. However, a full assessment of their structural condition will only be possible after a borescope inspection has been carried out.

Spalling and exposed rebar on the Orlit panel

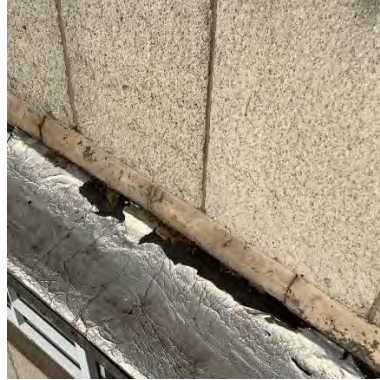
The top perimeter ledges of the building have undergone previous remedial work, evidenced by the application of flashband across multiple sections. While these interventions appear to have slowed active water ingress, some ledges still exhibit ongoing spalling and cracking, particularly at interfaces and junctions.

Previous flash band repairs.

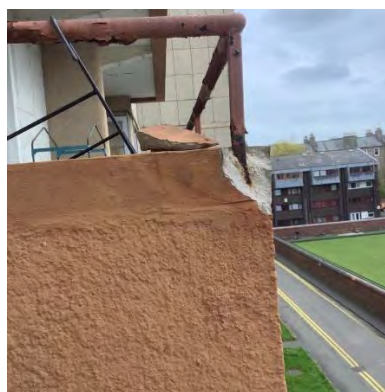
Several balcony slabs and soffits show signs of minor spalling and surface cracking. Although not currently posing a structural hazard, these defects should be monitored, and preventative maintenance is recommended to avoid progression. Additionally, there is visible corrosion to the handrails, which should be assessed and treated to prevent potential safety issues and material degradation.

Spalling on the balcony.

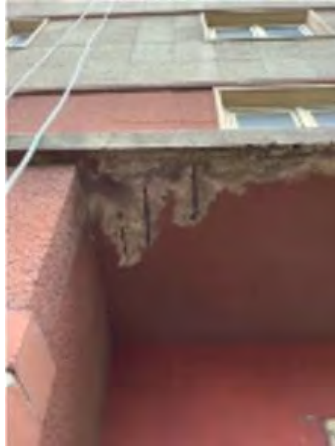
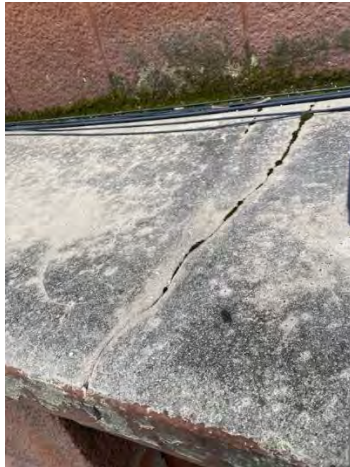
One of the canopies is in poor condition, exhibiting spalling and exposed reinforcement, while the other is in reasonable condition with minor defects and no immediate risk.

Concrete Canopy.

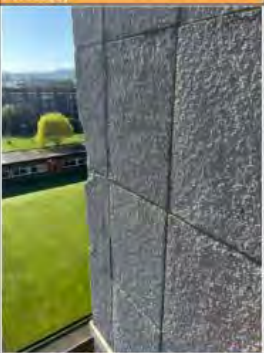
Ref.	Location	Size	Priority	Defect	Recommended Action	Photo(s)
4	East elevation 2	N/A	P2	220x220 size of the corner wall is missing	To clean area Apply mortar Smooth up and tidy up

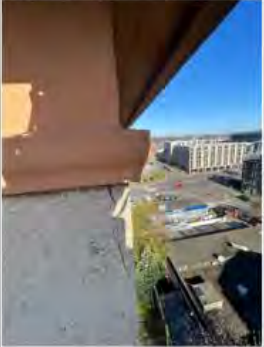
5	South elevation 1	N/A	P2	Slight cracking in top spollen	To re-seal And tidy up

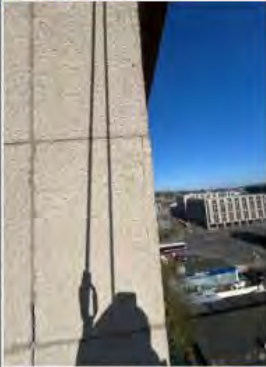
Ref.	Location	Size	Priority	Defect	Recommended Action	Photo(s)
6	South elevation	300x300	P2	Cracking down the corner of the building , tap tested and safe	To clean area And repair

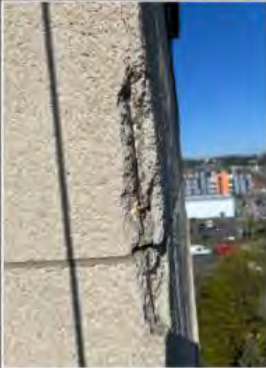
1.					
7	South elevation	220x220	P2	Damage is same as shown on east elevation 2 corner is missing and showing re-bar	To clean area And apply Mortar to seal up area Tidy up job

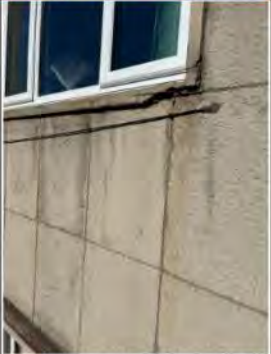
Ref.	Location	Size	Priority	Defect	Recommended Action	Photo(s)
9	South elevation	N/A	P2	Multiple chunks missing on sill	To clean area Apply mortar and smooth off Tidy job

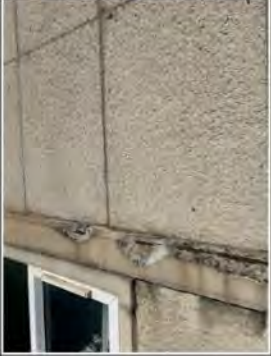
10	South elevation	N/A	P2	Chunks missing out of spollen in multiple areas	To clean area Apply mortar smooth off Tidy area

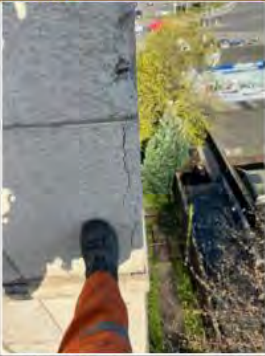
Ref.	Location	Size	Priority	Defect	Recommended Action	Photo(s)
7	South elevation	N/A	P2	Same as item 5	Same as item 5

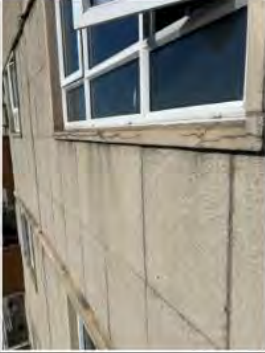
8	South elevation	N/A	P2	Hairline cracks running along multiple balcony's	To clean area To repair the cracks Tidy job

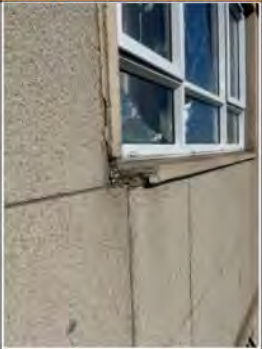
Ref.	Location	Size	Priority	Defect	Recommended Action	Photo(s)
11	South elevation 2	N/A	P2	Moderate size of sill missing , re-bar exposed	To clean area Seal and fix the cracks Fill out sill Tidy area

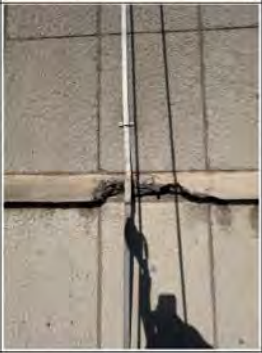
2.						
12	South elevation	250 x250	P2	Moderate size of spollen is missing and some cracks	To clean area Seal and apply mortar to fill in gap Tidy area

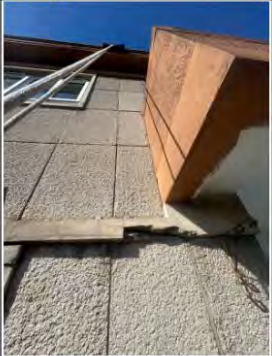
Ref.	Location	Size	Priority	Defect	Recommended Action	Photo(s)
15	South elevation 4	200x200	P2	Section of spollen is missing and few cracks	To tidy area Build out spollen and seal cracks running along Tidy job

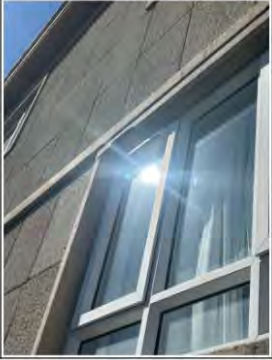
4.					
16	South elevation	N/A	P2	Part of sill missing	Clean area To build out sill seal any cracks smooth off Tidy job

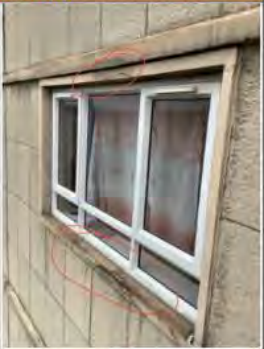
Ref	Location	Size	Priority	Defect	Recommended Action	Photo(s)
2	South 5	2m	P2	Damaged lintels and ledges (example image) x8 window blocks	Carry out concrete repairs

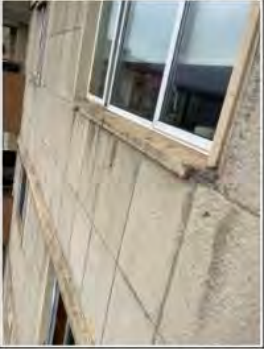
3	South 6 <div>6.</div>	2m x 2m	P2	Hairline cracks running through 5x sills , 2x of which have chunks missing	To clean area Seal cracks and mortar necessary parts smooth off Tidy job

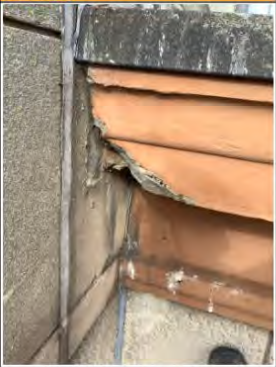
Ref.	Location	Size	Priority	Defect	Recommended Action	Photo(s)
10	South9	300mm	P2	Defective render / concrete and exposed rebar	Carry out concrete repair

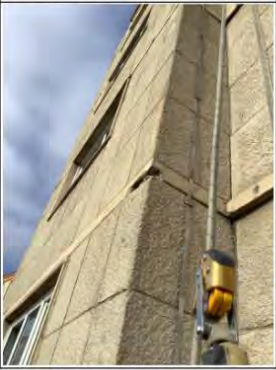
11	South9	N/A	P2	Defective stringcourse / exposed rebar	Carry out concrete repair

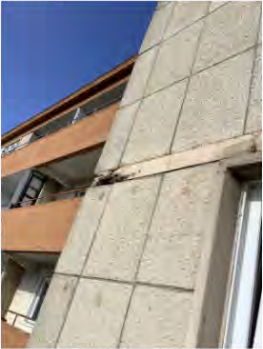
Ref.	Location	Size	Priority	Defect	Recommended Action	Photo(s)
12	South10	300mm	P2	X6 areas have defective concrete / exposed rebar (example image)	Carry out concrete repairs

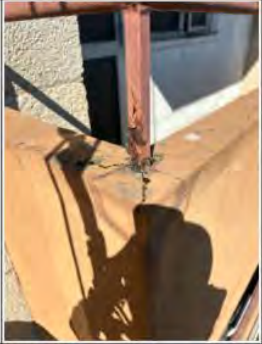
Ref.	Location	Size	Priority	Defect	Recommended Action	Photo(s)
17	South elevation	N/A	P2	Multiple cracks run along balcony	Tidy area Apply sealant to cracks and clean up job

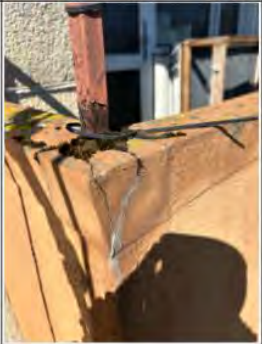
18	South elevation	N/A	P2	Multiple cracks on corner of balcony	Clean area Apply sealant or mortar to fill in cracks Tidy area

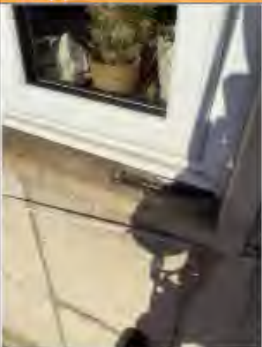
Ref.	Location	Size	Priority	Defect	Recommended Action	Photo(s)
1	South 15 b	2m	P2	Various ledges and lintels have defective concrete and exposed rebar example image	Clean area Strip out any loose/ broken debris, replace/repair any broken sills Tidy job

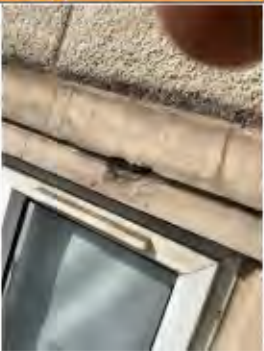
Ref	Location	Size	Priority	Defect	Recommended Action	Photo(s)
2	South 20	2m x3	P2	Various ledges and lintels have defective concrete and exposed rebar example image	Remove broken debris and clean the area then either repair the broken parts or replace the broken sills

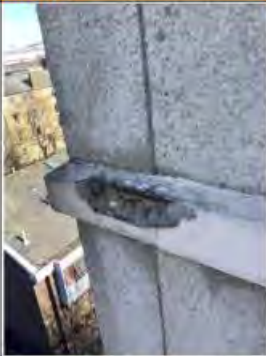
Ref	Location	Size	Priority	Defect	Recommended Action	Photo(s)
28	North1	300mm	P2	Various ledges and lintels have defective concrete and exposed rebar example image	Carry out concrete repairs

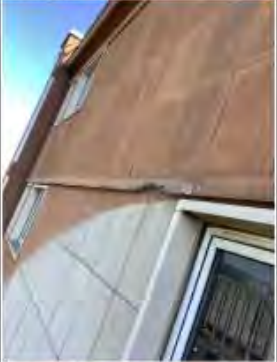
Ref	Location	Size	Priority	Defect	Recommended Action	Photo(s)
24	North4	300mm	P2	Various ledges and lintels have defective concrete and exposed rebar example image	Carry out concrete repairs

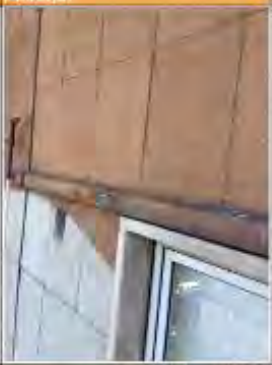
Ref.	Location	Size	Priority	Defect	Recommendation/Action	Photo(s)
20	North6	300mm	P2	Various ledges and lintels have defective concrete and exposed rebar example image	Carry out concrete repairs

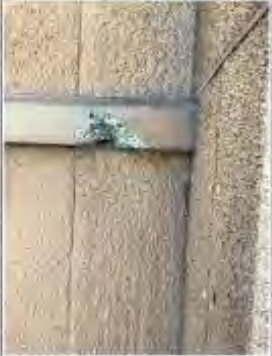
21	North6	300mm	P2	Various ledges and lintels have defective concrete and exposed rebar example image	Carry out concrete repairs

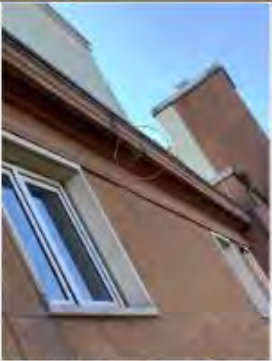
Ref	Location	Size	Priority	Defect	Recommended Action	Photo(s)
18	North7	300mm	P2	Various ledges and lintels have defective concrete and exposed rebar example image	Carry out concrete repairs

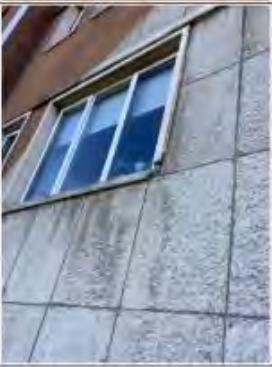
19	North7	300mm	P2	Various ledges and lintels have defective concrete and exposed rebar example image	Carry out concrete repairs

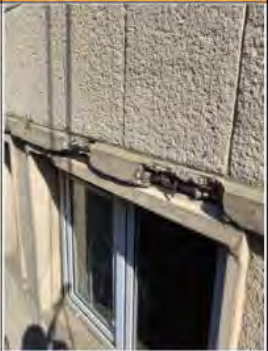
Ref.	Location	Size	Priority	Defect	Recommended Action	Photo(s)
16	North 25	2m	P2	Various ledges and lintels have defective concrete and exposed rebar example image	Remove all loose debris , prep area and Carry out concrete repairs / seal cracks

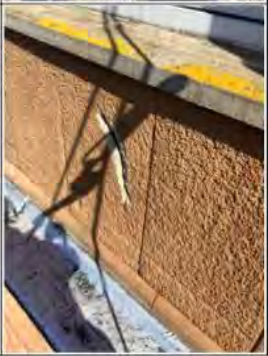
25.					
17	North 25	250	P2	Spalling on wall revealing rebar	Carry out concrete repairs

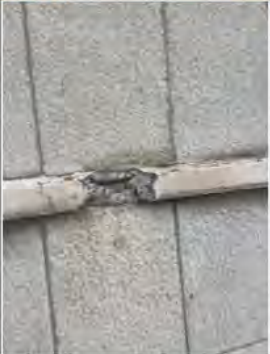
6	32 north	300mm	P2	Various ledges and lintels have defective concrete and exposed rebar example image	Remove any loose material, apply coating to rebar and carry out concrete repairs

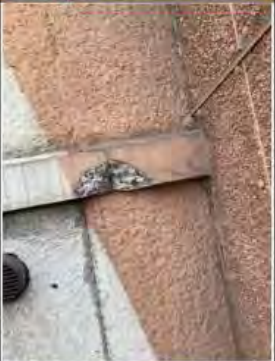
14	34 north	N/a	P2	Cladding panel damaged	Remove damaged panel, replace and point up area

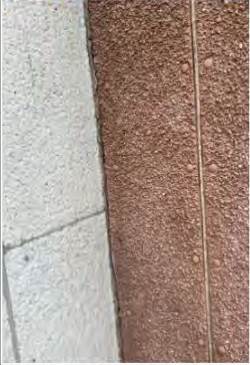
16	34 north	N/a	P2	Cladding panel damaged	Remove damaged panel, replace and point up area

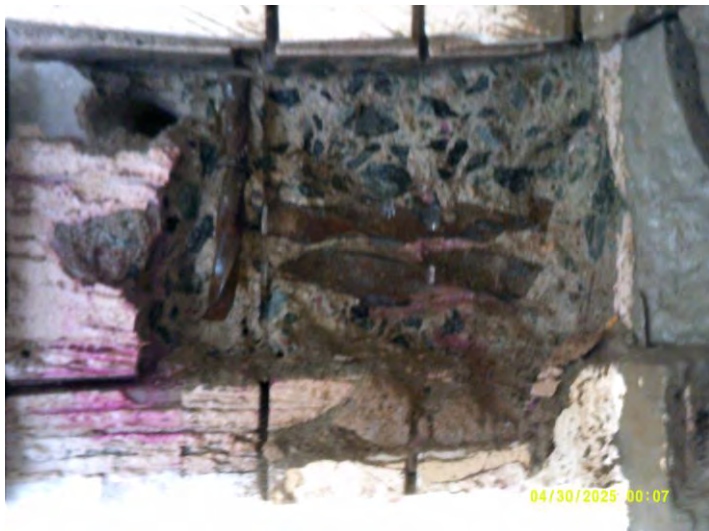
</div> <p>Breakout at location BO1 shows 15 and 20 mm Square Twist Main Bar with 11mm Square Twist Link Bar at 200mm spacing. All bars are in good condition. Both Longitudnal main Bars Extend into Column</p>		<p><u>Location BO1 Colmn (living room)</u></p> <div>

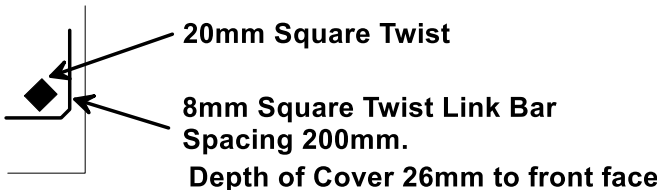
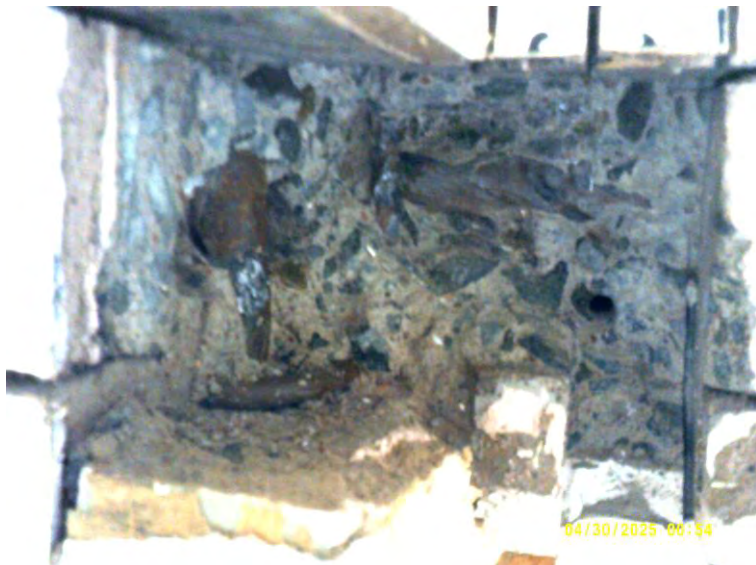
INVESTIGATION RESULTS			
Location BO3 Beam/Top of Column (Bedroom 1)			
BEAM		COLUMN

Breakout at location BO3 shows 20 mm Square Twist Main Bar with 8mm Square Twist Link Bar at 200mm spacing. All bars are in good condition. Longitudnal main Bar Extends into Column		Breakout at location BO3 Top of Column shows 25.4mm Round Vertical Main Bar With 9mm Round Link Bars	
NOTES:- Drawings not to scale. Reference Photographs 61-63			
Capital Testing Services Ltd Units 13/14 Laverock Road Stirling Road Industrial Estate Airdrie	PROJECT: Flat 2/1 Westfield Court, Edinburgh	CLIENT: Will Rudd Davidson 43 York Place, Edinburgh	PREPARED BY:

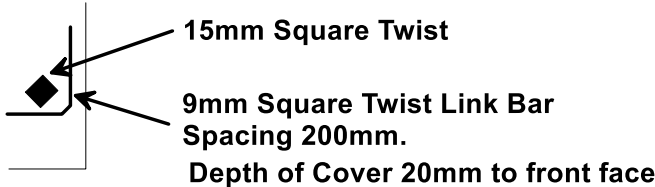
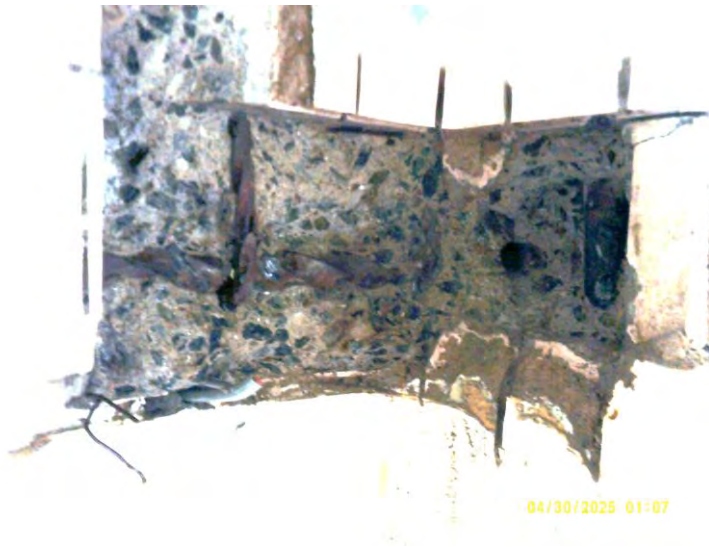
Breakout at location BO4 shows 15 mm Square Twist Main Bar with 9mm Square Twist Link Bar at 200mm spacing. All bars are in good condition. Longitudnal main Bar Extends into Column		Breakout at location BO4 Top of Column shows 25.4mm Round Vertical Main Bar With 8mm Round Link Bars	
NOTES:- Drawings not to scale. Reference Photographs 64-67			
Capital Testing Services Ltd Units 13/14 Laverock Road Stirling Road Industrial Estate Airdrie	PROJECT: Flat 2/1 Westfield Court, Edinburgh	CLIENT: Will Rudd Davidson 43 York Place, Edinburgh	PREPARED BY: <div></div> DATE: May 2025 SHEET NO.: b5c4

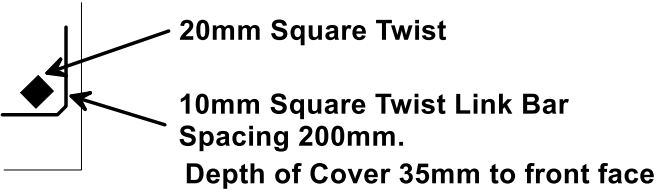
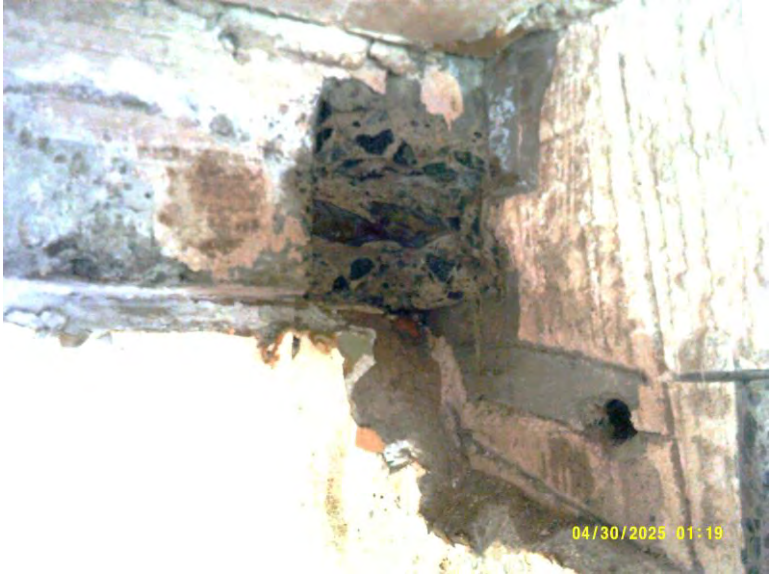
<p>20mm Square Twist</p><p>10mm Square Twist Link Bar Spacing 200mm.</p><p>Depth of Cover 35mm to front face</p></div>

<p>Breakout at location BO5 shows 20 mm Square Twist Main Bar with 10mm Square Twist Link Bar at 200mm spacing. All bars are in good condition. Longitudnal main Bar Extends into Column</p>			
<p>NOTES:- Drawings not to scale. Reference Photographs 68-73</p>			
Capital Testing Services Ltd Units 13/14 Laverock Road Stirling Road Industrial Estate Airdrie	PROJECT: Flat 2/1 Westfield Court, Edinburgh	CLIENT: Will Rudd Davidson 43 York Place, Edinburgh	PREPARED BY:

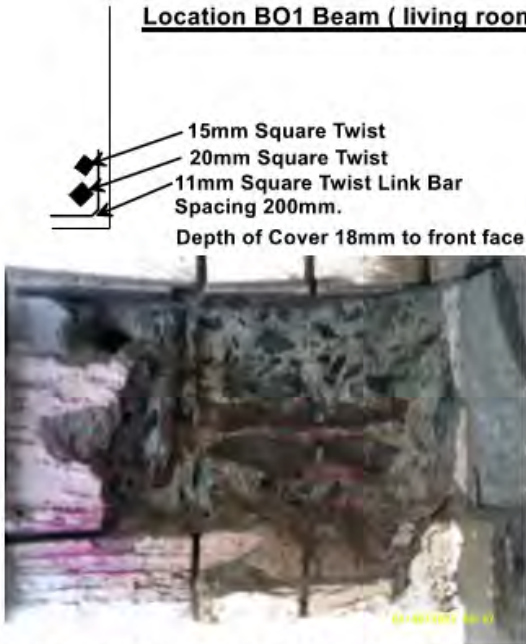
<p>Breakout at location BO1 shows 15 and 20 mm Square Twist Main Bar with 11mm Square Twist Link Bar at 200mm spacing. All bars are in good condition. Both Longitudinal main Bars Extend into Column</p>
