Stage 2 Road Safety Audit

City of Edinburgh Council

July 2025
2526_084

GREENBANK - MEADOWS CYCLE ROUTE

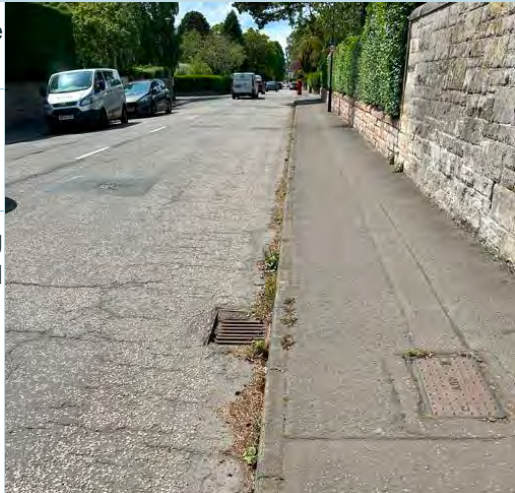
Problem:	3.1	
Location(s):	Scheme extents – cycle lanes

Drawing(s):	330610712-STN-HGN-02-DR-CH-0107 to 0110	
Summary:	Risk of cyclists falling due to detritus and surface water.

Debris and loose material were observed along carriageway edges and around gullies at several locations across the extents of the proposed cycle lanes. Detritus material may reduce tyre grip and unsteady a cyclist, increasing the risk of cyclists suffering injury from falls. This risk is exacerbated due to the potential for higher cycle speeds on sections with steep gradients such as Braid Avenue.

Furthermore, the debris may block gullies and impede drainage. This could result in water pooling on the cycleway potentially giving rise to cyclist injury from slips and falls, particularly during cold periods when water can form ice.

It is recommended that debris and loose material is removed, and that the cycleway is regularly maintained.

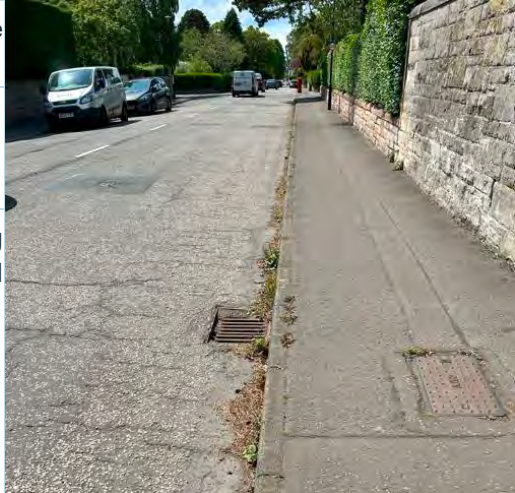
Problem:	3.2	
Location(s):	Scheme extents – cycle lanes

Drawing(s):	330610712-STN-HGN-02-DR-CH-0107 to 0110	
Summary:	Risk of cyclists falling due to older style and sunken gullies.

Older style iron gullies were observed at several locations across the extents of the proposed cycle lanes; some of which have sunken below surface levels. Gullies, particularly those pictured with large metal grates, within cycle lanes may result in the unsteading of cyclists leading to falls. Those sunk below carriageway surface may also destabilise a cyclist contributing to injury. This risk is exacerbated due to the potential for higher cycle speeds on sections with steep gradients such as Braid Avenue.

It is recommended cycle friendly gulley frames are provided and that sunken gullies are reset flush with cycleway surface.

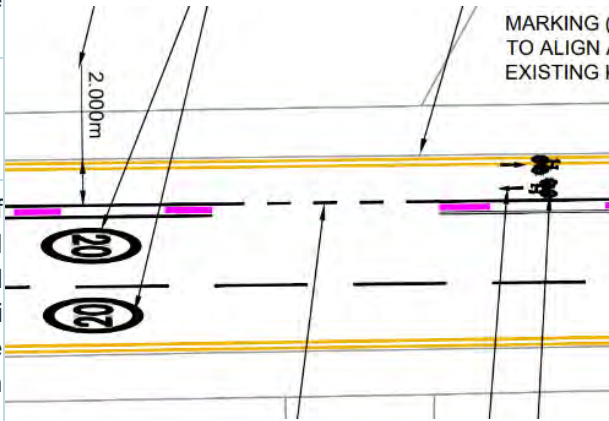
Problem	3.4	
Location(s):	Hermitage Drive Extends

Drawing(s):	330610712-STN-HGN-02-DR-CH-0107, 0109 & 0111	
Summary:	Combination of longitudinal road markings and narrow bi-directional cycle lane may result in collisions.

Whilst it is acknowledged a response has been provided to the potential risk due to narrow cycle lanes and proximity to kerb lines (RSA Stage 1 Problem Ref 3.2), there is a potential risk that due to the provision of double yellow lines within the narrow bi-directional cycle lane:

- cyclists may ride longitudinally along the markings which may reduce tyre grip, particularly in wet conditions, increasing the risk of destabilisation, or
- cyclists may ride centrally within the cycle lane to avoid the markings increasing the risk of side swipe or head on collisions with oncoming cyclists.

It is recommended that sufficient cycle lane width is provided. This may include but is not limited to an alternative cross section and road markings with suitable skid resistance.

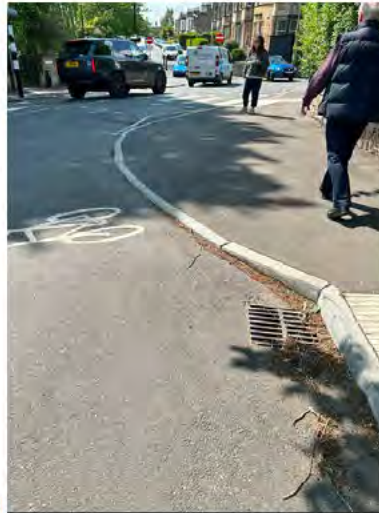
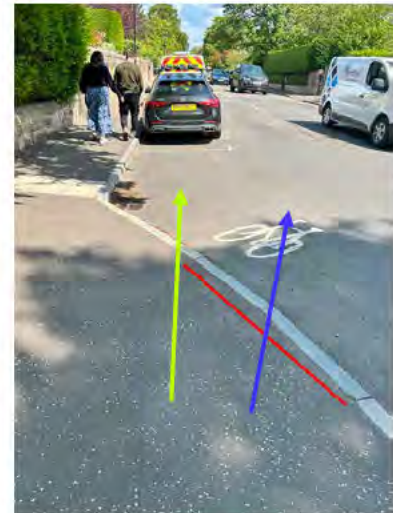
Problem:	3.5
Location(s):	Western Scheme Extents - Hermitage Drive at Braid Road
Drawing(s):	330610712-STN-HGN-02-DR-CH-0107
Summary:	Risk of cyclists becoming destabilised when transitioning between cycle and shared use facilities

At the western scheme extents, the proposed two-way cycle lanes will transition to and from an existing shared use area at footway level (Green arrow). However, the current flush kerb extents (shown in red above) and cycle road marking do not align with the proposed cycle lanes, directing cyclists into the primary position within the carriageway (Blue arrow). There is a risk that cyclists transitioning between the two facilities may become unsteadied when making sharp manoeuvres or when crossing the drop kerb at an acute angle which may lead to falls and an increased the risk of injury.

Furthermore, as pictured above, the extents of the dropped kerb are unclear on approach to the proposed two-way cycle lanes. There is a risk that during periods of inclement weather such as snow fall or leaf litter accumulation may further obscure the dropped kerb extents. It is anticipated cyclists will proceed directly between the cycle lanes and shared area, at risk of colliding with full height kerbs. This may contribute to injury from falls.

It is recommended that the existing flush kerb and/or markings are altered to better direct cyclists between the proposed cycle facility and the shared use path.

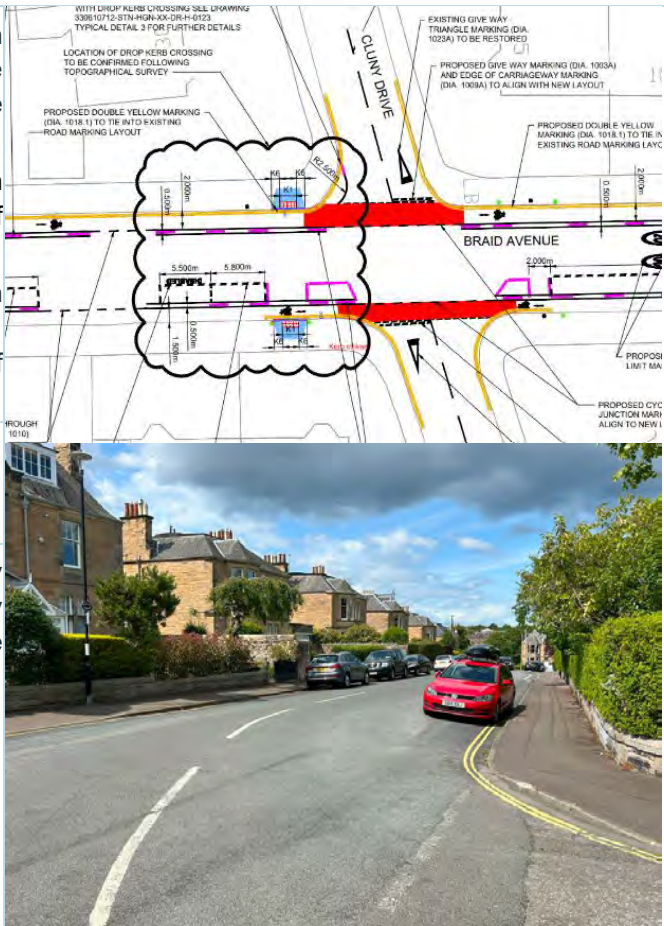
Problem	3.7
Location(s):	<p>Parking bay on Hermitage Drive east of Corrennie Gardens</p> <p>Parking Bay on Braid Ave north of Cluny Drive</p> <p>Parking bay on Hermitage Gardens North of Cluny Drive</p>
Drawing(s):	330610712-STN-HGN-02-DR-CH-0107 , 0109 & 0111
Summary:	<p>Reduced visibility at junctions may result in side impact collisions</p>

Parking bays are proposed adjacent to side road junctions at the locations noted above. When occupied, visibility to/from the junction may be obstructed which may contribute to side impact type collisions as vehicles emerge from side roads. The risk is exacerbated on Braid Avenue as parking bays have been relocated further into the carriageway from the existing kerbline to accommodate the proposed cycle lane, reducing visibility further.

It is recommended that parking bays extents are amended to provide suitable intervisibility at junctions.

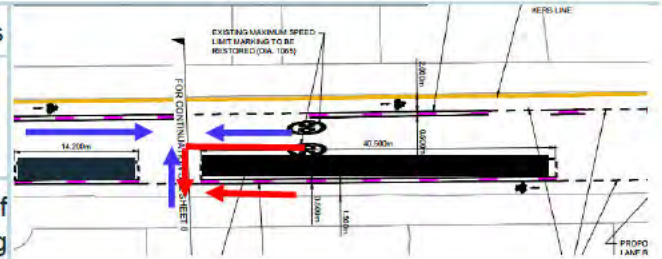
Problem:	3.10
Location(s):	Braid Avenue Extents
Drawing(s):	330610712-STN-HGN-02-DR-CH-0108 to 0110
Summary:	Proximity of formalised parking bays to accesses may restrict intervisibility between users.

Formalised parking facilities are proposed along Braid Avenue in close proximity to existing accesses. When the parking bays are occupied, it is anticipated that:

- parked vehicles may obstruct visibility between drivers exiting the accesses to vehicles on the mainline, increasing the likelihood of side impact collisions (blue arrows above); and
- parked vehicles may obstruct visibility of cyclists travelling along the cycle way from drivers tuning into accesses (particularly where long lengths of parking bays are proposed) which may contribute to collisions between vehicles and cyclists (red arrows above).

It is recommended that parking bay extents are amended to allow sufficient intervisibility between road users.

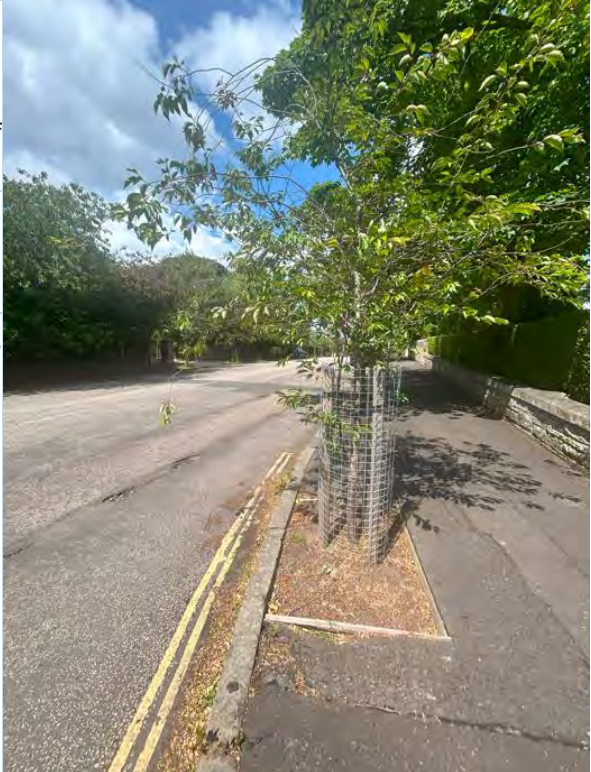
Problem	3.12	
Location(s):	Uncontrolled pedestrian crossing of Braid Avenue, North of Hermitage Drive

Drawing(s):	330610712-STN-HGN-02-DR-CH-0108	
Summary:	Risk of collisions between pedestrians and vehicles

Intervisibility between southbound drivers on Braid Avenue and pedestrians crossing from east to west is reduced by an existing tree immediately adjacent to the crossing. Reduced intervisibility between users increases the risk of collisions between vehicles and pedestrians, as pedestrians may inadvertently enter into the path of a vehicle to cross.

It is recommended that the tree is removed to provide sufficient intervisibility between road users.

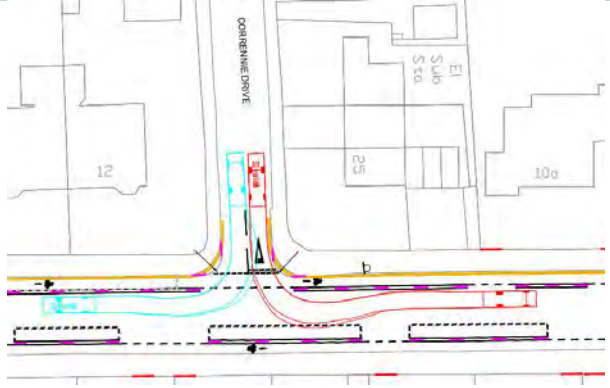
Problem:	3.15	
Location(s):	Braid Avenue and Corrennie Drive

Drawing(s):	330610712-STN-HGN-02-DR-CH-0109	
Summary:	Proximity of marked parking bays to junction may result in side-swipe collisions.

Marked parking bays are proposed on the south side of Braid Avenue opposite Corrennie Drive. As shown on the provided swept path drawing, large vehicles making the manoeuvre from Corrennie Drive to Braid Avenue will encroach into the parking bays which may result in side impact or nose to tail type collisions between manoeuvring and parked vehicles. Furthermore, drivers may undertake reversing manoeuvres to avoid collisions with parked vehicles at risk of reversing into the path of pedestrians, cyclists or ensuing vehicles.

It is recommended that the layout is amended to remove the conflict between parked and manoeuvring vehicles. This may involve but is not limited to amendment of parking bay location/ extents and/or alterations to the defender kerb layout.

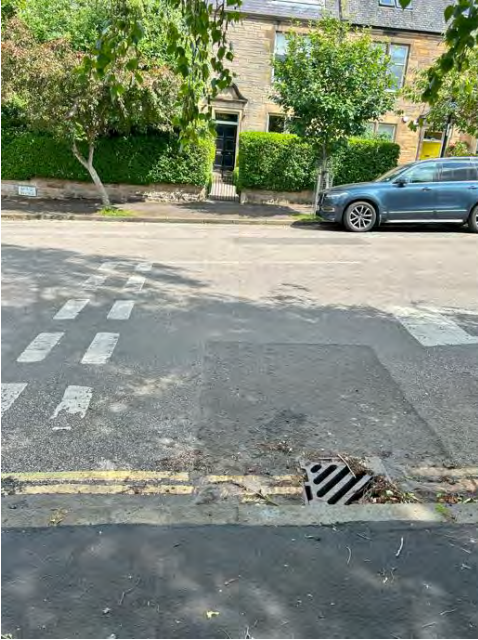
Problem:	3.16	
Location(s):	Uncontrolled pedestrian crossing of Braid Avenue, south of Cluny Drive

Drawing(s):	330610712-STN-HGN-02-DR-CH-0109	
Summary:	Gully within proposed pedestrian crossing may contribute to the likelihood of slips and falls

During the site visit it was observed that a gully will be located in the proposed pedestrian crossing of Braid Avenue. This increases the risk of pedestrian slips and falls which could result in injury. There is also potential for footwear, such as high heels to be caught in the open grating, which may also give rise to injury from falls

It is recommended that the gully is relocated, or the crossing be relocated out with the gully location.

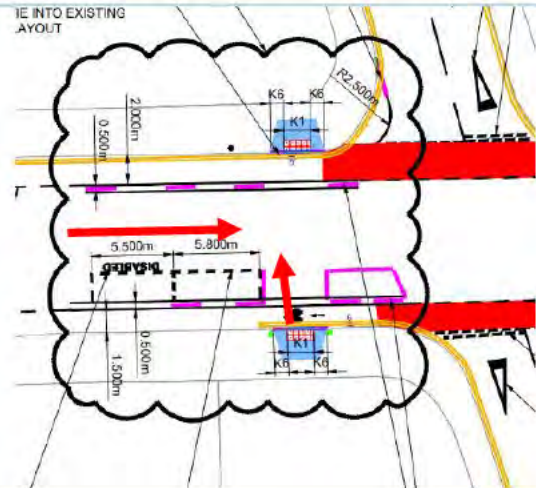
Problem: 3.17

Summary: Lack of intervisibility between users at crossing increases the risk of collisions between vehicles and pedestrians

Marked parking bays are located immediately adjacent to the proposed pedestrian crossing of Braid Avenue. Visibility between pedestrians crossing from the east and motorists travelling north on Braid Avenue may be restricted if the bays are occupied, increasing the risk of collisions between pedestrians and vehicles. The risk may be exacerbated due to the downhill gradient which increases the potential for higher vehicle speeds.

It is recommended that the parking layout is amended to provide sufficient intervisibility between pedestrians and motorists at the crossing.

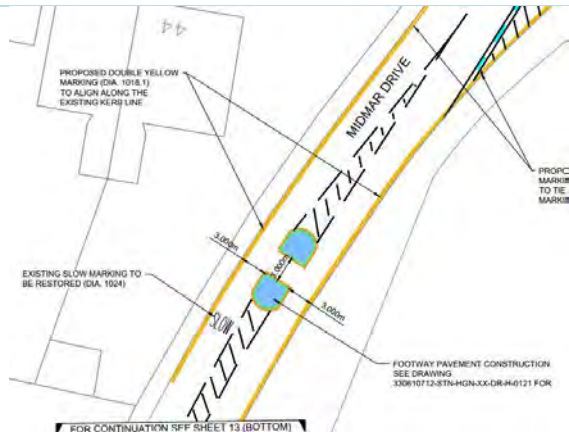
Problem:	3.20	
Location(s):	Midmar Drive	
Drawing(s):	330610712-STN-HGN-02-DR-CH-01113 & 0114	
Summary:	Lack of vertical elements increases the risk of vehicles colliding with kerbed refuges.

Kerbed islands are proposed on Midmar Drive. In the absence of vertical features to highlight the presence of the islands there is an increased risk of vehicles striking the kerb, which could lead to loss-of-control collisions or secondary incidents if tyres are damaged during a kerb strike. This may be exacerbated due to road markings on approach aligning with the kerb.

It is recommended that vertical features, such as reflective bollards, are provided to clearly highlight the kerbed islands within the carriageway. It is also recommended that proposed road markings guide drivers beyond the kerb extents.
