**ROAD LAYOUT  
HOUSING DEVELOPMENT  
FROGSTON ROAD (POD A, SITE 1)  
EDINBURGH**

STAGE 3 ROAD SAFETY AUDIT  
(SPA Ref No: 4282)

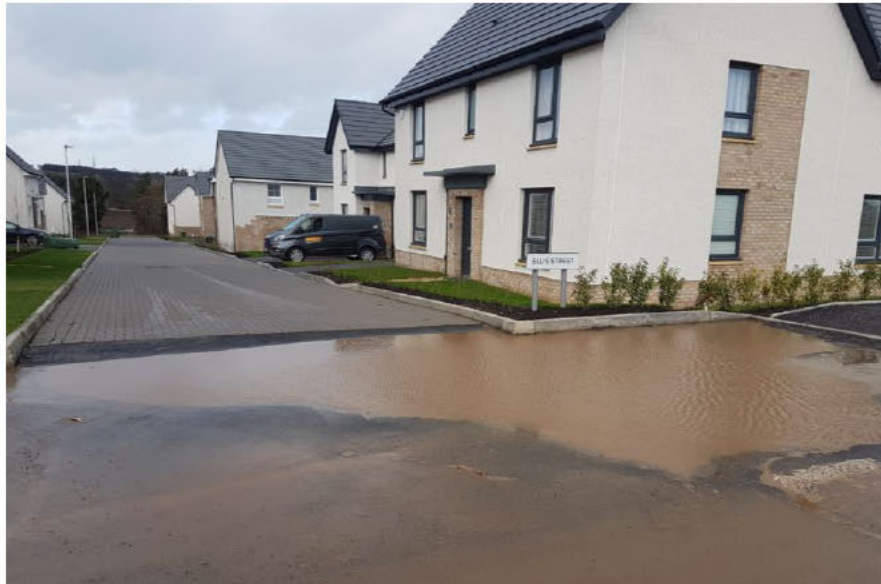
- 1.10 While outwith the area under inspection it was noted that there was extensive ponding at the east end of Ellis Street. This resulted in pedestrians having to walk into the live carriageway and haul route on Greenwell Wynd to avoid the ponding water. It is understood the final surfacing in this area is to be completed towards the end of February, but it should be recognised that the situation is not ideal and that potential short-term improvements should be investigated.

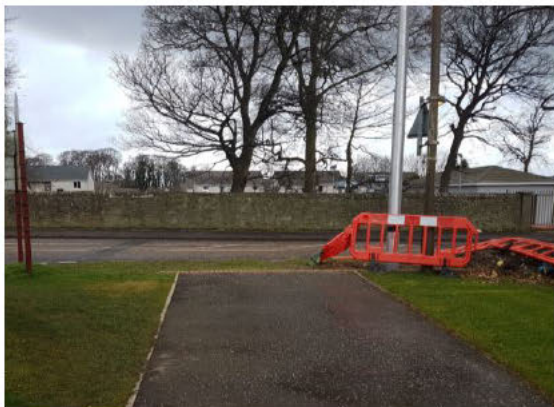
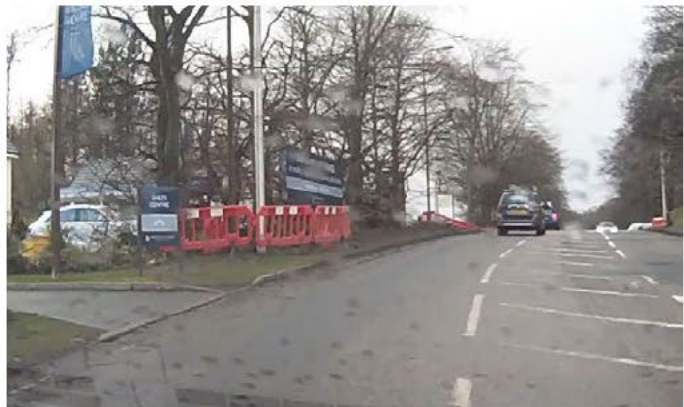
Location: Footpath leading to Frogston Road

Summary: Incomplete infrastructure can lead pedestrians to and from areas where appropriate surfaces are not provided and can therefore increase the potential for slipping and tripping type accidents

It was noted that the footpath leading from Printonan Crescent to Frogston Road there is no formal surfaced footway connection or crossing point at the north end.

The Audit Team recommends that the path be closed off until appropriate connections and surfacing are provided at Frogston Road.

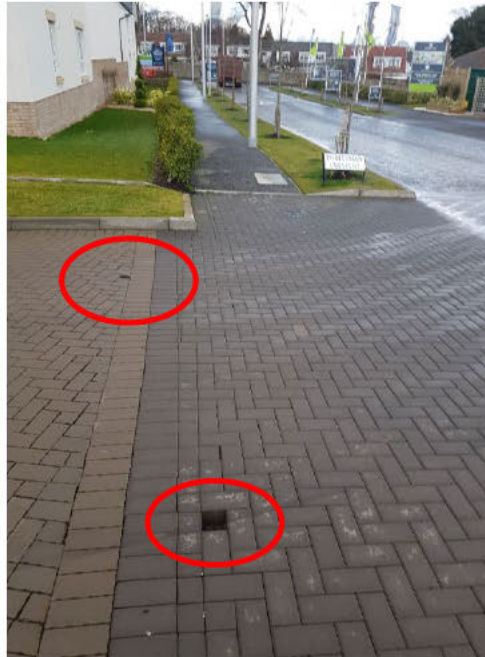
Location: Entry to Printonan Crescent from Greenwell Wynd.

Summary: Missing mono-block in a shared use surface introduces a trip hazard to pedestrians.

It was noted that some mono-block units were missing at the entry to Printonan Crescent.

The Audit Team recommends that the mono-block surfacing is repaired to provide a continuous surface.
