**ROAD LAYOUT  
HOUSING DEVELOPMENT  
FROGSTON ROAD (POD E)  
EDINBURGH**

STAGE 3 ROAD SAFETY AUDIT  
(SPA Ref No: 4282)

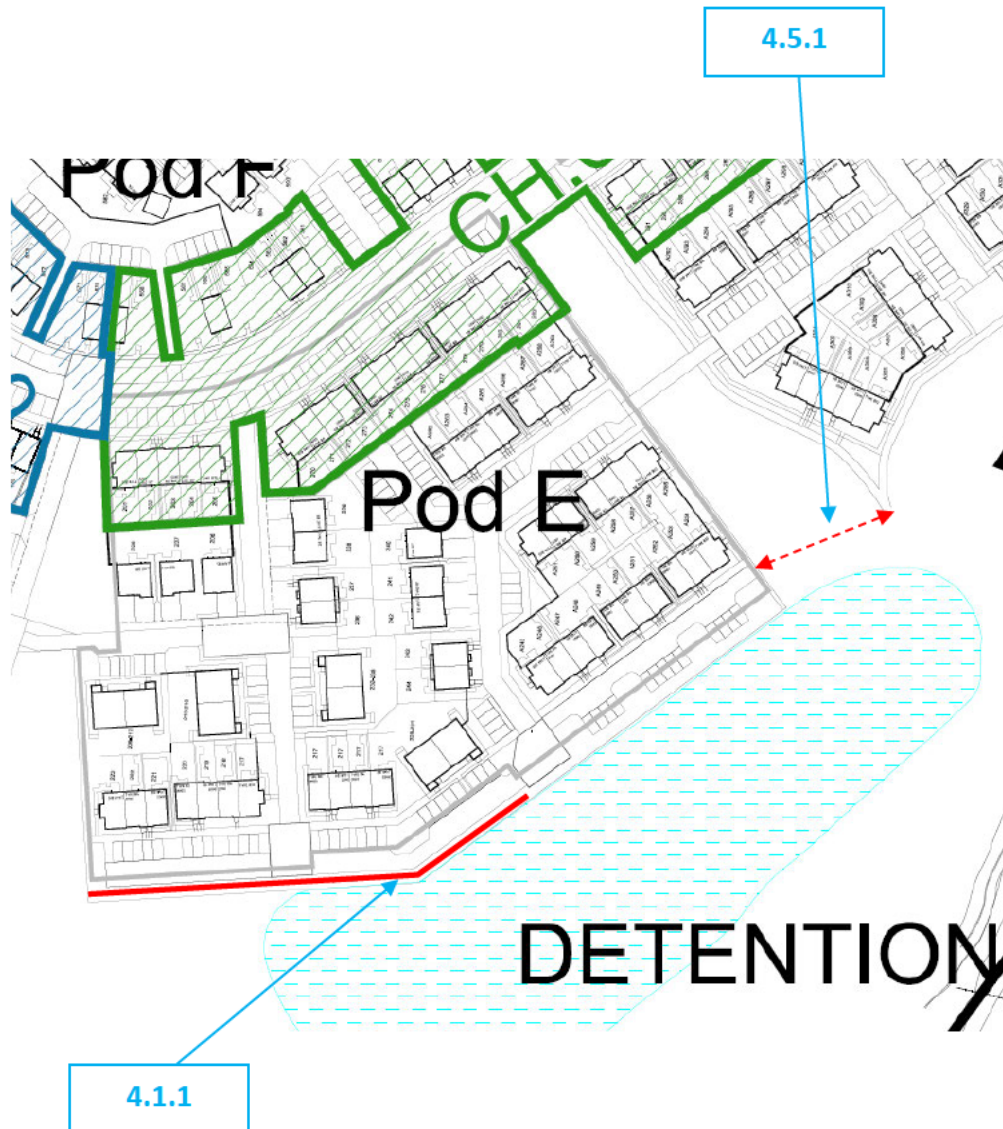
Annex 2      PROBLEM LOCATION PLAN

Location: SUDS Pond  
Drawing(s): E9876~0925  
Summary: Unprotected embankments can result in users reaching a SUDS pond.

It was noted that works were still ongoing at the south end of the SUDS pond. As such the proposed walls, fencing and planting designed to define the top of the embankment at the SUDS pond has not been provided.

Location: Footpath at north end of SUDS pond linking to Pod G

Summary: A lack of street lighting can increase the potential for road users to miss obstructions or level differences in the surface.

At the above location the gravel footpath that runs from Pod E to Pod G there is no lighting provision.

The Audit Team felt that the area appeared relatively dark at night-time. It is appreciated that there is a lit carriageway further north that offers an alternative route. However, the concern is that the gravel footpath is more likely to deteriorate over time and become potholed. This may increase the potential for tripping type incidents if the lighting conditions are limited.

It is recommended that the proposed works be completed as soon as possible being that some houses in this area are now occupied.

It is appreciated that this footpath does not lead directly to properties and has been provided to have a more 'rural' aspect. As this path is most likely not part of the adopted road network this issue is one that the developer should consider in terms of the risk of any future legal action should a person trip on this path in the hours of darkness.
