**ROAD LAYOUT
HOUSING DEVELOPMENT
FROGSTON ROAD (POD G, Ph 1, SITE 4)
EDINBURGH**

STAGE 3 ROAD SAFETY AUDIT
(SPA Ref No: 4282)

Roads Authority: The City of Edinburgh Council

Client: Barratt Homes

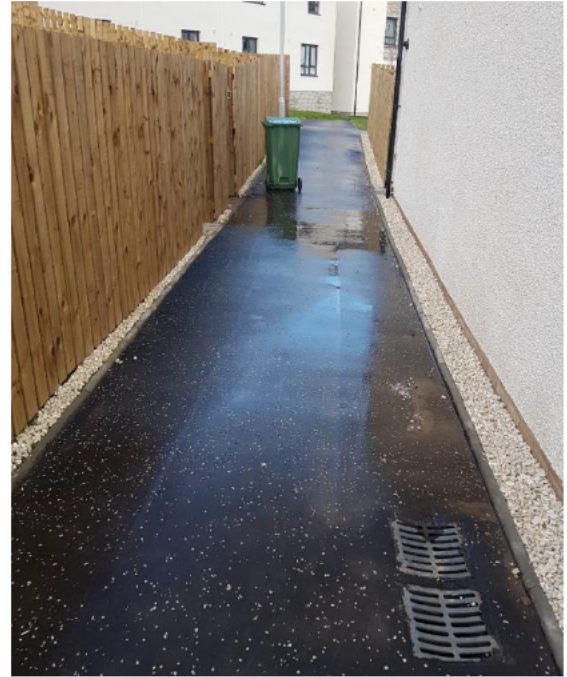
4.1.1 PROBLEM

Location: Paths on the adopted footpath network

Summary: Poor surface drainage can result in ponding. This in turn can cause a slip hazard to pedestrians especially in wintery conditions.

It was noted that on a footpath on the west section of Fisher Place, close to Greenhill Wynd there was evidence of ponding due to an uneven surface and the inability of water to flow, as intended to the nearby gully.

This Audit Team recommends that the surfacing and drainage arrangements in this area be reviewed with a view to ensuring surface water can be cleared as intended.

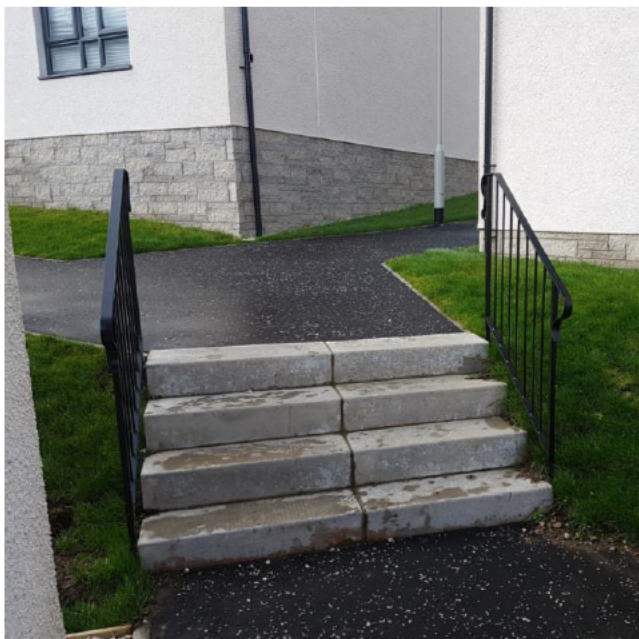
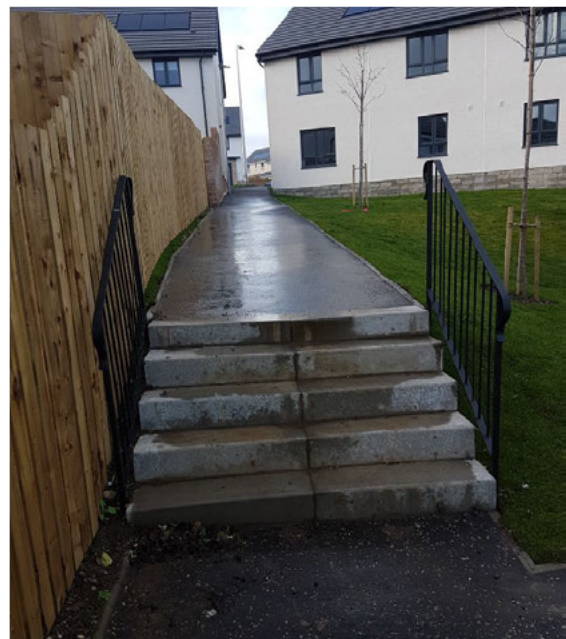
4.4.1 PROBLEM

Location: Two sets of steps on the adopted footpath network on the east side of Fisher Place
Drawing(s): 13006 (PL) 002A
Summary: Tactile paving at steps allows users with visual impairments to identify changes in level and reduce the probability of falls.

It was noted that there were two sets of steps that had not been provided with tactile paving, at the top and bottom of the steps, to warn users of the change in level on the path network.

This Audit Team recommends that appropriate tactile paving layouts be provided at these locations as soon as possible.

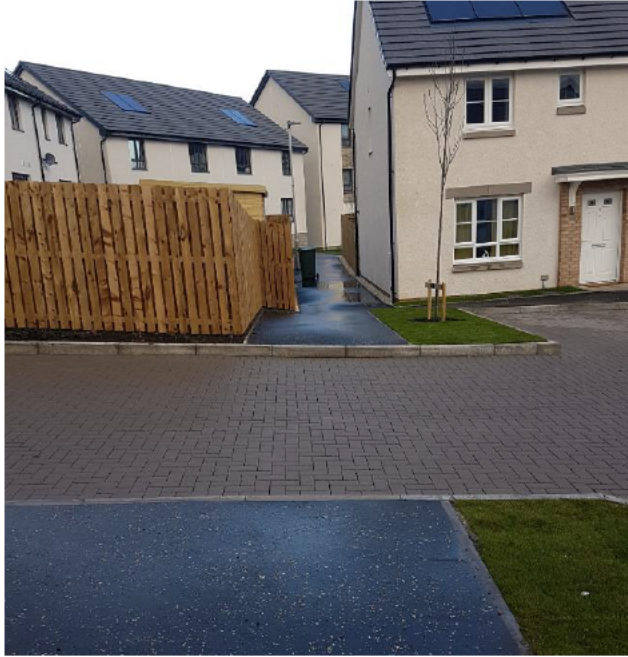
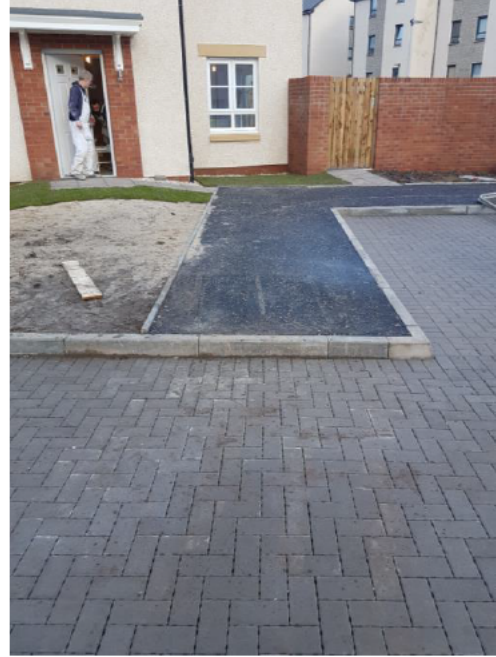
4.4.2 PROBLEM

Location: Two locations on the footpath network to west side of Fisher Place.
Drawing(s): 13006 (PL) 002A
Summary:
A lack of dropped kerbs at crossing points and transitions to shared space surfaces can increase the potential for trip type accidents.

It was noted that there were two locations where footpaths met a shared surface area, but no dropped kerbs were provided.

This Audit Team recommends that dropped kerbs be provided at these locations.
