Client: The City of Edinburgh Council

Water of Leith Flood Prevention Scheme

**Condition Survey
5/1 Ettrickdale Place**

**Inspection Date: External & Common Stair 24th November 2010
Internal No Survey**

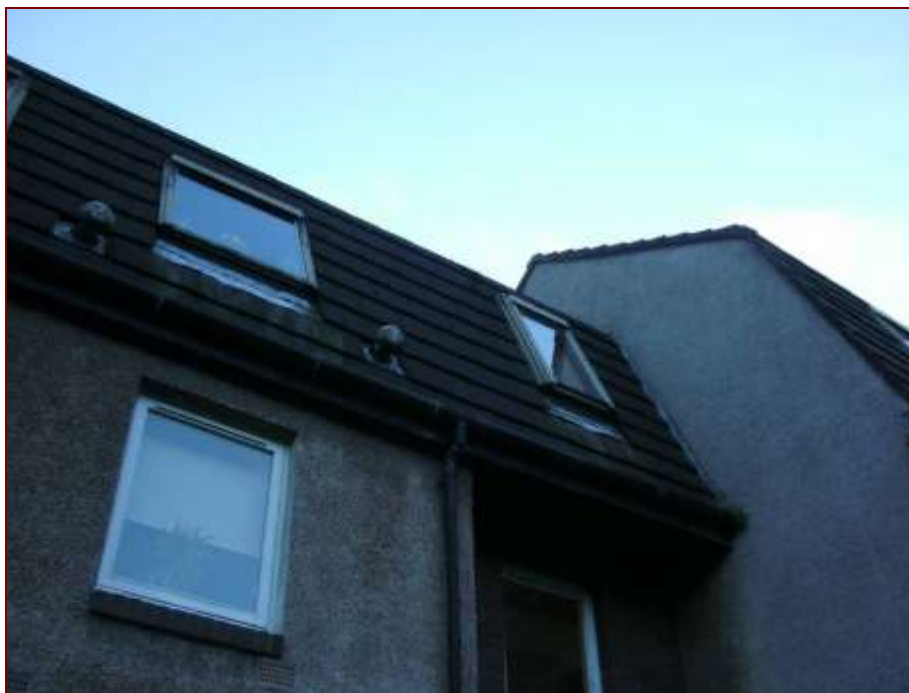
Ext 115
5 Ettrickdale Place North Elevation

LOCATION	DESCRIPTION	CONDITION	Photo graph
North Elevation – (front)			
Roof	Tiles	Average condition No signs of cracking/damage	114-116
Walls	Pebbledash brick/facing brickwork	Fair condition. No signs of cracking	117-124
East Elevation (gable)			
Wall			125-126
South Elevation (rear)			
Roof			127-128
Wall			129-137
West Elevation (gable)			
Wall			138-139

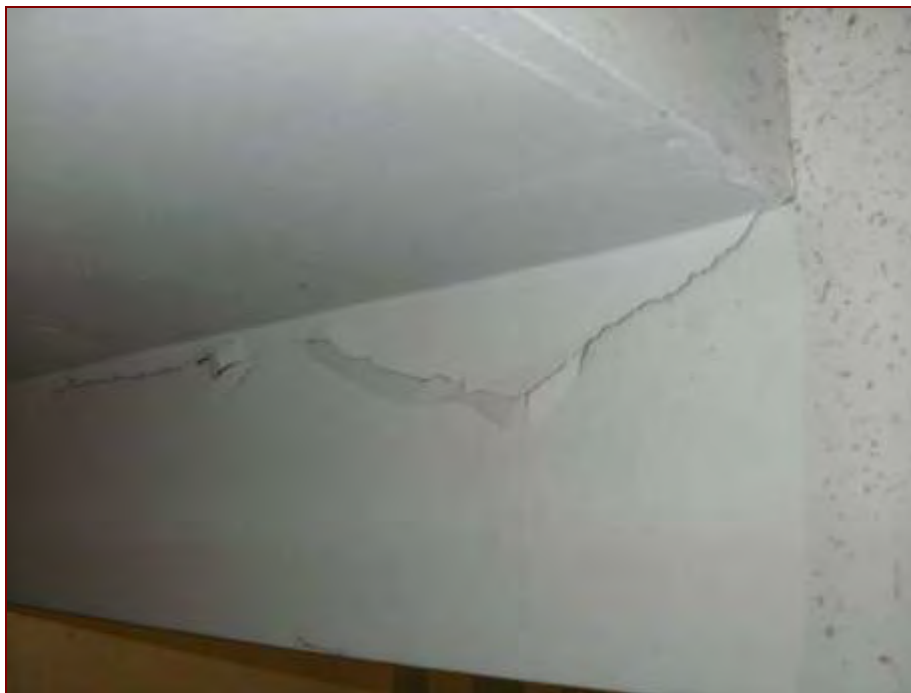
Int 236

LOCATION	DESCRIPTION	CONDITION	Photo graph
Wall	Paint on solid	Fair condition	233
		Minor horizontal crack to west wall above stairs	234-235
		Moderate crack to south beam on north face on east side	236-237
		Moderate horizontal cracks to west wall to south areas	238
		Minor vertical and horizontal crack to top of LHS of window to south area	239
		Minor vertical and horizontal cracking to south east boarded out area	240
		Minor vertical and horizontal cracking to north beam, south face spanning east to west	241
		Minor 2No. diagonal cracks to north beam, south face to east	242
		Minor vertical and horizontal to LHS and RHS of north window	243-244
Floor	Vinyl	Solid, sound, level	245
South window	Painted timber frame	Appears square, opens/closes freely	246
North window	Painted timber frame	Appears square. Opens/closes freely	247
Stairs	Vinyl on solid	Solid, sound, level	248
Ceiling above stairs	Paint on plaster	Fair condition Hairline cracks to top of stair spanning east to west	249 250

5 Ettrickdale Place common stair 1st floor moderate crack along south beam to north face spanning on east side

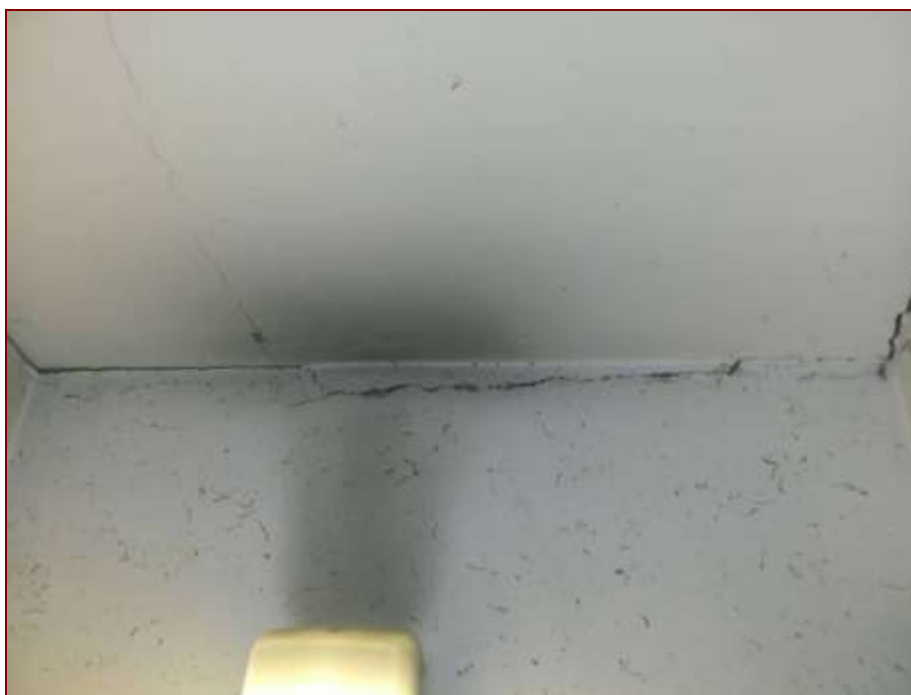
Int 238

5 Ettrickdale Place common stair 1st floor moderate horizontal crack to west wall to south area

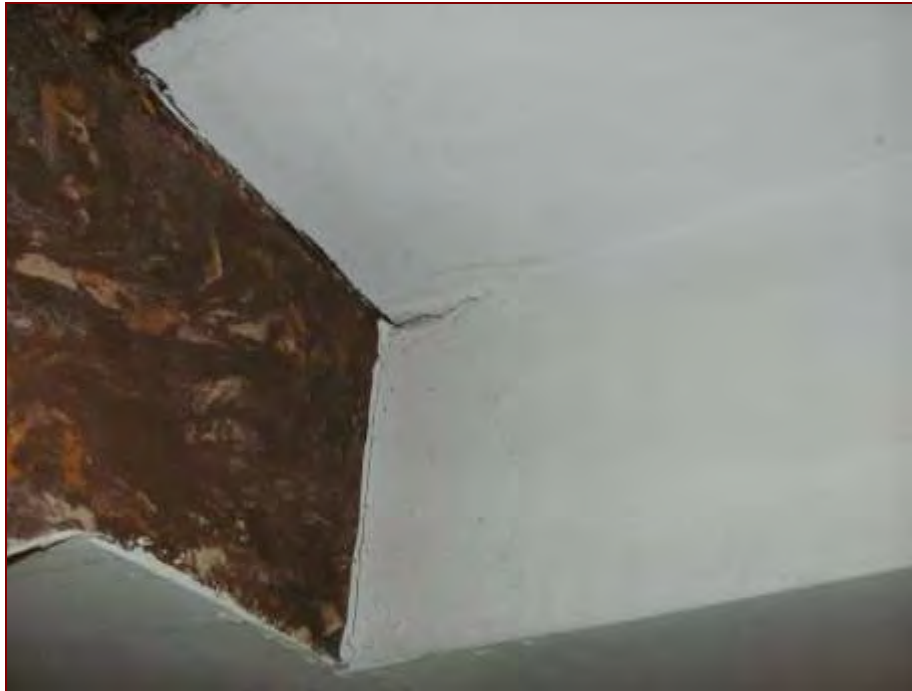
Int 241

5 Ettrickdale Place common stair 1st floor minor cracking to north beam south face

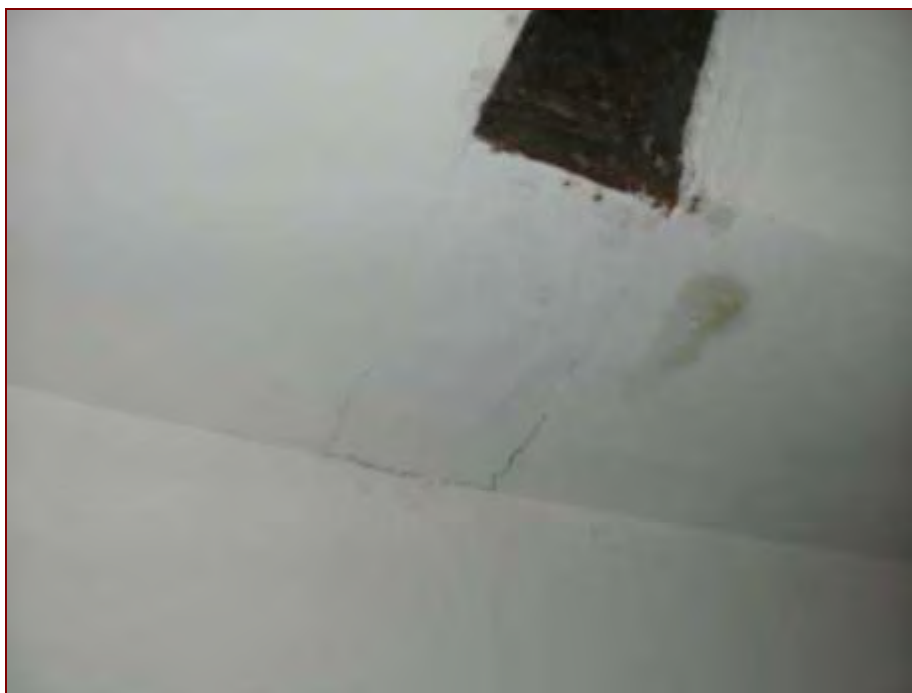
Int 255

Ground floor			
Ceiling	Paint on plaster	Fair condition	251
		Minor crack to south beam along downstand to south side	252-253
		Minor crack along south beam to north face to east area	254
		Minor cracking between upper stairs and landing to south	255
		Minor cracking spanning north/south to downstairs stair	256
		Hairline crack spanning east to west to north, adjacent to cupboard door	259

5 Ettrickdale Place common stair ground floor minor cracking between upper stair and landing
