Job No. E6351/04

Water of Leith Flood Prevention Scheme

**Condition Survey
5/3 Ettrickdale Place**

Inspection Date: External & Common Stair 24th November 2010
Internal No Survey

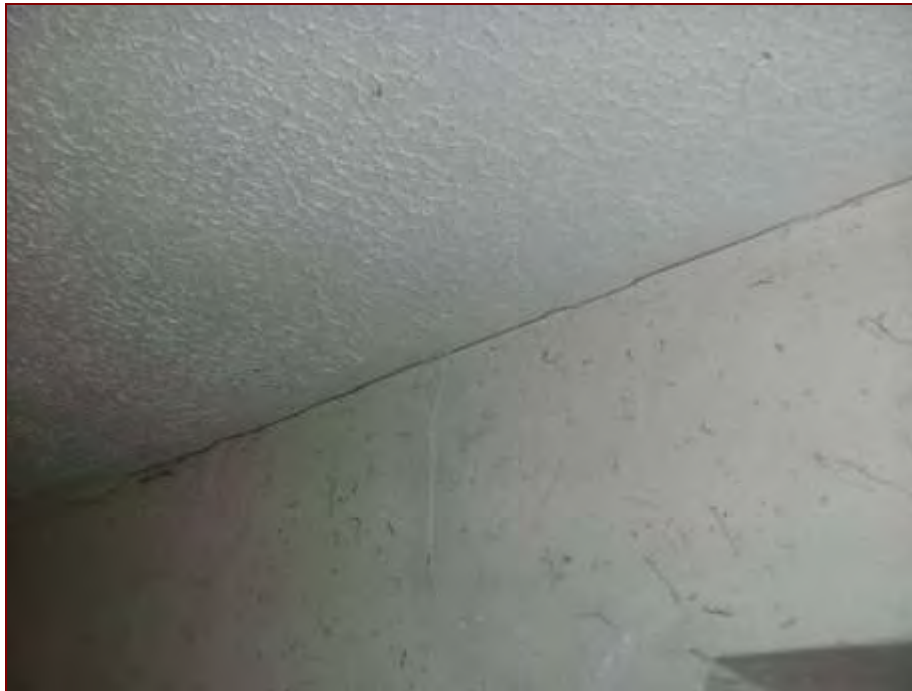
Int 212

5 Ettrickdale Place common stair 2nd floor minor horizontal cracking along ceiling to west wall

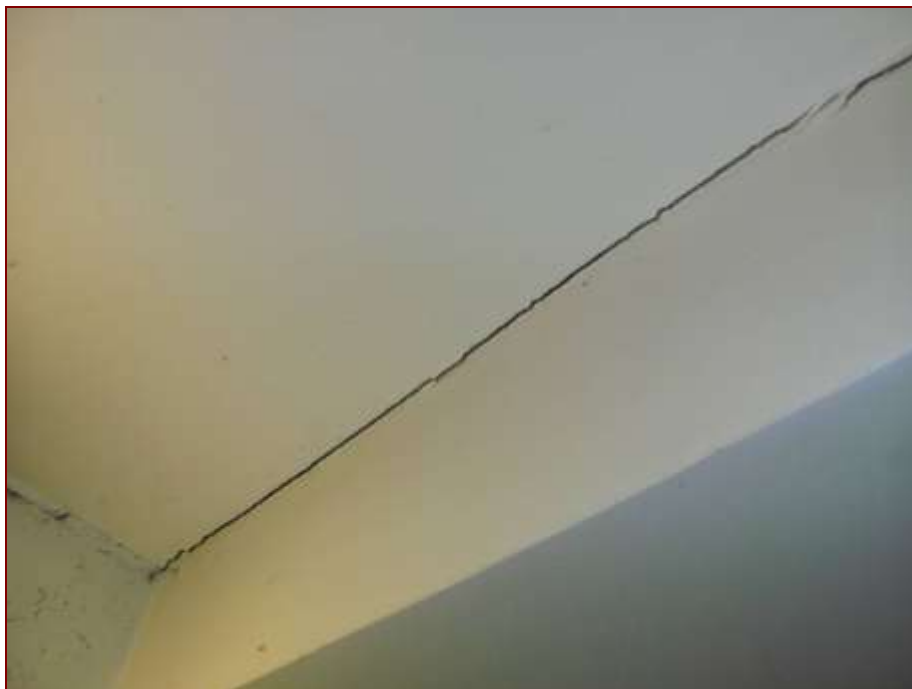
Int 223

5 Ettrickdale Place common stair 1st floor moderate crack along south beam to south face
spanning east west

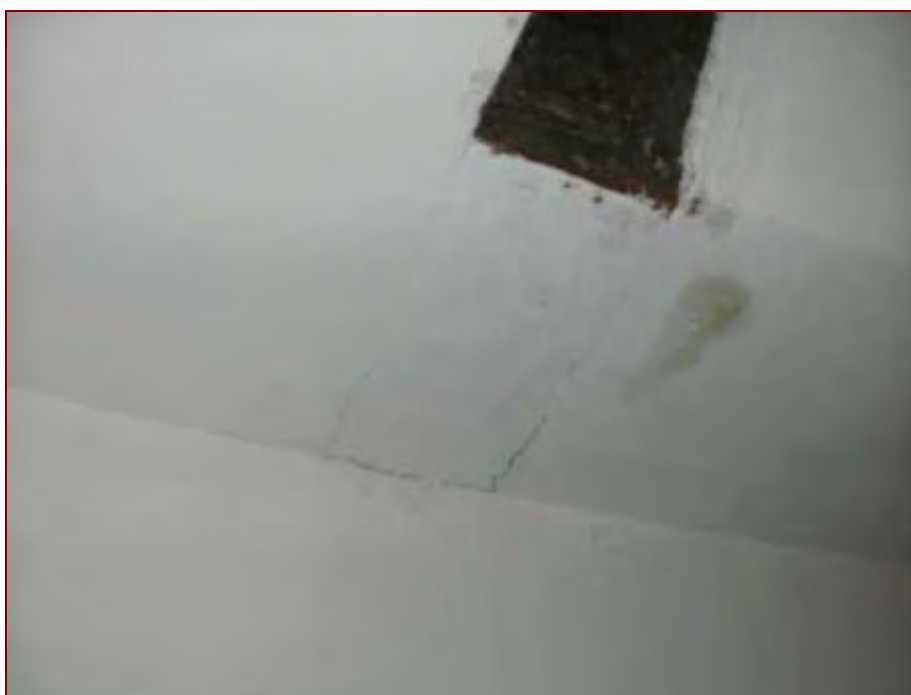
Int 255

5 Ettrickdale Place common stair ground floor minor cracking between upper stair and landing
