Client: The City of Edinburgh Council

Water of Leith Flood Prevention Scheme

**Condition Survey
5/4 Ettrickdale Place**

Inspection Date:	External & Common Stair	24th November 2010
	Internal	No Survey

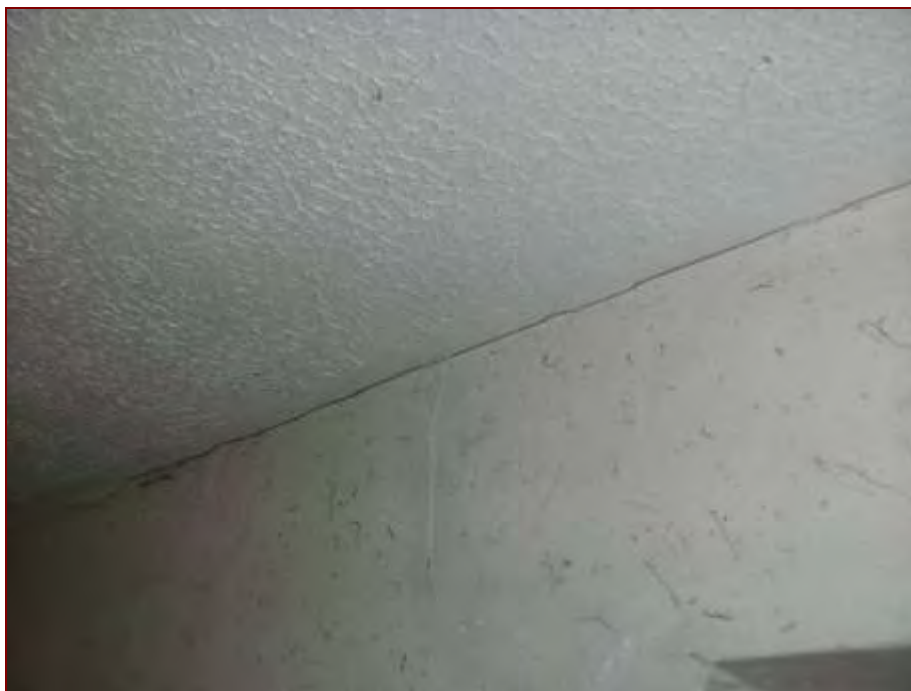
Int 212

5 Ettrickdale Place common stair 2nd floor minor horizontal cracking along ceiling to west wall

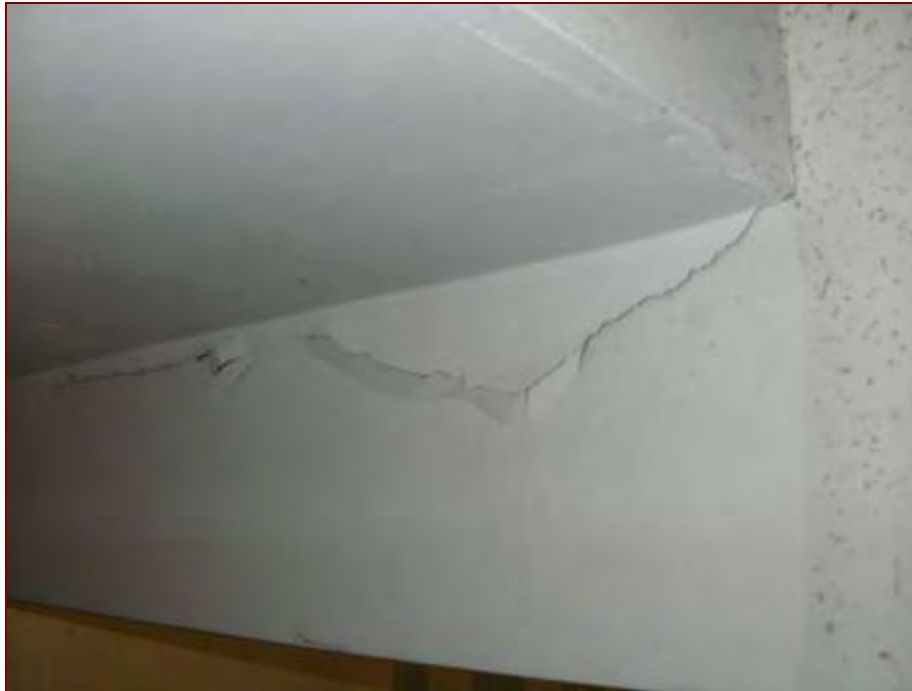
Int 236

5 Ettrickdale Place common stair 1st floor moderate crack along south beam to north face spanning on east side

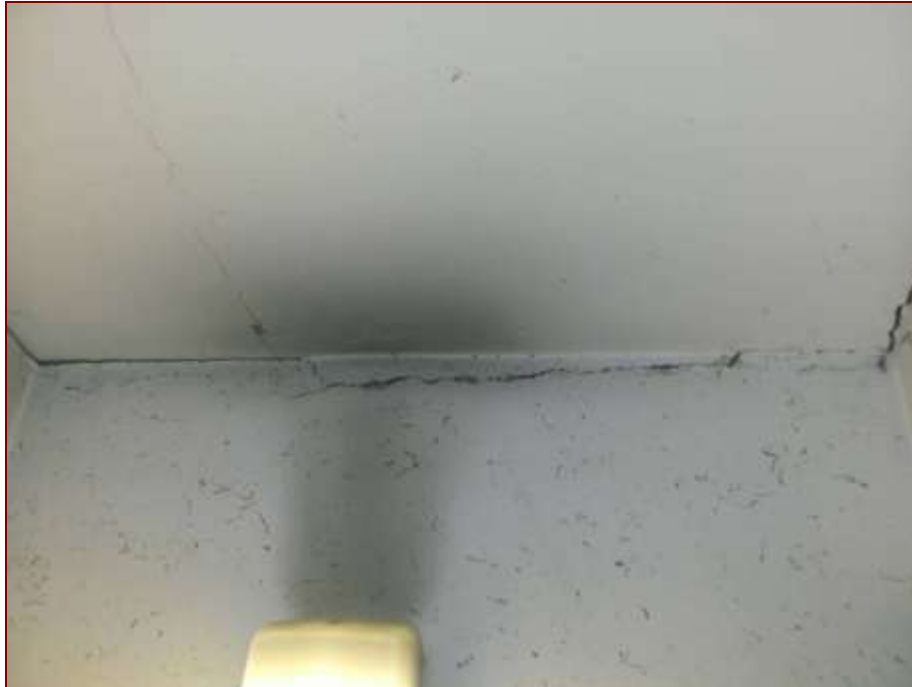
Int 238

5 Ettrickdale Place common stair 1st floor moderate horizontal crack to west wall to south area

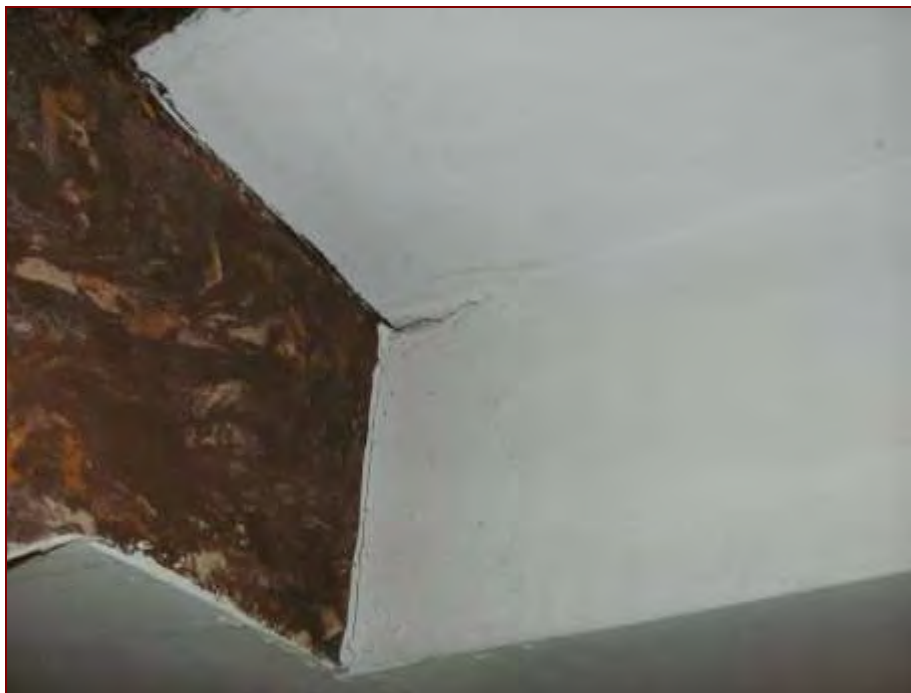
Int 241

5 Ettrickdale Place common stair 1st floor minor cracking to north beam south face

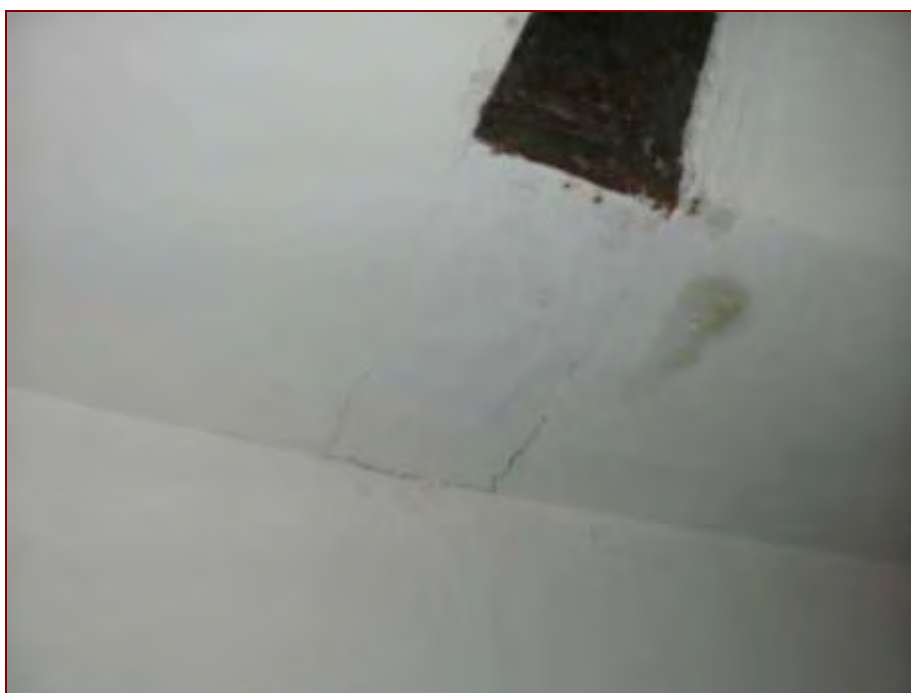
Int 255

5 Ettrickdale Place common stair ground floor minor cracking between upper stair and landing
