Job No. E6351/04

Water of Leith Flood Prevention Scheme

**Condition Survey
5/5 Ettrickdale Place**

Inspection Date:	External & Common Stair	24th November 2010
	Internal	30th August 2010

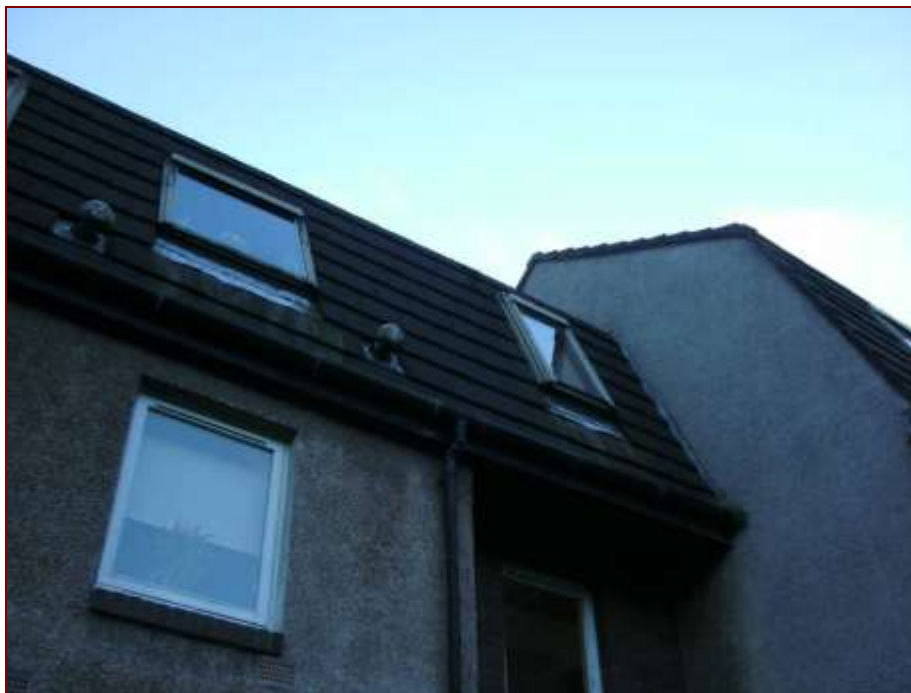
Ext 115
5 Ettrickdale Place North Elevation

LOCATION	DESCRIPTION	CONDITION	Photo graph
North Elevation – (front)			
Roof	Tiles	Average condition No signs of cracking/damage	114-116
Walls	Pebbledash brick/facing brickwork	Fair condition. No signs of cracking	117-124
East Elevation (gable)			
Wall			125-126
South Elevation (rear)			
Roof			127-128
Wall			129-137
West Elevation (gable)			
Wall			138-139

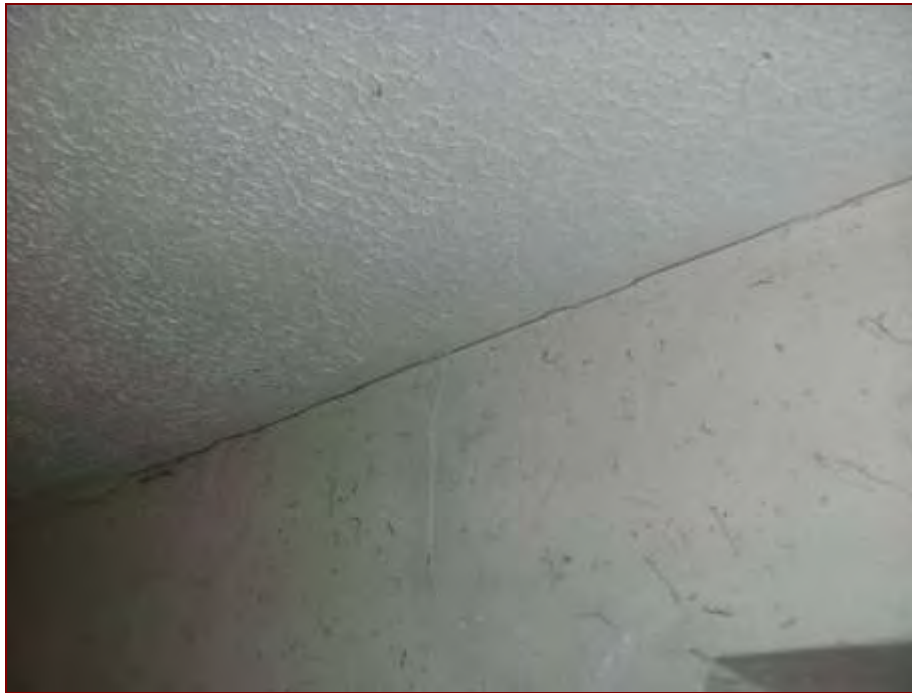
Int 212

5 Ettrickdale Place common stair 2nd floor minor horizontal cracking along ceiling to west wall

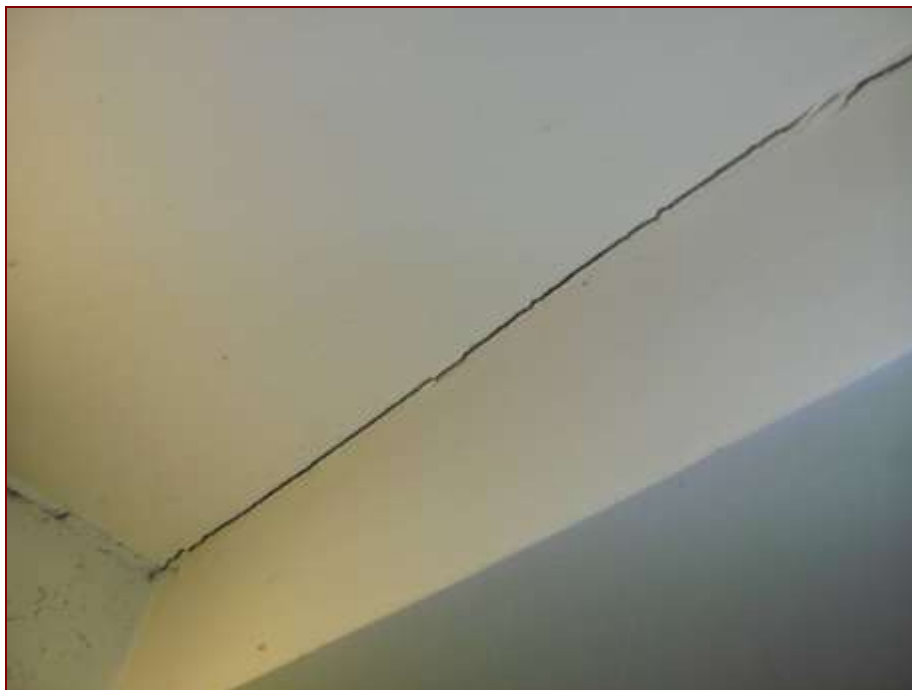
Int 223

5 Ettrickdale Place common stair 1st floor moderate crack along south beam to south face
spanning east west

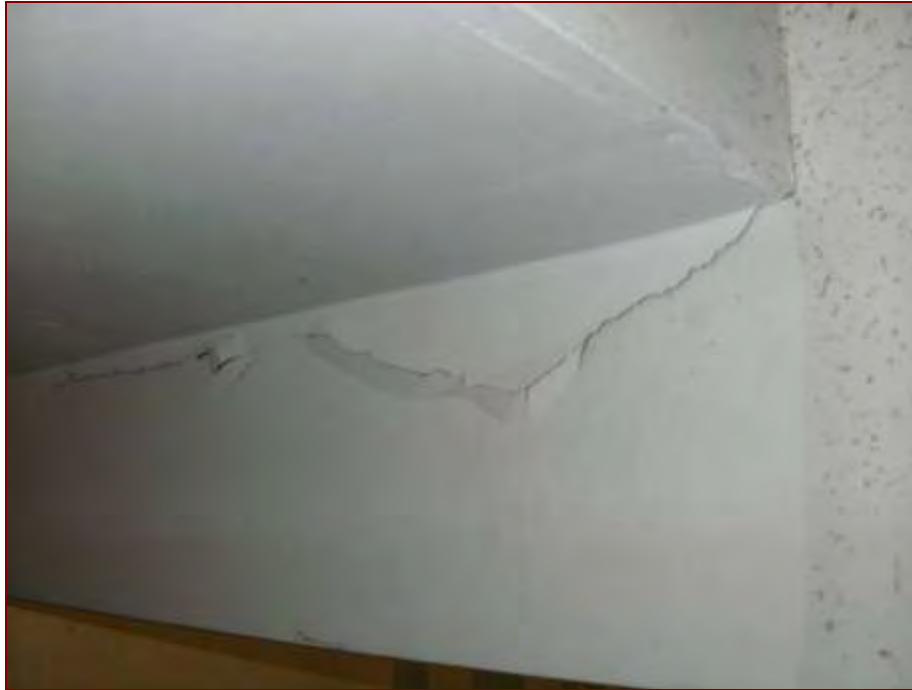
Int 236

LOCATION	DESCRIPTION	CONDITION	Photo graph
Wall	Paint on solid	Fair condition	233
		Minor horizontal crack to west wall above stairs	234-235
		Moderate crack to south beam on north face on east side	236-237
		Moderate horizontal cracks to west wall to south areas	238
		Minor vertical and horizontal crack to top of LHS of window to south area	239
		Minor vertical and horizontal cracking to south east boarded out area	240
		Minor vertical and horizontal cracking to north beam, south face spanning east to west	241
		Minor 2No. diagonal cracks to north beam, south face to east	242
		Minor vertical and horizontal to LHS and RHS of north window	243-244
Floor	Vinyl	Solid, sound, level	245
South window	Painted timber frame	Appears square, opens/closes freely	246
North window	Painted timber frame	Appears square. Opens/closes freely	247
Stairs	Vinyl on solid	Solid, sound, level	248
Ceiling above stairs	Paint on plaster	Fair condition Hairline cracks to top of stair spanning east to west	249-250

5 Ettrickdale Place common stair 1st floor moderate crack along south beam to north face spanning on east side

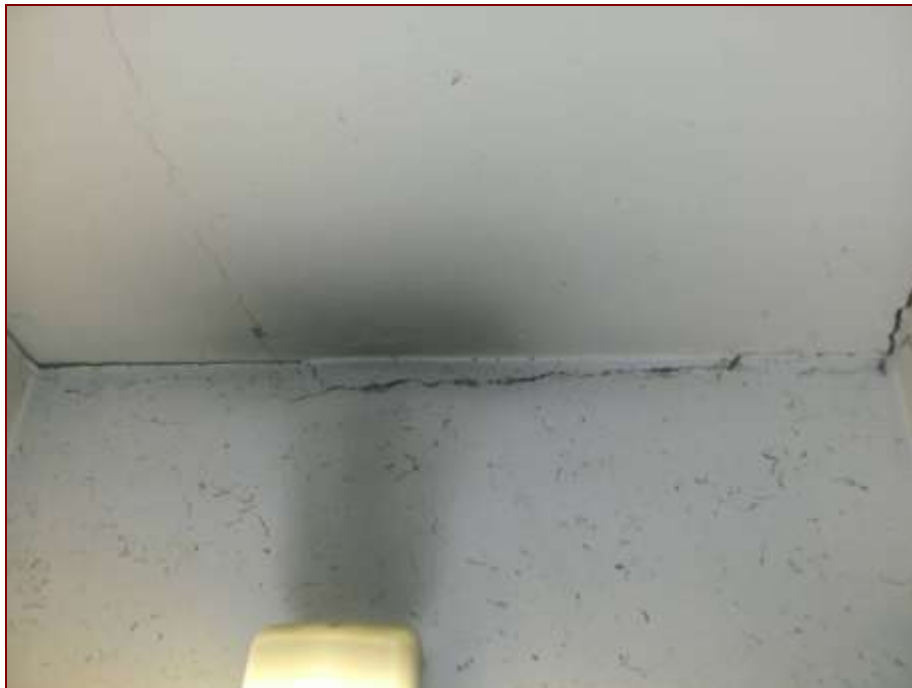
Int 238

5 Ettrickdale Place common stair 1st floor moderate horizontal crack to west wall to south area

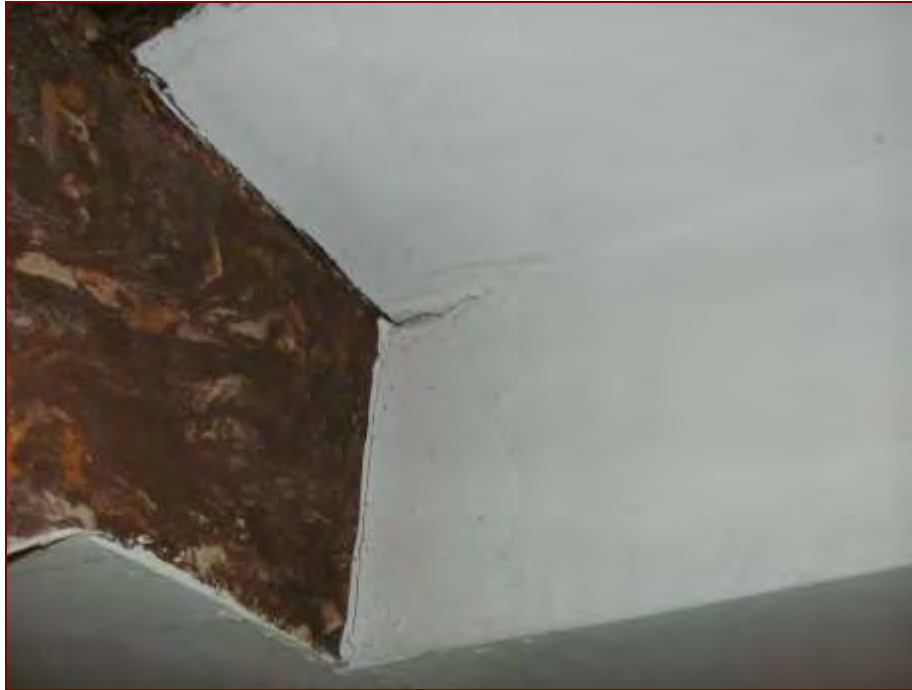
Int 241

5 Ettrickdale Place common stair 1st floor minor cracking to north beam south face

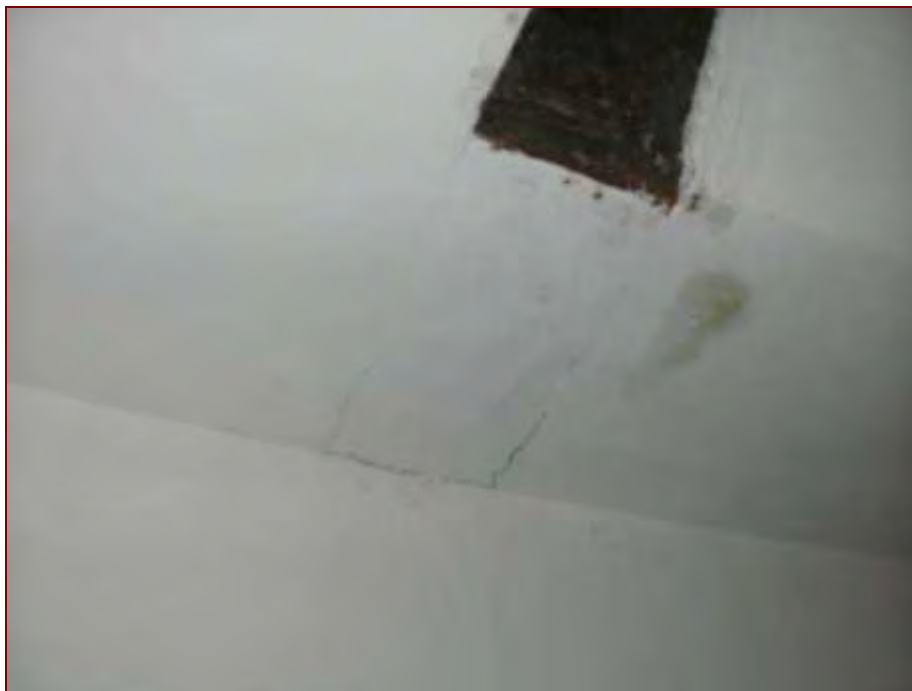
Int 255

Ground floor			
Ceiling	Paint on plaster	Fair condition	251
		Minor crack to south beam along downstand to south side	252-253
		Minor crack along south beam to north face to east area	254
		Minor cracking between upper stairs and landing to south	255
		Minor cracking spanning north/south to downstairs stair	256
		Hairline crack spanning east to west to north, adjacent to cupboard door	259

5 Ettrickdale Place common stair ground floor minor cracking between upper stair and landing
