Job No. E6351/04

Water of Leith Flood Prevention Scheme

Condition Survey

5/6 Ettrickdale Place

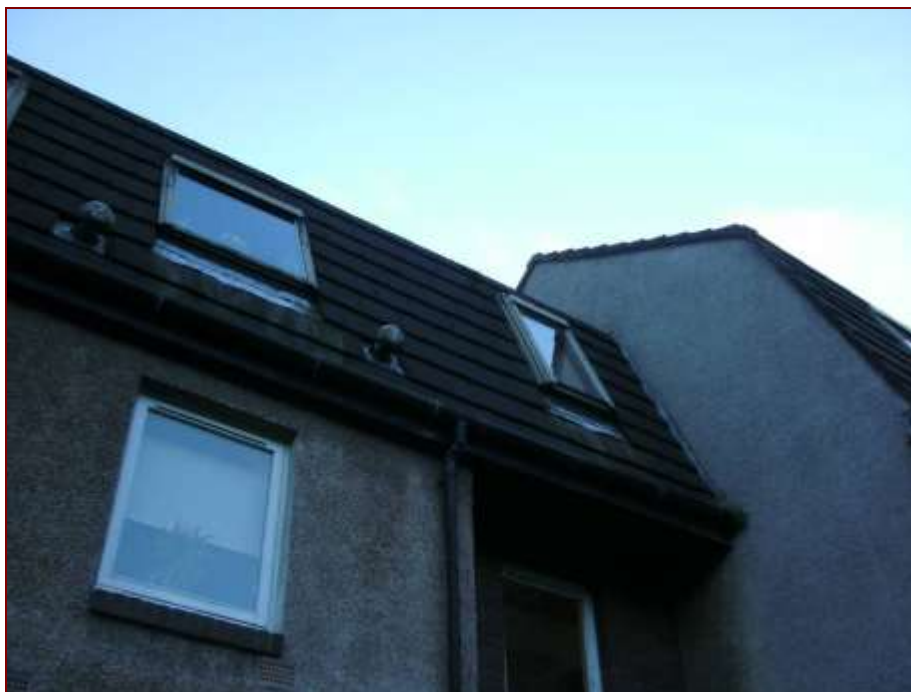
Ext 115
5 Ettrickdale Place North Elevation

LOCATION	DESCRIPTION	CONDITION	Photo graph
North Elevation – (front)			
Roof	Tiles	Average condition No signs of cracking/damage	114-116
Walls	Pebbledash brick/facing brickwork	Fair condition. No signs of cracking	117-124
East Elevation (gable)			
Wall			125-126
South Elevation (rear)			
Roof			127-128
Wall			129-137
West Elevation (gable)			
Wall			138-139

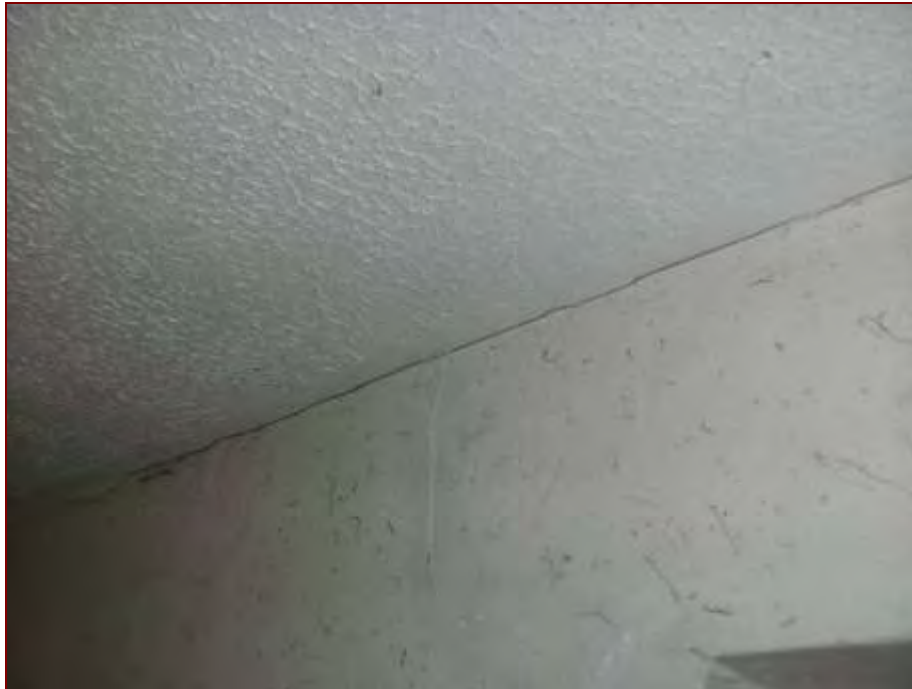
Int 212

5 Ettrickdale Place common stair 2nd floor minor horizontal cracking along ceiling to west wall

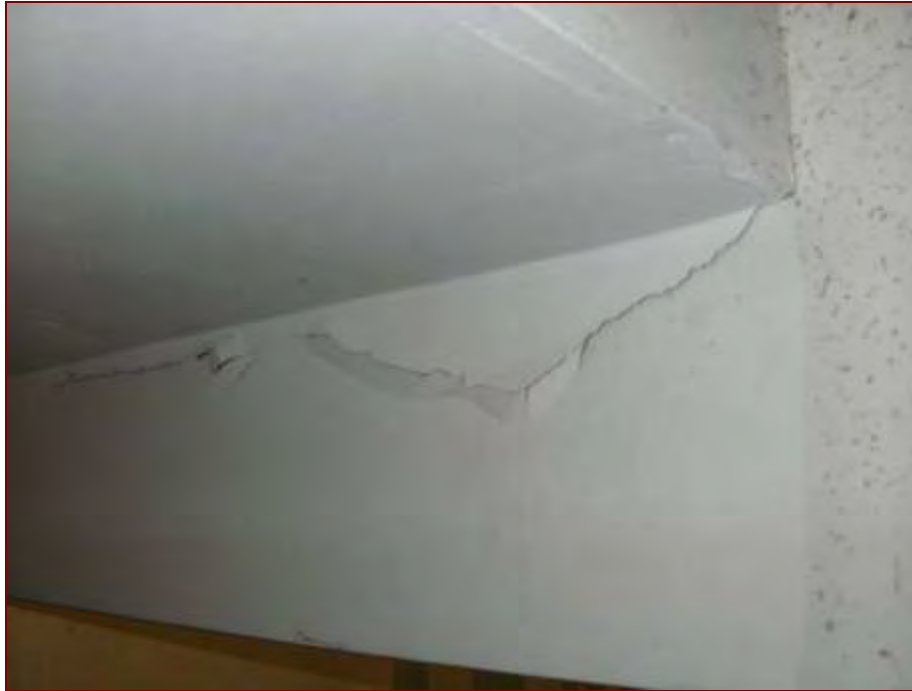
Int 236

LOCATION	DESCRIPTION	CONDITION	Photo graph
Wall	Paint on solid	Fair condition	233
		Minor horizontal crack to west wall above stairs	234-235
		Moderate crack to south beam on north face on east side	236-237
		Moderate horizontal cracks to west wall to south areas	238
		Minor vertical and horizontal crack to top of LHS of window to south area	239
		Minor vertical and horizontal cracking to south east boarded out area	240
		Minor vertical and horizontal cracking to north beam, south face spanning east to west	241
		Minor 2No. diagonal cracks to north beam, south face to east	242
		Minor vertical and horizontal to LHS and RHS of north window	243-244
Floor	Vinyl	Solid, sound, level	245
South window	Painted timber frame	Appears square, opens/closes freely	246
North window	Painted timber frame	Appears square. Opens/closes freely	247
Stairs	Vinyl on solid	Solid, sound, level	248
Ceiling above stairs	Paint on plaster	Fair condition Hairline cracks to top of stair spanning east to west	249 250

5 Ettrickdale Place common stair 1st floor moderate crack along south beam to north face spanning on east side

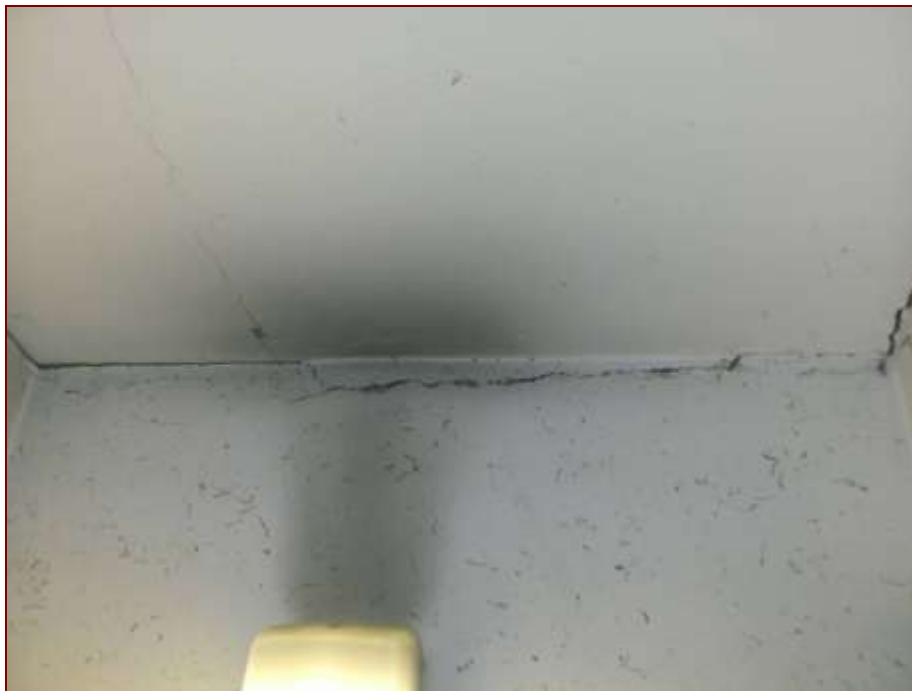
Int 238

5 Ettrickdale Place common stair 1st floor moderate horizontal crack to west wall to south area

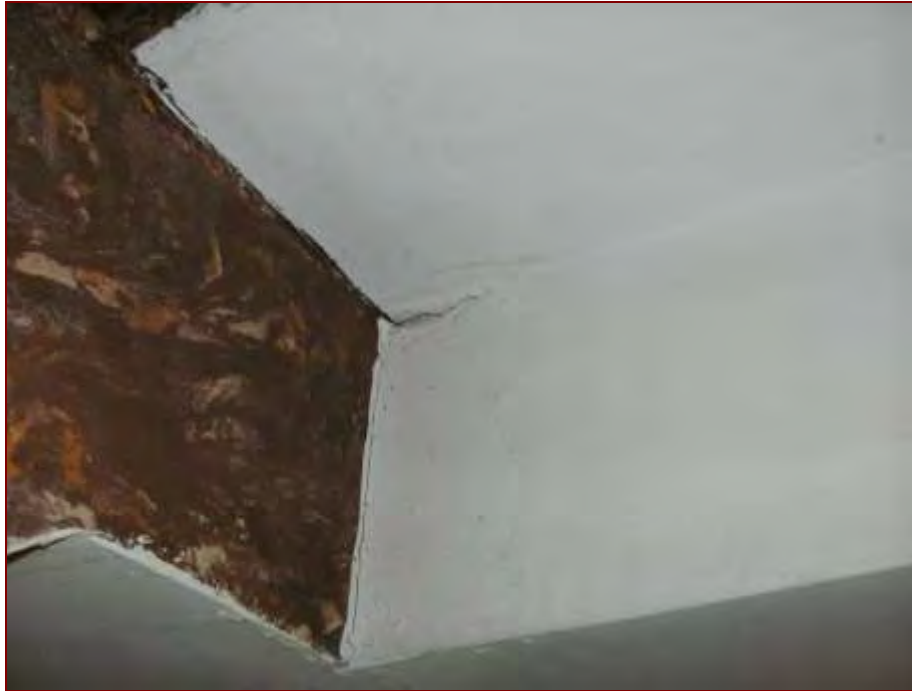
Int 241

5 Ettrickdale Place common stair 1st floor minor cracking to north beam south face

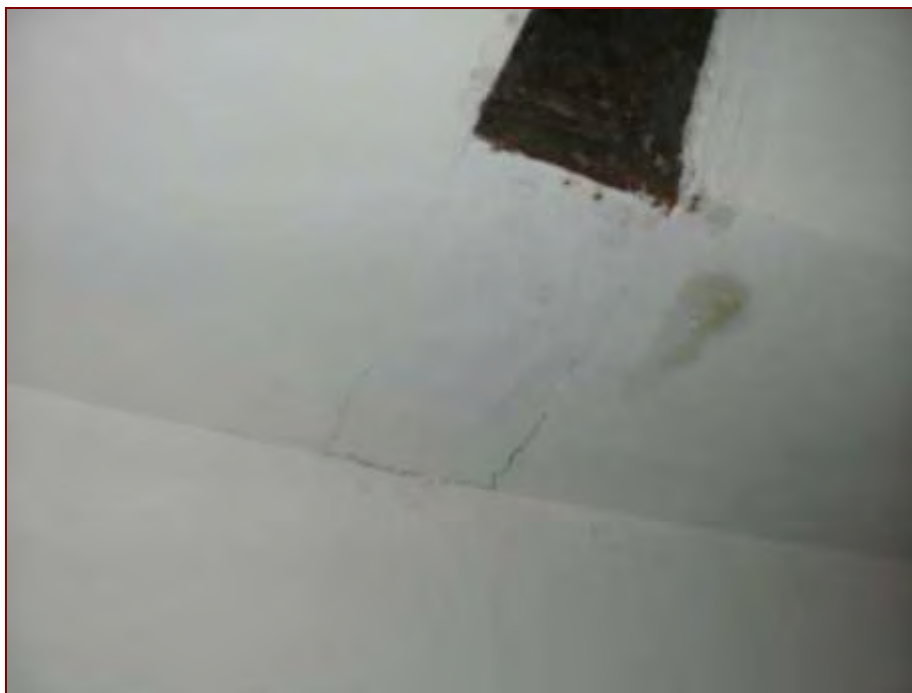
Int 255

Ground floor			
Ceiling	Paint on plaster	Fair condition	251
		Minor crack to south beam along downstand to south side	252-253
		Minor crack along south beam to north face to east area	254
		Minor cracking between upper stairs and landing to south	255
		Minor cracking spanning north/south to downstairs stair	256
		Hairline crack spanning east to west to north, adjacent to cupboard door	259

5 Ettrickdale Place common stair ground floor minor cracking between upper stair and landing
