## Asbestos Refurbishment Survey (with MA + PA)

Client Details	City of Edinburgh Council, Waverley Court, First Floor, Area 1.4, 4 East Market Street, Edinburgh, EH8 8BG
Site Details	Kaimes Special School, 140 Lasswade Road, Edinburgh, , EH16 6RT UPRN:
Date(s) of Surveys	13 Nov 2025
Report Reference Number	J139671
Brief Survey Scope of Works	Refurbishment Survey The scope of the survey was defined by Carin McLachlan of Franks Portlock and as defined in survey request document SR 184-2025-K.

Site address:	Kaimes Special School, 140 Lasswade Road, Edinburgh, , EH16 6RT		
Survey Type:	Refurbishment Survey		
Date of Survey:	13th November 2025		
Lead Surveyor(s):

Report generated date:	5 Dec 2025		
Agreed Scope of Work:	Location (s) within property: Building K1, Circulation 063 Detailed Scope of Works: Removal of rotten plasterboard damaged by continuous roof leaks (job ref MTC50086056). Our records show asbestos residue to metal roof and steel beams from textile firebreak in the Circulation 063. The residue is not visible on the photos (see attached) so it may be present in another area of the circulation space. There are also asbestos cement infill panels behind fibre board panels

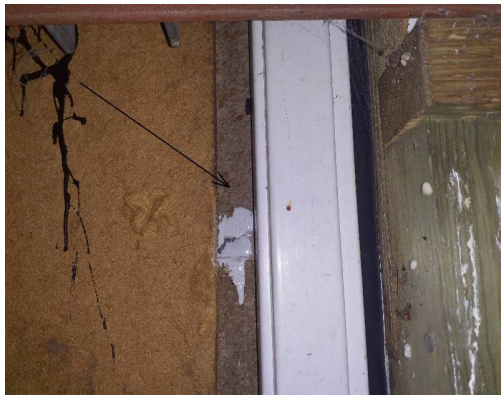
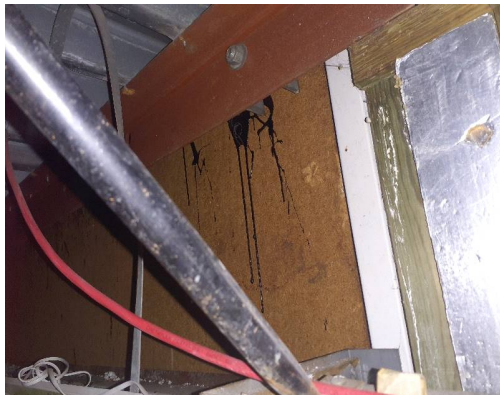
Item No: 4	Sample No: SX000628	Building ID: Kaimes Special School	Location: Circulation, 063	
	Level of ID: Identified			
Item Description: Cement - Window header panels

Sample Comments:				
Product Type:	Cement			1
Extent of Damage:	Good Condition			0
Surface Treatment:				1
Asbestos Type:	Chrysotile			1

Location	Rooms up to 100m <sup>2</sup>	2	Number of occupants	>10	3
Accessibility	Usually inaccessible or unlikely to be disturbed	0	Frequency of use of area	Infrequent	0
Extent / Amount	<10m <sup>2</sup> or <10m pipe run	1	Average time area is in use	<1 hour	0
<b>Likelihood of disturbance</b>	<b>Average Score</b>	<b>1</b>	<b>Human exposure potential</b>	<b>Average Score</b>	<b>1</b>

<b>Normal occupant activity:</b>	<b>Low disturbance</b>	<b>1</b>	Material Assessment Score	<b>3</b>
Type of maintenance activity	Minor disturbance	0	Priority Assessment Score (*)	<b>3</b>
Frequency of maintenance activity	Unlikely	0	Total Risk Score (*)	<b>Very Low Risk (6)</b>
<b>Maintenance activity</b>	<b>Average Score</b>	<b>0</b>	<b>Recommendation</b> Remove prior to refurbishment/demolition where the works will affect this material
