Morningside and Bruntsfield, Edinburgh

Temporary Pedestrian and Cycle Infrastructure

Road Safety Audit Stage 3

Overseeing Organisation Reference: RSA/20/033
AECOM Reference: RSA/284/S3-A

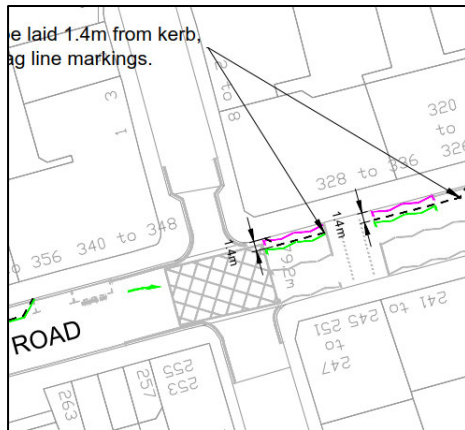
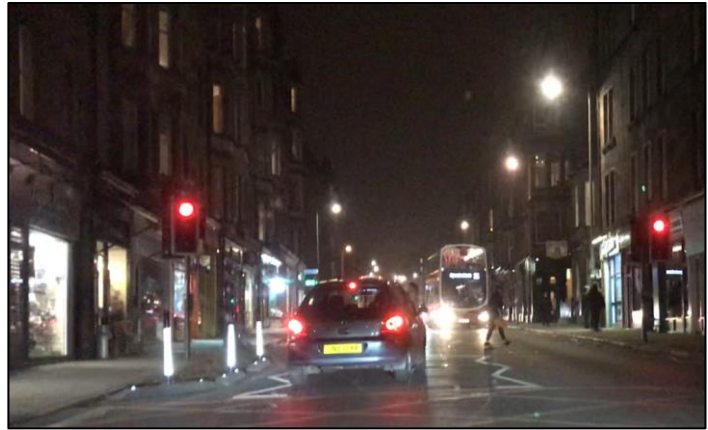
Problem: 4.1.1

Summary: Risk of left turning vehicles colliding with temporary kerb units and losing control, due to proximity of kerb units to side road junction and lack of road markings / signage

As shown in the image and photograph above, a temporary pedestrian area is provided on Morningside Road immediately north of Millar Crescent. The Audit Team have concerns that the driver / rider of a vehicle turning left from Millar Crescent may be unaware of the build out and may have insufficient time to react. This could lead to them colliding with the temporary kerb units and losing control of their vehicle.

It is recommended that the temporary footway area that is demarcated by the temporary kerb units is offset further from the side road junction. It is also recommended that appropriate measures are provided to alert the drivers / riders of left turning vehicles to the change in carriageway alignment on the carriageway, such as road markings and / or traffic signage.

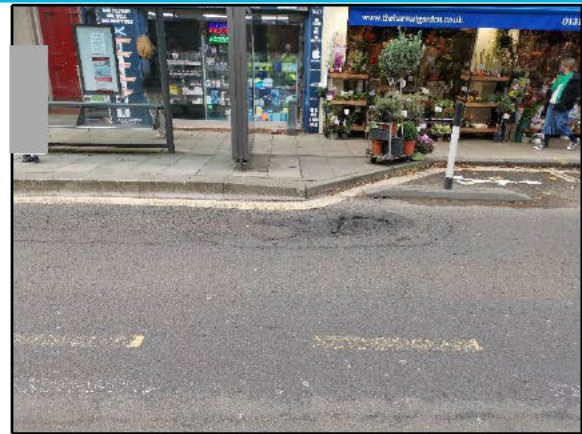
Problem: 4.1.2**Location(s):** Morningside Road (west side) at Church Hill Theatre**Drawing(s):** Sheet 3 of 7**Summary:** Risk of drivers / riders losing control due to uneven carriageway surfacing.

During the site investigation it was observed that the carriageway surface on the west side of Morningside Road at the Church Hill Theatre is uneven. As shown in the photograph above, the carriageway has started to break up at the bus stop.

There is a risk that the uneven surface could lead to drivers / riders losing control of their vehicles.

It is recommended that the surface of the carriageway is appropriately repaired / made good.

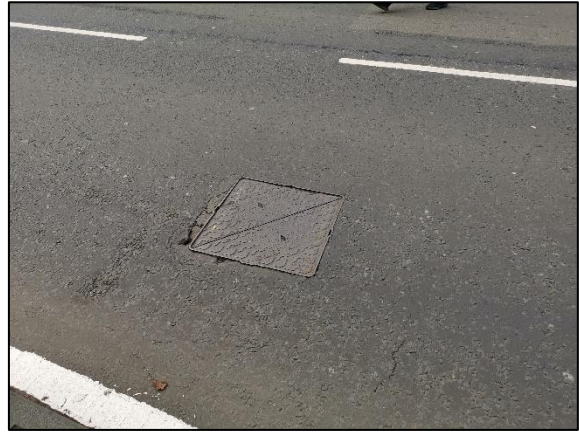
Problem: 4.1.3

Summary: Risk of vehicles losing control on
uneven carriageway surface due to
ironwork failing.

On the east side of Morningside Road, between the junctions with Abbotsford Park and Newbattle Terrace, a service cover is provided in the carriageway. During the site investigation it was observed that this appeared to be in the wheel track of vehicles and there was a noticeable noise, with the cover frame being loose, whenever a vehicle passed over it. As a build out has been provided at this location, the position of vehicles within the lane may have been pushed further from the original kerb line, meaning that the service cover may not have been trafficked in the previous arrangement.

The Audit Team have concerns that the existing ironwork could fail. This could lead to an uneven carriageway surface or a void appearing, which could result in vehicles losing control when they overrun this area.

It is recommended that the ironwork is appropriately re-set and the surrounding carriageway made good.

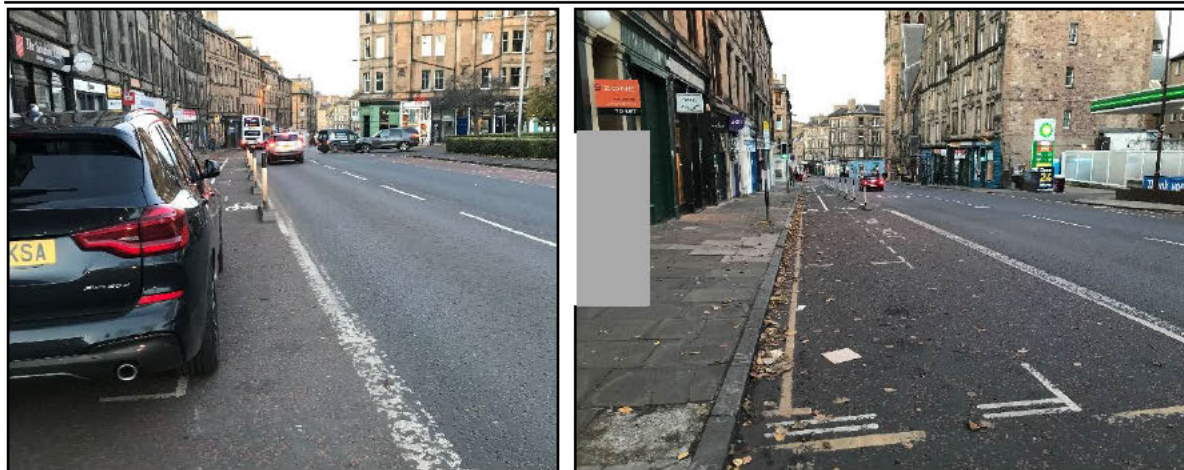
Summary: Risk of vehicles colliding with non-motorised users, resulting in them sustaining personal injuries, due to area for non-motorised users being provided within bus lanes.

Risk of side-swipe collisions occurring due to vehicles undertaking late lane changes upon realising that the bus lane is closed.

A bus lane is provided in the northbound direction on Bruntsfield Place. Temporary areas for non-motorised users are provided within the bus lane, as shown in the photographs above.

No measures appear to have been provided to inform the drivers / riders of approaching vehicles that they cannot continue in the bus lane. The existing bus lane signage and markings are still in place.

There is a risk that these arrangements could lead to vehicles colliding with and injuring non-motorised users. There is also a risk that side-swipe collisions could occur due to vehicles suddenly merging to avoid the temporary areas for non-motorised users upon realising that they cannot continue northbound in the bus lane.

It is recommended that it is made clear to drivers / riders which sections of bus lane are operational and which are closed. It is also recommended that appropriate signage is provided to indicate the start and end of the bus lanes.

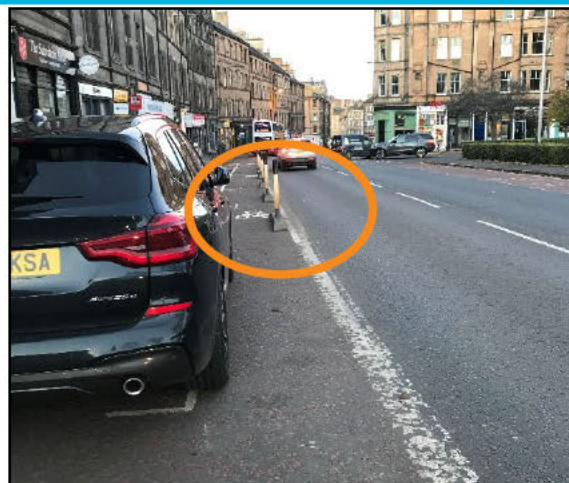
Problem: 4.1.5

Summary: Risk of cyclists striking a stopped vehicle or temporary kerbing unit and sustaining a personal injury, due to position of loading areas and temporary kerbing units with respect to the cycle lane.

Temporary segregated areas for use by cyclists are provided within the northbound bus lane on Bruntsfield Place. At the southern-most build out, loading bays are provided immediately upstream of the temporary segregated area. This arrangement is shown in the photograph above. As shown in the photograph, there would be very little space for a cyclist to manoeuvre between a vehicle parked in the loading bay and the edge of the temporary kerb unit.

The Audit Team have concerns that the positioning of the loading area with respect to the cycle areas could lead to collisions involving cyclists and stopped vehicles. Cyclists could strike a stopped vehicle or strike a temporary kerbing unit whilst attempting to manoeuvre past the vehicle, resulting in them sustaining personal injuries.

It is recommended that sufficient space is provided for cyclists to manoeuvre past parked vehicles.

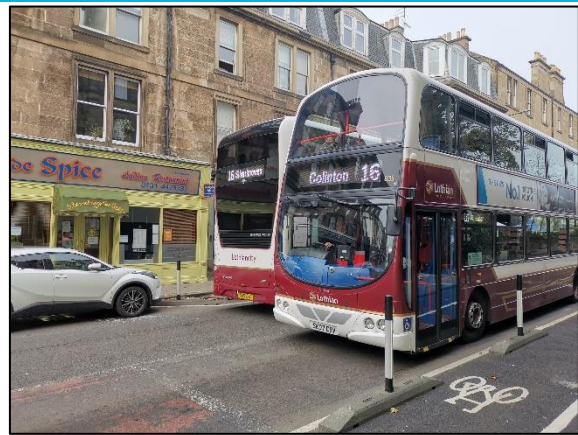
Problem: 4.2.1

Summary: Risk of head-on collisions due to narrow carriageway width.

During the site investigation it was observed that the carriageway width between the new build out and existing bus stop at this location is around 5.80 to 5.85 metres. Whilst on site, the Audit Team observed large vehicles struggling to pass one another. An example of such an instance, involving two buses, is shown in the photograph above. Furthermore, during the site investigation it was observed that northbound vehicles tended to occupy a more central position within the northbound lane in order to avoid the large depression forming in the carriageway, as per issue 4.1.2.

The Audit Team have concerns that the narrow carriageway width could lead to vehicles colliding.

It is recommended that the carriageway width is appropriately wide to allow two vehicles to pass one another.

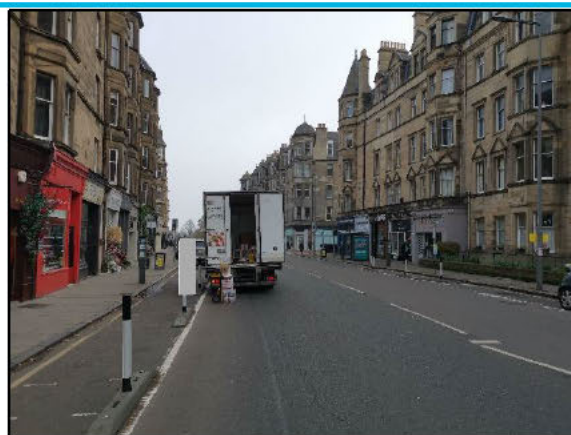
Summary: Risk of vehicles crossing the centre line and colliding head-on with oncoming vehicles due to reduced forward visibility and vehicles loading on the carriageway.

During the site investigation several vehicles were observed loading adjacent to the new build outs. An example is shown in the photograph above. At this location, a vehicle would have to cross the centre line in order to pass the loading vehicle. There is a slight bend in the road downstream and vehicles may not have sufficient visibility to oncoming vehicles. This could lead to vehicles crossing the centre line to overtake a loading vehicle and striking oncoming vehicles.

There are existing off-peak parking and loading restrictions at this location, however it is unclear whether vehicles are permitted to park or load in the carriageway. This layout and scenario can be found elsewhere in the scheme.

It is recommended that it is clarified whether vehicles can load at these locations. It is also recommended that locations are provided for vehicles to load where there is appropriate forward visibility and sufficient space for vehicles to overtake a loading vehicle without coming into conflict with oncoming traffic.

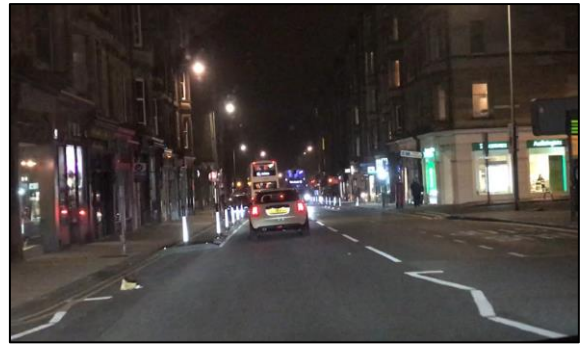
Problem: 4.2.3

Summary: Risk of vehicles striking a temporary kerb unit and losing control.

Risk of vehicles entering pedestrian space and striking pedestrians, leading to them sustaining personal injuries.

No road markings or signage have been provided at the build out on the east side of Morningside Road, south of the junction with Steel's Place. There is a risk that the driver / rider of an approaching vehicle may be unaware of the presence of the build out, which could result in them striking a temporary kerb unit and losing control. There is also a risk of vehicles entering the pedestrian space and striking pedestrians, leading to them sustaining personal injuries.

It is recommended that appropriate signage and / or road markings are provided to highlight the presence of the build out to the drivers / riders of approaching vehicles.

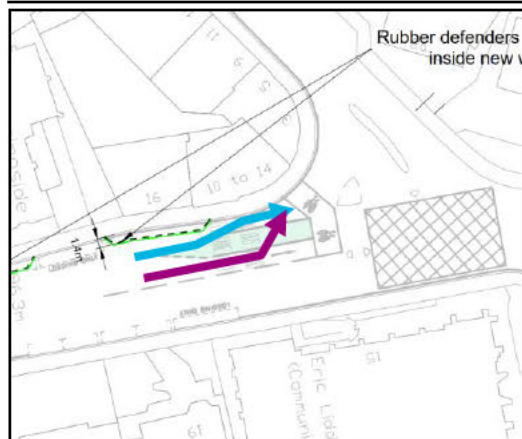
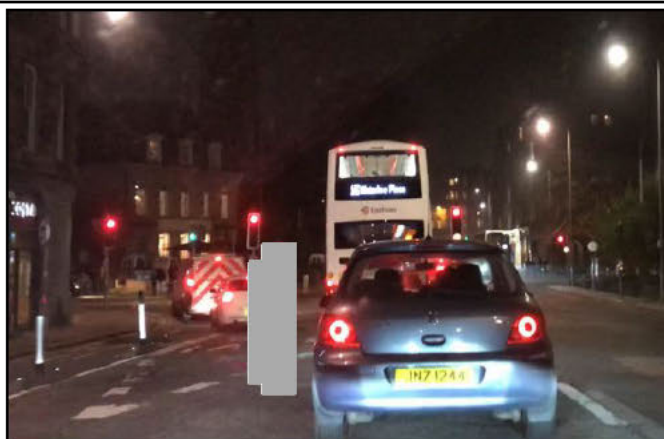
Problem: 4.3.1

Summary: Risk of late lane changes due to unclear junction arrangement, leading to side-swipe collisions.

The scheme includes a build out on the west side of Morningside Road, immediately south of its junction with Colinton Road. This build out shortens the left turn lane, forcing vehicles to enter or cross the bus lane in order to access it.

There is a risk that vehicles may make late lane changes when attempting to access the left turn lane, due to the unclear arrangement. This could lead to side-swipe collisions occurring.

It is recommended that the road marking arrangement at the junction is altered to clarify how motorised road users should access the left turn lane.

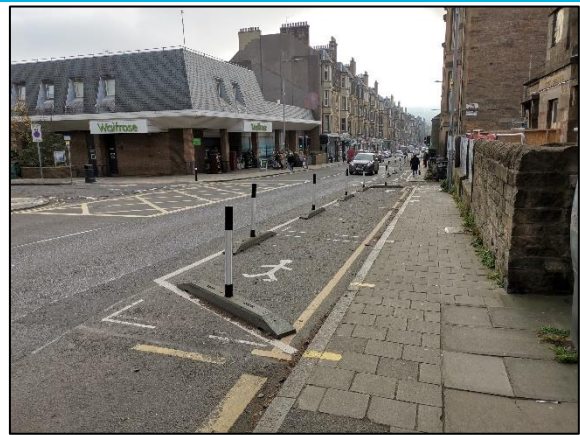
Problem: 4.4.1

Summary: Risk of pedestrians tripping and sustaining personal injuries when transitioning to or from the carriageway, due to lack of provision of dropped kerbs or ramps.

During the site investigation it was noted that no means of transitioning between the footway and temporary pedestrian space are provided. An example of this is shown in the figure above.

There is a risk that a pedestrian could sustain a personal injury due to tripping and falling when attempting to transition between the footway and carriageway.

It is recommended that appropriate means are provided for pedestrians to transition between the footways and temporary pedestrian areas on the carriageway.

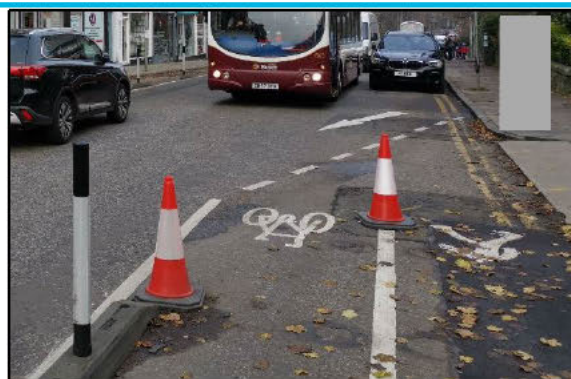
Problem: 4.4.2

Summary: Risk of non-motorised users colliding with other non-motorised users and sustaining personal injuries, due to delineation of non-motorised user space on the carriageway.

As shown in the photograph above, three of the build outs include both a space for pedestrians and a cycle lane, with these spaces being segregated via a white line. Pedestrian and cycle (to Diagram 1057, TSRGD 2016) road marking symbols are provided at the start and end of the build out to indicate which side of the white line should be used by which mode. The pedestrian symbols are orientated in the same direction as the flow of traffic, but it is unclear if it is intended for bi-directional use.

The Audit Team have concerns that the arrangement could lead to collisions between non-motorised users due to pedestrians encroaching on the cycle side of the build out and vice-versa.

It is recommended that the areas that are intended for use by cyclists and pedestrians are appropriately delineated.

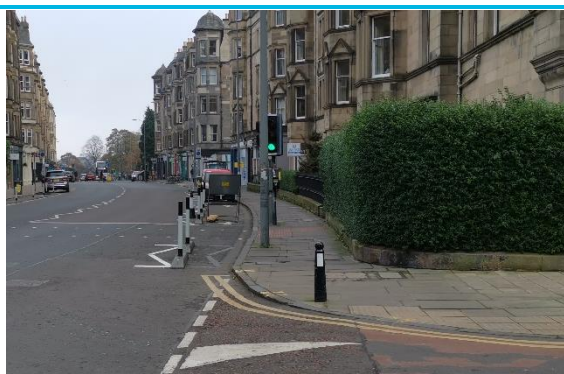
Problem: 4.4.3

Summary: Risk of pedestrians walking into carriageway and being struck by passing vehicles, resulting in them sustaining personal injuries, due to extents of temporary pedestrian area being unclear.

As shown in the photograph above, no measures are currently provided to indicate the boundary of the temporary pedestrian space on Bruntsfield Place at Bruntsfield Gardens. There is a risk that pedestrians could continue walking southwards, out of the protected area and into the carriageway. This could lead to them being struck and injured by passing vehicles.

It is recommended that the boundary of the temporary pedestrian area is highlighted through the use of a temporary kerb unit or road markings.

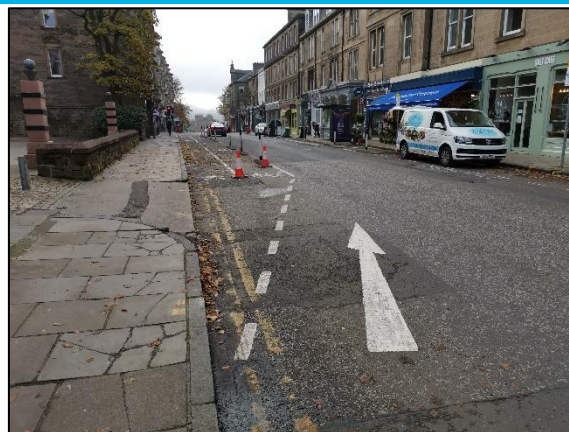
Problem: 4.4.4

Summary: Risk of vehicles entering the temporary space for non-motorised users due to the limited provision of road markings and signage. This could lead to vehicles striking non-motorised users, with the non-motorised users sustaining personal injuries.

The Audit Team have concerns that vehicles could inadvertently enter some of the temporary protected spaces intended for use by pedestrians and cyclists. As shown in the example in the photograph above, the temporary spaces that include a cycle lane next to an area for pedestrian use are wide and could be mistaken for a general traffic or bus lane. At the location shown in the photograph above, traffic cones had been positioned in the temporary build out, offset from the taper. It is assumed that this is because there have been issues with vehicles entering this area.

If a vehicle was to enter this area, there is a risk that it could collide with and injure non-motorised users.

This risk is heightened by the general lack of road markings and signage at these build outs.

It is recommended that appropriate road markings and / or signage is provided to highlight to the drivers / riders of approaching vehicles that the space is for non-motorised users and that there is a change in alignment of the carriageway.

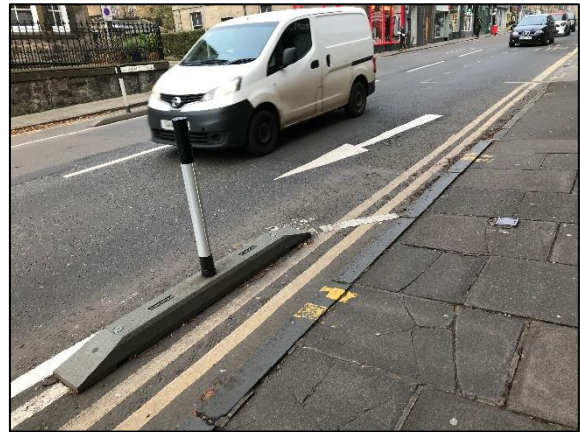
Problem: 4.4.5

Summary: Risk of cyclists entering space designated for use by pedestrians. This could lead to collisions occurring between cyclists and pedestrians, and non-motorised users sustaining personal injuries.

A temporary build out is provided between the junctions with Abbotsford Park and Newbattle Terrace. It is unclear whether this is for use by pedestrians or cyclists. The fact that this is not clear could lead to both pedestrians and cyclists using this space, increasing the risk of collisions occurring between pedestrians and cyclists and non-motorised road users sustaining personal injuries.

It is recommended that the use of this area is appropriately clarified.

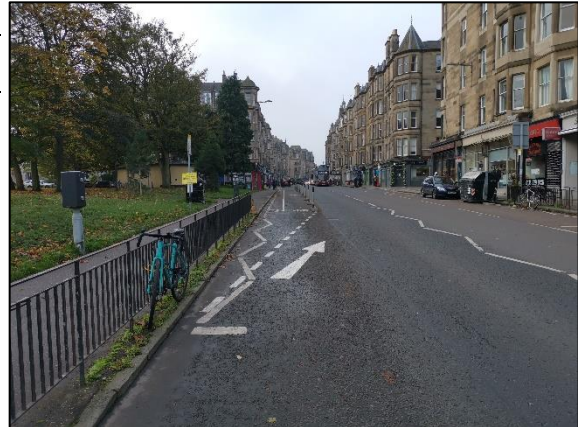
Problem: 4.5.1

Summary: Risk of vehicles colliding with temporary kerb units and losing control, due to position and appearance of deflection arrows.

Risk of vehicles entering space reserved for non-motorised users, due to position and appearance of deflection arrows. This could lead to them striking and injuring non-motorised users.

Several issues were noted with the placement and provision of deflection arrows within the scheme extents:

- Arrows being placed too close to the build out to give sufficient time for a driver / rider to react;
- Arrows being located in positions where they could be masked by a stopped vehicle; and
- Arrows not being marked according to Diag. 1014 (TSRGD, 2016).

There is a risk that the issues listed above could lead to vehicles colliding with temporary kerb units and losing control, or of vehicles entering space reserved for non-motorised users and striking and injuring non-motorised users.

It is recommended that the deflection arrows are provided at appropriate locations and that they are appropriately marked and orientated.

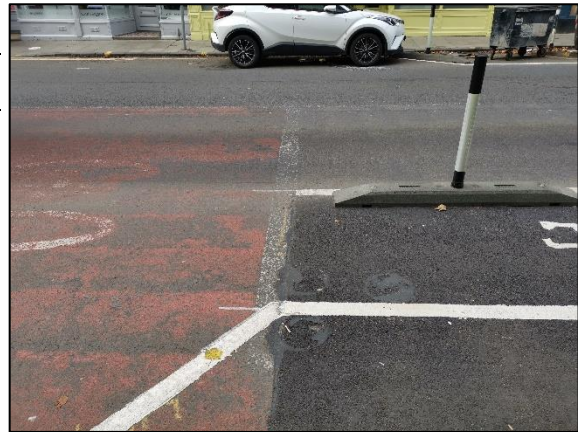
Summary: Risk of vehicles crossing stop lines when it is not safe to do so and striking crossing pedestrians or turning vehicles, due to stop lines being worn / insufficiently conspicuous.

During the site investigation it was observed that several of the existing stop lines within the scheme are very worn. An example is shown in the photograph above.

If stop lines are not sufficiently conspicuous, there is a risk that drivers / riders may not appreciate that they need to stop, which could lead to vehicles crossing stop lines when it is not safe to do so and striking crossing pedestrians or turning vehicles.

It is recommended that the stop lines are appropriately refreshed.

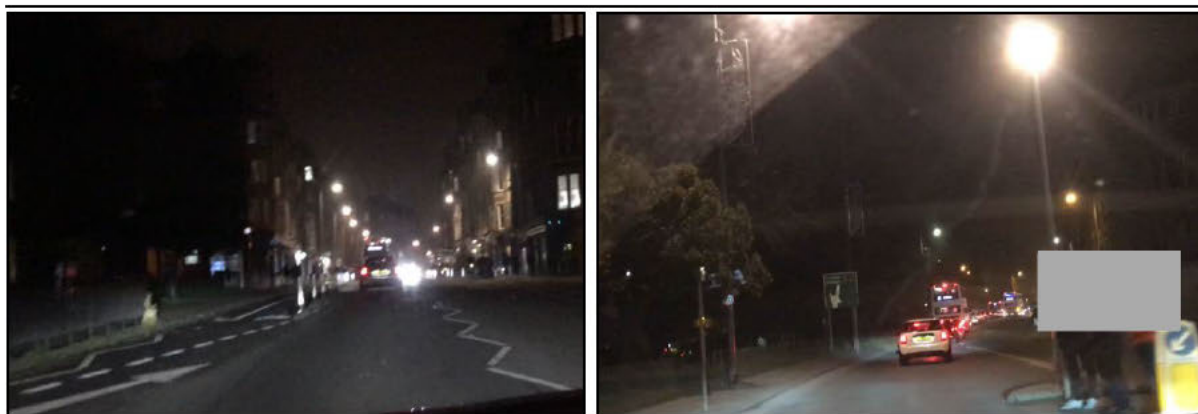
Problem: 4.5.3

Summary: Risk of vehicles colliding with crossing pedestrians, resulting in the pedestrians sustaining personal injuries, or vehicles colliding with temporary kerb units and losing control, due to insufficient illumination.

During the site investigation that was undertaken during the hours of darkness it was observed that two lighting columns were not functioning: one on Bruntsfield Place opposite Leamington Terrace and the other on Morningside Road opposite Maxwell Street. When lighting columns are not functioning, dark spots can form on the carriageway and footways. There is a risk that this could lead to vehicles colliding with crossing pedestrians, resulting in the pedestrians sustaining personal injuries, or vehicles colliding with temporary kerb units and losing control.

It is recommended that the lighting columns that are not functioning are appropriately repaired.

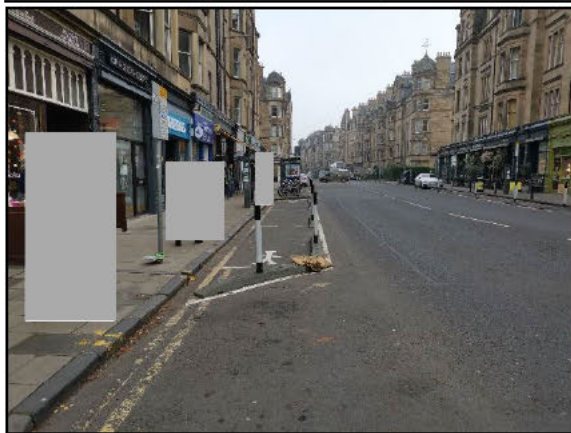
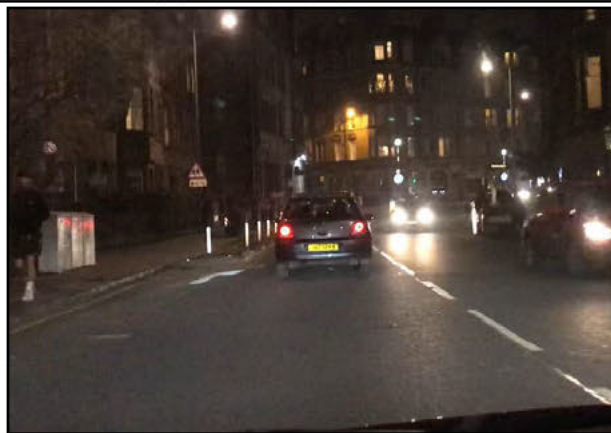
Problem: 4.5.4

Summary: Risk of cyclists attempting to enter the pedestrianised area and colliding with segregation unit, potentially falling and sustaining personal injury.

During the site investigation it was observed that the grey base of the segregation units can blend into its surroundings as it is similar in colour to the carriageway. These units are being used across the city to segregate cycling facilities, as well as pedestrian areas.

It is acknowledged that a white line is also provided adjacent to the segregation units, however during periods of inclement weather (heavy rain / snow) these lines may not be visible.

There is a risk that cyclists may think that they are approaching a cycling facility and proceed to enter. However, a unit is placed at an angle to prevent access. There is concern that cyclists may collide with it and fall, possibly resulting in personal injury, due to the base blending into the background.

It is recommended that a reflect strip is applied to those base units are used to prevent access to the segregated area.
