### CS001270

| Survey Description | Survey Date | Survey Status | Surveyor | Organisation |
|---|---|---|---|---|
| Site | SIT0782 NICOLSON SQUARE<br>GROUND (AND PUBLIC<br>CONVENIENCE) | | | |

## Building Summary BLD01460 NICOLSON SQUARE PUBLIC CONVENIENCE

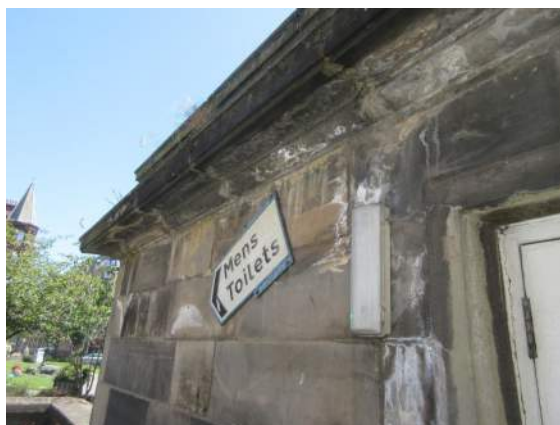
| <b>Code:</b> | IW00024701 | <b>Site:</b> | SIT0782 NICOLSON SQUARE GROUND (AND PUBLIC CONVENIENCE) |

| <b>Priority:</b> | 02 Essential - Within 2 years | <b>Defect:</b> | Severe water ingress and dampness noted internally; externally walls are saturated |
| <b>Manufacturer:</b> | | <b>Defect Location:</b> | Roof level ; ladies toilet |

| <b>Condition:</b> | C Poor | <b>Remedy:</b> | Roof survey by specialists advised ; provisional sum allowed for renewal included else where; cost for inspection only<br>Target year: 2019 |

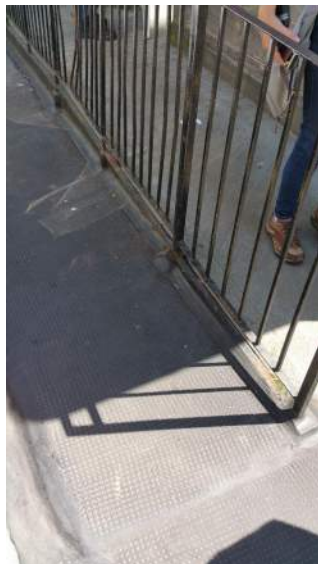
| <b>Code:</b> | IW00024250 | <b>Site:</b> | SIT0782 NICOLSON SQUARE GROUND (AND PUBLIC CONVENIENCE) |

| <b>Priority:</b> | 03 Desirable - Within 3 to 5 years | <b>Defect:</b> | the area above the basement Gents toilet area has recently been recovered with a water proofing membrane |
| <b>Manufacturer:</b> | | <b>Defect Location:</b> | paved area above Gents Toilet |

| <b>Condition:</b> | B Satisfactory | <b>Remedy:</b> | monitor and allow for further possible work to make area watertight<br>Target year: 2022 |

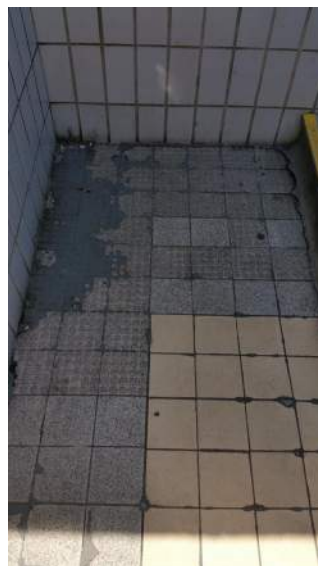
**Code:** IW00024243

**Defect:** floor tiles in poor condition, mixture of tiles, damage to tiles and applied coating breaking up

**Defect Location:** access steps to Gents Toilet, landing at foot of steps

**Remedy:** replace tiles with appropriate floor finish  
Target year: 2019

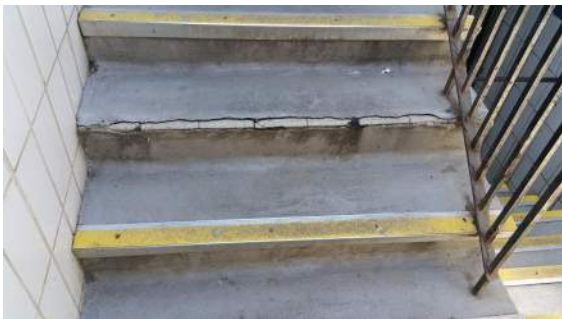
| <b>Priority:</b> | 01 Urgent | <b>Defect:</b> | missing stair nosing and defective floor finish below<br>exposing tiles damage to ceiling in Attendants Room<br>(below steps) likely to be caused by defective floor<br>finish (see separate Identified Work) |
| <b>Manufacturer:</b> | | <b>Defect Location:</b> | access steps to Gents Toilet |

| <b>Condition:</b> | D Bad | <b>Remedy:</b> | make good defective floor finish and replace nosing<br>Target year: 2019 |

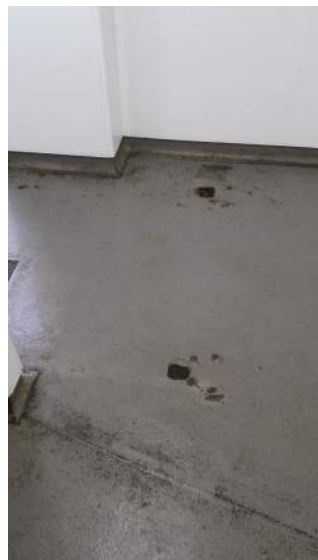
**Code:** IW00024245

**Defect:** defective floor finish where (assumed) barrier removed  
staff comments on difficulty in keeping floor finish clean

**Defect Location:** Gents Toilet main area

**Remedy:** replace floor finish with appropriate specification  
Target year: 2020

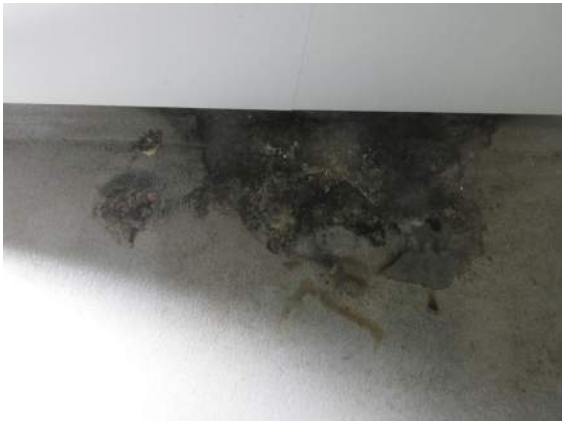
| <b>Priority:</b> | 02 Essential - Within 2 years | <b>Defect:</b> | Defective areas of vinyl |
| <b>Manufacturer:</b> | | <b>Defect Location:</b> | Ladies and Accessible toilet |
| <b>Comments:</b> | Flooring has been subjected to vandalism /fire raising | | |

| <b>Condition:</b> | C Poor | <b>Remedy:</b> | Replace floor finish with appropriate specification<br>Target year: 2020 |

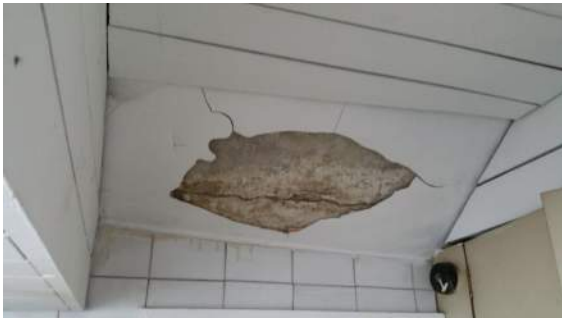
| <b>Code:</b> | IW00024248 | <b>Site:</b> | SIT0782 NICOLSON SQUARE GROUND (AND PUBLIC CONVENIENCE) |

| <b>Priority:</b> | 01 Urgent | <b>Defect:</b> | plaster ceiling to underside of access steps |
| <b>Manufacturer:</b> | | <b>Defect Location:</b> | Gents Toilet attendants room |
| <b>Comments:</b> | damage to ceiling likely to be as a result of water ingress from entrance steps above | | |

| <b>Condition:</b> | D Bad | <b>Remedy:</b> | repair/replace defective cupboard unit<br>Target year: 2019 |

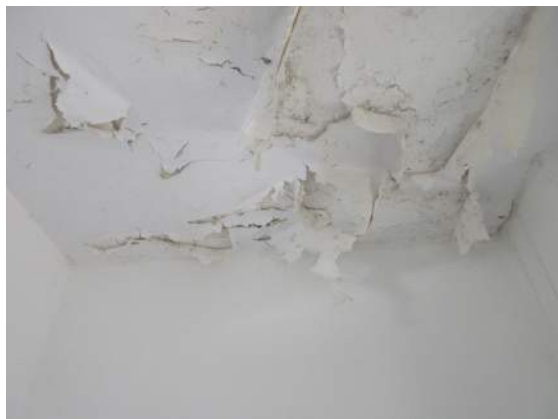
| <b>Code:</b> | IW00024745 | <b>Site:</b> | SIT0782 NICOLSON SQUARE GROUND (AND PUBLIC CONVENIENCE) |

| <b>Priority:</b> | 02 Essential - Within 2 years | <b>Defect:</b> | Damage to ceiling caused by water ingress from defective roof coverings |
| <b>Manufacturer:</b> | | <b>Defect Location:</b> | Ladies and Accessible Toilet |

| <b>Condition:</b> | C Poor | <b>Remedy:</b> | replace defective ceiling linings , in completion of roof works, and paint surface on completion<br>Target year: 2020 |

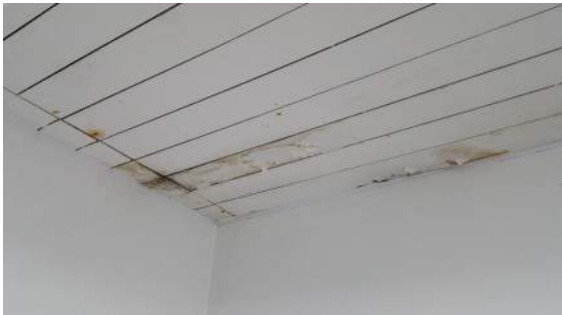
| <b>Code:</b> | IW00024246 | <b>Site:</b> | SIT0782 NICOLSON SQUARE GROUND (AND PUBLIC CONVENIENCE) |

| <b>Priority:</b> | 02 Essential - Within 2 years | <b>Defect:</b> | damage to ceiling caused by water ingress through "roof" which is paved area at ground level |
| <b>Manufacturer:</b> | | <b>Defect Location:</b> | Gents Toilet main area |

| <b>Condition:</b> | C Poor | <b>Remedy:</b> | replace defective ceiling lining and paint surface on completion<br>Target year: 2020 |

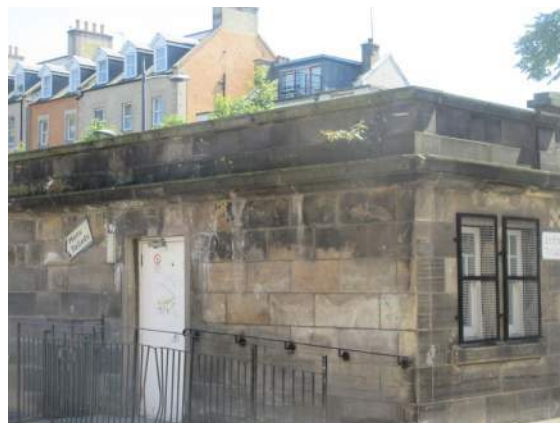
| <b>Code:</b> | IW00024743 | <b>Site:</b> | SIT0782 NICOLSON SQUARE GROUND (AND PUBLIC CONVENIENCE) |

| <b>Priority:</b> | 02 Essential - Within 2 years | <b>Defect:</b> | Isolated areas of open joints to masonry |
| <b>Manufacturer:</b> | | <b>Defect Location:</b> | All elevations |
| <b>Comments:</b> | Some previous pointing has been crudely executed with inappropriate cement mortar | | |

| <b>Condition:</b> | C Poor | <b>Remedy:</b> | Rake out and re-point with appropriate lime mortar<br>Target year: 2019 |

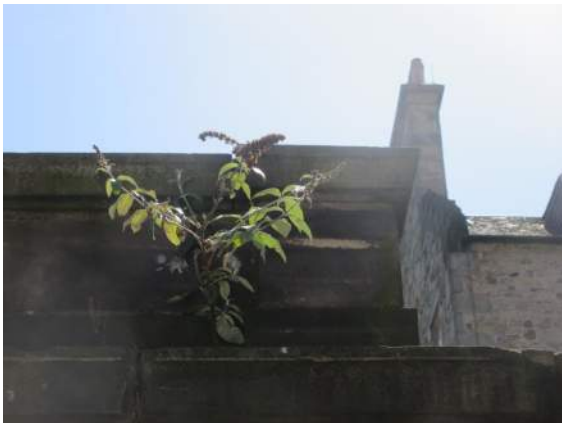
| <b>Code:</b> | IW00024700 | <b>Site:</b> | SIT0782 NICOLSON SQUARE GROUND (AND PUBLIC CONVENIENCE) |

| <b>Priority:</b> | 02 Essential - Within 2 years | <b>Defect:</b> | Vegetation distorting masonry |
| <b>Manufacturer:</b> | | <b>Defect Location:</b> | Blocking course /cope at roof level |
| <b>Comments:</b> | FM aware | | |

| <b>Condition:</b> | C Poor | <b>Remedy:</b> | Hands on inspection required to determine integrity of structure<br>Target year: 2019 |

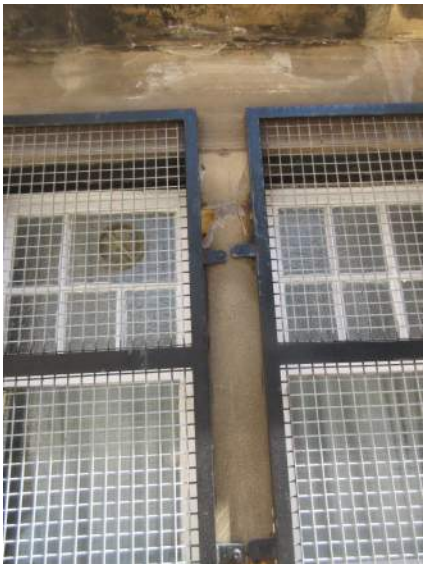
| <b>Code:</b> | IW00024742 | <b>Site:</b> | SIT0782 NICOLSON SQUARE GROUND (AND PUBLIC CONVENIENCE) |

| <b>Priority:</b> | 02 Essential - Within 2 years | <b>Defect:</b> | Defective stone mullion |
| <b>Manufacturer:</b> | | <b>Defect Location:</b> | Ground floor window |
| <b>Comments:</b> | Fixings of metal grills have expanded causing stone to shear | | |

| <b>Condition:</b> | C Poor | <b>Remedy:</b> | Replacement of masonry unit required<br>Target year: 2019 |

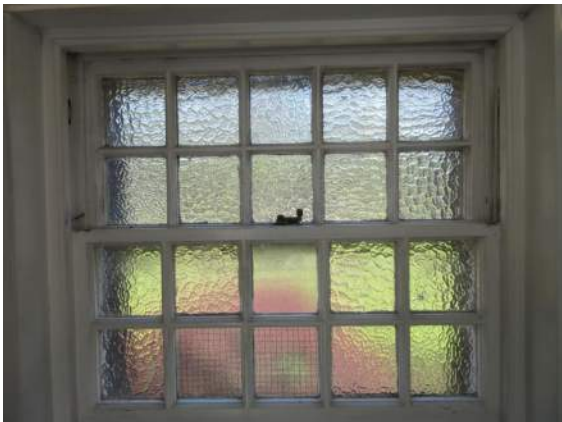
| <b>Code:</b> | IW00024746 | <b>Site:</b> | SIT0782 NICOLSON SQUARE GROUND (AND PUBLIC CONVENIENCE) |

| <b>Priority:</b> | 04 Long Term - Beyond 5 years | <b>Defect:</b> | Sash and case windows in good condition |
| <b>Comments:</b> | Windows nailed/screwed shut ; timbers sound only redecoration required | | |

| <b>Condition:</b> | A Good | <b>Remedy:</b> | no works identified<br>Target year: 2023 |

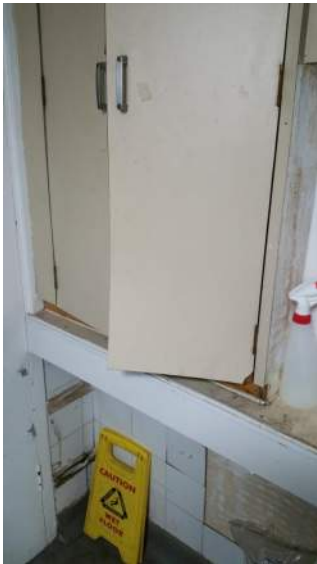
| <b>Code:</b> | IW00024251 | <b>Site:</b> | SIT0782 NICOLSON SQUARE GROUND (AND PUBLIC CONVENIENCE) |

| <b>Priority:</b> | 02 Essential - Within 2 years | <b>Defect:</b> | defective and missing wall tiles |
| | | <b>Defect Location:</b> | Gents Toilet attendants room |

| <b>Condition:</b> | C Poor | <b>Remedy:</b> | Target year: 2020 |

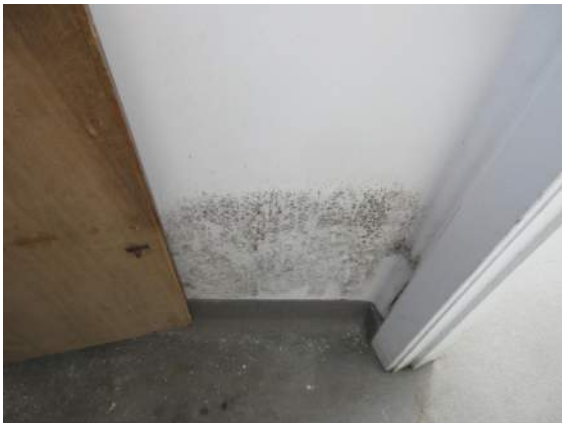
| <b>Priority:</b> | 02 Essential - Within 2 years | <b>Defect:</b> | Defective areas of plaster |
| <b>Manufacturer:</b> | | <b>Defect Location:</b> | Ladies Toilet ; isolates areas |
| <b>Comments:</b> | Dampness caused by water ingress at ground level has caused plaster to loose adhesion; continue to monitor; on confirmation that area has dried out due to recent waterproofing re-plaster | | |

| <b>Condition:</b> | C Poor | <b>Remedy:</b> | Hack off defective plaster and renew<br>Target year: 2020 |

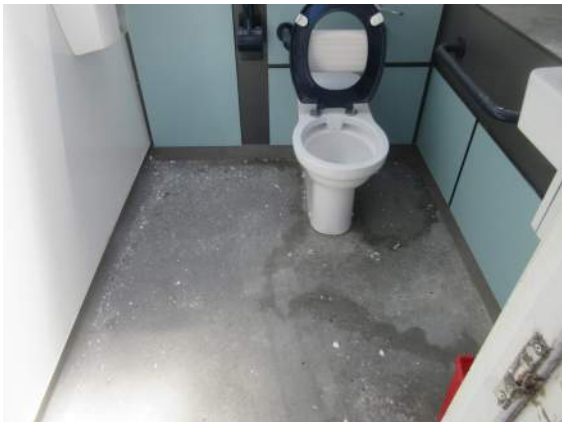
| <b>Priority:</b> | 02 Essential - Within 2 years | <b>Defect:</b> | The sanitary ware has recently been upgraded |
| <b>Comments:</b> | The overall condition of the floor , wall and ceiling finishes are poor . This is attributed to water ingress from defective roof coverings. If these items are not addressed the overall condition of the facilities with deteriorate. | | |

| <b>Condition:</b> | A Good | <b>Remedy:</b> | No replacement envisaged<br>Target year: 2020 |

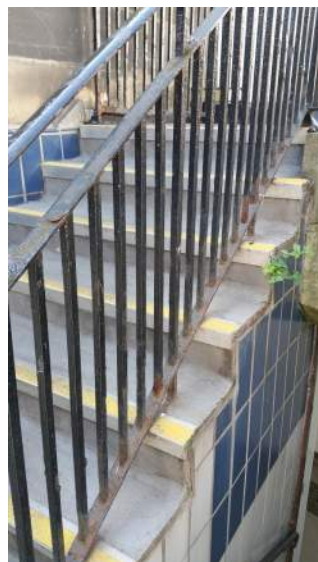
**Defect:** surface corrosion to stair handrail and entrance gate

**Defect Location:** access steps to Gents Toilet

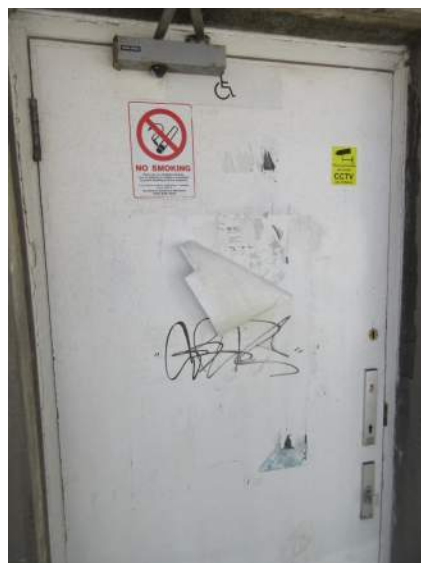
**Defect:** Graffiti to doors

**Defect Location:** Access doors

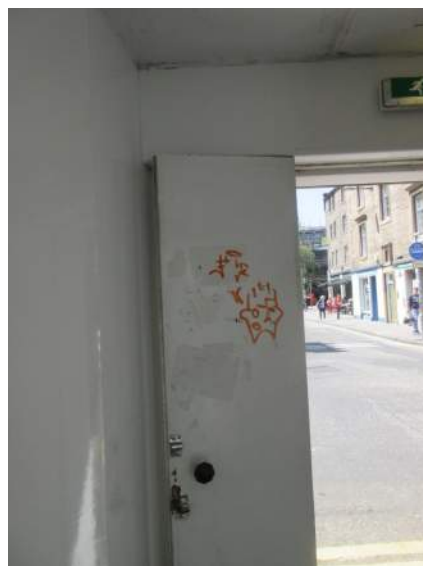
**Code:** IW00024749

**Defect:** Refresh of all painted surfaces required

**Defect Location:** All areas including internal doors

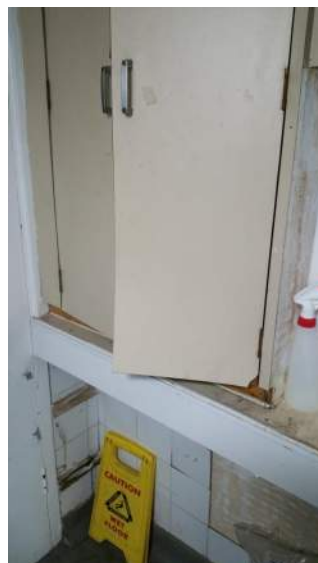
**Defect:** cupboard housing for services in poor condition

**Defect Location:** Gents Toilet attendants room

**Remedy:** repair/replace defective cupboard unit  
Target year: 2020

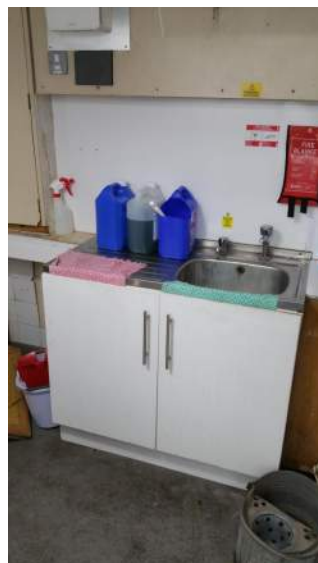
**Defect:** kitchen fittings are functional but will require upgrading within the next 5 years

**Defect Location:** Gents Toilet attendants room

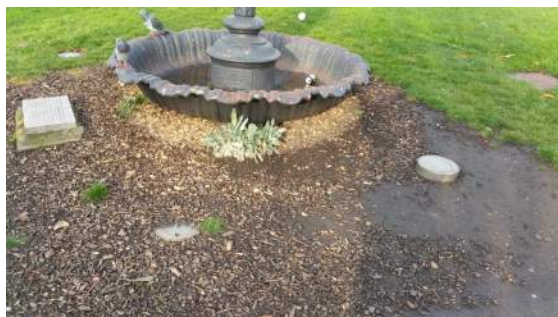
| <b>Priority:</b> | 03 Desirable - Within 3 to 5 years | <b>Defect:</b> | lighting to ground area may not be functioning |
| <b>Manufacturer:</b> | | <b>Defect Location:</b> | around fountain and pillar |

| <b>Condition:</b> | B Satisfactory | <b>Remedy:</b> | check and ensure lighting is functioning or remove if not required<br>Target year: 2021 |

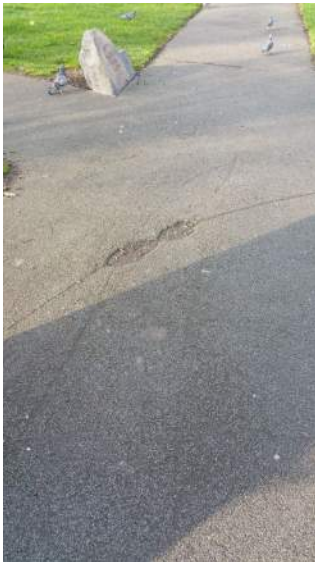
| <b>Code:</b> | IW00022204 | <b>Site:</b> | SIT0782 NICOLSON SQUARE GROUND (AND PUBLIC CONVENIENCE) |

| <b>Priority:</b> | 03 Desirable - Within 3 to 5 years | <b>Defect:</b> | some surface damage to pathway |
| <b>Manufacturer:</b> | | <b>Defect Location:</b> | area at "crossroad" to pathways |

| <b>Condition:</b> | B Satisfactory | <b>Remedy:</b> | make good defective area<br>Target year: 2021 |
