# **The City of Edinburgh Council**

## **Roof Condition Report**

7-8 Saunders Street

EH25029:1

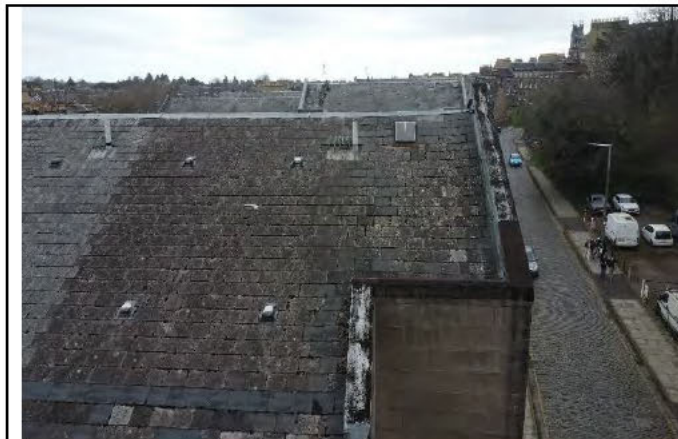
1

Block 8 front right view

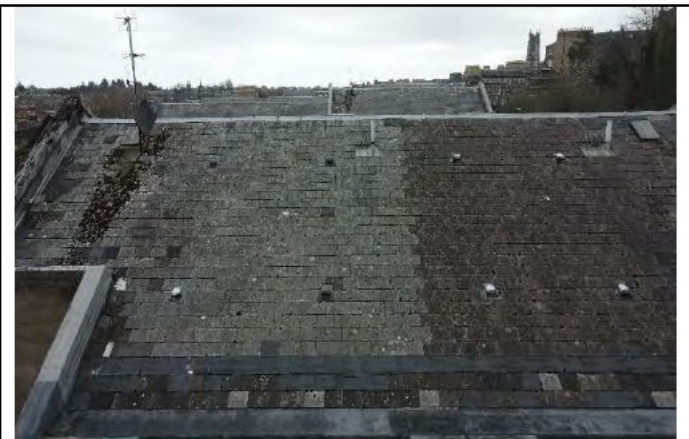
2

Block 8 front middle view

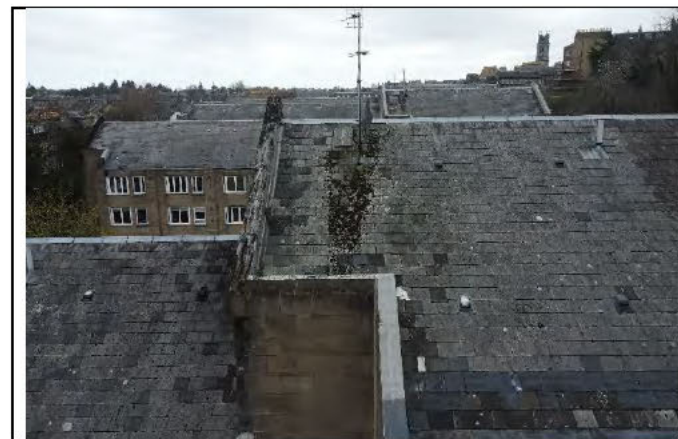
3

Block 8 front left view

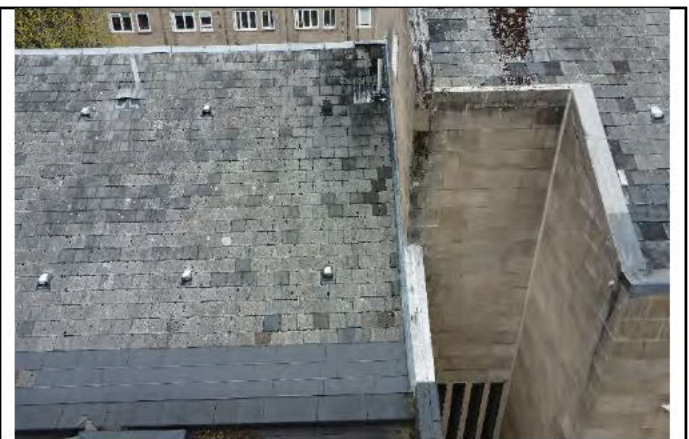
4

Block 7 front right

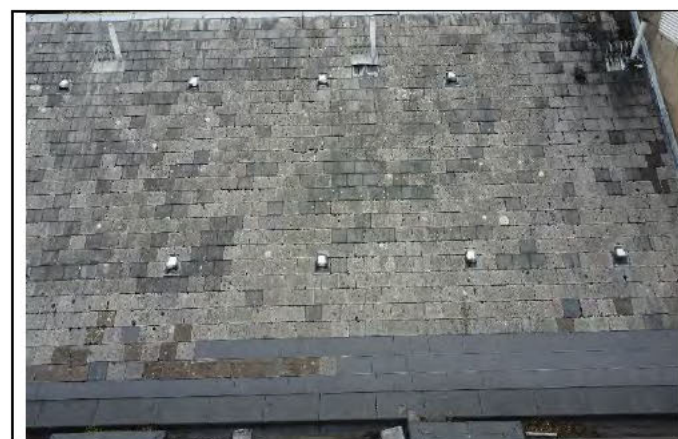
5

Block 7 front right repair

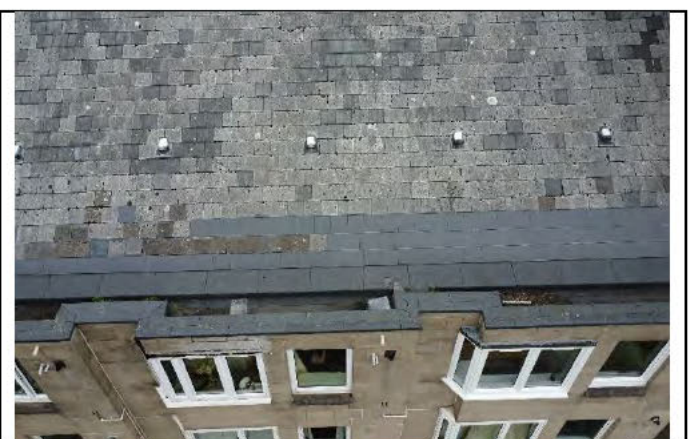
6

- 3.2.1 Rainwater drainage to the building consists of wall head gutters running into internal drainpipes.
- 3.2.2 Gutters and parapets to both elevations show evidence of recent repairs having been carried out. These are on the block of No.7, using a bitumen-based material. This is in satisfactory condition; however, the parapet gutters of the block of No. 8 are in poor condition. Widespread deterioration of the bitumen felt, where replacement has not been carried out, was noted, which would suggest that the material is nearing its end-of-life cycle. Replacement in the short term would be recommended however this should be carried out when the roof covering replacement is underway. The gutters are partially choked with vegetation and debris, which will be affecting the efficiency of the drainage system. This may also be contributing to any potential leaks within the roof space.

Block 7 parapet and gutter repair

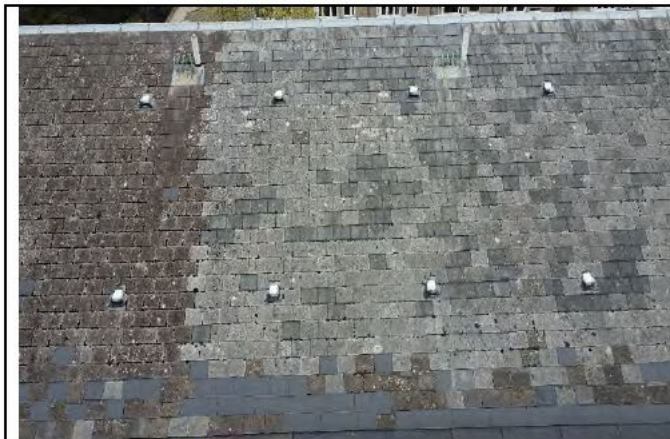
Block 7 front middle general view

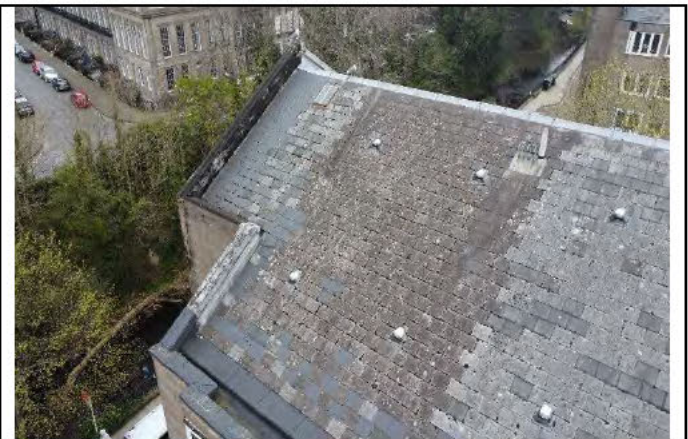
8

Block 7 front right general view

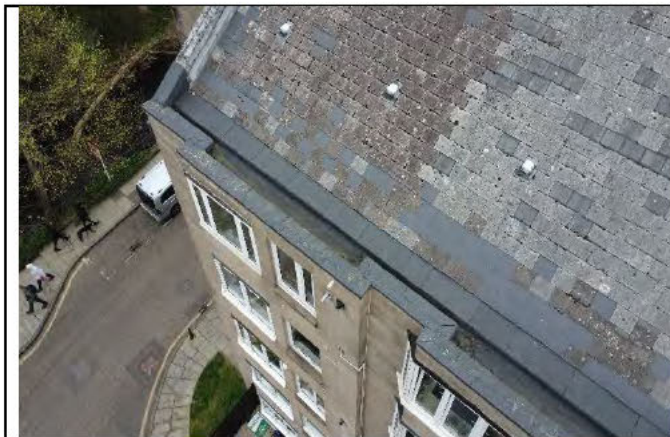
9

Block 7 front right gutter repair

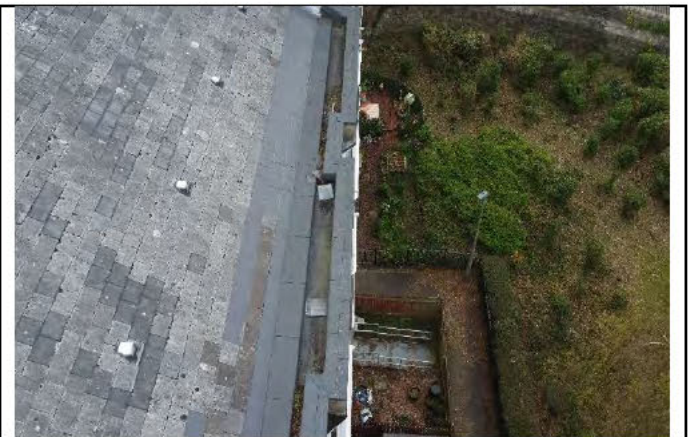
10

Block 7 front middle gutter repair

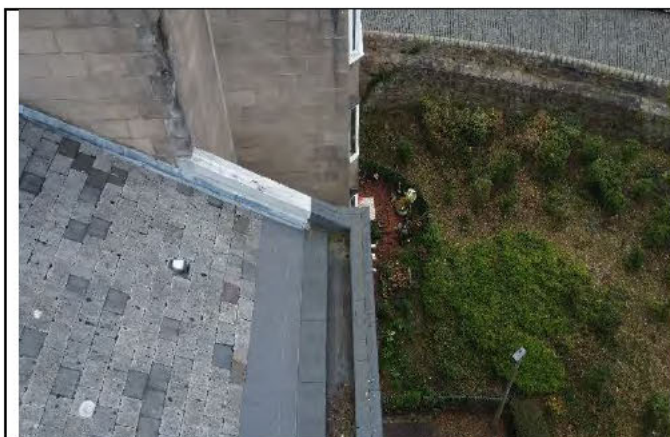
11

Block 7 front right gutter repair

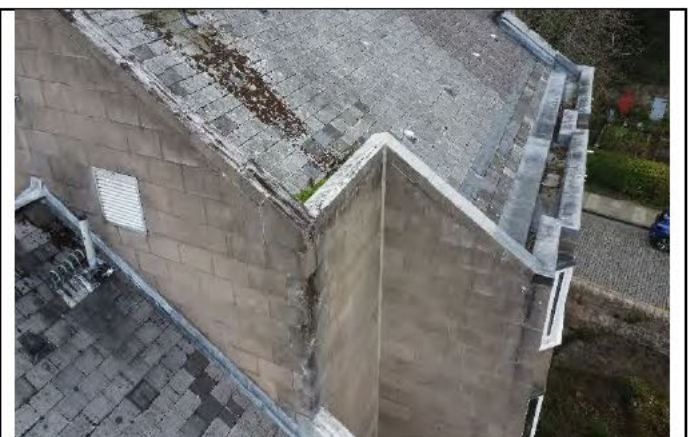
12

- 4.5 Debris in the gutters is effectively hindering the natural flow of rainwater and preventing it from clearing. This should be removed in the medium term.

Block 8 front left choked gutter

- 3.2.3 Regular clearing of the gutters and downpipes should be carried out as part of cyclical maintenance programmes. This will reduce the risk of the internal downpipes becoming choked with debris. Leaf guards are recommended to the tops of the downpipes, which would reduce the volume of organic debris entering the downpipes.

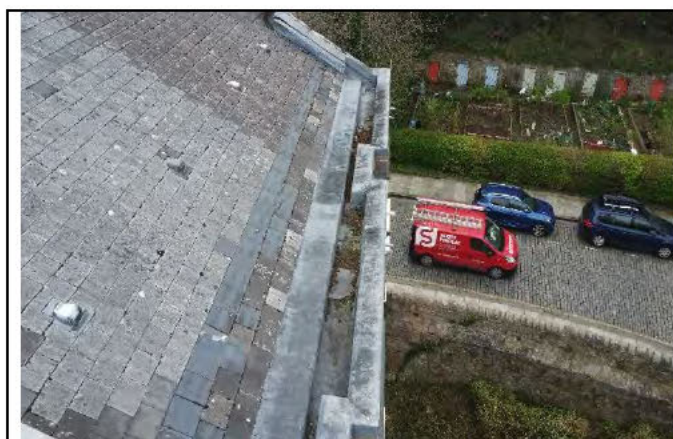
13

Block 8 front gutter choked with vegetation

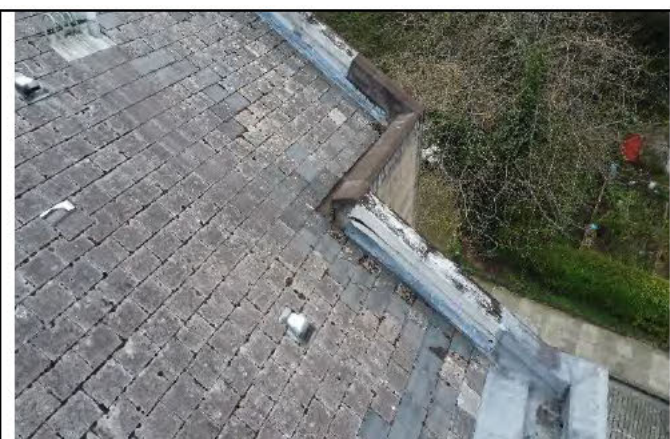
14

Block 8 front right parapet general view

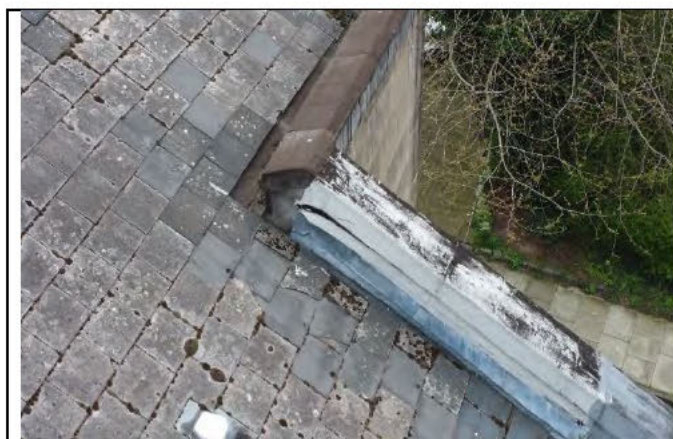
15

Block 8 parapet close-up view

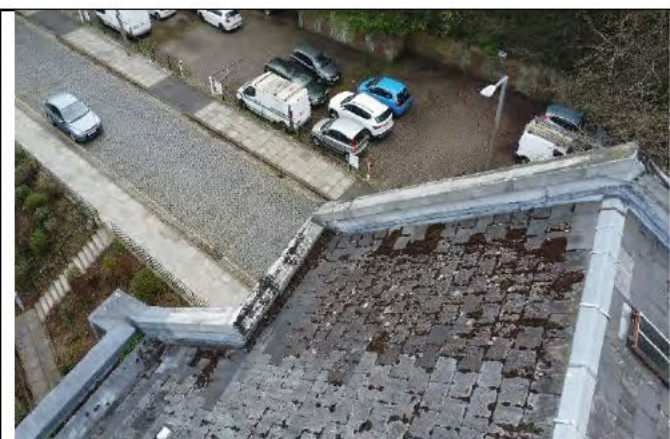
16

Block 8 rear right view

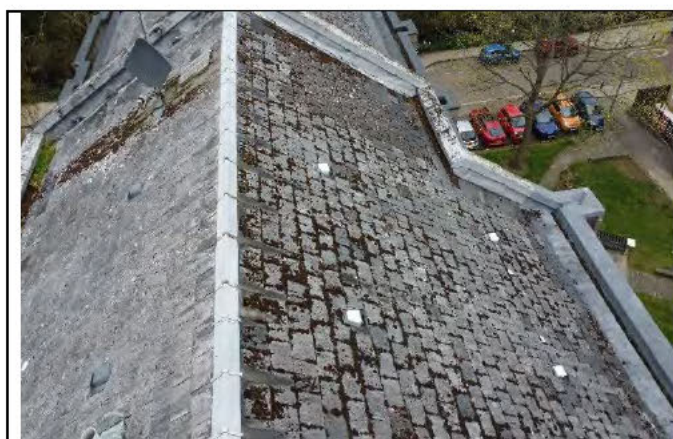
17

Block 8 rear left general view

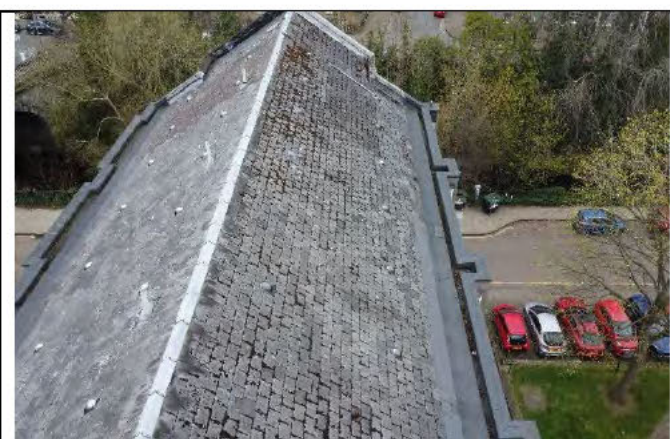
18

Block 7 rear general view

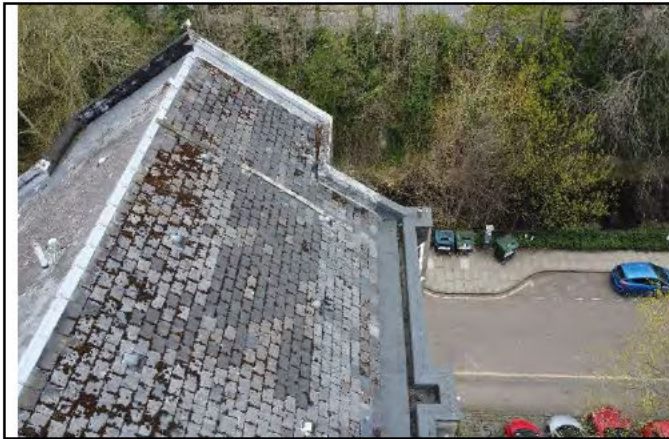
19

Block 7 rear middle general view

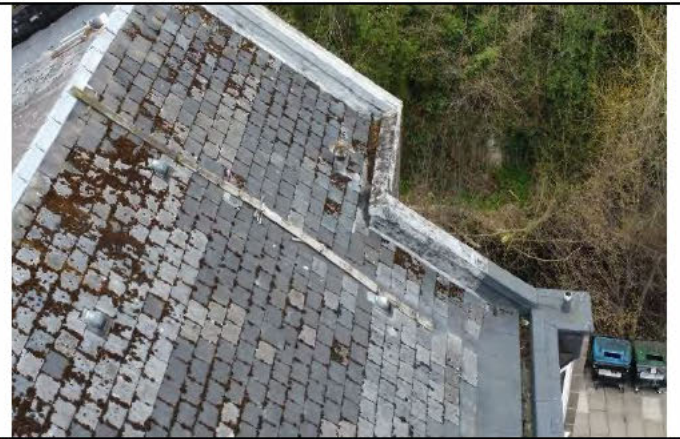
20

Block 7 rear left view

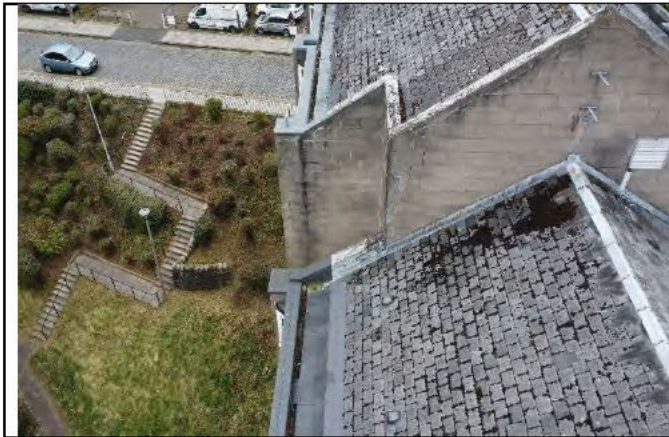
21

Block 7 rear right view

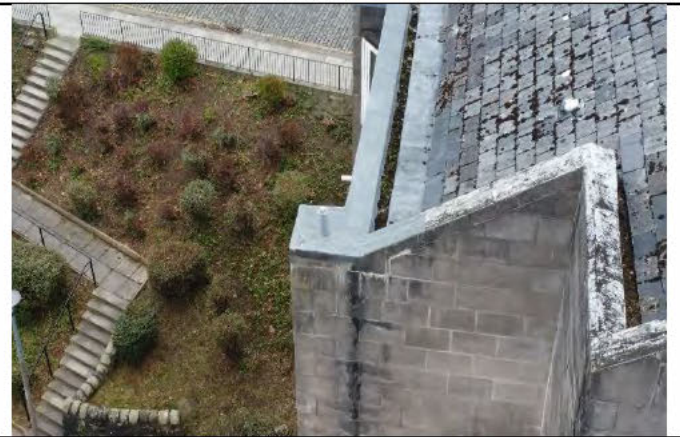
22

Block 8 rear left gutter and SVP

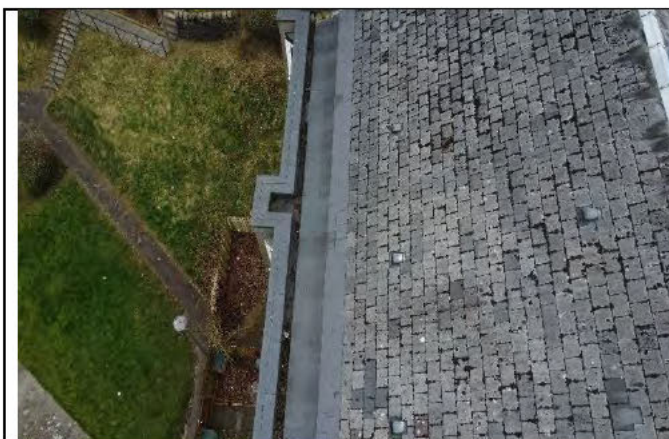
23

Block 8 rear middle gutter

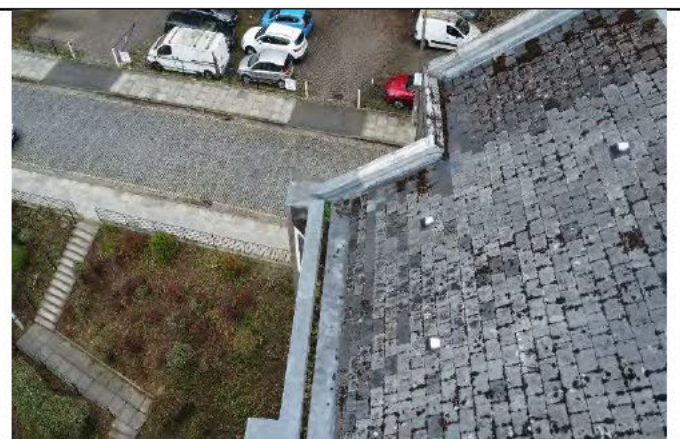
24

Block 8 rear right gutter

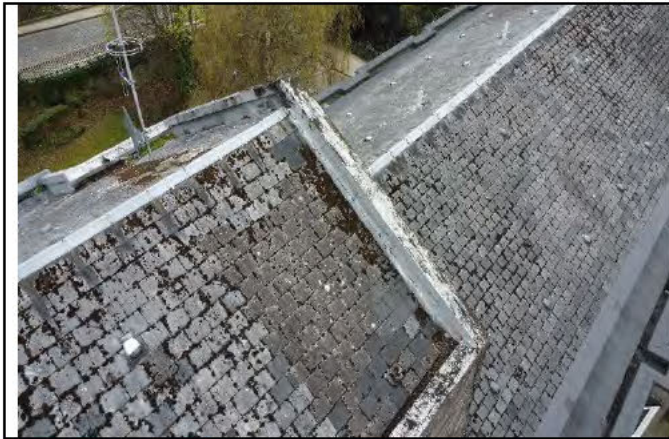
25

Block 7 rear right parapet view

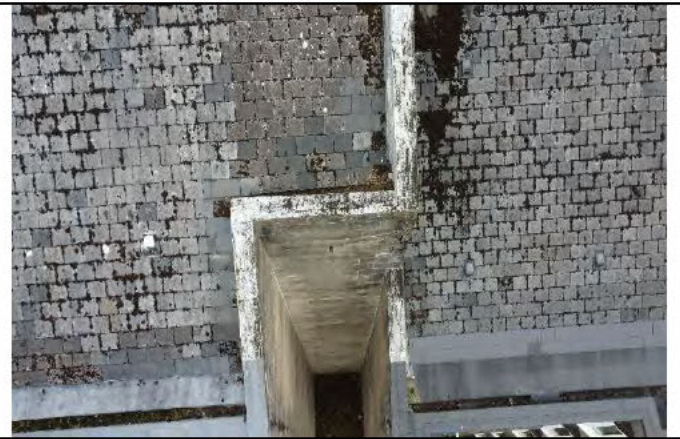
26

Top-down view of rear parapet

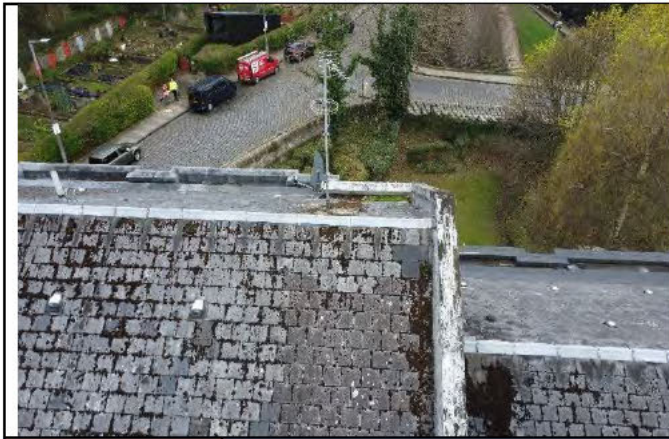
27

- 3.1.5 The ridge is capped using zinc. This is in reasonable condition with no major signs of deterioration. There is some localised deformation, but this is relatively minor. It would be advisable to renew this during the roof covering recovering works.

Block 8 left ridge

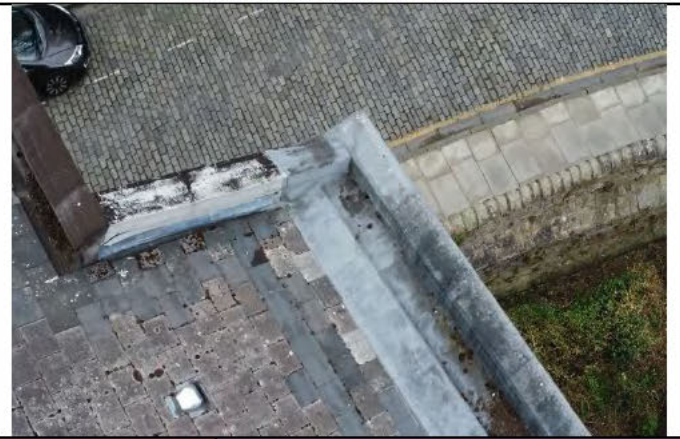
28

Block 8 front right gutter close-up

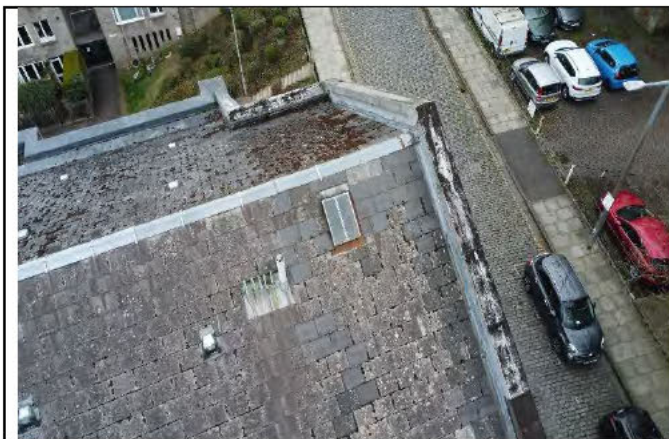
29

- 3.1.2 Across all sections of roof there are several cast iron rooflights. These are in poor condition and are showing signs of corrosion with some slipped / missing tiles in the surrounding areas. These should be replaced when the roof covering is being done in the medium term.

Block 8 front skylight

- 4.8 The skylights should be replaced in the medium term; however, this should be done when the roof covering is being replaced.
- 4.9 The Monopitch roof covering is at the end of life and should be replaced in the medium term. This has been patch repaired over the life of the building. The parapet gutter in the same area should be replaced when the mono pitch is being replaced

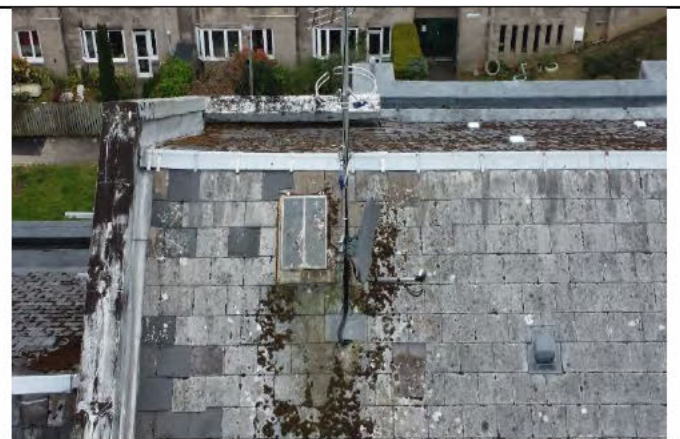
30

Block 7 front skylight

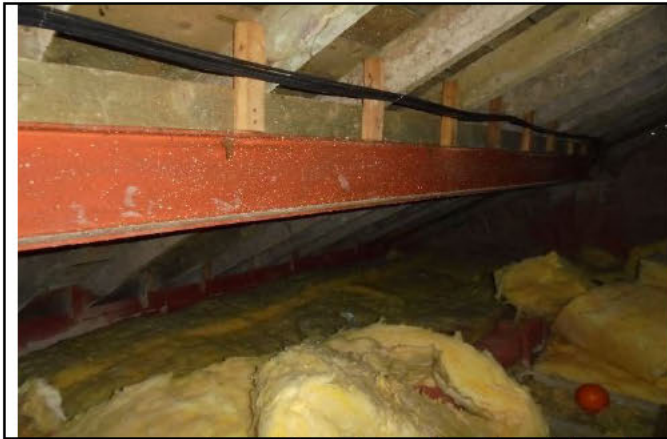
55

Block 8 Section 1 wall head  
general view

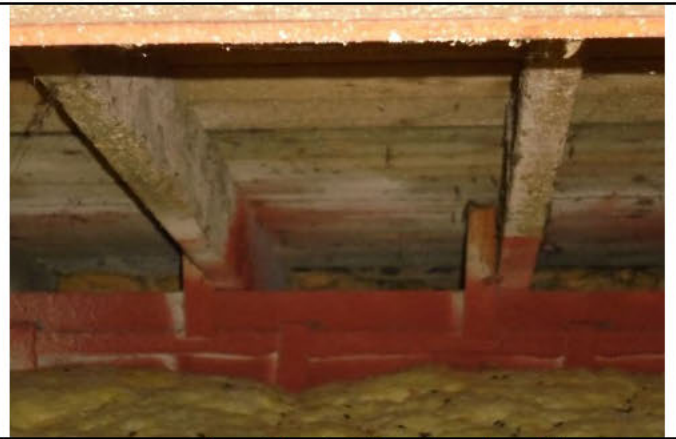
56

Block 8 Section 1 wall head  
close-up

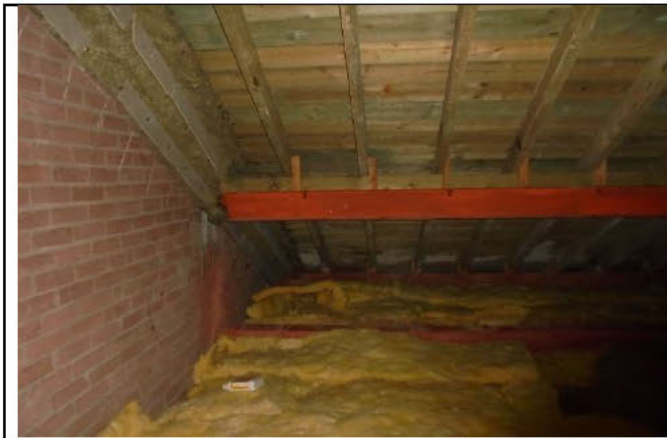
57

Block 8 Section 2 wall head  
general view

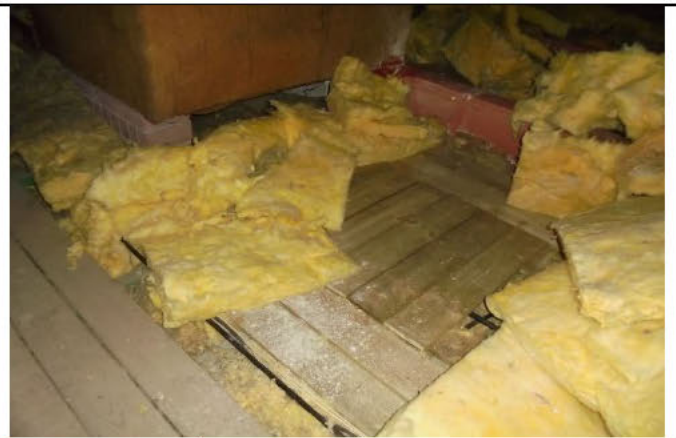
58

Block 8 walkway example

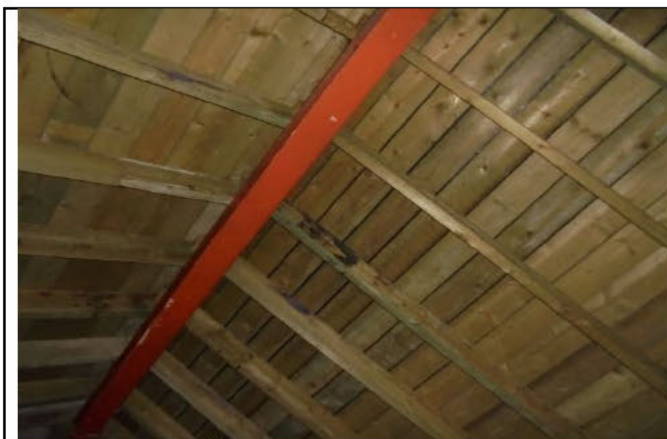
59

Block 8 section 2 front slope

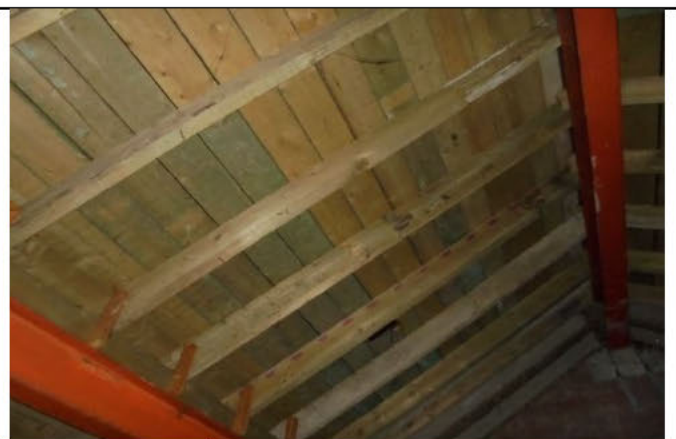
60

Block 8 section 2 rear slope

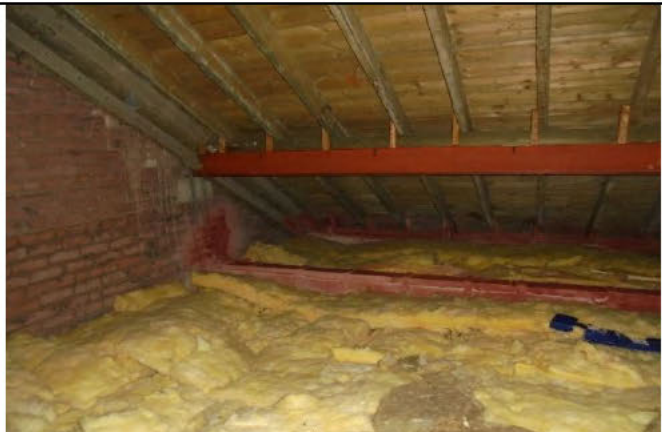
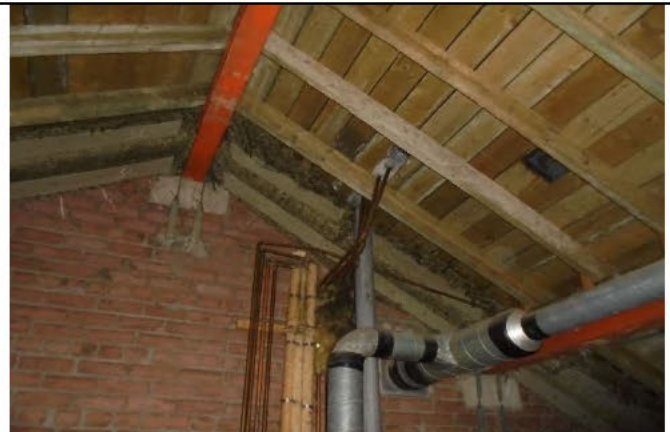
| 79 | Block 7 section 2 front slope & wall head. | 80 | Block 7 section 2 front pipe penetrations. |

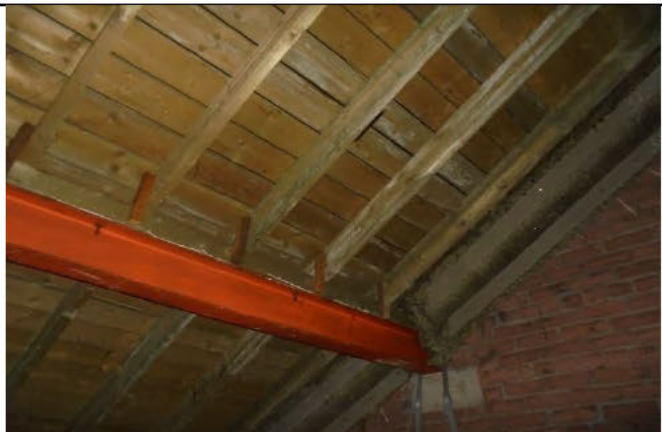
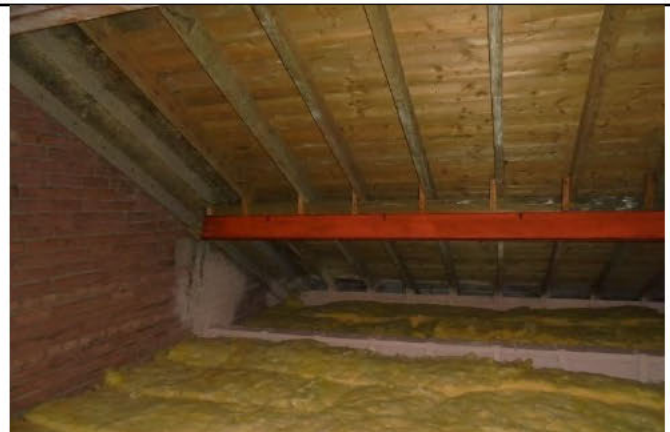
| 81 | Block 7 section 3 rear slope. | 82 | Block 7 section 3 front slope & wall head |

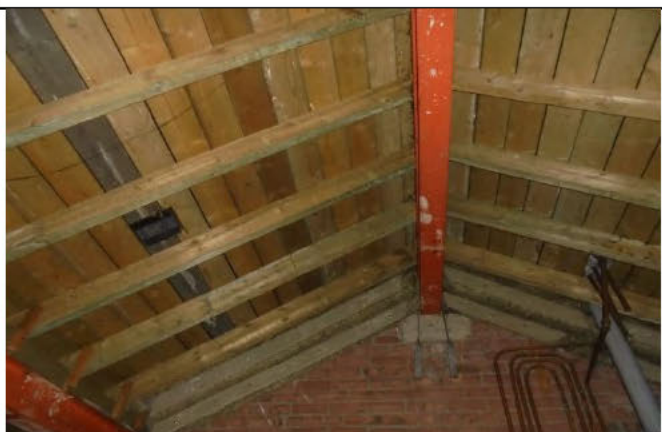
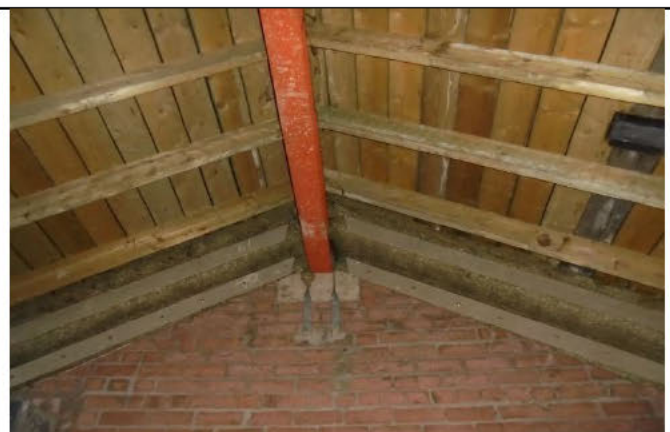
| 83 | Block 7 section 3 pipe penetrations | 84 | Block 7 section 3 ridge |
