# Gilmerton Road, Edinburgh

## *Temporary Cycle Infrastructure*

Road Safety Audit Stage 3

04 February 2021

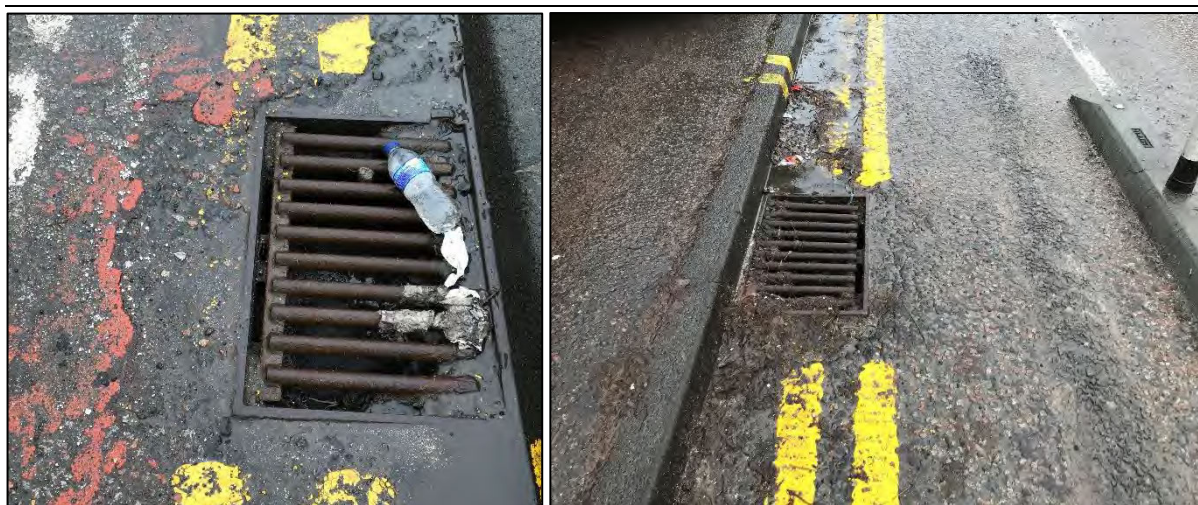
**Problem:** 4.1.1

**Summary:** Risk of cyclists getting their wheels stuck in a gully, falling from their bicycles and sustaining personal injuries.

During the site investigation it was observed that there are road gullies within the cycle lanes in which cyclists could get their wheel stuck. Two examples are shown in the photographs above.

If a cyclist was to get their wheel stuck in the gap between the grate and gully frame, it could lead to them falling from their bicycle and sustaining a personal injury.

It is recommended that these gully covers are replaced with covers that are cycle friendly.

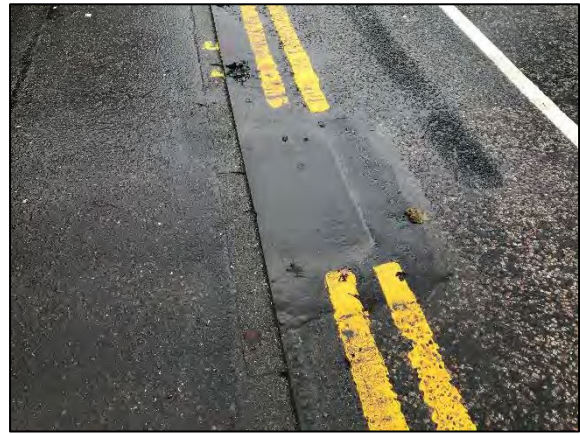
**Problem:** 4.1.2**Location(s):** Scheme extents**Drawing(s):** GIL-12727-1100-01 to GIL-12727-1100-03**Summary:** Risk of road users skidding and losing control of their vehicles resulting in injuries to vehicle occupants / riders, due to excess surface water on the carriageway.

During the site investigation water was observed pooling on the carriageway at several locations within the extents of the scheme. It is acknowledged that the site visit took place following a period of wet weather. Furthermore, at least one blocked gully was observed in the cycle lane, as shown in the photograph above.

There is a risk that excess surface water on the carriageway could lead to vehicles (both motorised and non-motorised) skidding and drivers / riders losing control of their vehicles. This could lead to vehicle occupants / riders sustaining personal injuries. This risk is heightened during periods of cold / freezing weather, when the surface water could freeze and form ice.

It is recommended that drainage is appropriate throughout the extents of the scheme and that any blocked gullies are appropriately cleared.

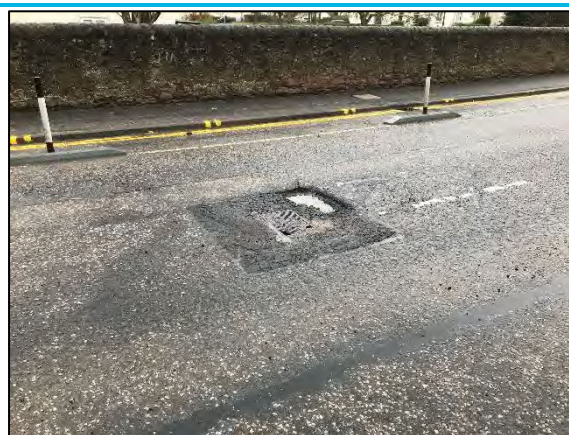
**Problem:** 4.1.3

**Summary:** Risk of drivers / riders losing control of their vehicles and resulting in the vehicle occupants / riders sustaining personal injuries, due to uneven carriageway surface.

Adjacent to Inchpark Surgery, an area of uneven surfacing was observed in the centre of Gilmerton Road, as shown in the photograph above. The carriageway surface appears to have broken up around the ironwork, which itself was also damaged.

There is a risk that a driver / rider could lose control of their vehicle were they to travel over this area of surfacing, which could lead to the vehicle occupants / riders sustaining personal injuries. There is also a risk that a driver / rider could swerve to attempt to avoid this area, which could lead to them colliding with another road user.

It is recommended that the ironwork and the surface of the carriageway are appropriately repaired / made good.

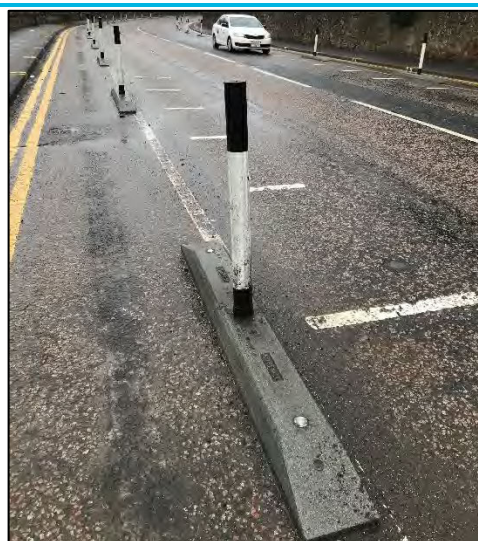
**Problem: 4.1.4****Location(s):** Scheme extents**Drawing(s):** GIL-12727-1100-01 to GIL-12727-1100-03

**Summary:** Risk of vehicles striking a temporary segregation unit, resulting in vehicle occupants / riders sustaining personal injuries, due to lack of signage and temporary segregation units not being conspicuous.

During the site investigation it was observed that reflectorized red discs had been mounted on some of the temporary segregation units. These were generally provided where the cycle lane starts at either end of the scheme and at the first units that vehicles turning onto Gilmerton Road from side roads would encounter. However, this was not the case throughout the extents of the scheme. An example where a red reflector has not been provided at the first unit that a vehicle turning onto Gilmerton Road from a side road would encounter is shown in the photograph above (at Rutherford Drive).

Furthermore, no signage is provided on the side roads to alert drivers / riders to the presence of cycle lanes on the road on which they are turning onto.

There is a risk that a driver / rider may not be aware of the presence of the temporary segregation units due to the general lack of signage and the relative inconspicuity of the units. This could lead to vehicles colliding with a temporary segregation unit, resulting in the vehicles occupants / riders sustaining injuries.

It is recommended that additional measures are provided to ensure that drivers / riders are aware of the presence of the segregation units, which could include enhancing the conspicuity of the units and / or providing suitable signage.

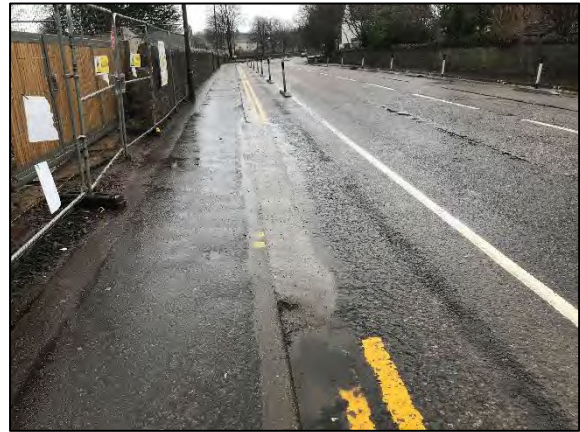
### Problem: 4.4.1

**Summary:** Risk of cyclists colliding with temporary ramp, falling from their bicycles and sustaining personal injuries due to presence of ramp within cycle lane.

During the site investigation it was observed that there is a temporary ramp provided within the cycle lane, which appears to be associated with construction works adjacent to Liberton Primary School.

There is a risk that a cyclist may not see the ramp and could collide with it, resulting in them falling and sustaining a personal injury. This risk is heightened during the hours of darkness, when the ramp may be less conspicuous.

It is recommended that the temporary ramp is removed or that appropriate measures are provided to make it conspicuous to approaching cyclists.

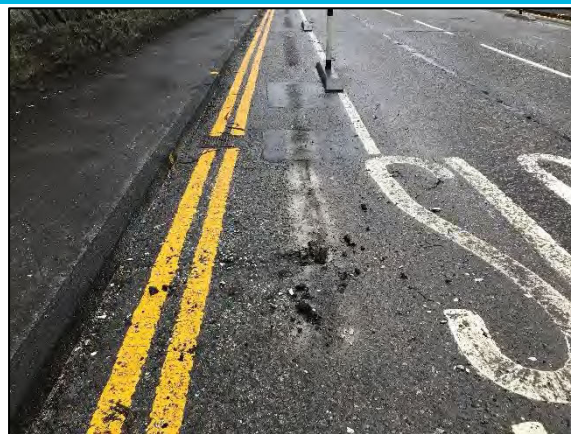
**Problem:** 4.4.2

**Summary:** Risk of cyclists falling from their bicycles and sustaining personal injuries due to uneven surfacing within cycle lane.

As shown in the photograph above, the surfacing in the cycle lane at this location was found to be very uneven, with part of the surface having come loose and with a small pothole in the surface.

There is a risk that a cyclist could travel over this area of surfacing, lose control of their bicycle and sustain a personal injury. There is also a risk that a cyclist could swerve to avoid the pothole / debris and collide with another road user, a kerb or an item of street furniture.

It is recommended that the surface of the cycle lane is appropriately repaired / made good.

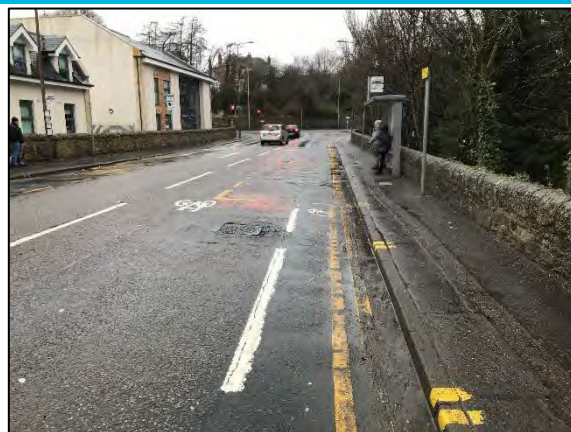
**Problem:** 4.5.1

**Summary:** Risk of drivers / riders undertaking sudden manoeuvres in order to avoid entering the cycle lane, resulting in them colliding with other vehicles, due to markings and lack of signage in advance of cycle lane.

The cycle lane on Gilmerton Road south-eastbound starts abruptly downstream of a bus stop, as shown in the photograph above. No measures are provided in advance of the cycle lane to warn approaching drivers / riders of its presence and no taper is provided at the start of the cycle lane.

There is a risk that the driver / rider of an approaching motorised vehicle may undertake a sudden manoeuvre in order to avoid entering the cycle lane and could collide with another vehicle whilst doing so.

It is recommended that appropriate measures are provided to highlight the presence of the cycle lane to approaching drivers / riders, such as signage and / or providing a taper at the start of the cycle lane.

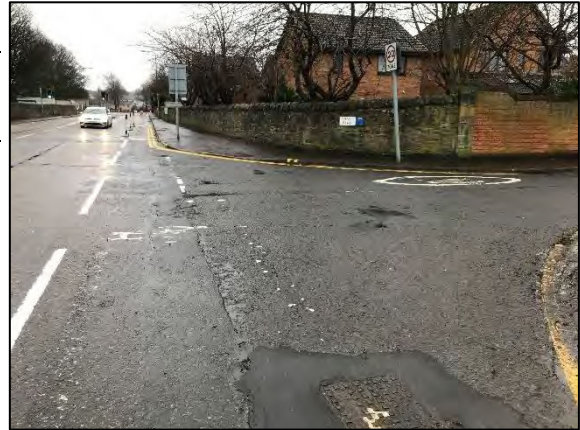
**Problem:** 4.5.2**Location(s):** Scheme extents**Drawing(s):** GIL-12727-1100-01 to GIL-12727-1100-03**Summary:** Risk of vehicles overshooting give way lines and colliding with a passing cyclist or vehicle, due to give way markings not being sufficiently visible.

During the site investigation it was observed that there are several priority side road junctions where the existing give way markings are very faded. An example, from Orrok Park, is shown in the photograph above.

There is a risk that a vehicle could fail to give way due to the markings not being sufficiently visible, which could lead to them colliding with a passing cyclist or vehicle.

It is recommended that the give way markings are appropriately refreshed.

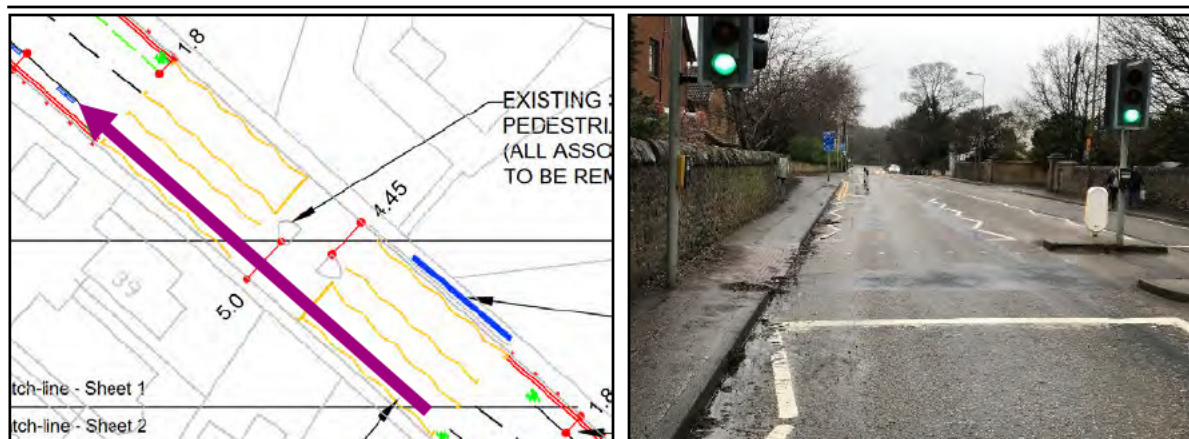
**Problem: 4.5.3****Location(s):** Gilmerton Road at controlled crossing at Liberton Primary School**Drawing(s):** GIL-12727-1100-01**Summary:** Risk of vehicles striking a temporary segregation unit, resulting in vehicle occupants / riders sustaining personal injuries, due to alignment of zig zag markings and position of temporary segregation units.

Segregation units have been placed downstream of the controlled crossing at Liberton Primary School. The segregation unit positioned on the north-westbound side of the carriageway is shown in the image and photograph above. The zig zags are parallel to the kerb and do not indicate to an approaching driver / rider that they need to deviate from their path in order to avoid striking the temporary segregation unit.

There is a risk that the alignment of the zig zag markings could lead to vehicles colliding with the temporary segregation unit, resulting in vehicle occupants / riders sustaining personal injuries. The potential alignment of vehicles in the north-westbound direction, were they to follow the alignment of the zig zags, is shown as a purple arrow in the image on the left above.

It is recommended that the zig zags are appropriately realigned and / or that the temporary segregation units are removed or repositioned further from the crossing.
