# Meadows to George Street, Edinburgh

## *Active Travel, Footway and Carriageway Improvements*

Road Safety Audit Stage 1  
RSA 262/S1-A

Overseeing Organisation: City of Edinburgh Council

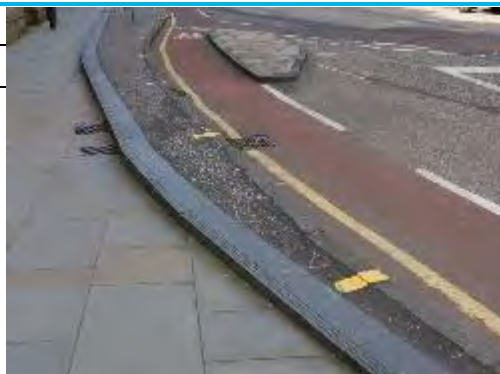
| Summary: | Risk of vehicles skidding and losing control and of pedestrians slipping and falling due to excess surface water. |

From the plans provided it is unclear as to the relative levels at the interfaces between the new and existing sections of footway, and between the new sections of footway and carriageway. There is a risk that the relative levels could lead to water pooling at these interfaces. Excess surface water increases the risk of vehicles skidding and losing control and / or of pedestrians slipping and falling, particularly during periods of cold / freezing weather where the surface water could freeze and form ice.

It is recommended that appropriate drainage is provided throughout the extents of the scheme.

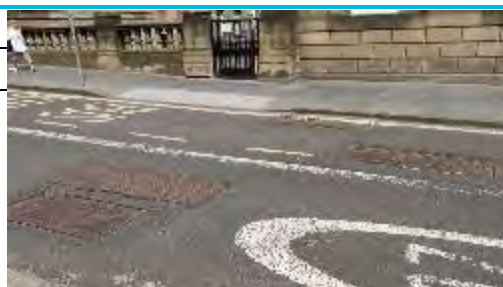
**Summary:** Risk that vehicles could lose control on utility covers especially in wet / damp conditions and strike pedestrians and / or street furniture resulting in personal injuries.

From the plans provided it is not clear if the existing ironwork is being raised / lowered to match the proposed surface course level and / or replaced due to being worn. There is a risk that vehicles could lose control especially in wet / damp conditions and strike pedestrians and / or street furniture resulting in personal injuries.

It is recommended that ironwork is raised / lowered and / or replaced to match the proposed surface course level.

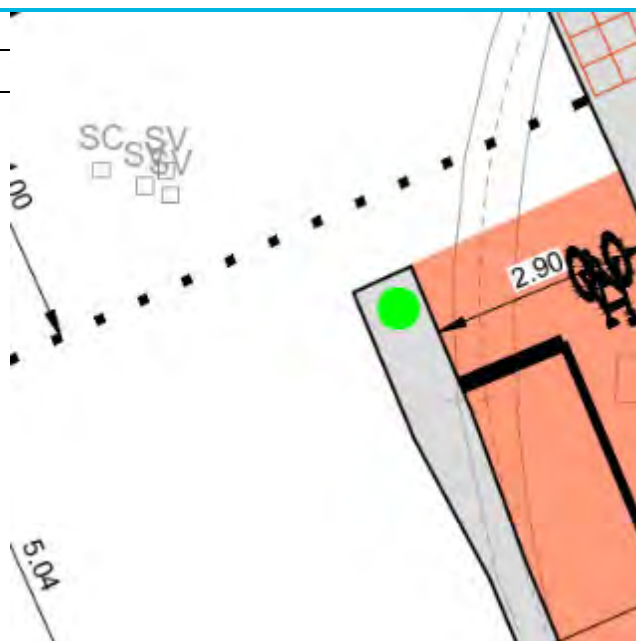
**Summary:** Risk of vehicles clipping sharp vertical faces of kerbs and causing damage to vehicle resulting in loss of control and potential collision.

Various locations within the scheme appears to have kerbs forming a sharp 90-degree edge, many on the leading edges of islands. If a vehicle clips the kerb there is a potential of loss of control collisions occurring or to damage to the vehicle which could lead to secondary loss of control collisions. It is noted that at this stage the drawings may be indicative to show the general layout, however, any kerb line or islands should be constructed with appropriate radii or tapers.

It is recommended that a radius is formed at kerbed corners.

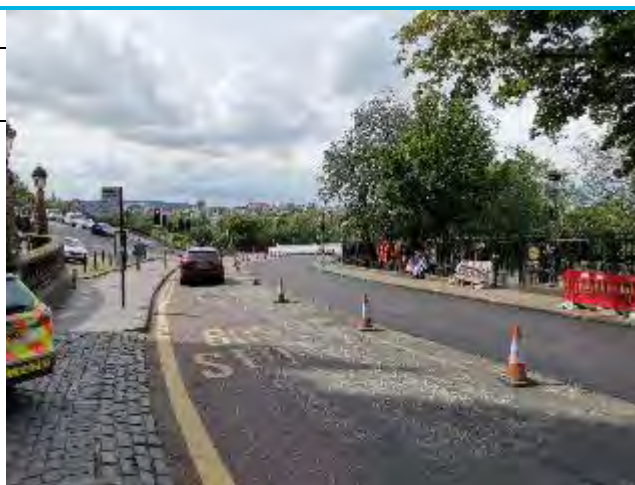
**Summary:** Risk of vehicles skidding during braking and overshooting the stop line and colliding with over road users.

From the plans provide no high friction surfacing appears to be proposed on the approaches to any of the traffic signalling facilities. There is a risk that if vehicles are not provided sufficient grip that they could skid and overshoot the stop line, potentially resulting in collision with pedestrians or other road users. Of particular concern are those stops on downhill gradients, such as, Bank Street, North Bank Street and The Mound.

It is recommended that an appropriate length of surfacing with a suitable level of grip or High Friction Surfacing is provided on approach to traffic signals.

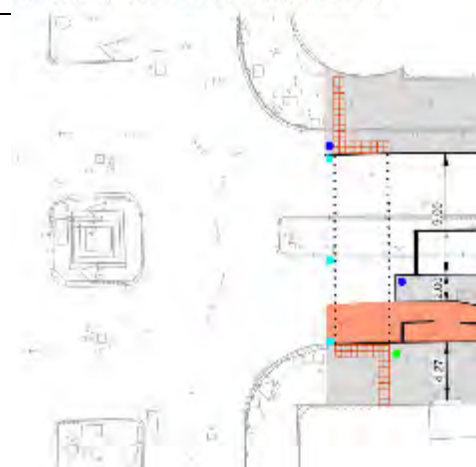
From the plans provided, the proposals do not appear to tie into neighbouring infrastructure. Therefore, as designed, the footway will extend into the carriageway. There is a risk that vehicles will mount the footway and collide with pedestrians and / or street furniture

It is recommended that the scheme suitably ties into the neighbouring infrastructure.

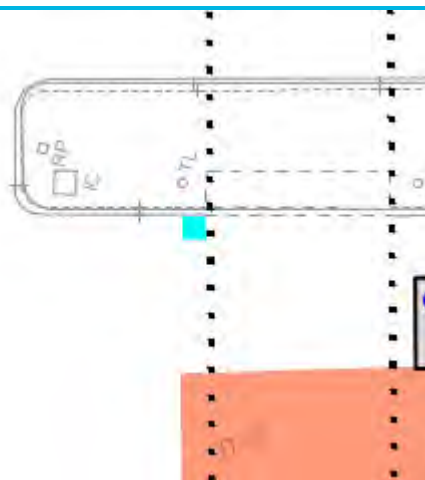
**Summary:** Risk of vehicles losing control on drainage gully or a depression in the carriageway.

From the plans provided a drainage gully is proposed to be located in the running lane of the carriageway. There is a risk, particularly to two-wheeled vehicles, of losing control on the gully, especially during wet / damp conditions. In addition, over time with regular over running by vehicles there is a risk that a depression in the carriageway could be formed.

It is recommended that the gully is relocated to the channel.

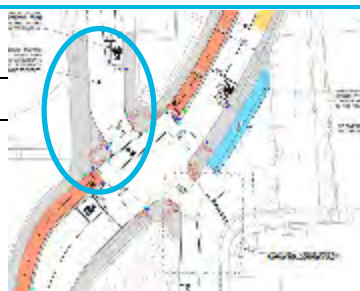
**Summary:** Risk of vegetation obscuring proposed traffic signals, increasing the risk of vehicles overrunning the stop line and potentially colliding with pedestrians.

From the plans provided a number of trees are located in the vicinity of the proposed new signalised junction. It is anticipated that these will impact visibility to the traffic signal heads. If visibility is restricted there is a risk of vehicles overrunning the stop line and potentially colliding with pedestrians.

It is recommended that sufficient forward visibility is provided to the traffic signal heads.

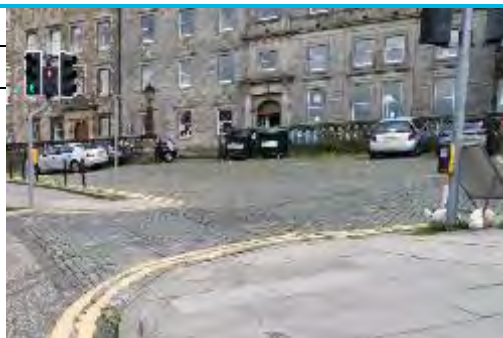
**Summary:** Risk during wet/damp conditions that motorised road users when braking will have insufficient grip and could lose control resulting in personal injury

It was observed during the site visit that the junction is surfaced on the approach to the existing stop or give way line with traditional cobbled setts. From the plans provided there was no indication if a different carriageway surfacing was being proposed. There is a risk during wet/damp conditions that motorised road users when braking will have insufficient grip and could lose control resulting in personal injury.

It is recommended that an appropriate level of grip material is provided on the approach to all stop lines.

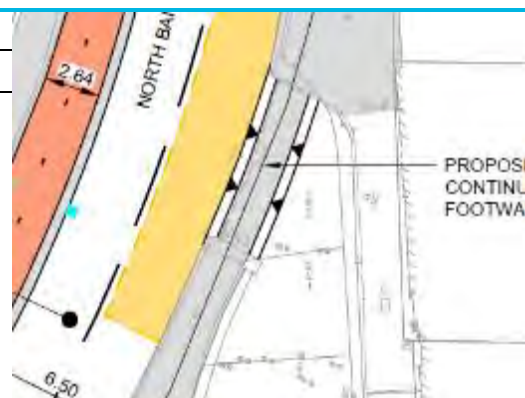
**Summary:** Risk of vehicles skidding and losing control or of pedestrians slipping and falling due to the relative levels of carriageway and footways.

From the plans provided a continuous footway is provided across a private access to residential parking. There is evidence of surface water pooling between the existing and proposed interfaces. There is a risk that the relative levels could lead to water pooling at these interfaces.

It is recommended that appropriate drainage is provided.

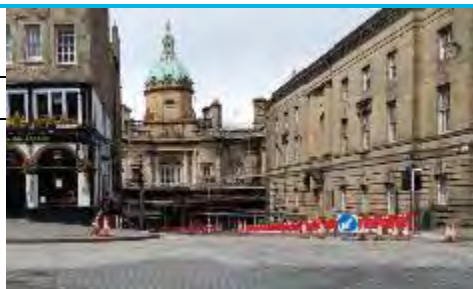
**Summary:** Risk of collision between vehicles and other road users due to them failing to stop or overshooting the stop line due to low grip surfacing.

It is noted that setts are used to surface the carriageway at this junction, it is unclear the relative grip available on the setts compared to standard carriageway surfacing materials. There is a risk that drivers braking on approach could skid or lose control particularly in wet conditions, resulting in potential impact with other users including pedestrians or cyclists crossing, or could collide into a queuing vehicle.

It is recommended that an appropriate level of grip material is provided on the approach to all stop lines.

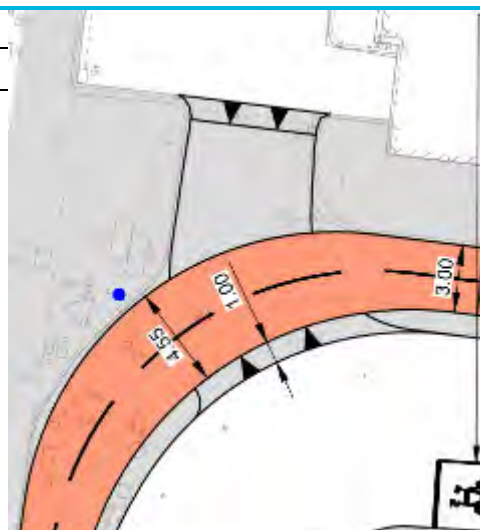
**Summary:** Risk of drivers / riders entering the junction when it is unsafe to do so, potentially resulting in head-on collisions.

From the plans provided it appears St Giles Street is the minor arm of a major / minor junction, however the major arms on North Bank Street are traffic signal controlled. St Giles Street appears neither to be traffic signal controlled nor subject to any operational restrictions. Therefore, drivers from St Giles Street could emerge onto North Bank Street, into the path of oncoming vehicles, potentially resulting in head-on collisions.

It is recommended that either St Giles Street is traffic signal controlled or the exit onto North Bank Street is prohibited.

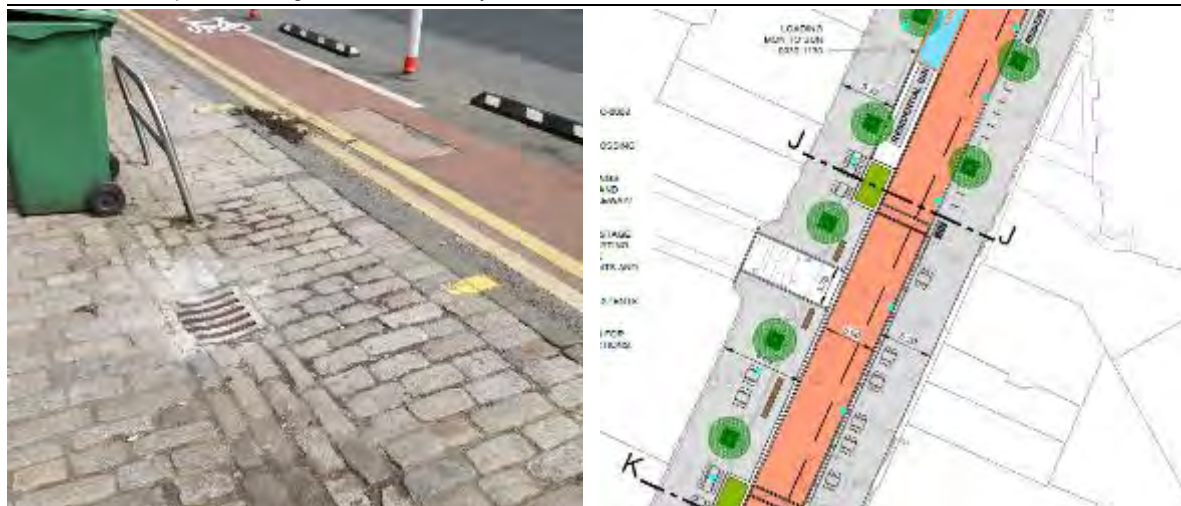
**Summary:** Risk of pedestrians slipping and falling, particularly during periods of cold/freezing weather due to the presence of gullies in the footways.

From the plans provided there are a number of existing gullies located within the footway as shown by the image above to the left. The existing gullies proposed to be replaced within the footway as shown by the plans, highlighted above with the image to the right. There is a risk that the relative levels could lead to surface water pooling at these interfaces. Excessive water increases the risk of pedestrians slipping and falling, particularly during periods of cold/freezing weather.

There is an additional risk that if a non-pedestrian friendly gully cover is provided; pedestrians could trip and fall leading to personal injury.

It is recommended that the levels of the footway are adequate for drainage and that a suitable gully cover is provided.

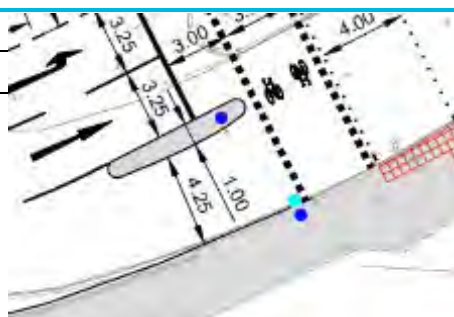
**Summary:** Risk of vehicles colliding with traffic signal heads.

The proposals include the provision of several traffic islands with new signal heads. An example is shown in the figure above. From the plans provided it is unclear as to what the clearance is proposed to be between the edge of the traffic signal heads and the adjacent carriageway. If the clearance is not appropriate, there is a risk that vehicles could collide with traffic signal heads.

It is recommended that an appropriate clearance is provided from the edge of each of the traffic signals heads to the carriageway.

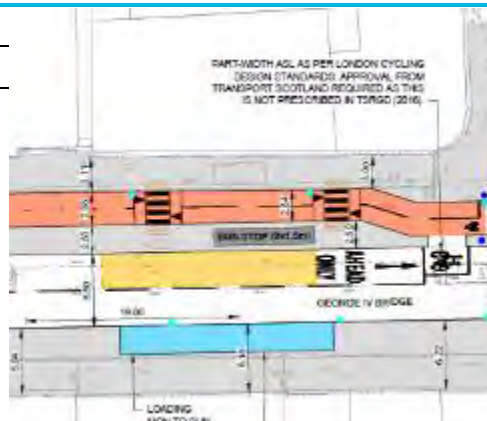
**Summary:** Risk that motorised road users could miss the nearside signals which may be obscured by bus shelters and / or stationary buses, resulting in collisions with pedestrians and other vehicles.

The position of the proposed bus stop and bus shelter upstream of the traffic signals is likely to restrict visibility. There is a risk that motorised road users could miss the traffic signals resulting in them driving through a red signal into conflict with pedestrians or other vehicles at the junction.

It is recommended that visibility to the nearside traffic signal head is not restricted.

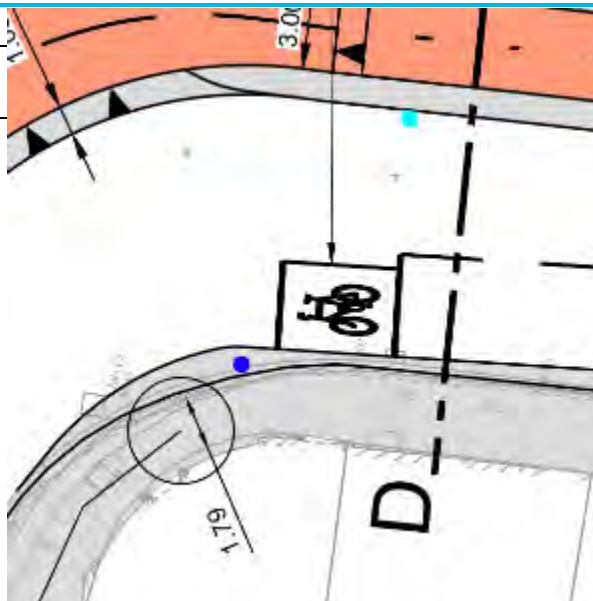
**Summary:** Risk of an elevated footway, guardrail and pedestrians obscuring the traffic signal, increasing the risk of drivers overshooting the stop line and potentially colliding with oncoming vehicles.

The level difference between the western footway and the carriageway of Bank Street increases as traffic approaches the stop line. The footway is estimated to be around 0.5m above the carriageway with the guardrail estimated to increase the height by 1m. Signal mounting heights are between 2.1m and 4m (TSRGD 2016), there is a risk that the signals will be mounted around the same height as pedestrians on the footway. As a result, drivers may not observe the light and continue through the junction potentially into head-on conflict with other vehicles. There is a secondary risk of loss of control resulting from sudden braking on the downhill approach upon seeing the lights late.

It is recommended that the signal post is relocated to a position where visibility is unrestricted and the traffic lights are not impacted by pedestrians.

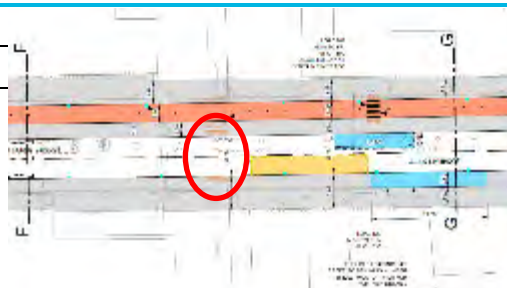
**Summary:** Risk that pedestrians could step out from the western footway onto the carriageway and be struck by passing vehicles resulting in personal injury

From the plans provided the visibility from the pedestrian crossing may be obstructed by the bus stop. There is a risk that pedestrians could step out on to the carriageway and be struck by passing vehicles resulting in personal injury.

It is recommended that adequate visibility is provided for pedestrians utilising the crossing.

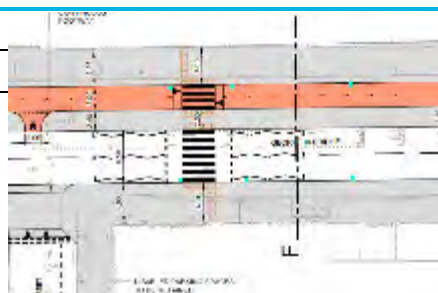
**Summary:** Risk that drivers braking on approach to the zebra crossing could skid or lose control resulting in them colliding with pedestrians on the crossing or into the rear of other vehicles

There is concern that drivers approaching the newly proposed zebra crossing might not appreciate the presence of the controlled crossing or potential queuing vehicles on the approach. There is a risk that drivers braking on approach could skid or lose control particularly in wet conditions resulting in potential impact with other users including pedestrians crossing or could collide into a waiting vehicle.

It is recommended that an appropriate level of grip is provided on the approach to the controlled crossing.

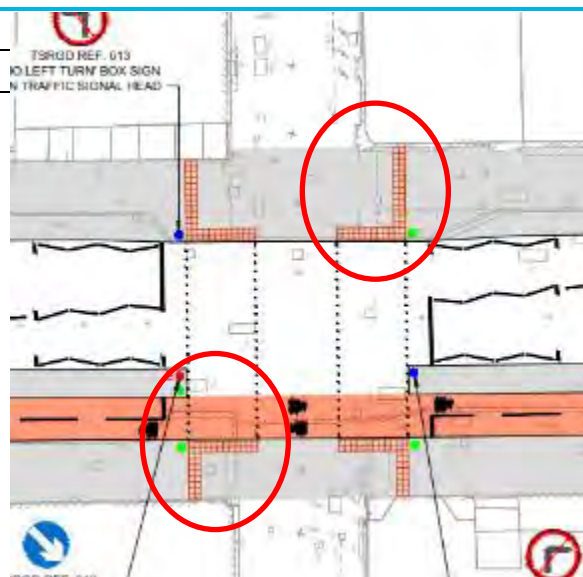
Summary: Incorrect tactile paving layout and position of pedestrian push button could result in visually impaired pedestrians being unable to locate the push button. This could lead to them crossing the road out-with green signal and being struck by passing vehicles resulting in personal injury.

It is noted that the proposed layout at this crossing point is not to standard. The pedestrian push button and tactile paving stem should be located to the right side. Visually impaired pedestrians would attempt to locate the push button to the right of the stem. If they cannot locate a post, they may assume it is an uncontrolled crossing and step out in front of passing vehicles resulting in personal injury.

It is recommended that the tactile paving layout is amended and that a pedestrian push button is erected on the right side of the crossing point.

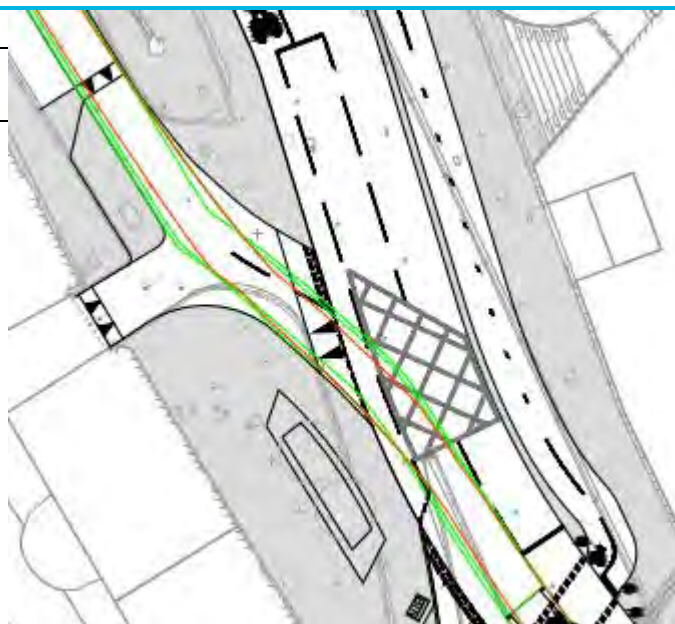
**Summary:** Risk of head-on collisions occurring if two vehicles meet travelling in opposite directions.

From the plans provided it was observed that Candlemaker Row has been reduced in width from a single carriageway to a single lane, with traffic flows remaining as a two-way flow, albeit restricted to public transport. It is unclear with the vertical and horizontal alignments, along with the existing built environment and high pedestrian flows how much inter-visibility opposing drivers will have of one another. There is a risk of head-on collision if drivers fail to give way to the oncoming vehicle.

Taking cognisance of the swept path analysis it appears a bus turning into Candlemaker Row would need to stop on George IV Bridge, as there is insufficient space for one vehicle to pass another. There is a secondary risk of shunt collisions caused by following vehicles not expecting a stationary bus on the carriageway.

It is recommended that opposing buses are either controlled or have sufficient visibility and space to give way to one another safely. It is also recommended that the bus stop on Candlemaker Row is relocated away from its proposed location.

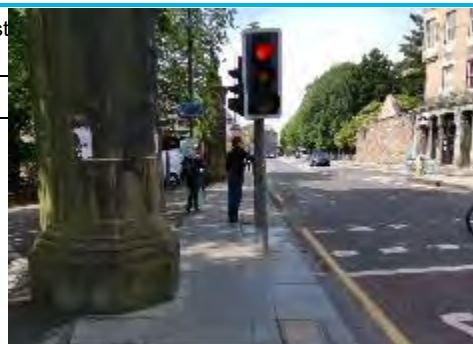
Secondary risk of vehicles striking the build out and losing control.

It is recommended that the effective width be maximised.

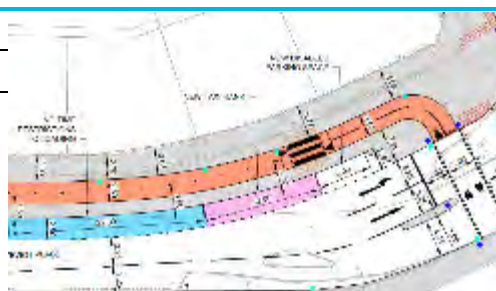
**Summary:** Risk of drivers / riders not seeing traffic signals, proceeding into the junction when it is not safe to do so and being struck by passing vehicles, due to traffic signal heads being obscured.

It is recommended that visibility to each of the traffic signal heads is appropriate.

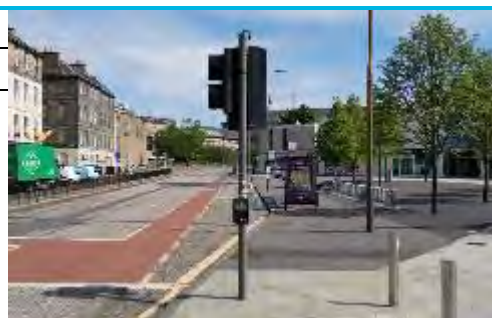
**Summary:** Risk of drivers / riders not seeing traffic signals, proceeding into the junction when it is not safe to do so and being struck by passing vehicles, due to signal heads being obscured.

It is recommended that visibility to each of the traffic signal heads is appropriate.

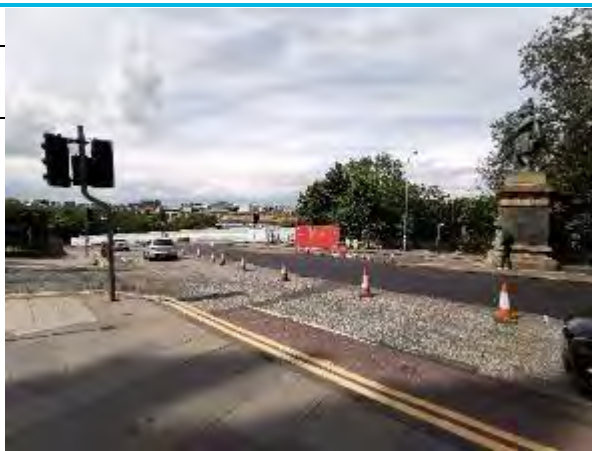
**Summary:** Risk of conflict between pedestrians and vehicles due to high relative flows.

The proposals do not provide any directional signage or advance signage to inform drivers of restrictions or alternative routes. Therefore, drivers may in frustration make unsafe manoeuvres, congestion may increase and there may be an increased conflict with other road users, including pedestrians. Of particular concern is high vehicle numbers potentially being diverted onto Lawnmarket which is an area of high pedestrian movements, particularly during events such as the Fringe Festival.

It is recommended that the traffic impacts of the bus lane are fully assessed and the impacts on other junctions considered. This may require adjustments to other junctions to accommodate anticipated traffic loadings. It is also recommended that a comprehensive signing strategy is undertaken to minimise the amount of through traffic attempting to use The Mound and George IV Bridge.

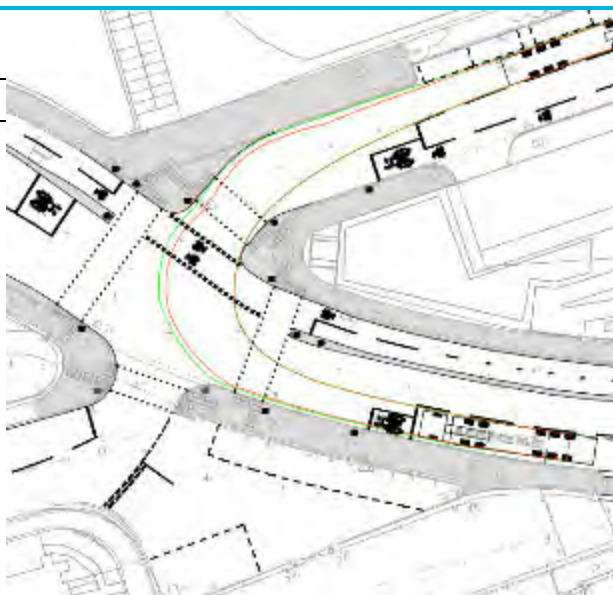
**Summary:** Risk of buses overrunning the kerb, potentially resulting in collisions with pedestrians and street furniture.

It is noted that the turning manoeuvre will be on a considerable gradient, vehicles turning right into Market Street are faced with an adverse camber which may influence the turning performance of a vehicle. It is unclear if this has been considered as part of the swept path analysis.

It is recommended that the most onerous vehicle expected to use the junction is accommodated.

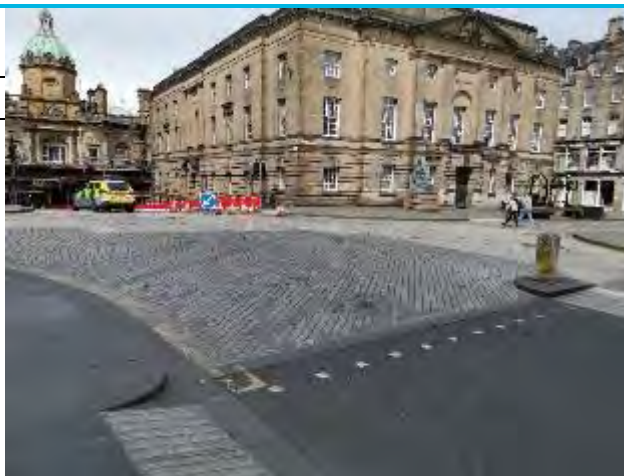
**Summary:** Risk of buses overrunning the kerb, potentially resulting in collisions with pedestrians and street furniture.

It is noted that the junction is at the point that the uphill gradients of Bank Street and George IV Bridge intersect, forming a subtle crest. This crest may also impact turning performance.

It is recommended that the actual turning performance of a bus is tested on-site to determine if it can safely complete the manoeuvre.

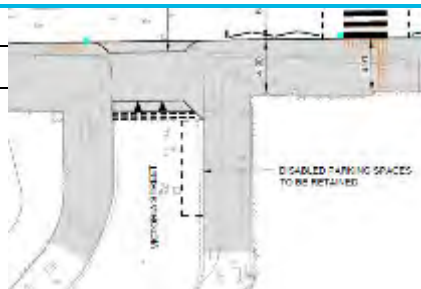
**Summary:** Risk of conflict between pedestrians and vehicles due to high relative flows and non-standard junction layout.

It is proposed that a continuous footway is to be provided across Victoria Street at George IV Bridge. It is noted that the City of Edinburgh Council are proposing continuous footways throughout the city, however currently they are a non-typical arrangement in the local area. There is concern that vulnerable road users and visitors to the city unfamiliar with continuous footways may not be aware how to use such a facility. Pedestrians and motorists may be unsure who has right of way and in a confused situation there is an increased risk of conflict and collision.

It is recommended that the vehicular space, pedestrian space and priority is clearly defined.

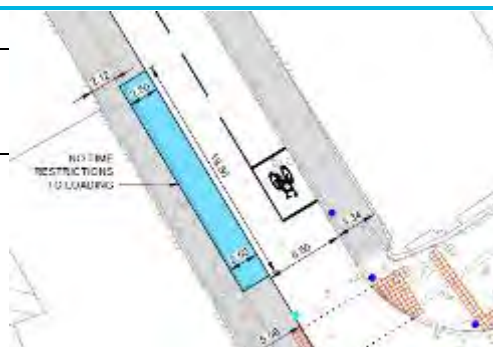
| <b>Summary:</b> | Risk that the vulnerable road users could step out into the carriageway and sustain personal injury. |

From the plans provided it was observed that there are several locations where public amenities such as benches are to be located within the proposed flexible loading bays (shown in light blue above). The flexible loading bays are bounded by a single row of tactile paving; therefore, pedestrians must cross the tactile paving to access the benches. It is understood that the bay will have a limited upstand to the carriageway. No tactile paving is proposed along the carriageway edge. As a result, there is a risk that vulnerable road users, such as visually impaired pedestrians could be unaware that they are in a location open to motorised road users and could step out into the carriageway into traffic sustaining personal injury.

It is recommended that appropriate measures are provided to reduce the risk of vulnerable road users stepping out on to the carriageway.

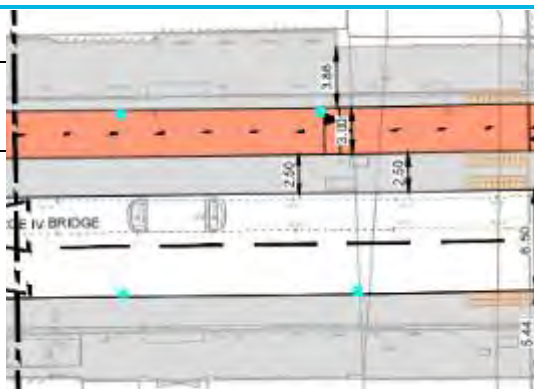
**Summary:** Risk of collisions between opposing cyclists and pedestrians and cyclists resulting in personal injury.

The Audit Team have not been provided anticipated walking and cycling flow rates; however, it is acknowledged that the scheme passes through one of the busiest areas in Edinburgh, which becomes acutely busy during events such as the Fringe Festival. The addition of the new route, continuing development of Active Travel in the city and existing pedestrian and cycling flows active travel flows are likely to be high. The widths of the cycleway in general are 3.0metres. It is unclear if this will be sufficient for the predicted flow. Whilst it is noted that in DMRD CD195 and 'Cycling by Design' state the desirable width for two-way cycling is 3.0m; both qualify this based on flow. CD195 suggest 3.0m is suitable for 150 cycles per hour or less and 'Cycling by Design' 200 cycles per hour or less.

If footways and cycleways are not sufficiently wide there is a risk of conflict and potential collisions resulting in personal injury, either as a result of cyclists entering the footway due to congestion on the cycleway or pedestrians stepping onto the cycleway. It is noted that the width of footways alongside the cycleways are generally the same as currently.

The issue could be exacerbated by the limited physical segregation. Whilst it is noted there will be a 50mm separation in levels between the footway and cycleway the chamfered kerbs would make transition between the footway and cycleway fairly easy.

It is recommended that the footway and cycleway provision is sufficiently wide to accommodate likely pedestrian and cycle flows.

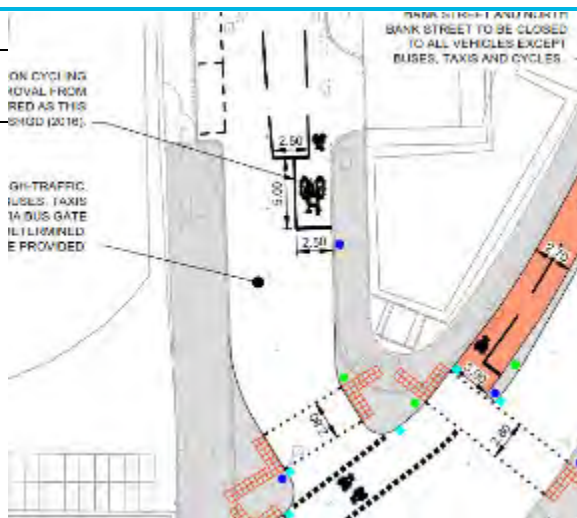
**Summary:** Risk of left hooking injuries involving vehicles and cycles moving off from Market Street.

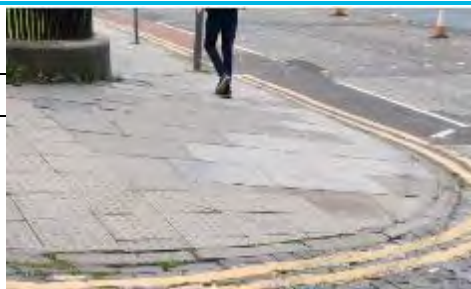
**Summary:** Risk that pedestrians may slip or inadvertently step onto the slopes and fall, resulting in personal injuries.

It is recommended that the footway profile is amended to reduce the risk of pedestrians falling on a steep gradient.

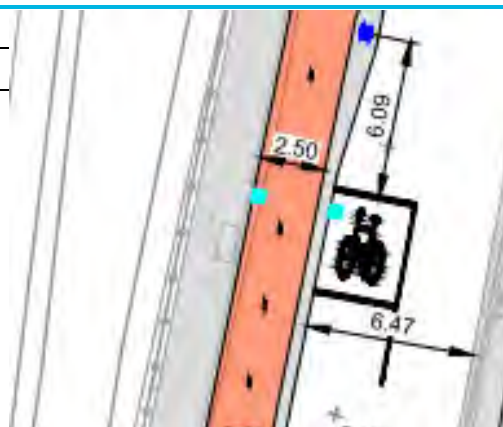
**Summary:** Risk of head-on collisions between cyclists due to narrow cycle lane resulting personal injury.

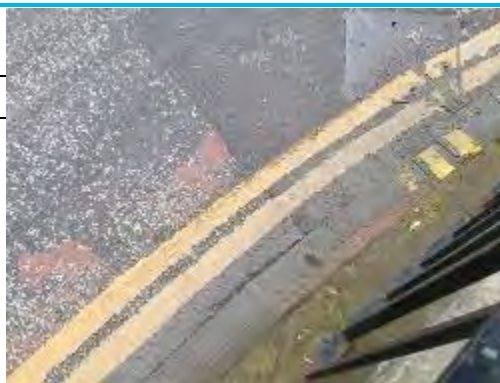
**Summary:** Risk that pedestrians may become trapped between the wall and motorised road users resulting in personal injury.

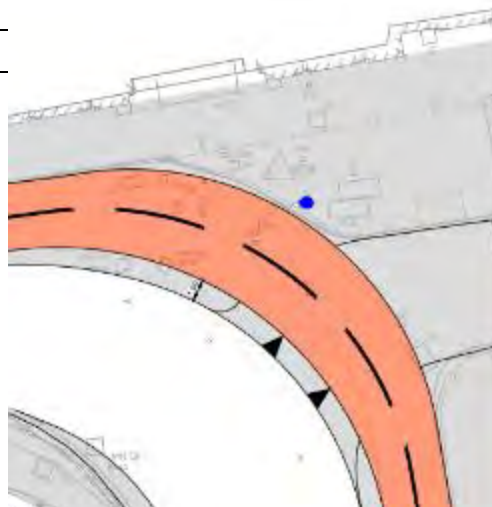
**Summary:** Risk that visually impaired road users may not be able to determine that they have stepped onto the carriageway, potentially resulting in personal injuries if struck by a passing motorised vehicle.

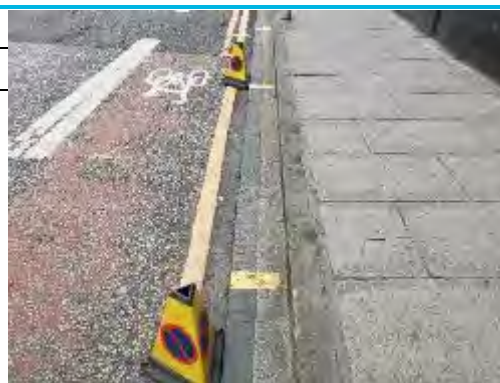
**Summary:** Risk of pedestrians tripping over a step in the centre of the footway, potentially resulting in personal injury.

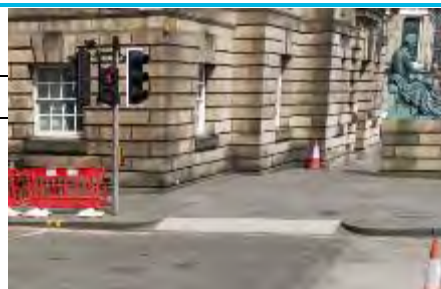
**Summary:** Risk that pedestrians may slip and fall, especially in wet conditions resulting and personal injury.

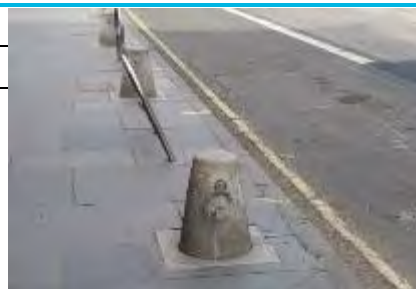
**Summary:** Risk that pedestrians may trip and fall and could result in personal injury.

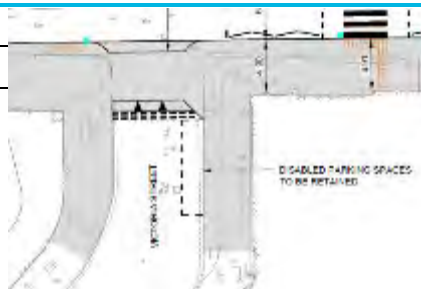
**Summary:** Risk that visually impaired road users may not be able to determine that they have stepped onto the carriageway, potentially resulting in personal injuries if struck by a passing motorised vehicle.

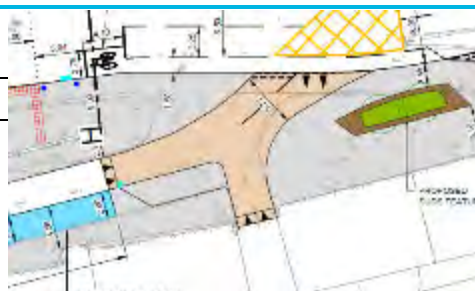
**Summary:** Risk that visually impaired road users may not be able to determine that they have stepped onto the carriageway, potentially resulting in personal injuries if struck by a passing motorised vehicle.

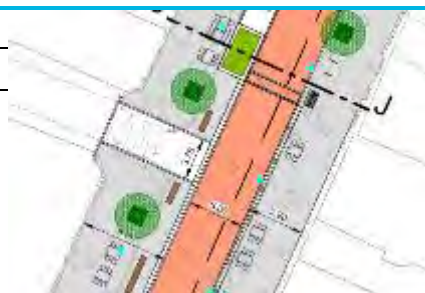
**Summary:** Risk that visually impaired road users may not be able to determine that they have stepped onto the carriageway, sustaining personal injuries if struck by a passing motorised vehicle.

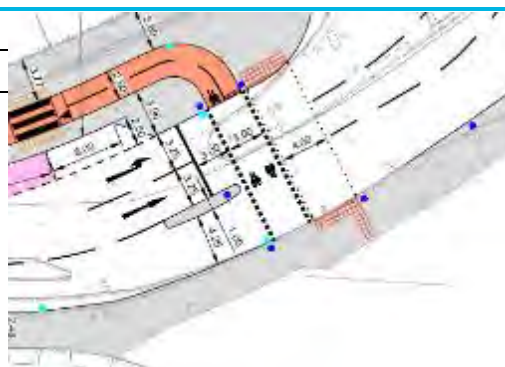
**Summary:** Risk that pedestrians and cyclists will be in-conflict and could increase the risk of personal injury being sustained.

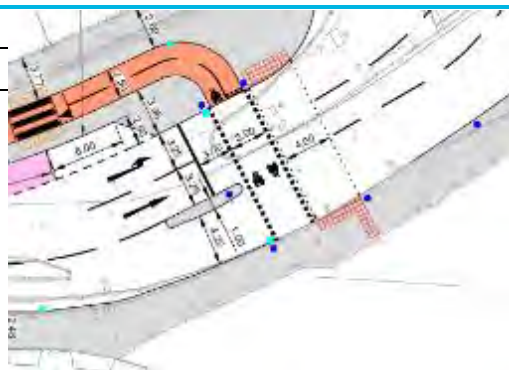
**Summary:** Risk that visually impaired road users may not be able to locate the crossing over Teviot Place on the northern footway.

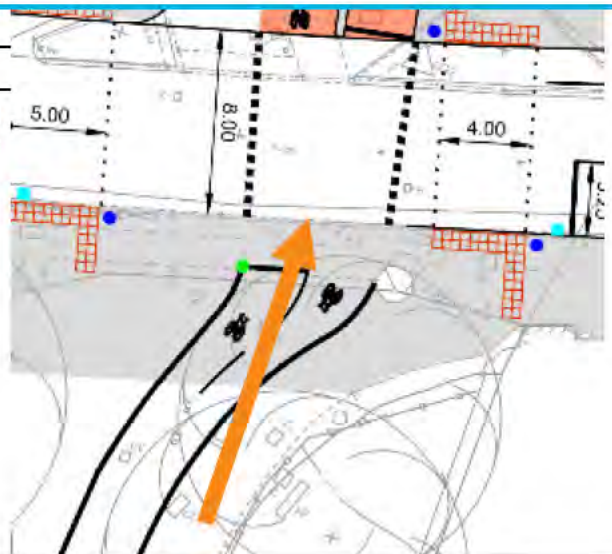
Summary: Risk of visually impaired pedestrians walking onto the carriageway, potentially resulting in collisions with vehicles.

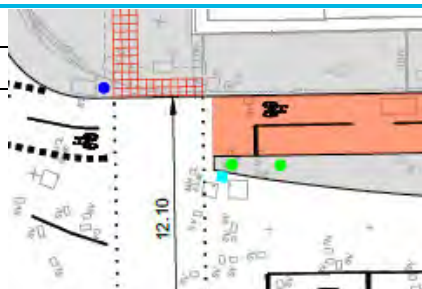
**Summary:** Risk of sideswipe and loss of control collisions resulting from vehicles striking kerbs in the carriageway.

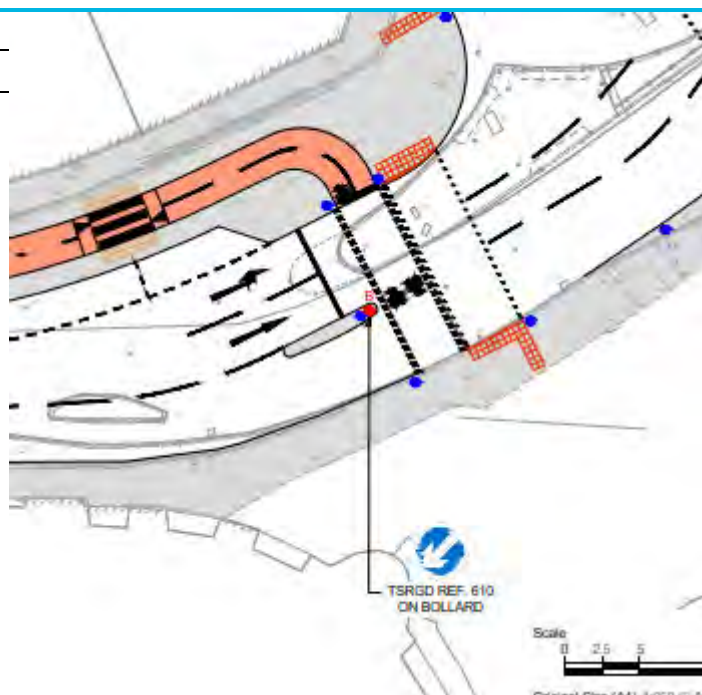
**Summary:** Risk of sideswipe and loss of control collisions resulting from vehicles striking kerbs in the carriageway.

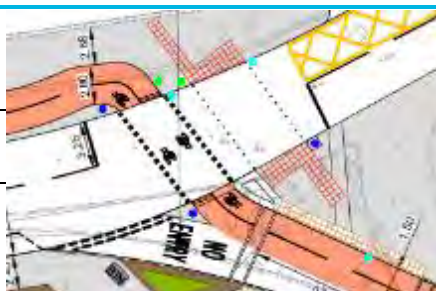
**Summary:** Risk of conflict between vehicles proceeding through a green light and crossing cyclists.

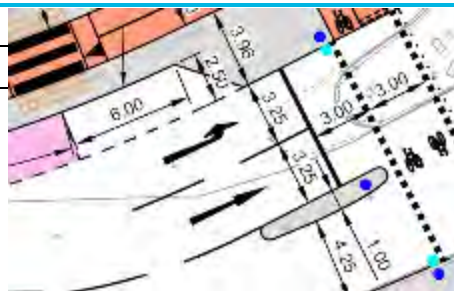
**Summary:** Risk of side swipe collisions as motorised road users make late manoeuvres across the lanes.

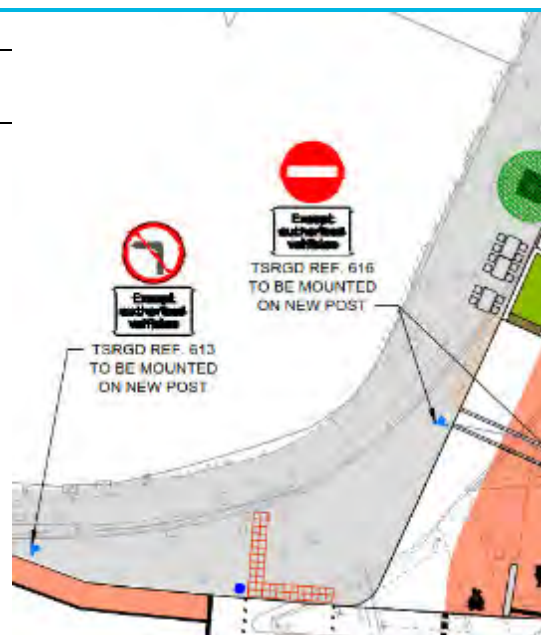
**Summary:** Risk of large turning vehicles overrunning the footway and colliding with pedestrians and / or street furniture.
