111-117 Bellevue Road, Edinburgh

**Structural Report:**

**111-117 Bellevue Road  
Edinburgh  
EH7 4DG**

**January 2014**

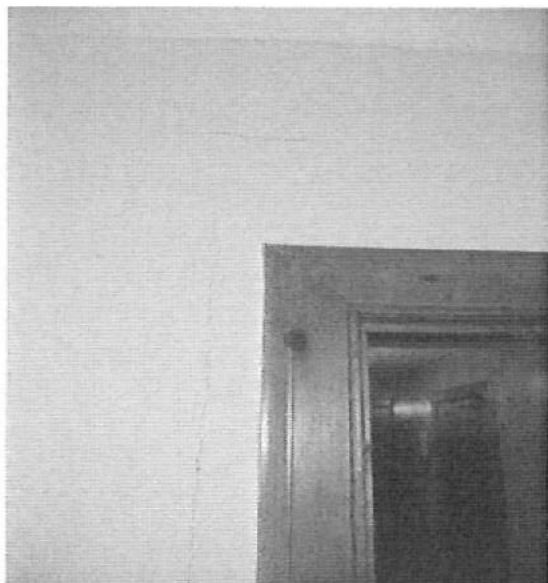
Fig.1

- Hairline plaster crack around the door at the junction of the brickwork and the timber door surround (Fig.1).
- Vertical hairline crack in the lath and plaster lining above the fireplace (Fig.2).

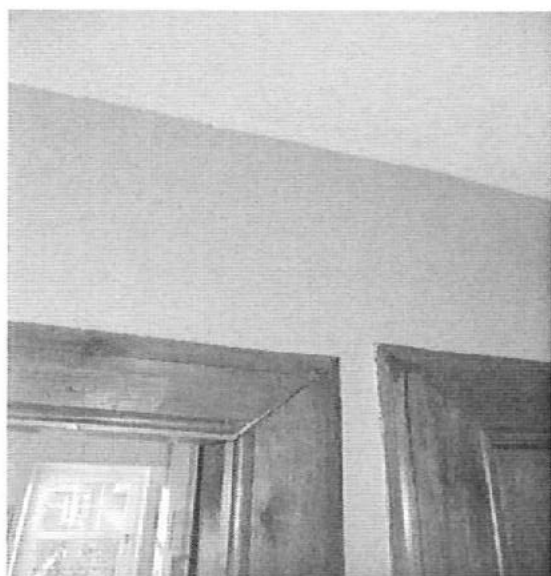
Fig.3

- Vertical hairline crack above the door to the kitchen (Fig.3). This wall is of timber stud construction. The mitred joint to the door surround has opened up slightly in the same location.
- Horizontal crack in plaster above the door to the living room (Fig.4).

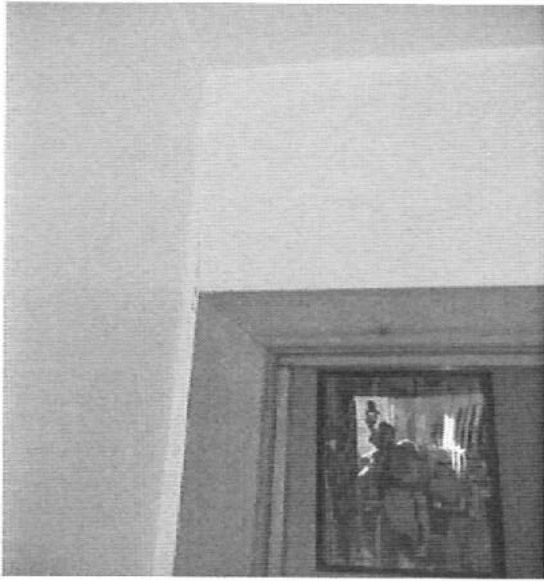
Fig.5

- Vertical hairline crack in plaster above the door (Fig.5), reflecting similar crack on the other side of this wall, within the hall.

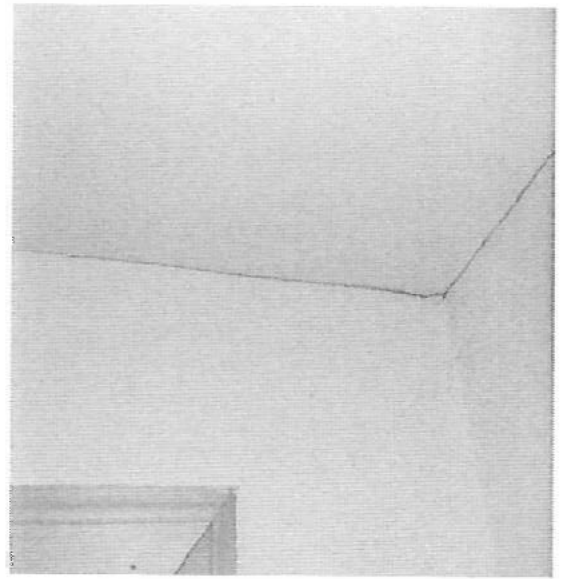
Fig.6

- Horizontal crack in plaster at wall/ceiling junction on south and east walls (Fig.6). This crack does not appear to be particularly recent but may have worsened in recent months, attracting the notice of the residents.

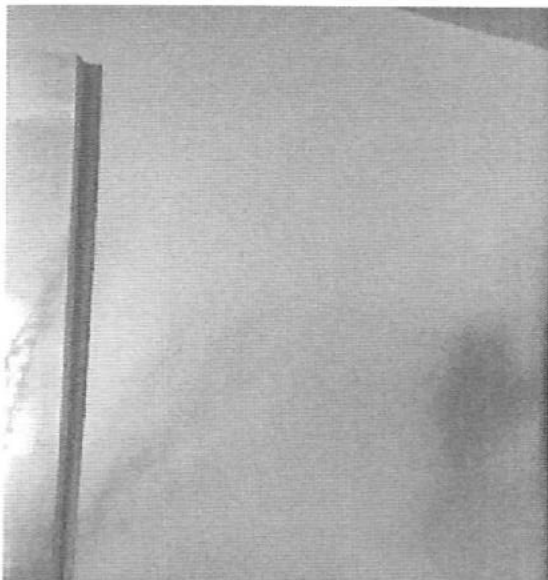
Fig.7

- Vertical hairline plaster crack on north wall (Fig.7).
- Vertical crack in plaster above door (Fig.8). This crack has been repaired in the past but appears to have reopened.

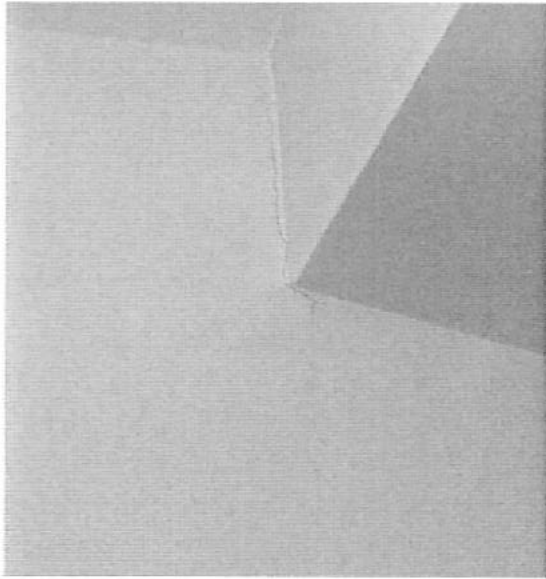
Fig.9

- Hairline crack in plaster at junction of south wall and sloped ceiling (Fig.9).
- Hairline crack in plaster at junction of north wall and sloped ceiling (Fig.10).

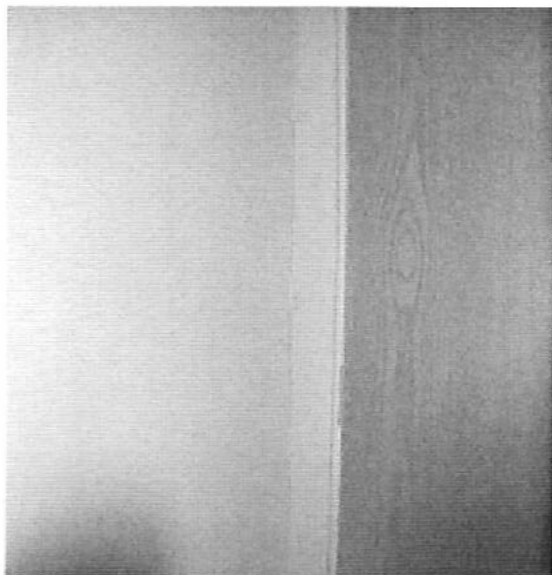
Fig.11

- Vertical hairline crack to east of main entrance door (Fig.11).
- Crack across ceiling in north/south direction at junction of plasterboard (Fig.12).
