**Property Address:** 3 1F1 Saughton Grove, EH12 5SN

**Date of inspection:** 09/12/2025

**Property Description:** 4 in a block

### **EXTERNAL OBSERVATIONS**

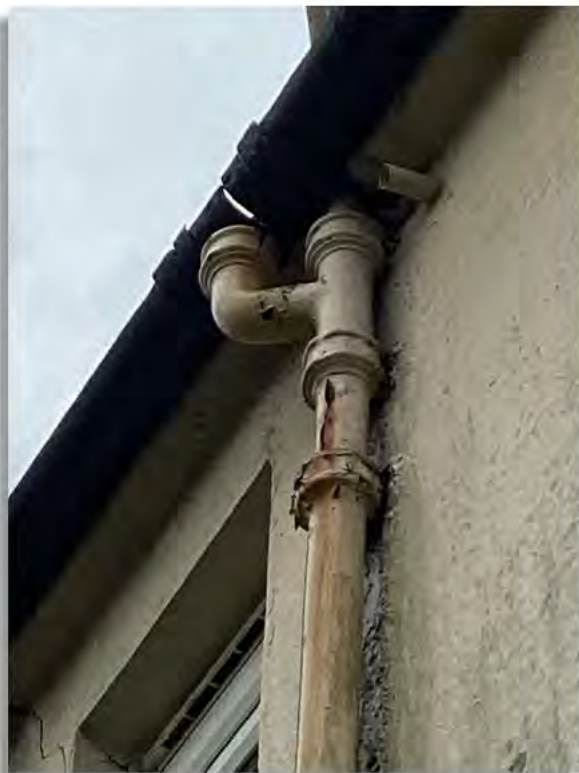
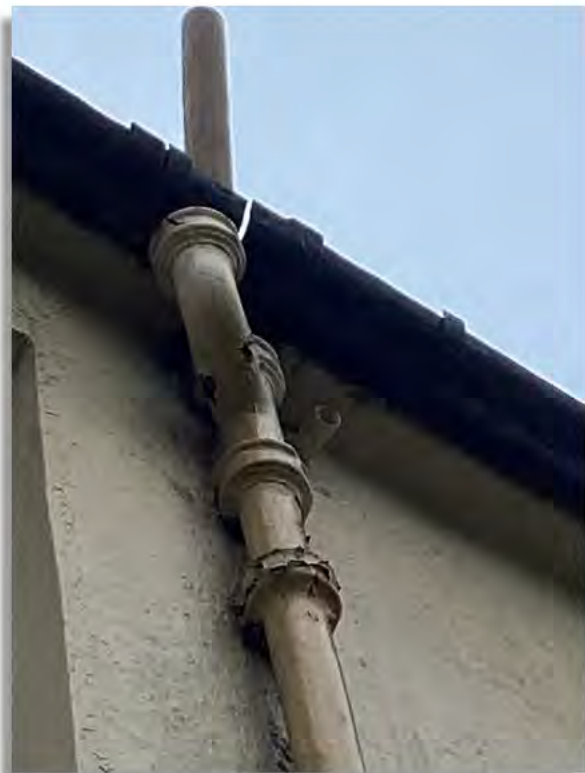
- A gap was noted within the guttering on the rear elevation; this is allowing water from the roof to run down the rear external wall. We were unable to establish if this gap was caused by a disconnect between sections of the guttering or if it was cracked.

- We would recommend that CEC contact the relevant trades to inspect and repair the above noted defects as required.
- The cracks in the external render need a full investigation to clarify if there may be a structural issue within the building or if it's just damaged render.

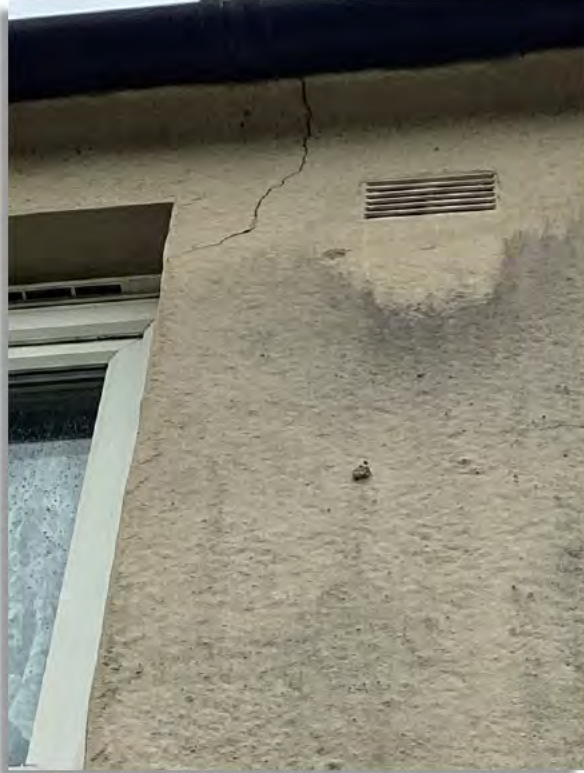
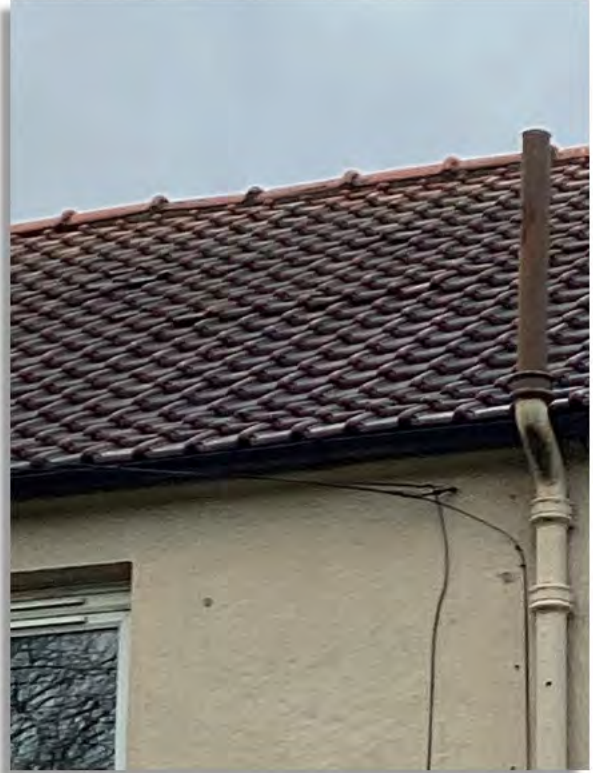
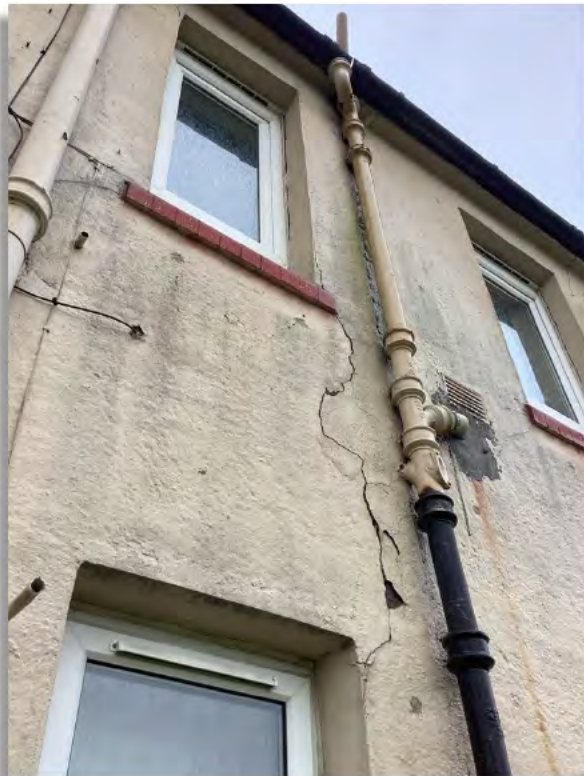
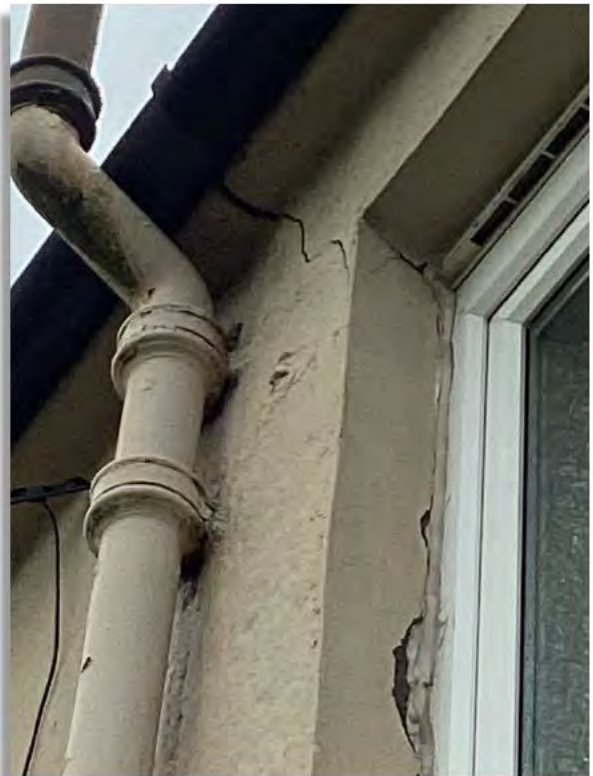
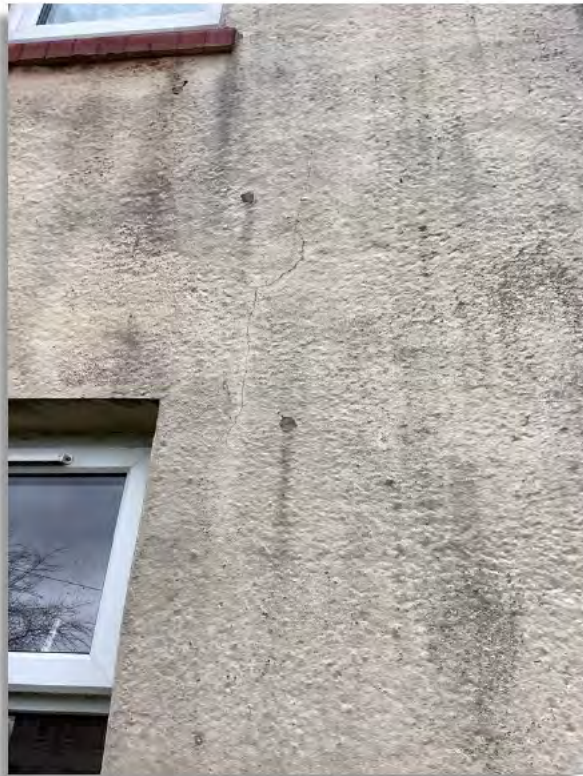
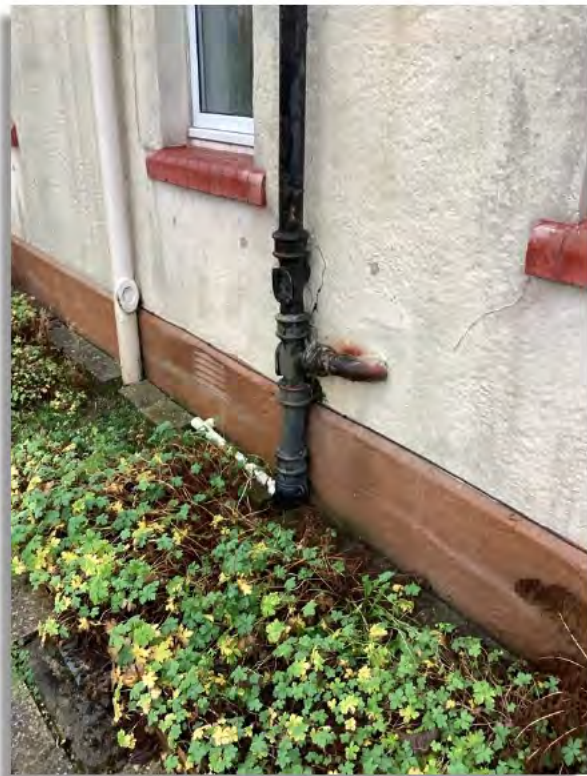
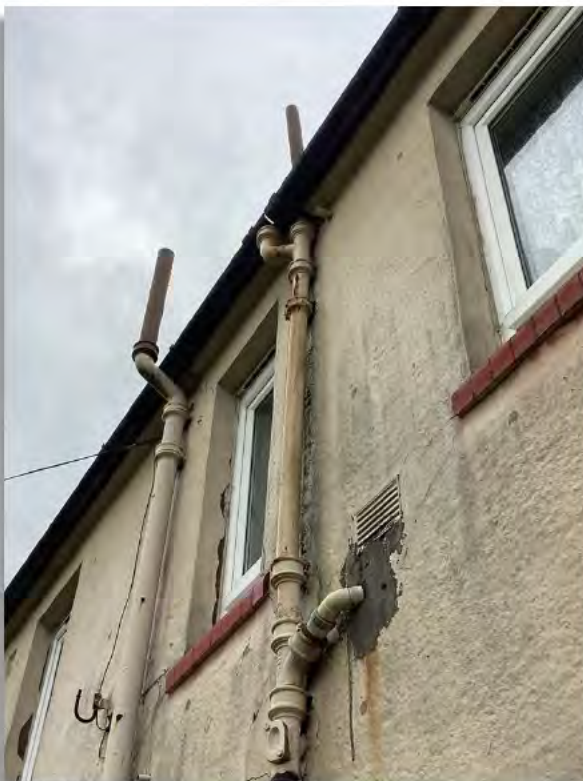
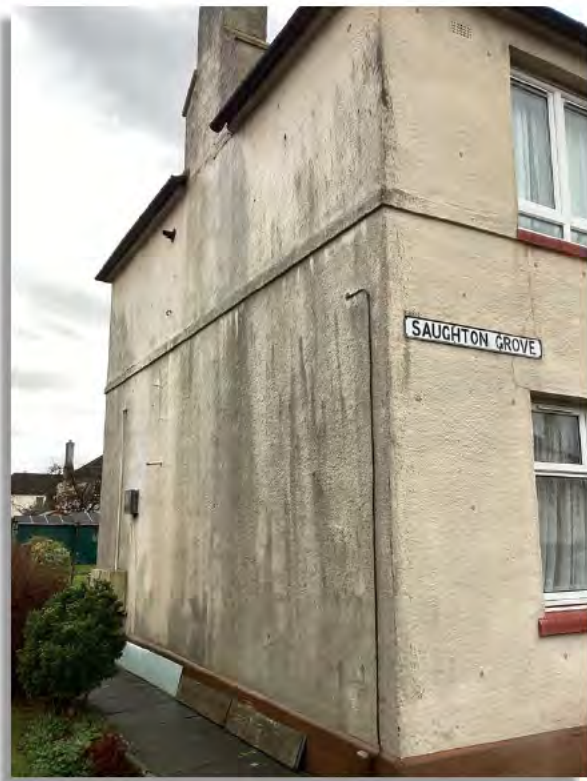
- Damaged render was noted primarily on the left elevation of the property, large sections of render are embossed and sounded hollow when tapped, significant cracks were also noted around the windows on the rear elevation.

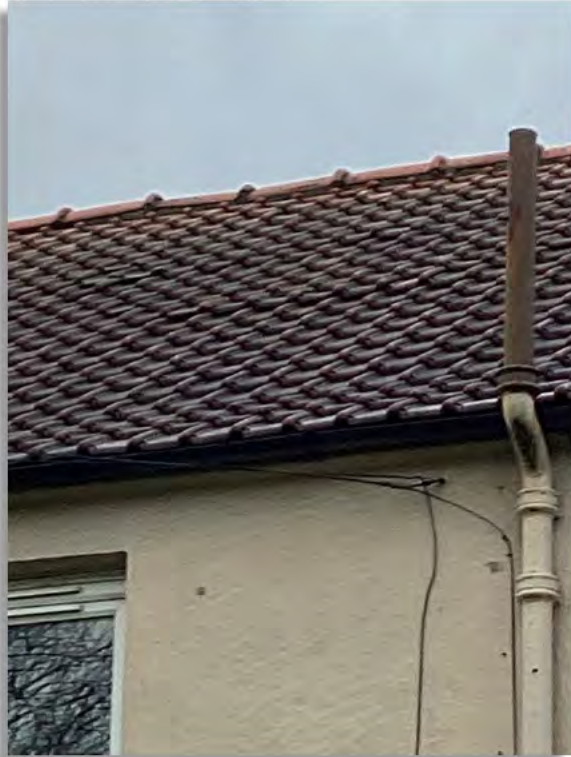
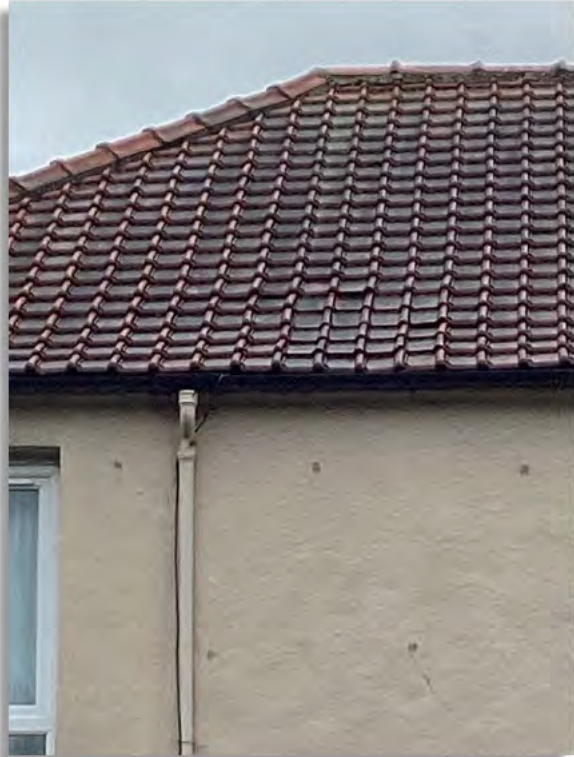
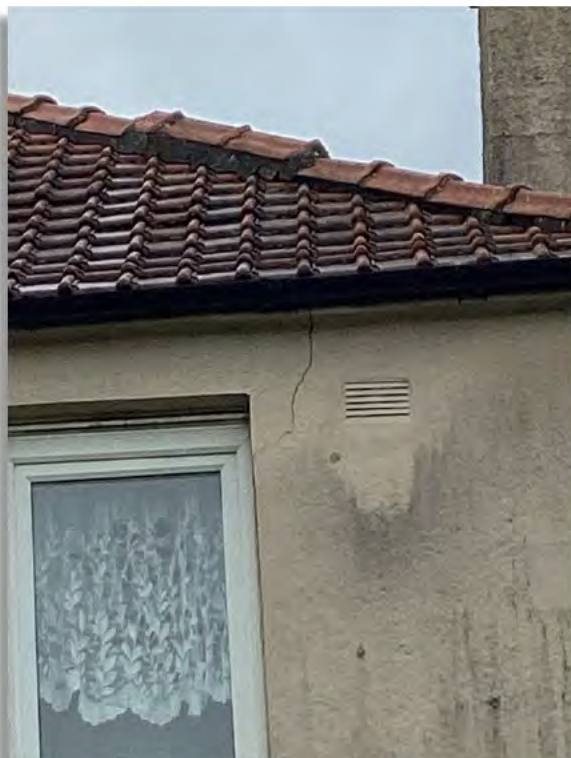
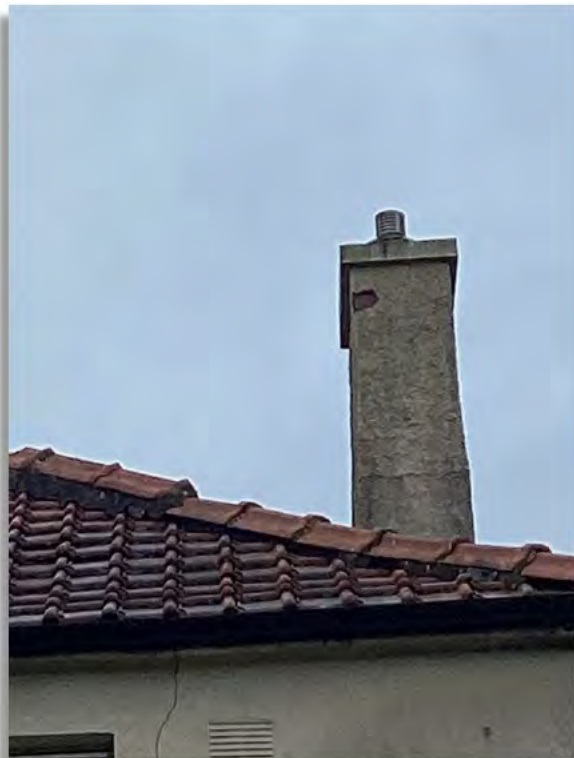
- Several roof slates on the front and rear elevations appeared to have been raised slightly, it's difficult to tell whether these defects are allowing driving rain to penetrate the fabric of the building.

- A poor repair was noted to the rear left ridge tiles, one tile is raised significantly above the others, this may have been done as a temporary repair to re-bed the tile onto a mortar footing without removing the old mortar bed.
