## STAGE 3 ROAD SAFETY AUDIT REPORT FOR EDINBURGH TRAM NETWORK

Report Reference:-  
Airport – York Place Final Stage3.

Date 06.04.2014

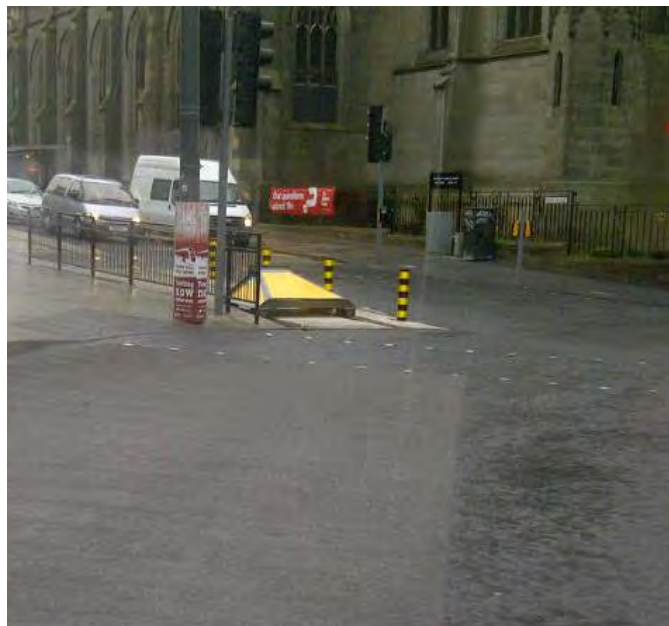
The works at the Tram Buffer were incomplete at the time of the site visit on 12<sup>th</sup> February. The area around the buffer was protected by temporary traffic management. Eastbound vehicles in the nearside lane turning right from York Place towards the Picardy Place roundabout, were observed encroaching into the offside lane forcing cars in this lane towards the temporary barriers around the proposed buffer location. Poor lane discipline here is likely to force some cars towards the buffer, risking a collision and slight or serious injury to vehicle occupants.

Since the site visit on 12<sup>th</sup> February bollards have been provided around the buffer and the buffer has been made more conspicuous with the application of reflective markings. The Audit team consider these measures to meet the above recommendation.

The buffer and the deflection area behind the buffer should be protected by a series of passively safe reflective bollards that if hit can be quickly replaced. The audit team have been advised that “Visiflex” bollards in “NAL” sockets are to be provided around the area of the buffer along with retro-reflective markings on the buffer.

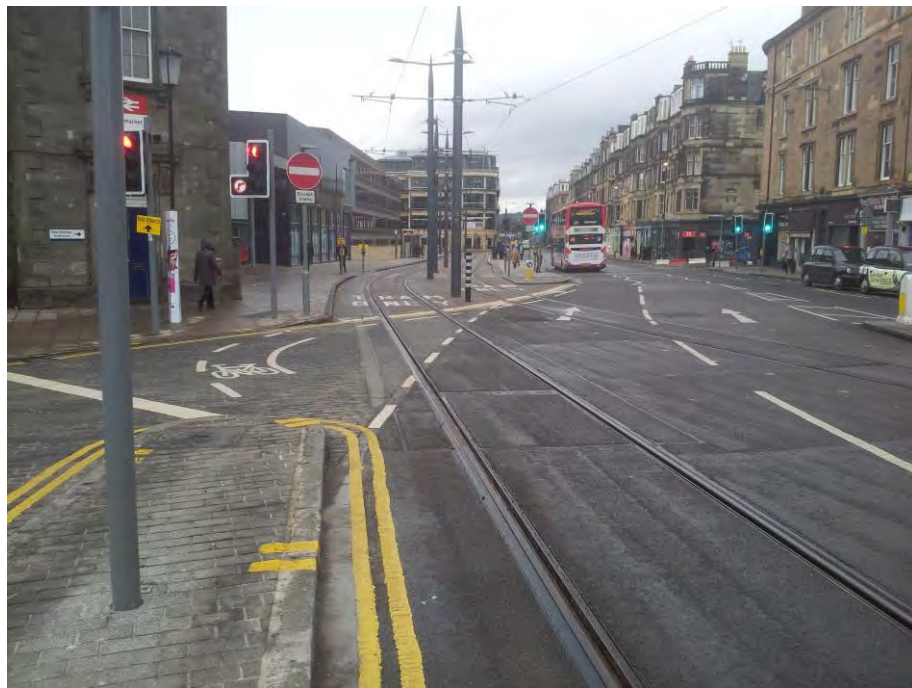
During the site visit on the 12<sup>th</sup> February the old Haymarket Station was closed for refurbishment and taxis have been relocated to the northwest side of Haymarket Terrace. Cyclists are encouraged to use the short “jug handle” design cycle lane within the Haymarket Station junction in order to cross the tram lines at a safer angle. A member of the audit team cycled through this area during the site visit and found it to be safe provided the marked alignment was taken.

City of Edinburgh Council continue to promote good cycling practice and publicize to cyclist the recommended methods of crossing tram lines.

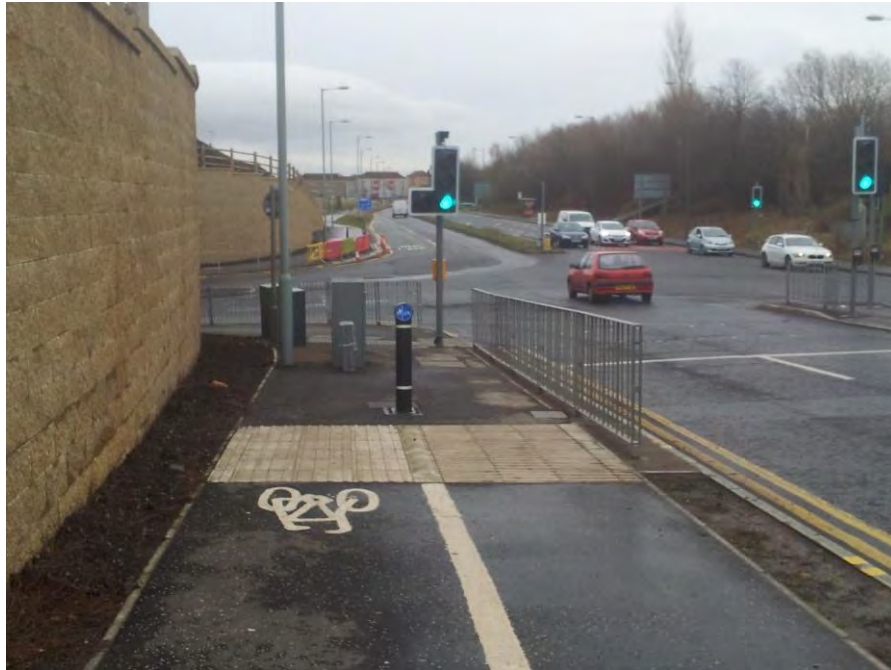
Cyclist are forced to deviate around street furniture and will come into conflict with pedestrians and other cyclists. There was evidence of cyclists passing the street furniture on the left, between the cabinets and the retaining wall.

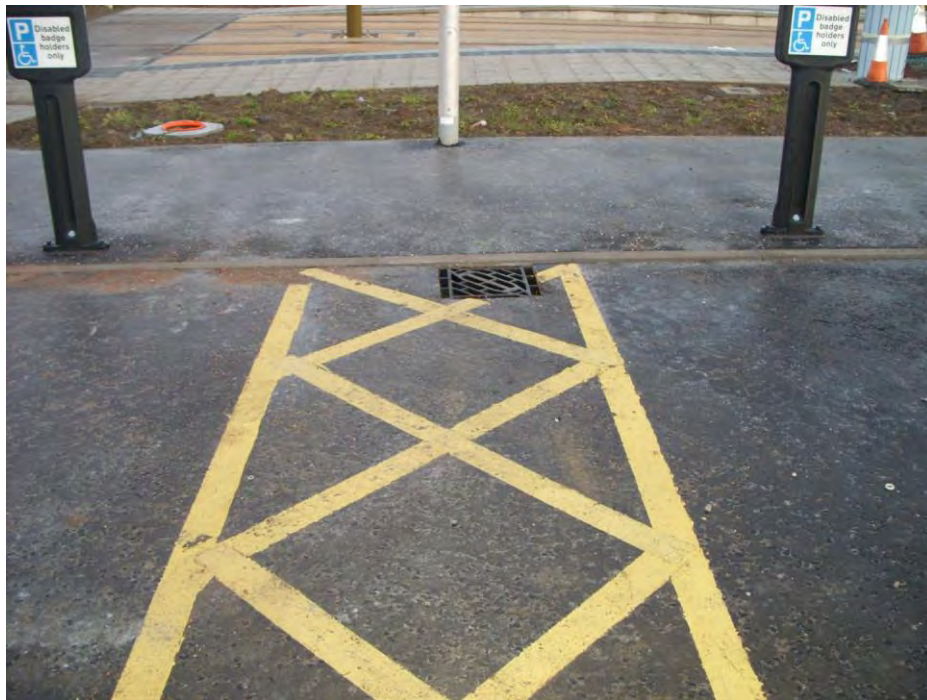
There is a risk that wheel chair users will get the small front wheels of their chair stuck in the drainage gully covers that are located at the end of the yellow hatched area beside the disabled parking bays.

Recommendation. Provide a gully cover with openings that run parallel to the adjacent kerb.

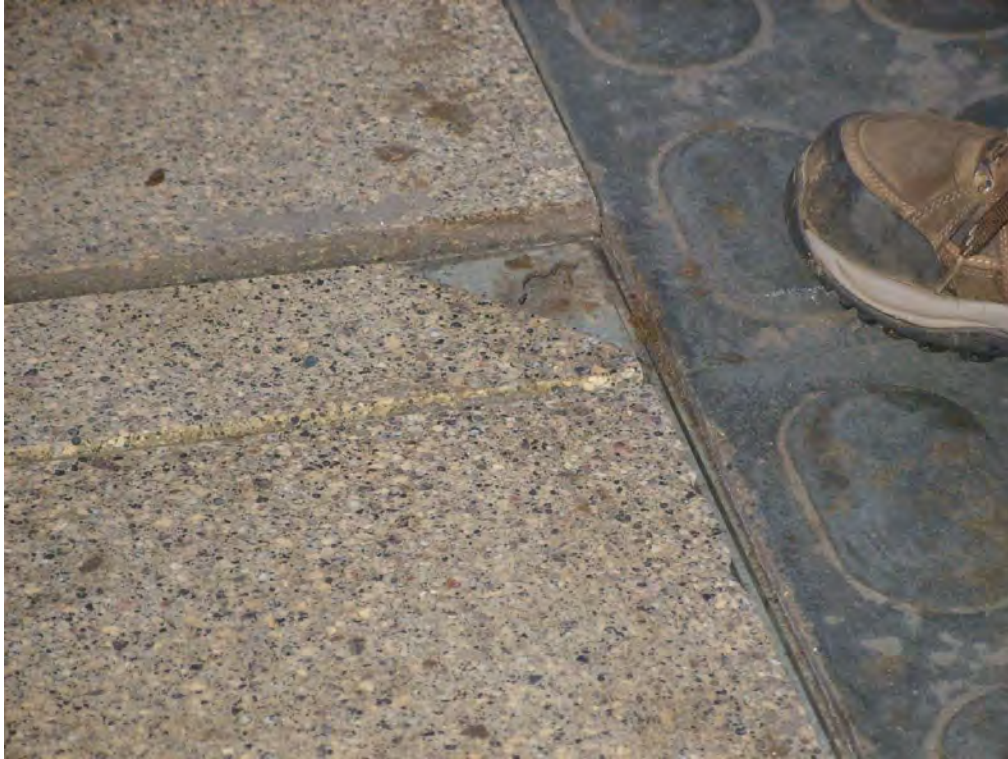
The level of some of the access covers on the platform has been set to low whilst the infill slabs to the covers have been set to the correct level. This has resulted on a tripping point between the cover and the slab fitted to the cover.

Recommendation. Reset the covers and slabs to the correct level to remove the tripping point.

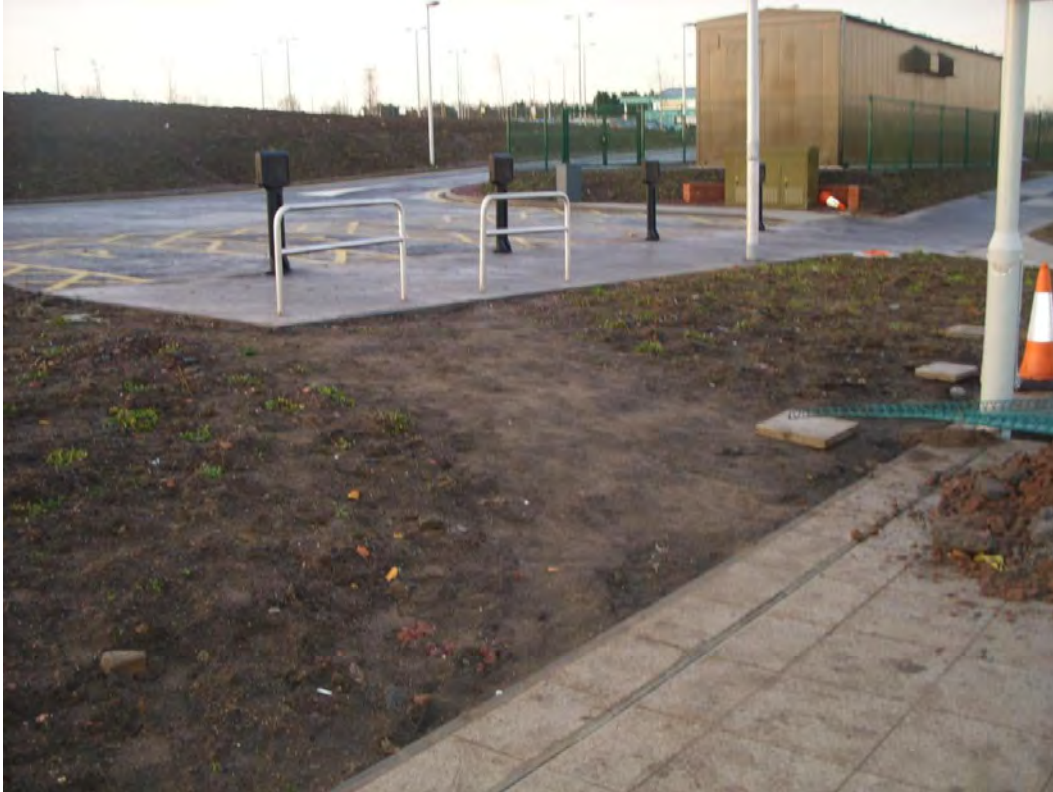
There is already evidence of pedestrians walking from the platform directly through the landscaping to the cycle stands. Whilst there is little risk to the safety of those pedestrians who walk across the soft landscaping consideration should be given to providing a surfaced path from the cycle stand to the platform.

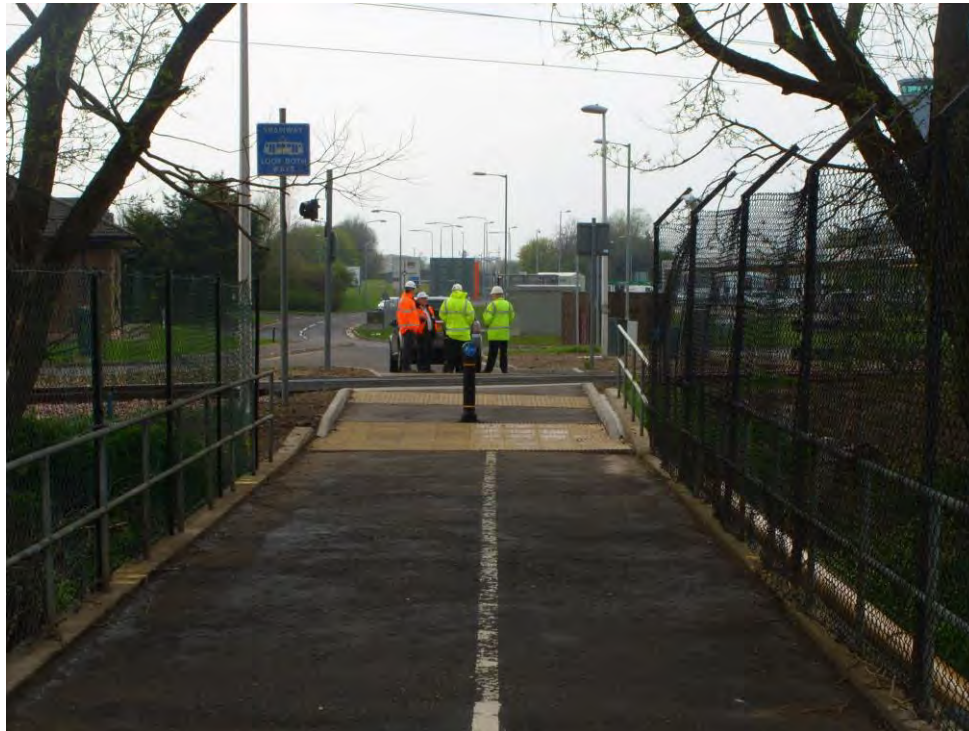
A tree branch in front of the “Trams – Look Both Ways” sign will grow and obstruct sightlines to the sign.

Recommendation. Cut the branch from the tree.

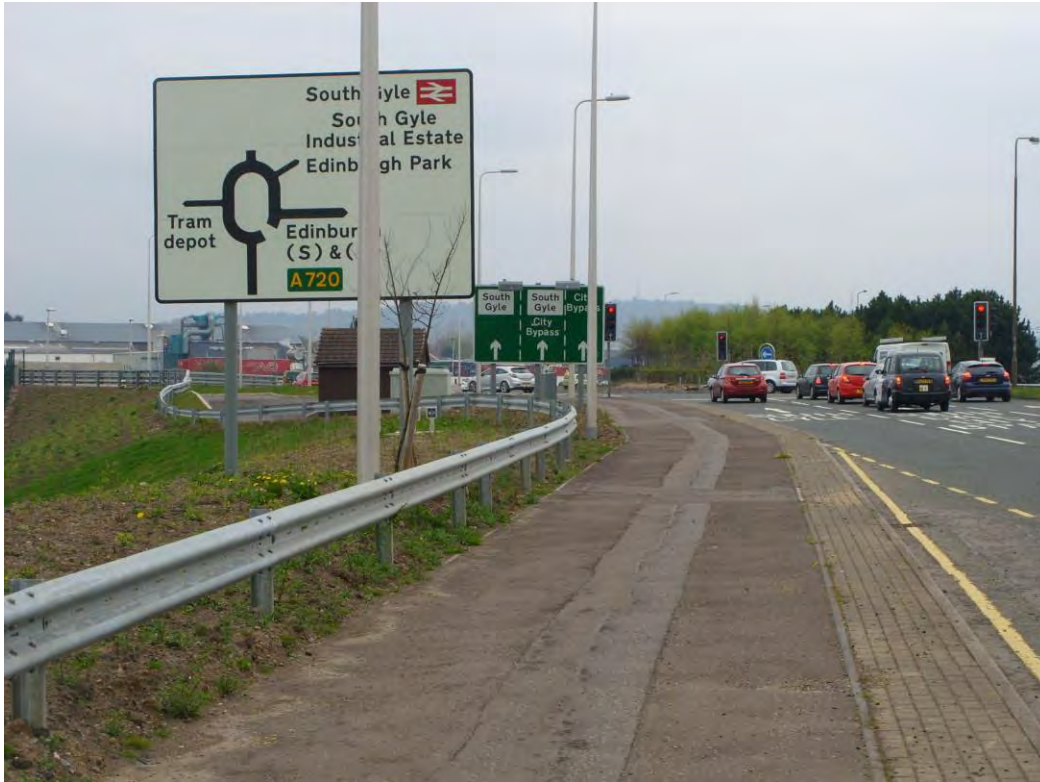
Two trees have been planted in front of the new Advance Direction sign. These will grow and obstruct drivers' view of the sign.

Recommendation. Replant the trees behind the sign.

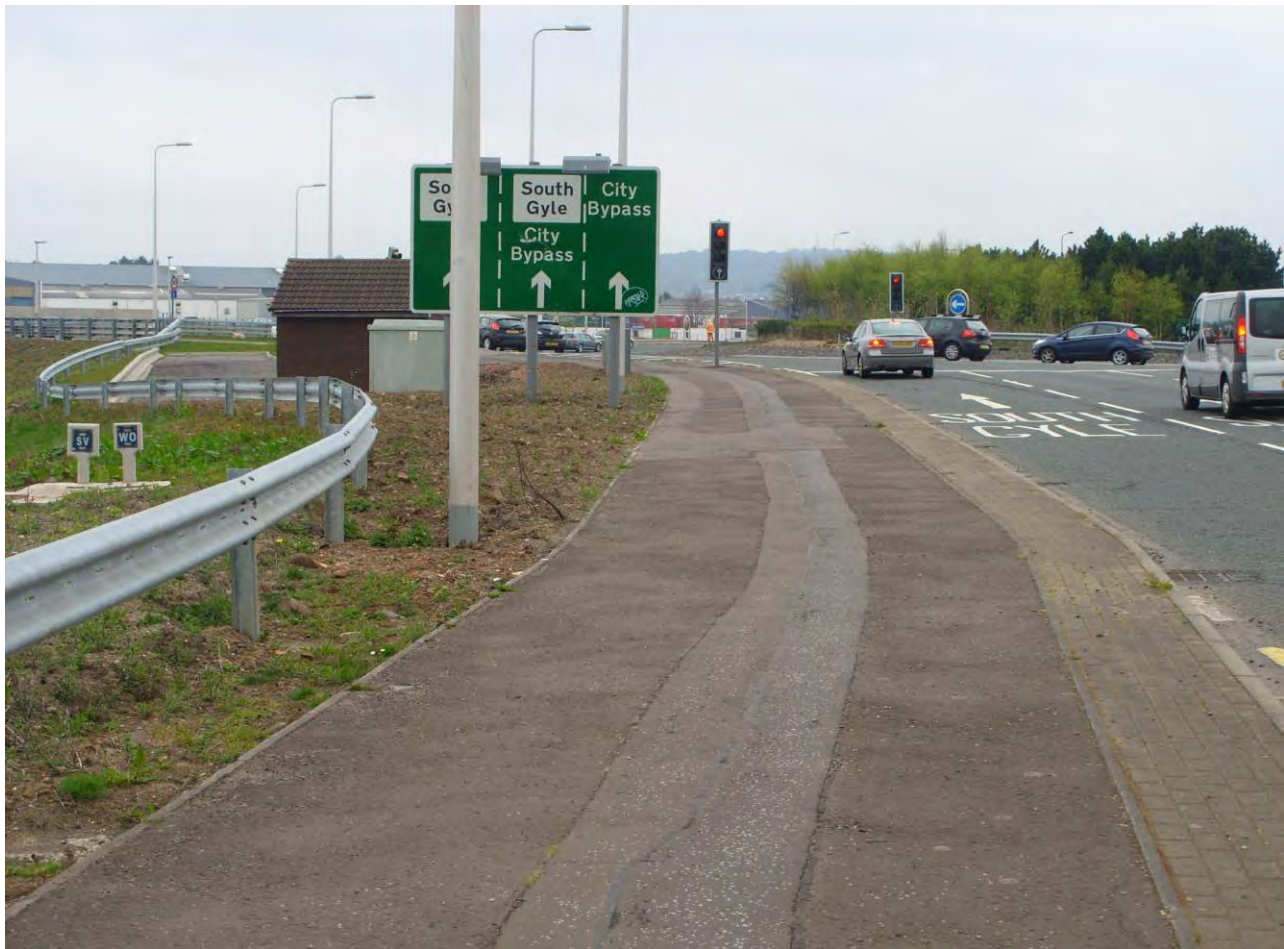
This VCB is provided to prevent errant vehicles from entering the Tram Depot. If it has been assessed that vehicles will leave the carriageway at this point then there is a risk that they will impact with the lighting columns and signs. The Audit team has considered the safety implications of this. The columns are approximately 4m from the kerb and within a 40 mph speed limit.

Recommendation. Provide a VCB at the rear of the footway in front of the last 2 lighting columns and the advance direction sign or provide passively safe street furniture at this location.

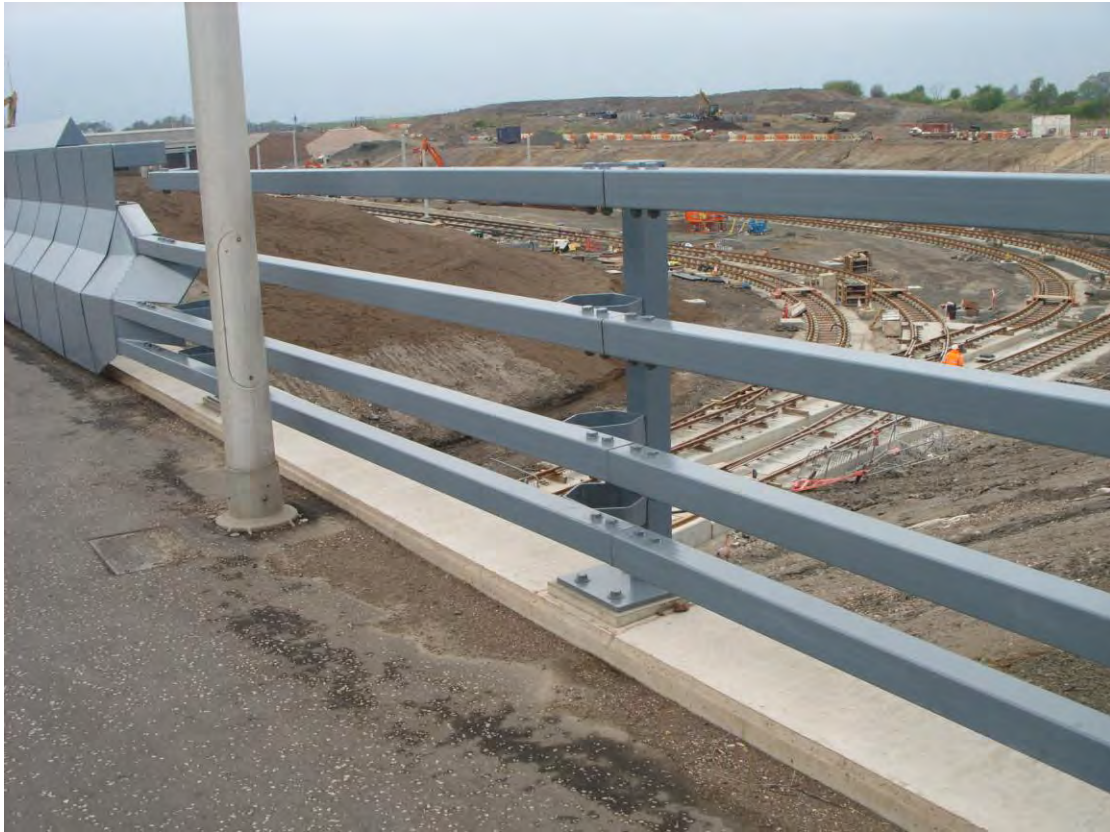
The approach parapet rails provide an opportunity for people to climb on and through to gain access to the 7m high embankment. Young children in particular are likely to climb on these rails in order to see the passing trams.

Recommendation. Provide a mesh to the rails, similar to that provided on the parapet rails on the nearby A8 Gogar roundabout approach retaining walls.

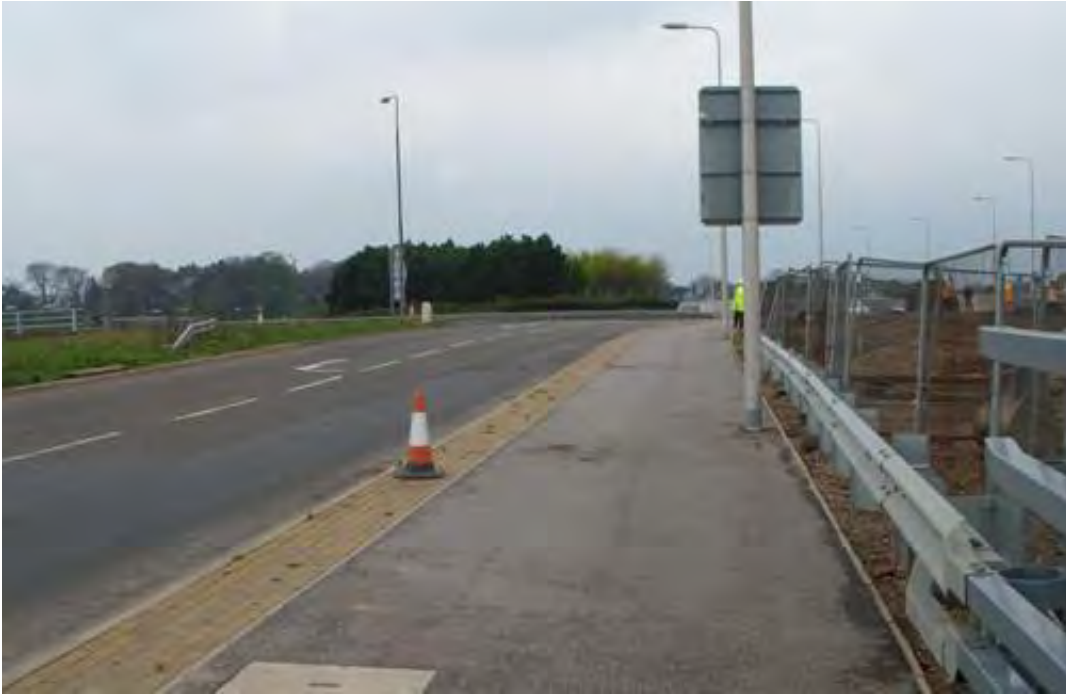
The lighting columns between the Gogar roundabout eastbound exit and the A8 Tram underpass are placed in front of the vehicle crash barrier (VCB). The merging of the two lane roundabout exit into one lane could lead to swipe type collisions and impact with the VCB and lighting columns.

Recommendation. Relocate the lighting columns to behind the VCB. Similar to the detail used along the Gogar Tram Depot access road.

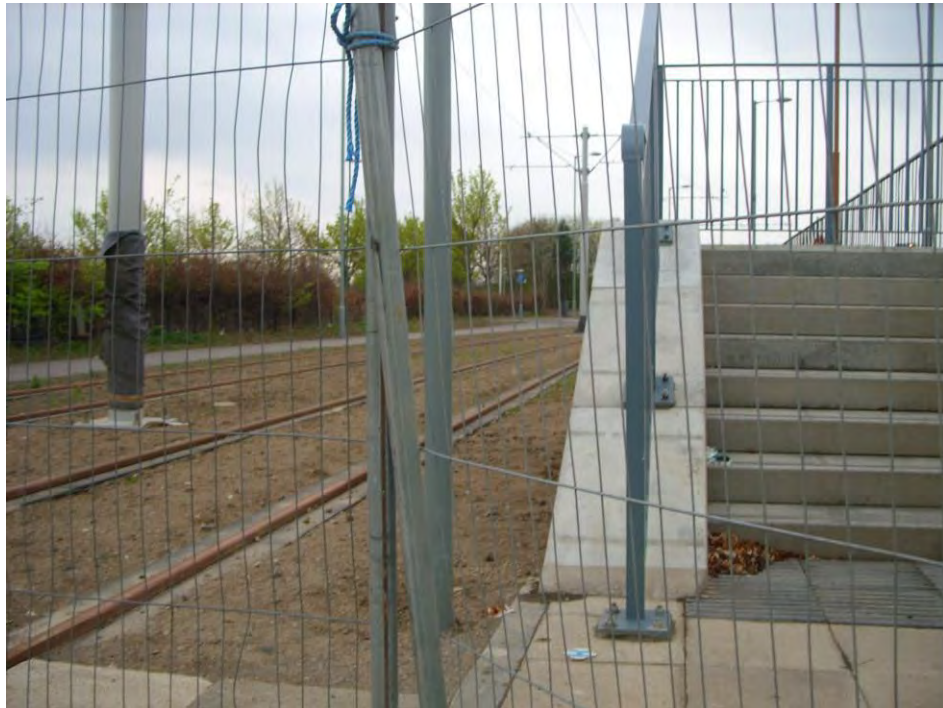
Sightlines for small children crossing the tram tracks towards the Morrison store are restricted by the adjacent steps. Young children do not have the skills to judge speeds and distances and are known to be impulsive.

Recommendation. Provide signage for approach tram drivers to highlight the possibility of children stepping out from behind the steps.

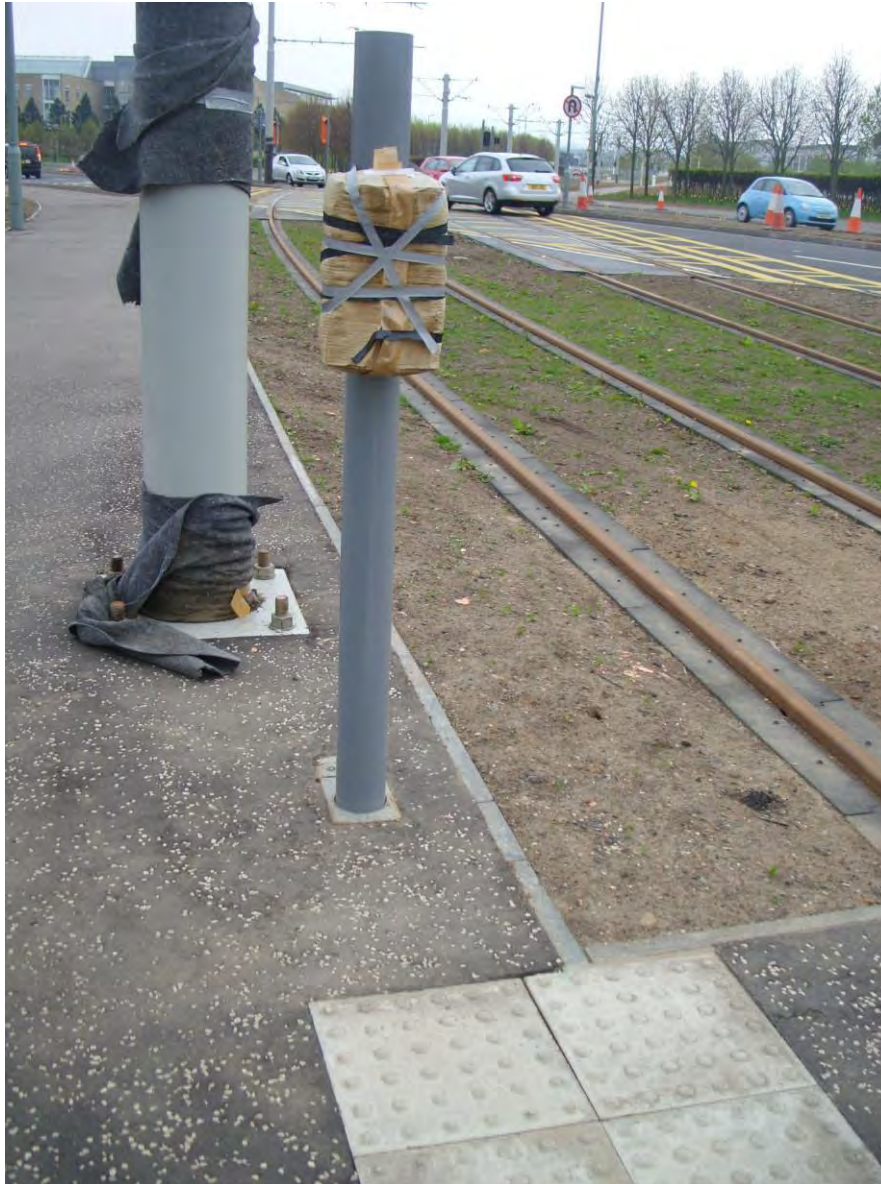
At several locations within the junction the pedestrian crossing push button facility is too far from the tactile slabs. This may result in visually impaired pedestrians not being able to locate the push button.

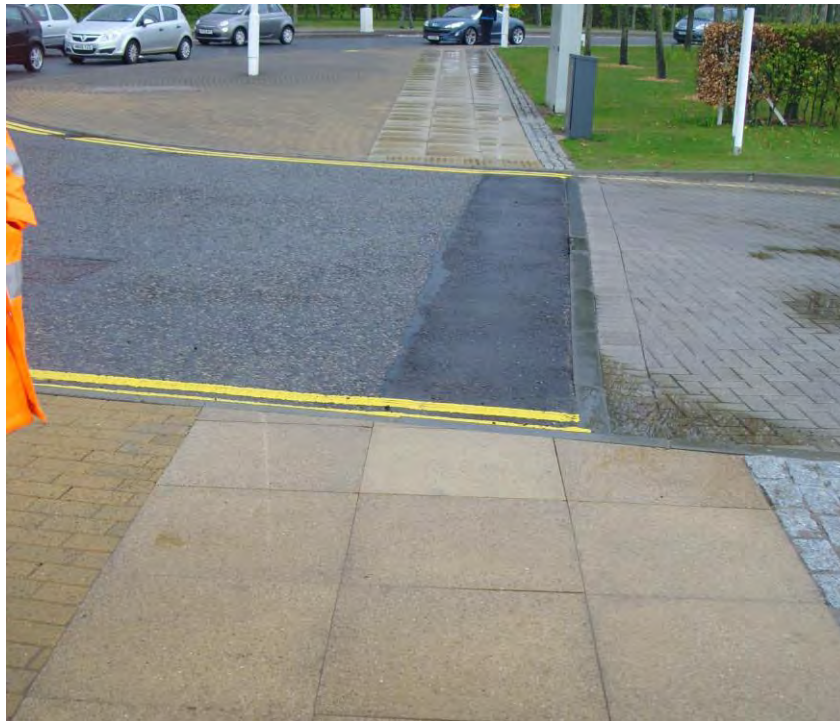
Drop kerbs need to be provided to match the existing drop kerbs on the opposite side of the carriageway.

Recommendation. Provide drop kerbs and tactile slabs.

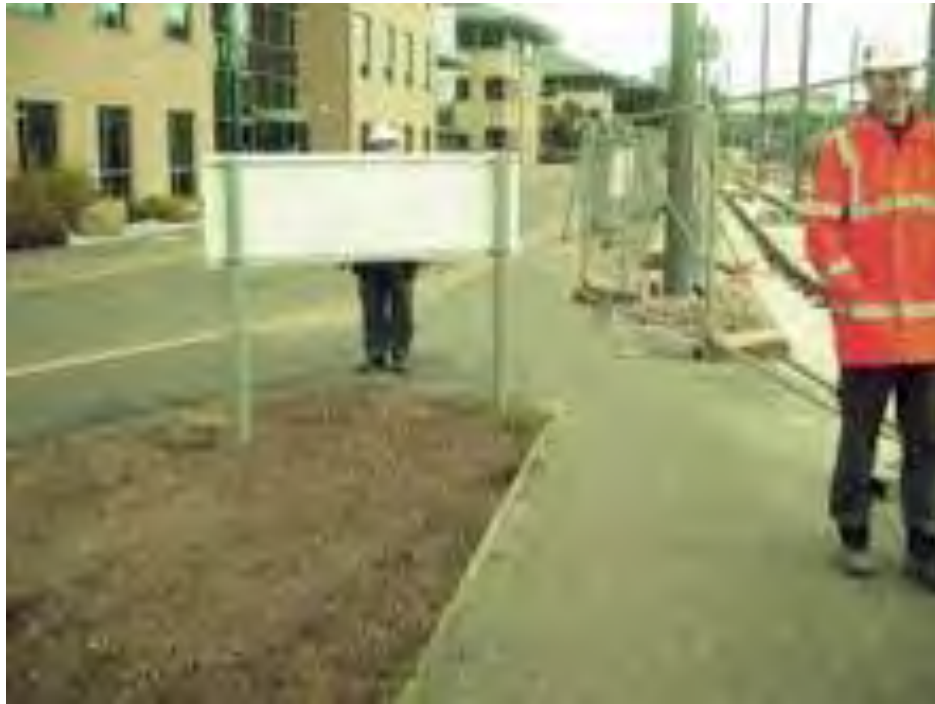
The narrowness and stepped alignment of the pedestrian and cyclist route from Balbirnie Place as it joins Haymarket Yards has the following hazards for cyclists;

- a) The sign to the Chartered Accountants is too close to the edge of the path and there is a risk, especially for eastbound cyclist that their handlebars will hit this sign.
- b) The tram tracks are close and at a lower level than the pedestrian and cyclist path.

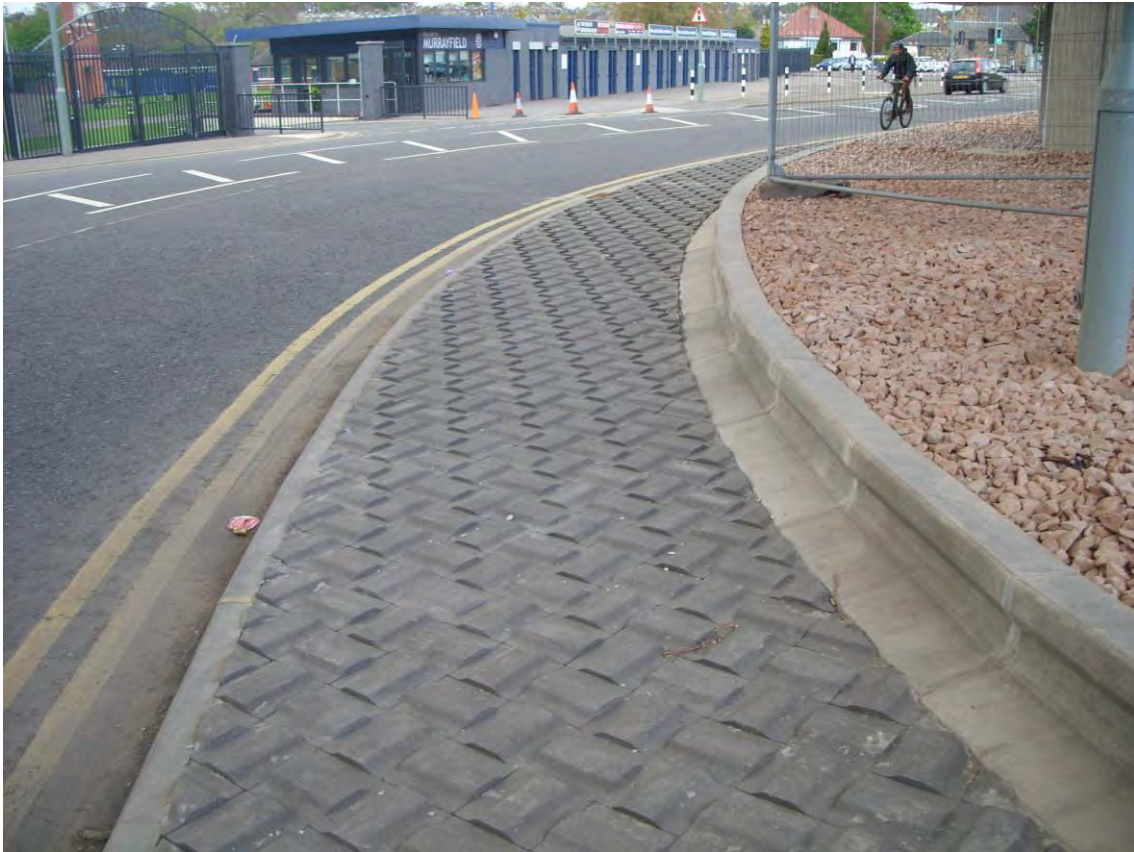
Pedestrian deterrent surfacing has been provided on Roseburn Street to discourage pedestrians walking towards the railway bridge as there is no footway under the eastside of the bridge. The chosen deterrent slab is not very effective. The Audit Team feel that pedestrians will still walk on the surface and end up nearer the bridge where the footway width tapers out and poor sightlines make crossing Roseburn Street hazardous.

Recommendation. Provide a pedestrian refuge island within the hatched area of Roseburn Street.

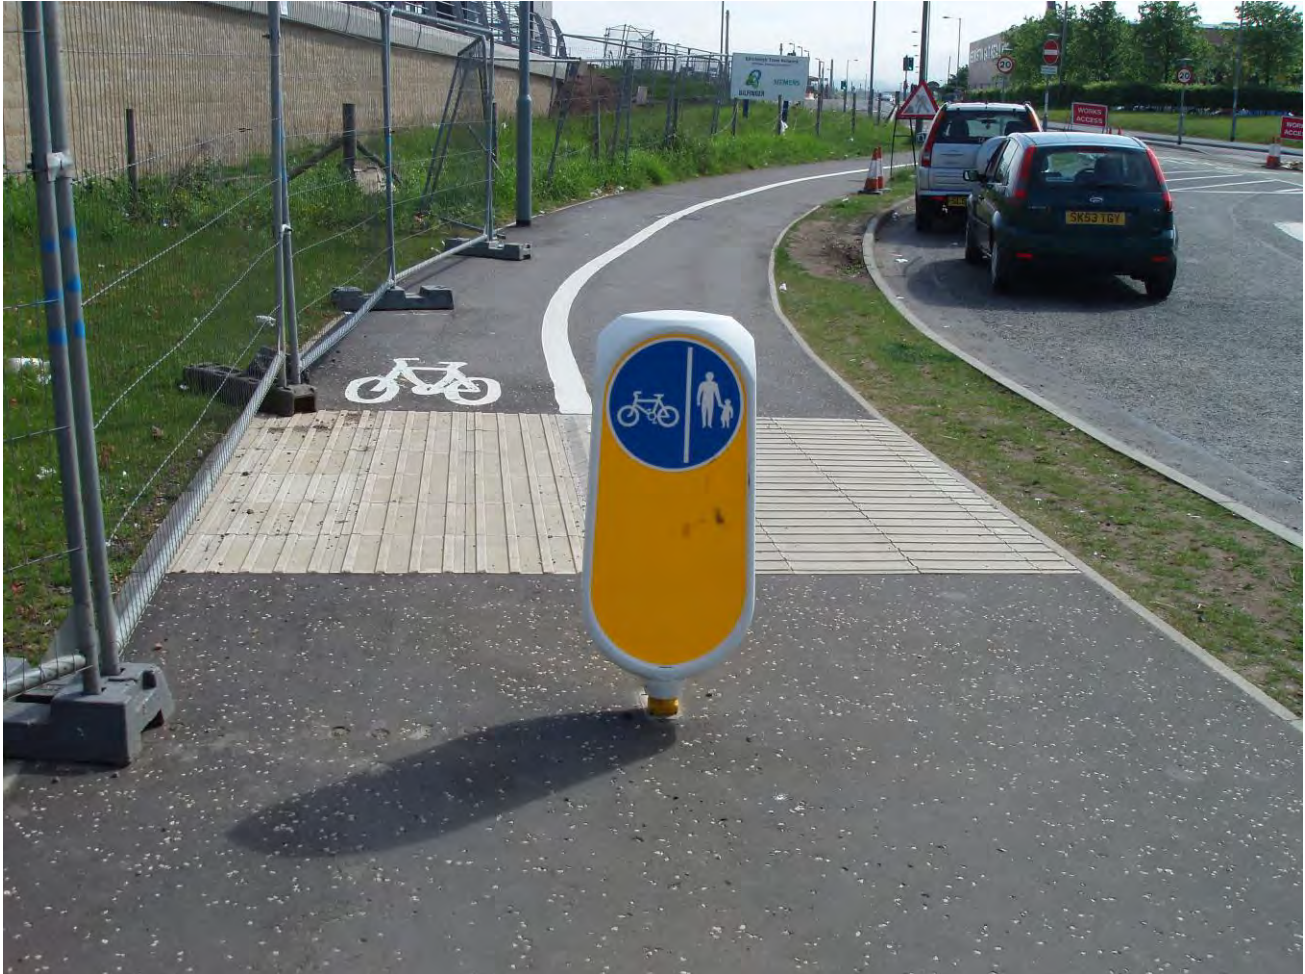
The flexible bollards installed to differentiate the cycle and pedestrian sections of the footway / cycleway are hazardous to both cyclists and pedestrians. Their width reduces the available width and in windy conditions they may sway sufficiently to strike pedestrians and cyclists.

Recommendation. Replace these bollards with ones similar to those installed near Edinburgh Airport.

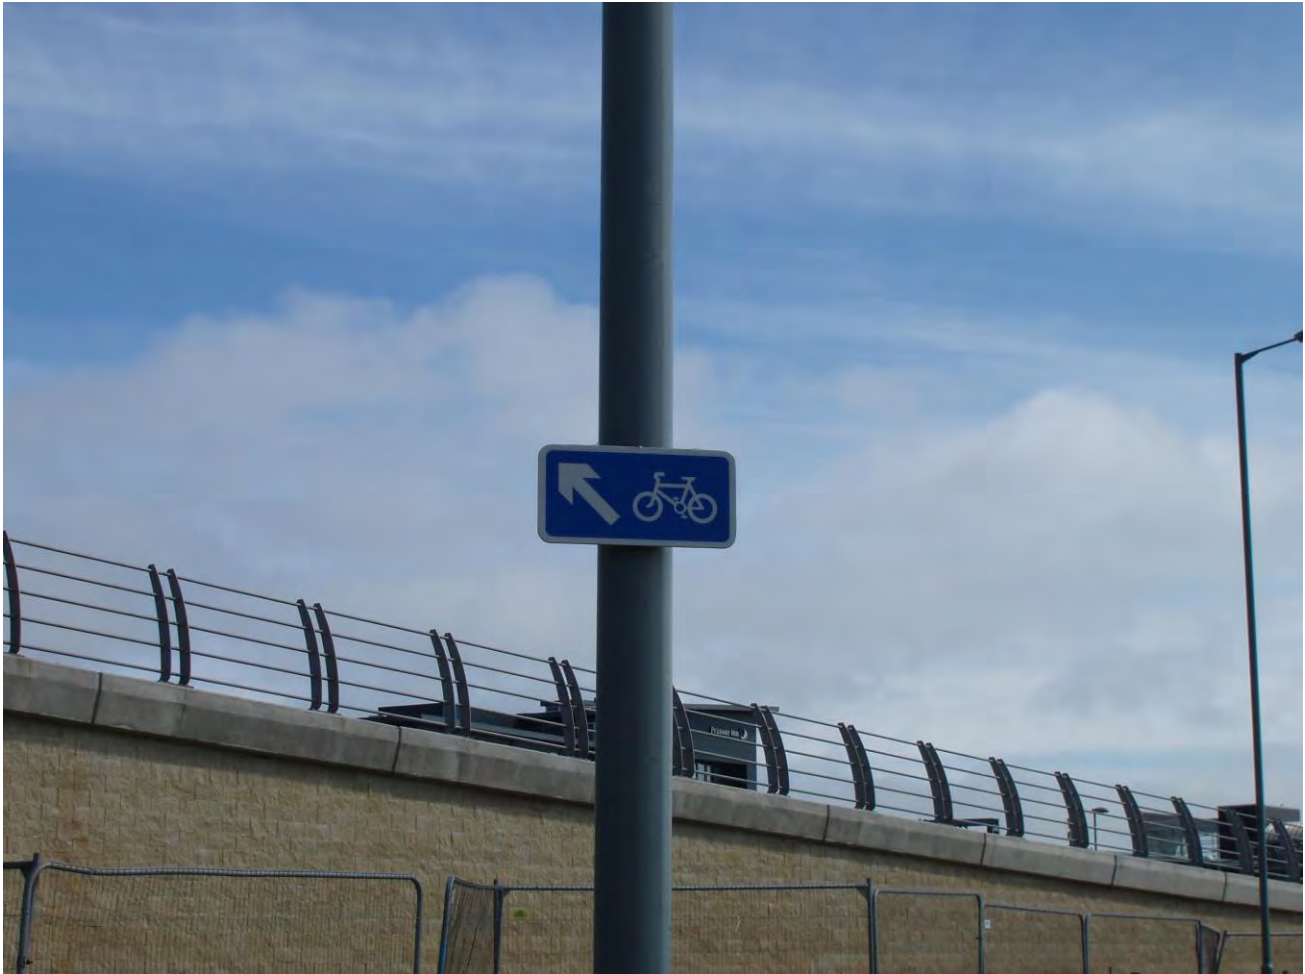
The cycle route direction signs erected at this location may be confusing to cyclists who see the route provided adjacent to the carriageway.

Recommendation. Provide cycle signing showing destinations.

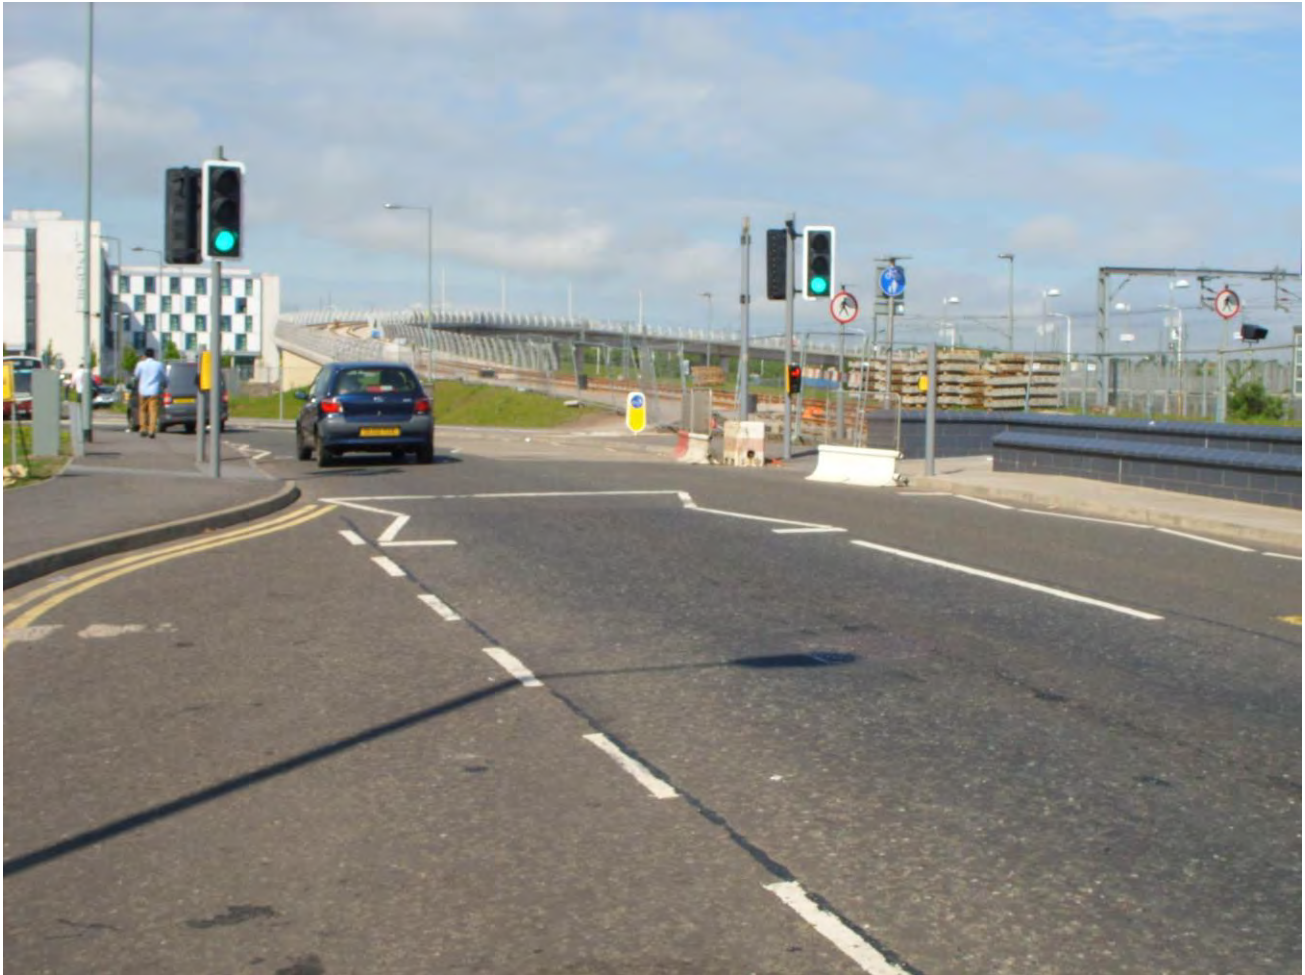
The toucan crossing at this location only has high friction surfacing on one approach and only two zig-zag markings on one approach. Lack of high friction surfacing may result in vehicles skidding onto the crossing risking collision with pedestrians crossing.

| Recommendation | Provide the full complement of line markings and high friction surfacing on both approaches. |

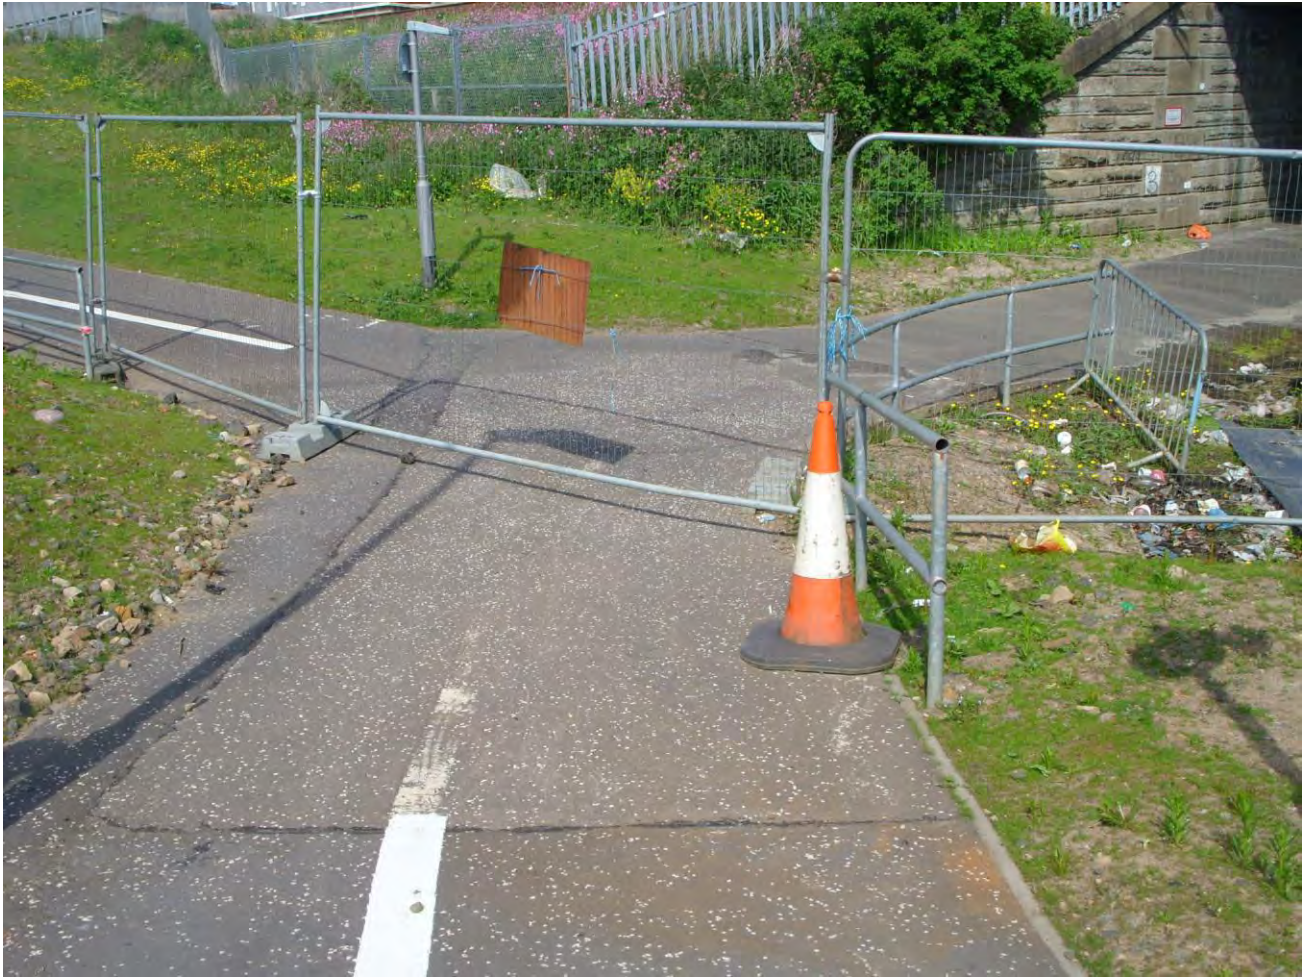
Two separate footway / cycleways merge before the route heads into the underpass below the tramline. Lack of priority markings may result in cycle to cycle or cycle to pedestrian collisions resulting in personal injury.

| Recommendation | Provide priority markings to allow safe movement onto the merged footway / cycleway. |

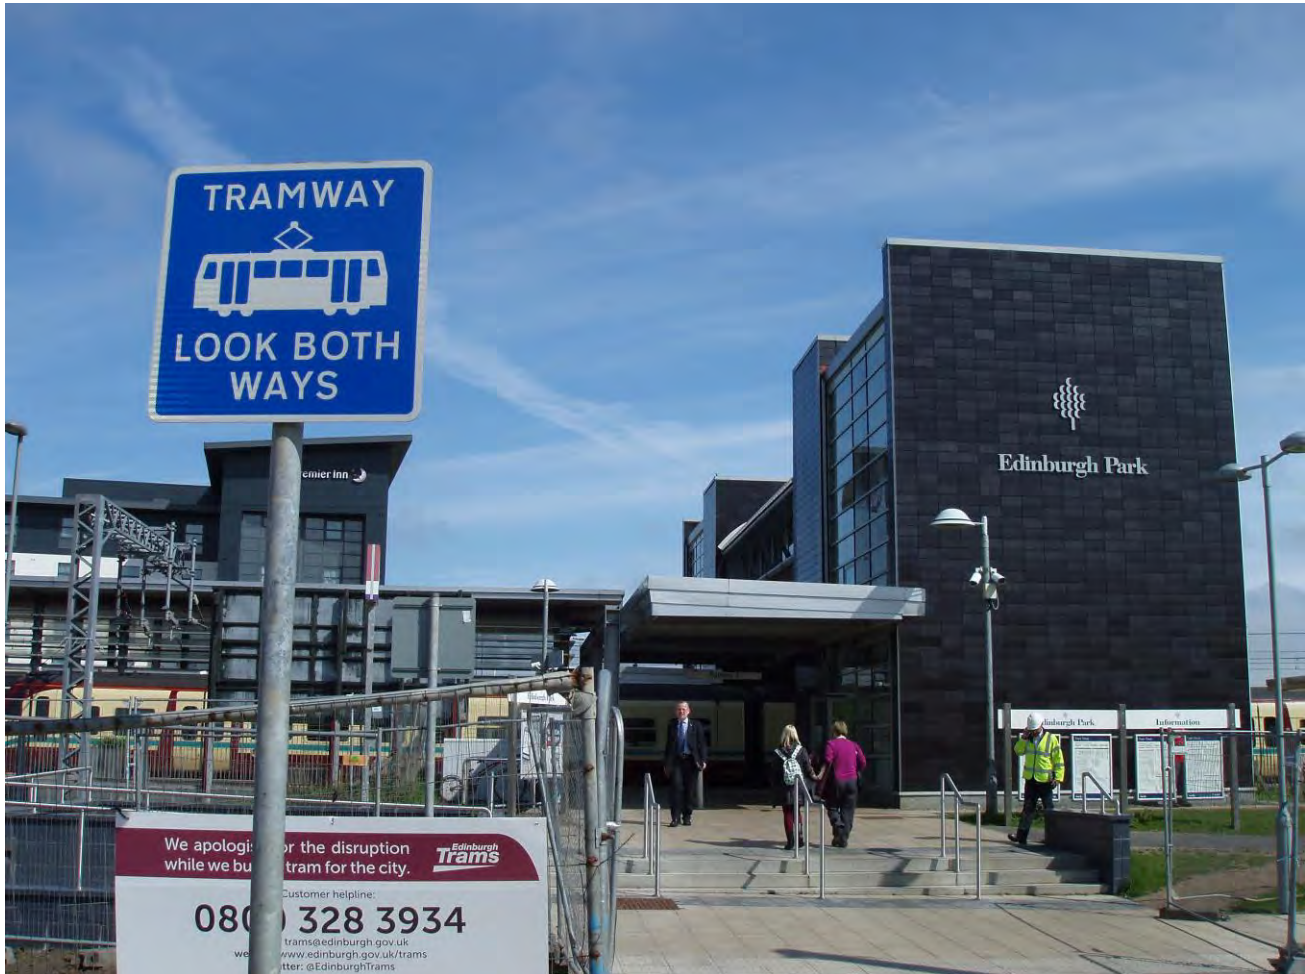
The 'Look Both Ways' tram signing located adjacent to the crossing point is unlikely to be seen by pedestrians about to cross the tram tracks.

Recommendation. In order to provide sufficient warning of the presence of trams to pedestrians provide back to back signing on both sides of the track.

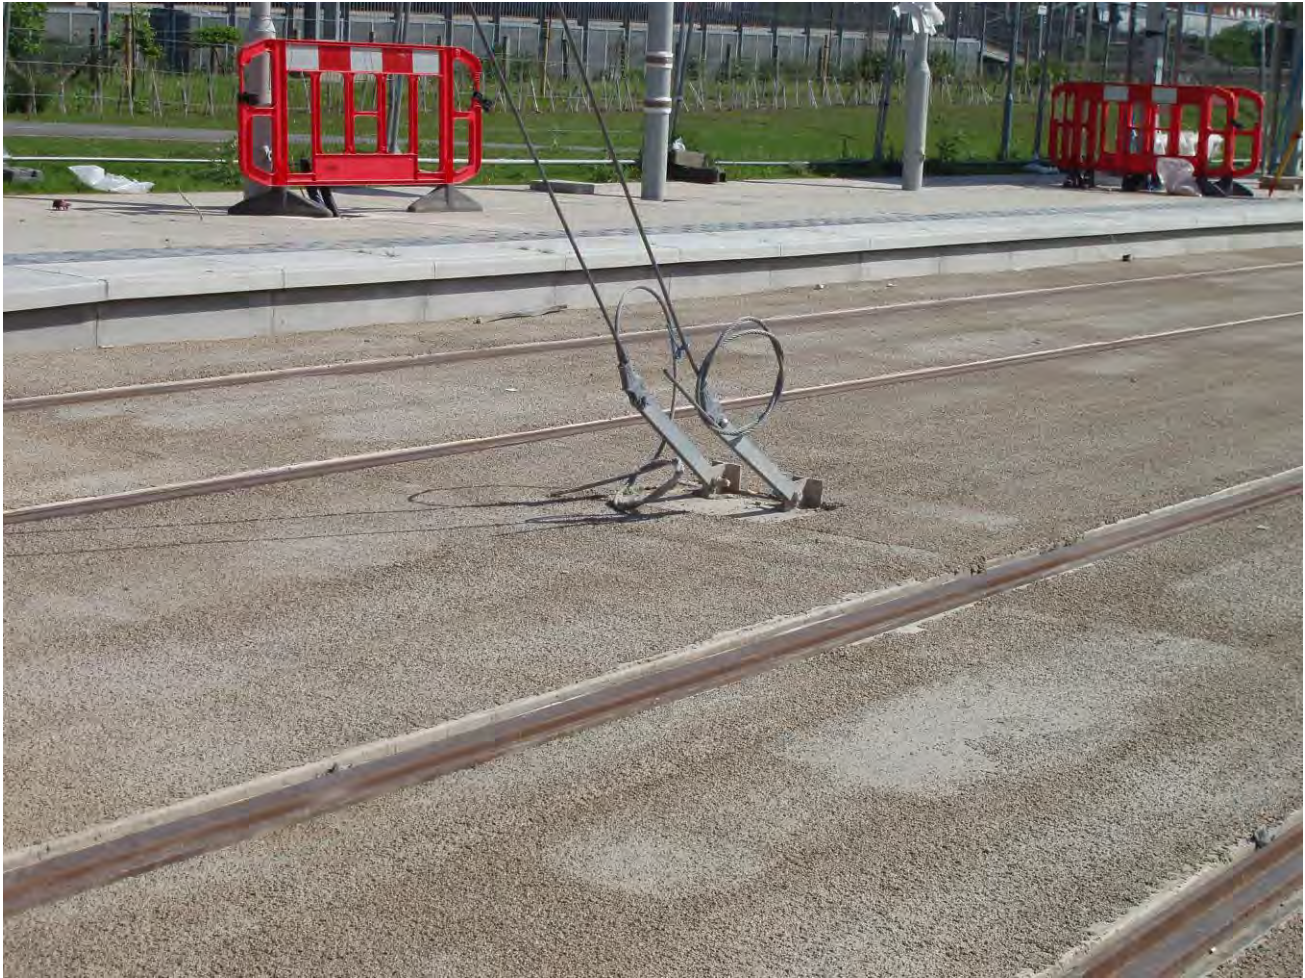
The stays for the overhead cables are anchored within the area of the stop which is accessible to pedestrians. At night or in inclement weather it is possible that pedestrians may trip over these stay or walk into them.

Recommendation. Provide conspicuous covers around the stays
