## STAGE 3 ROAD SAFETY AUDIT REPORT FOR EDINBURGH TRAM NETWORK

Report Reference:-  
Airport – York Place Final Stage3.

Date 06.04.2014

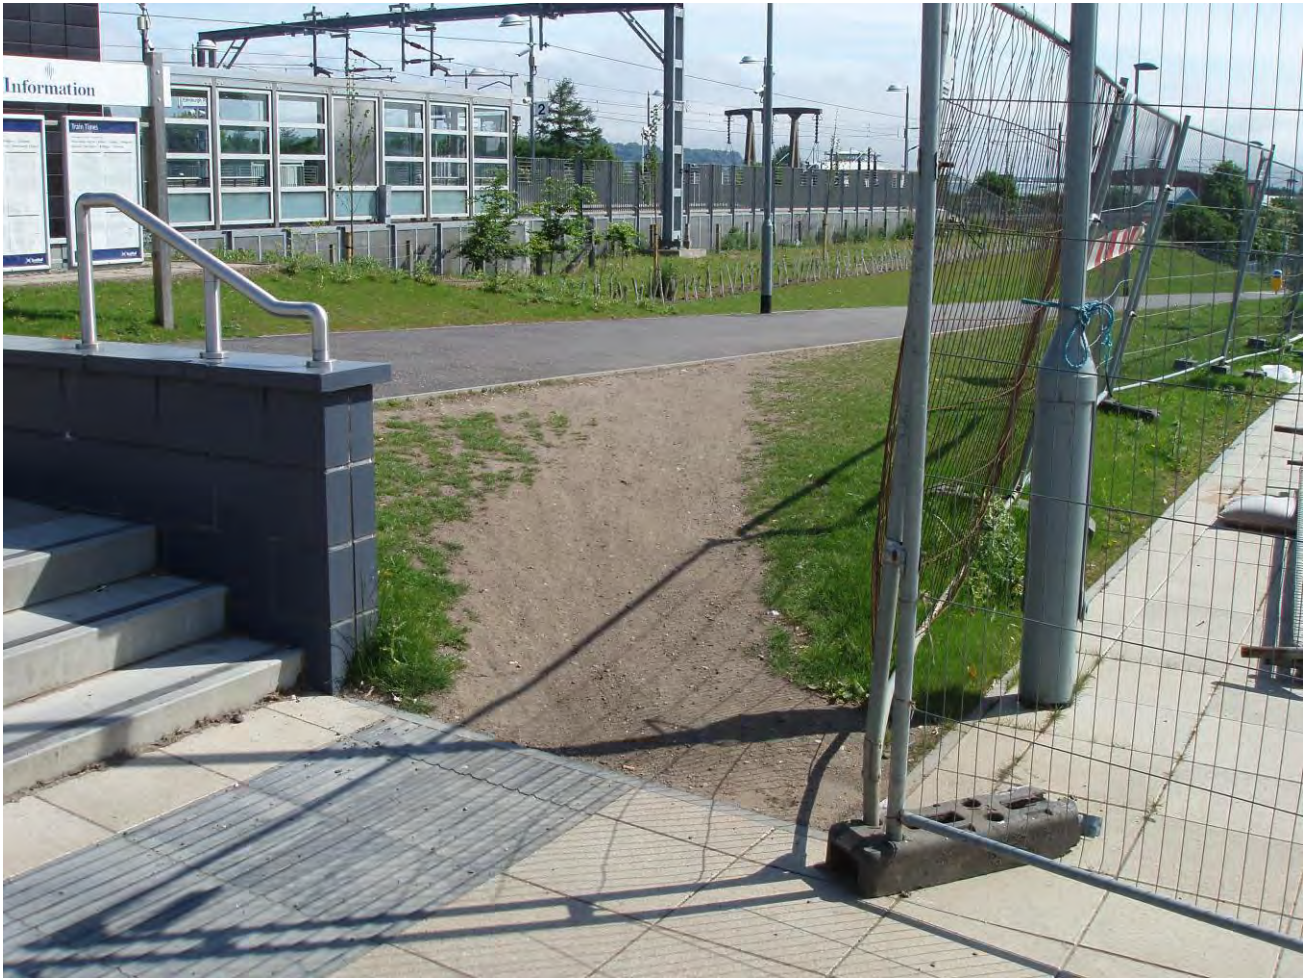
Cyclists have been using an informal short cut between the cycle route and Hermiston Gait to avoid the ramp provided. This is likely to continue after the works are complete and may result in cyclists falling in wet or freezing conditions.

Recommendation. Formalise this short cut in bituminous material and with a Give Way marking for cyclists.

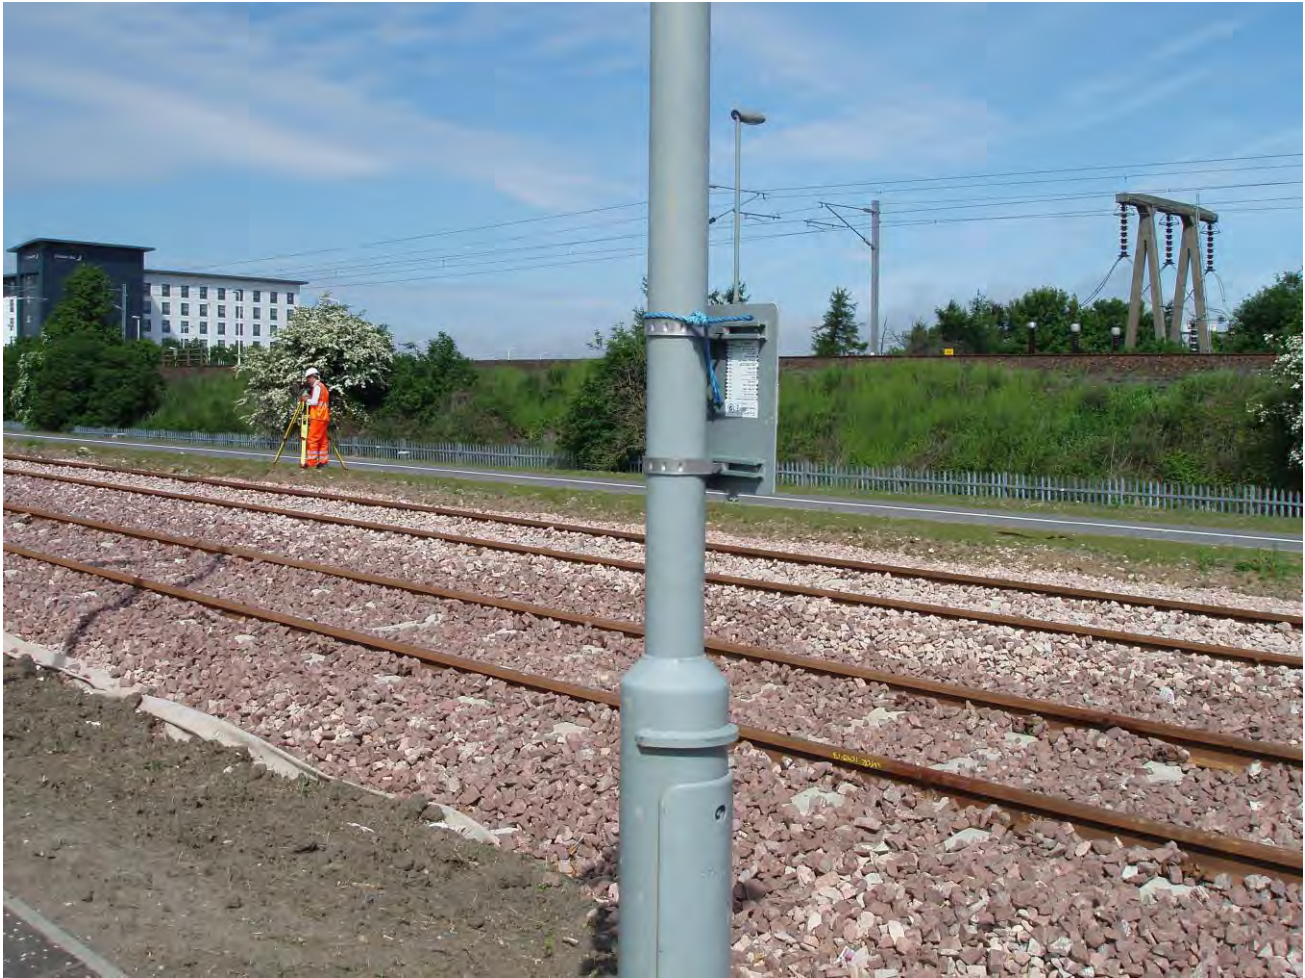
The "No Waiting" sign at this location is below the recommended height and facing the wrong way. This may cause injury to passing pedestrians.

Recommendation. Ensure that all signing at this location is above the recommended 2.25m mounting height.

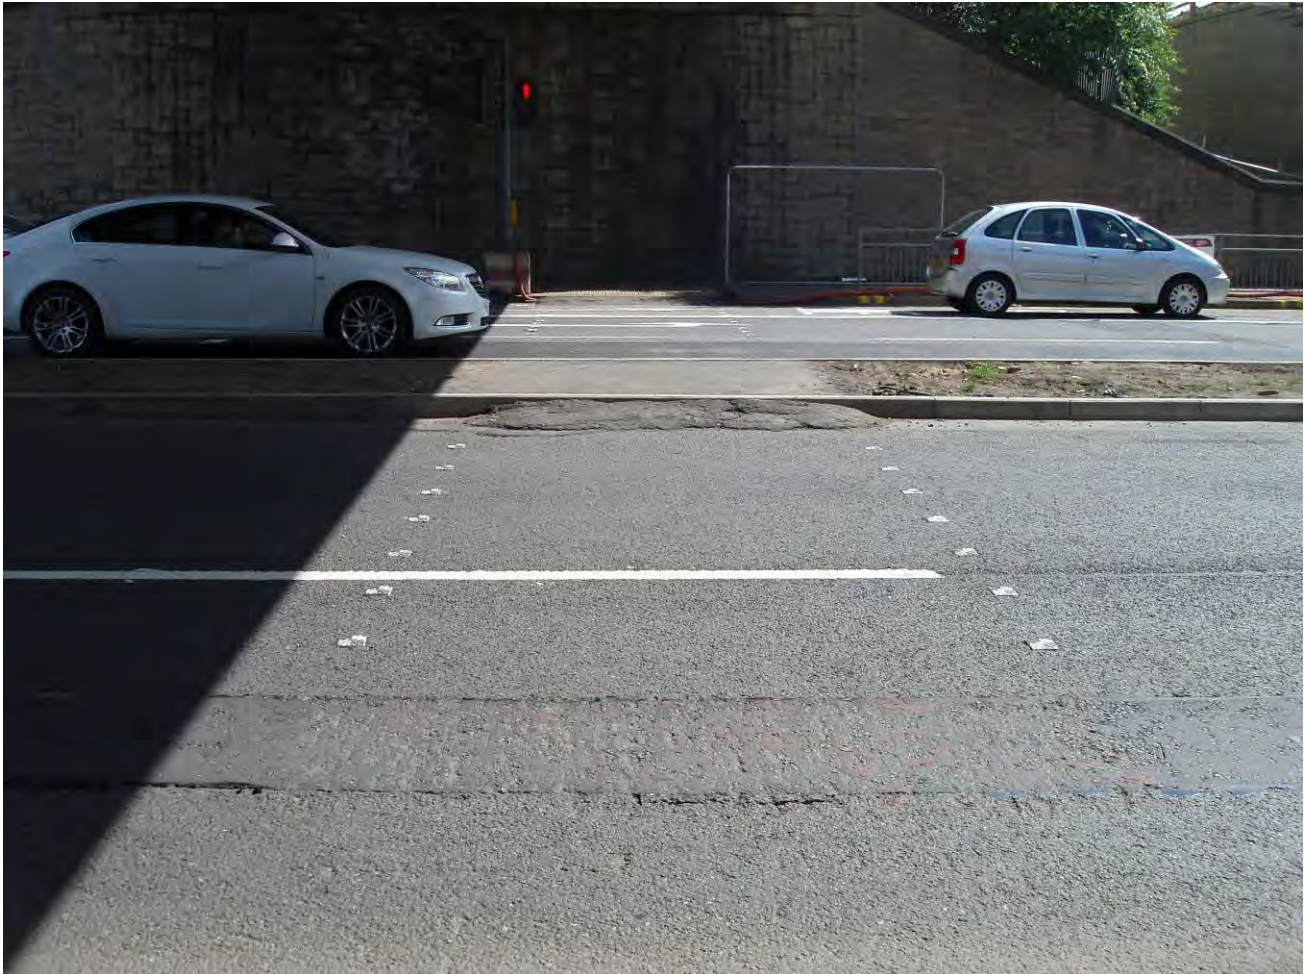
The temporary pedestrian crossing at this location is unsuitable for mobility impaired pedestrians and wheelchair users.

Recommendations. Provide dropped kerb crossing points at this location and reinstate to full height kerbs once the works are complete.

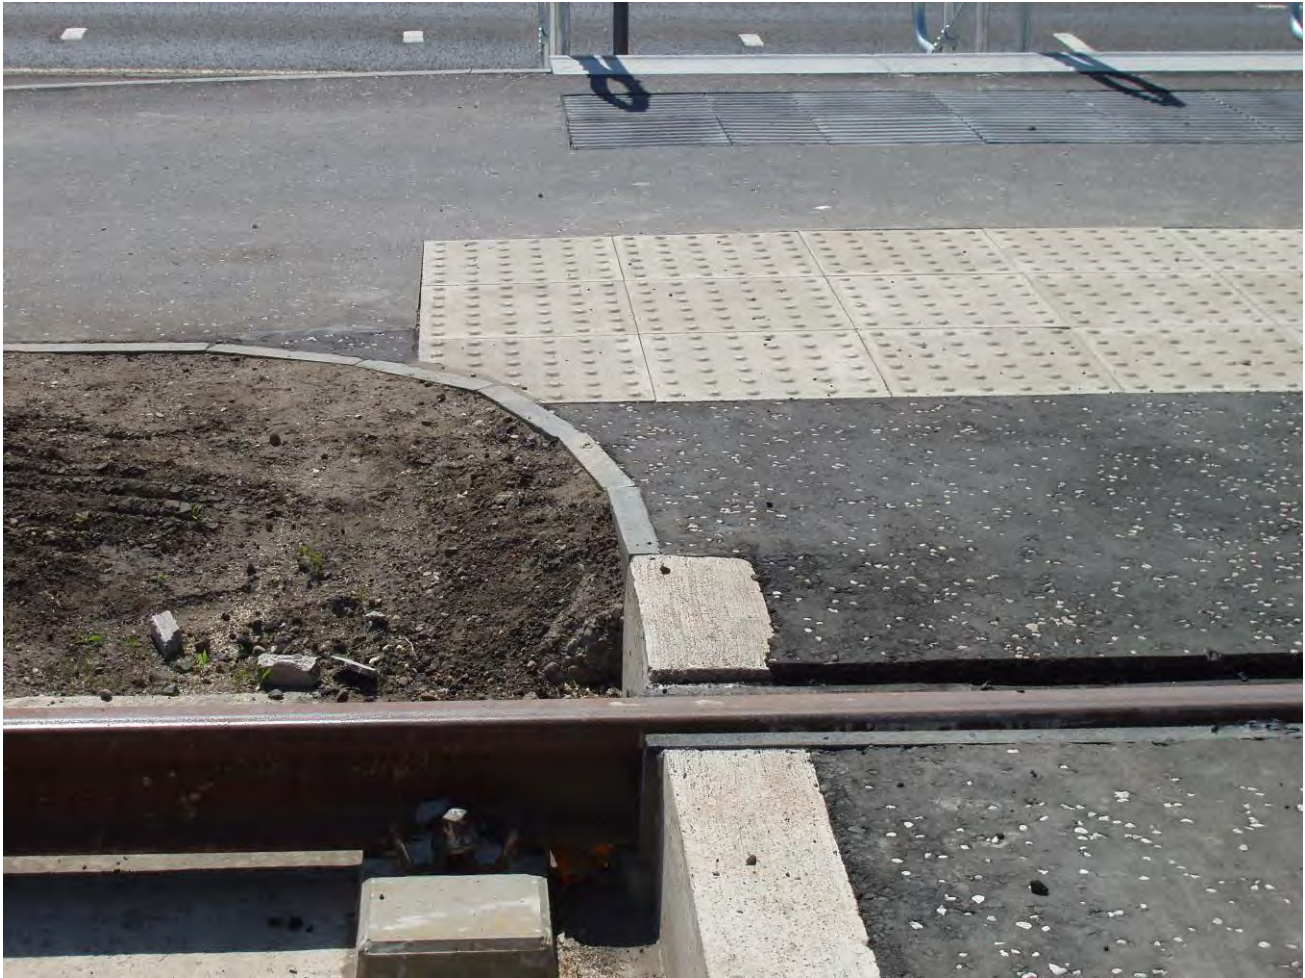
The tactile paving provided at both crossing points extends beyond the crossing width. Visually impaired pedestrians may fall onto the tram tracks if they use the ends of the tactile paving as a guide

Recommendation. Reduce tactile paving width to match the width of the crossing point.

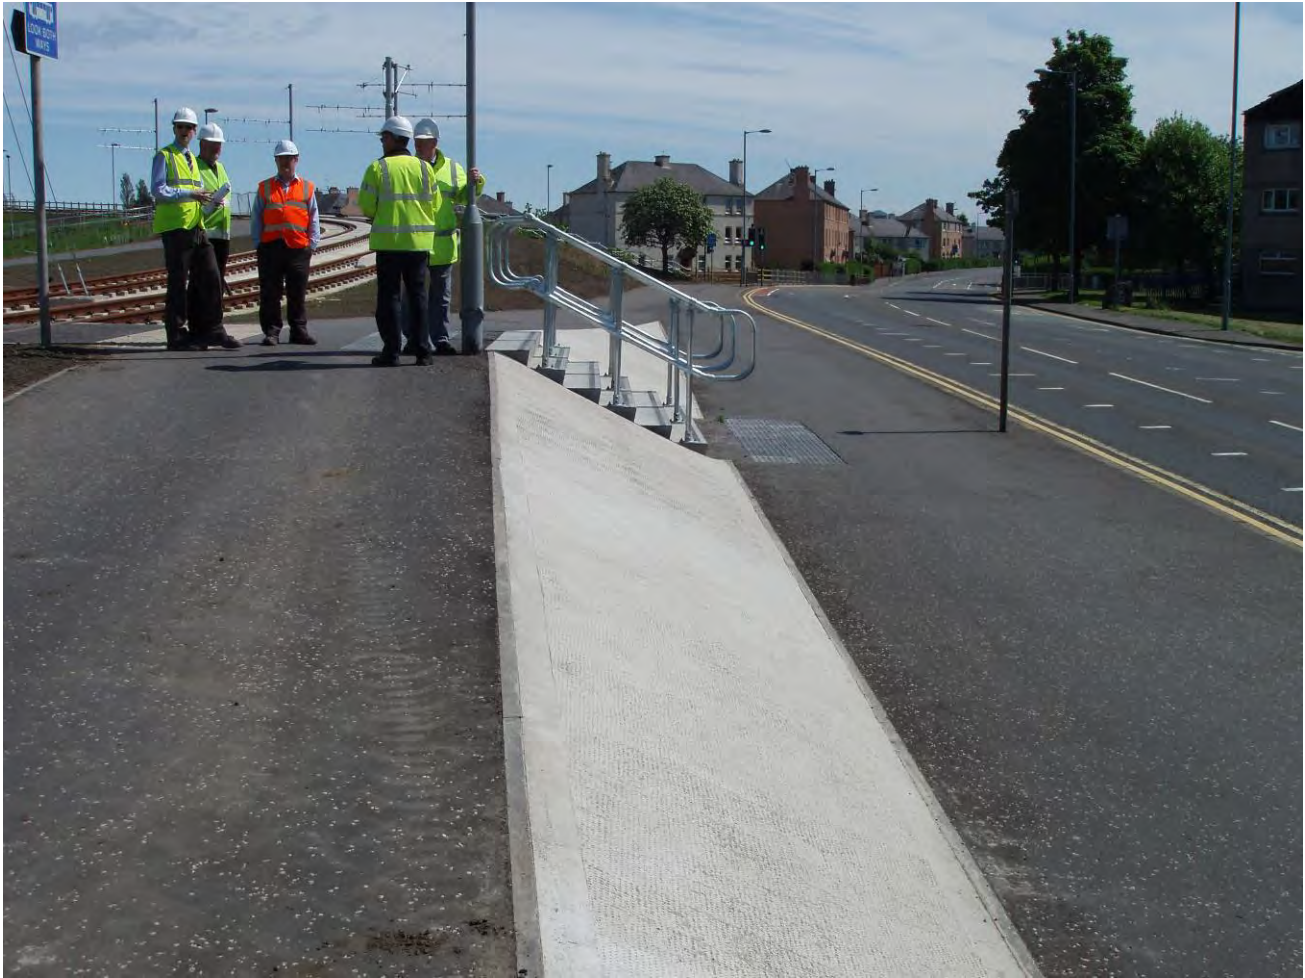
Stairs and perpendicular ramps have been provided to give access between the tramline and the Stenhouse Drive footway. The sides of the ramps have been formed in concrete and are unprotected. This may result in pedestrians falling down the slopes and sustaining personal injury.

| Recommendation | Provide handrails at the edge of the ramps to aid safe negotiation and minimize the risk of pedestrians falling down the slope. |

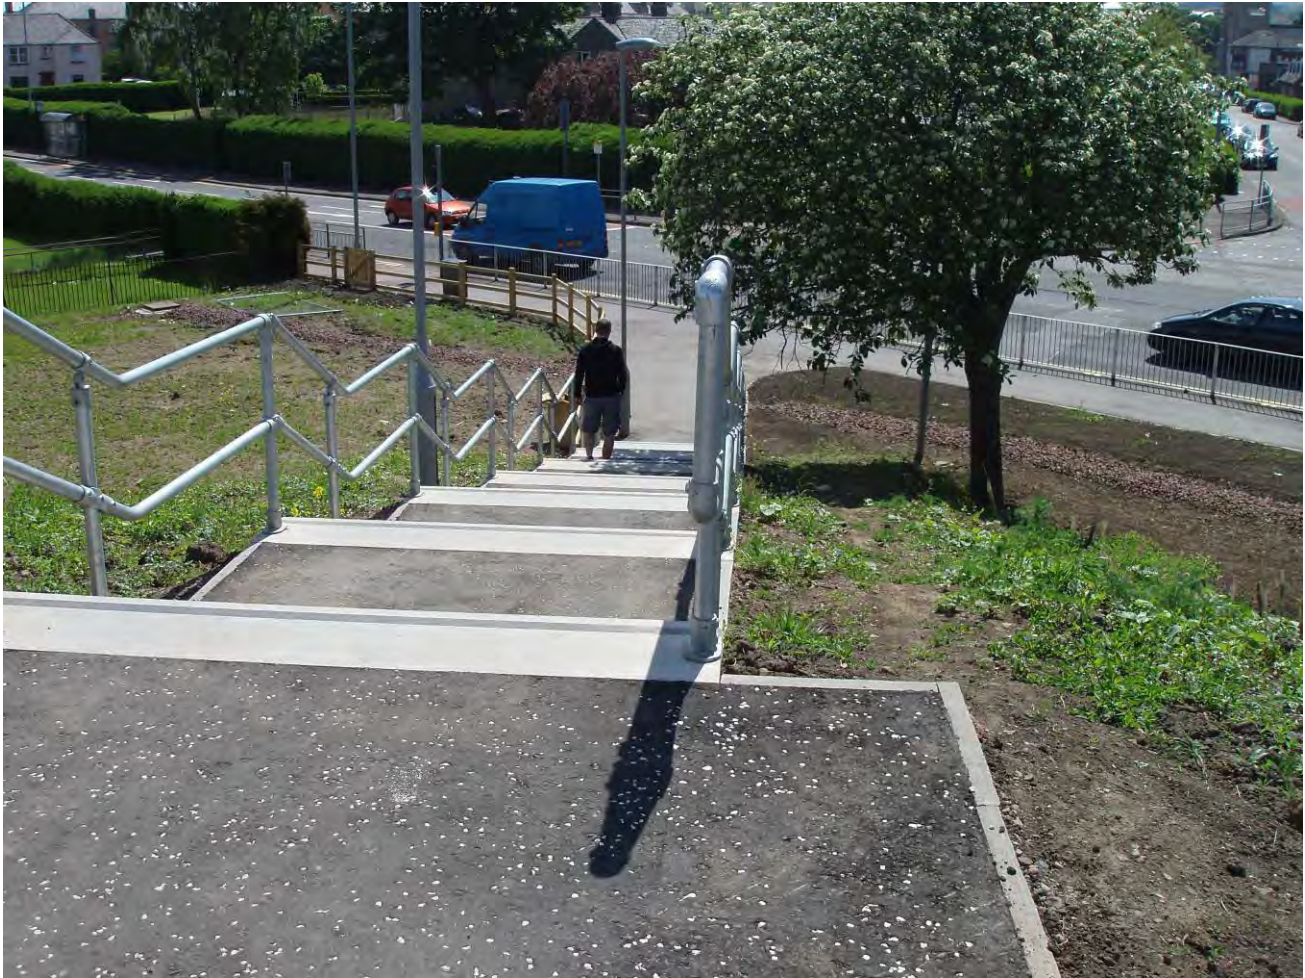
It was obvious from the site visit that cyclist have been leaving the surfaced footway / cycleway and riding down the slope adjacent to the stairs to access Stenhouse Drive. In wet weather they risk falling off and sustaining personal injury. A ramped access is provided nearby.

**Recommendation**      Install a section of fence to prevent cyclists riding down the slope and to encourage them to use the dedicated cycle route to access Stenhouse Drive.

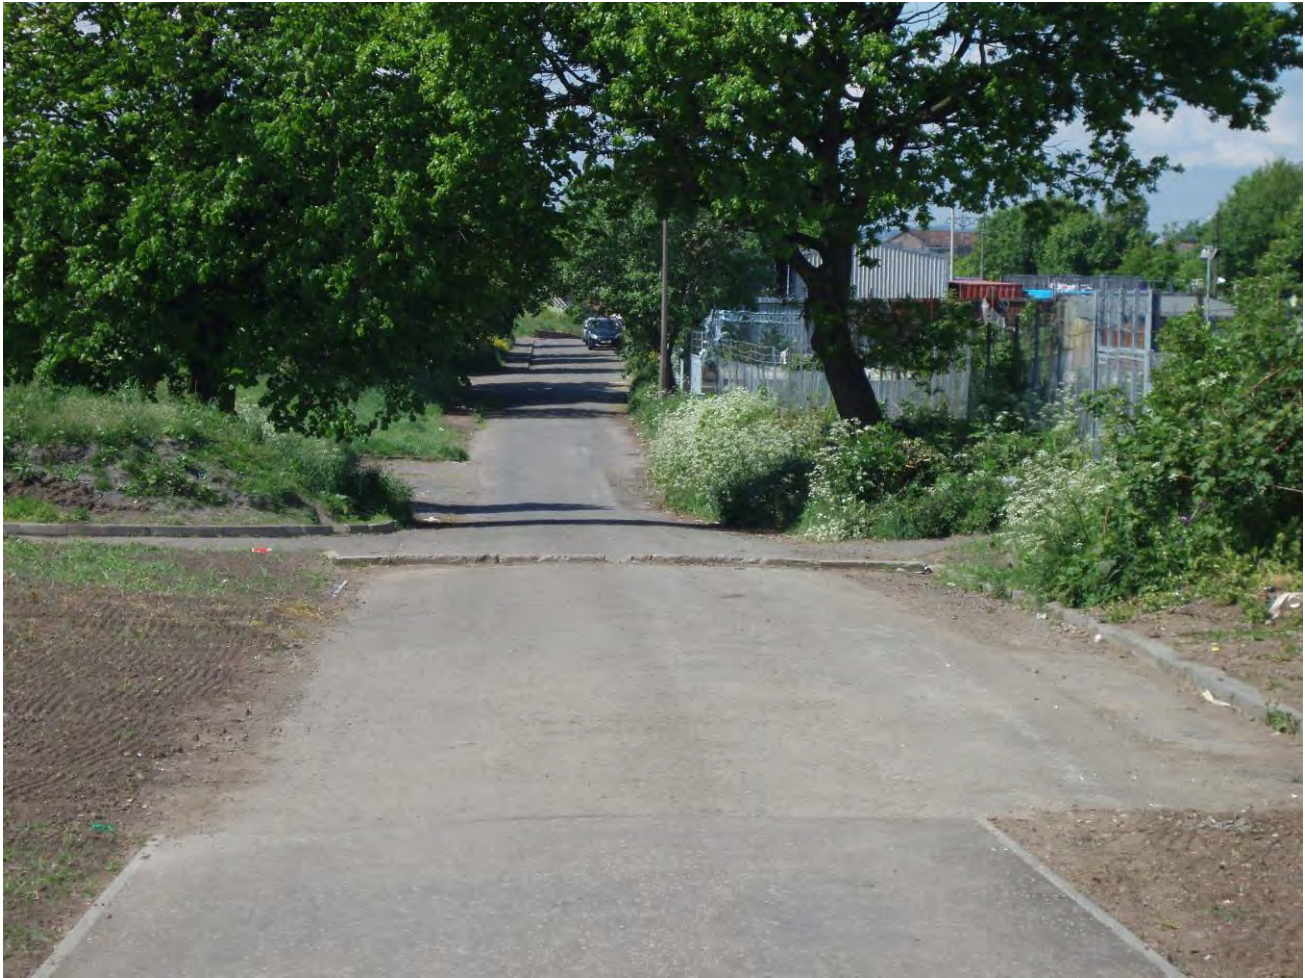
The access road and cycle route are at the same level and are separated by a line of kerbs. At night or in inclement weather it may be difficult to see the kerb edging and this may result in injury to cyclists or damage to vehicles

Recommendation. Replace kerblines with a series of bollards to provide easier access for cyclists and pedestrians and highlight the end of the access road for vehicles.

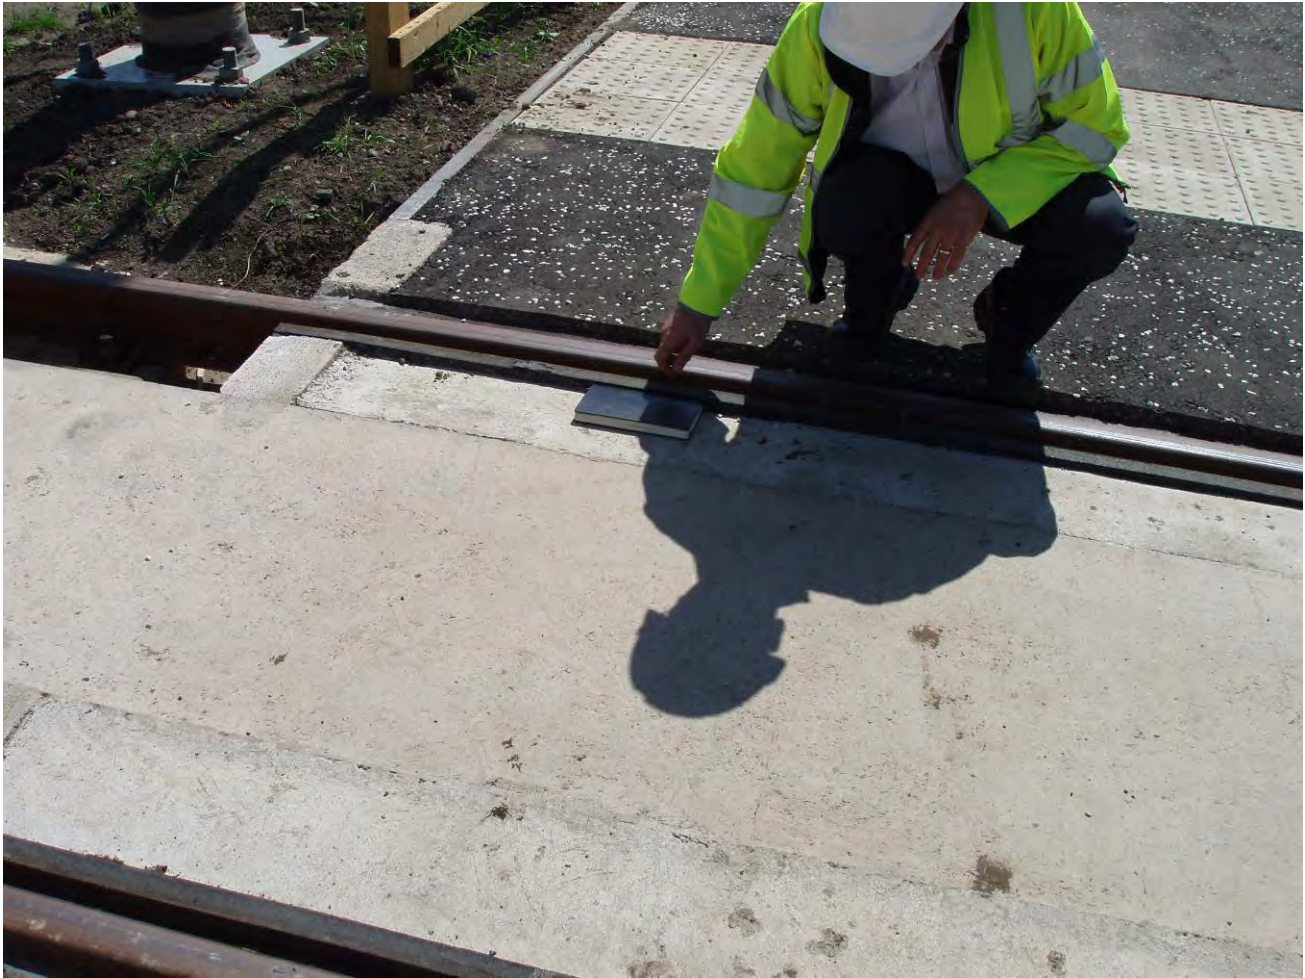
The concrete surface at the crossing point is approximately 20 to 30mm below the level of the rubberized insert next to the track. This is likely to be a tripping hazard particularly to elderly or mobility impaired pedestrians.

| Recommendation | Bring the level of concrete crossing point up to the level of the rubberized track insert. |

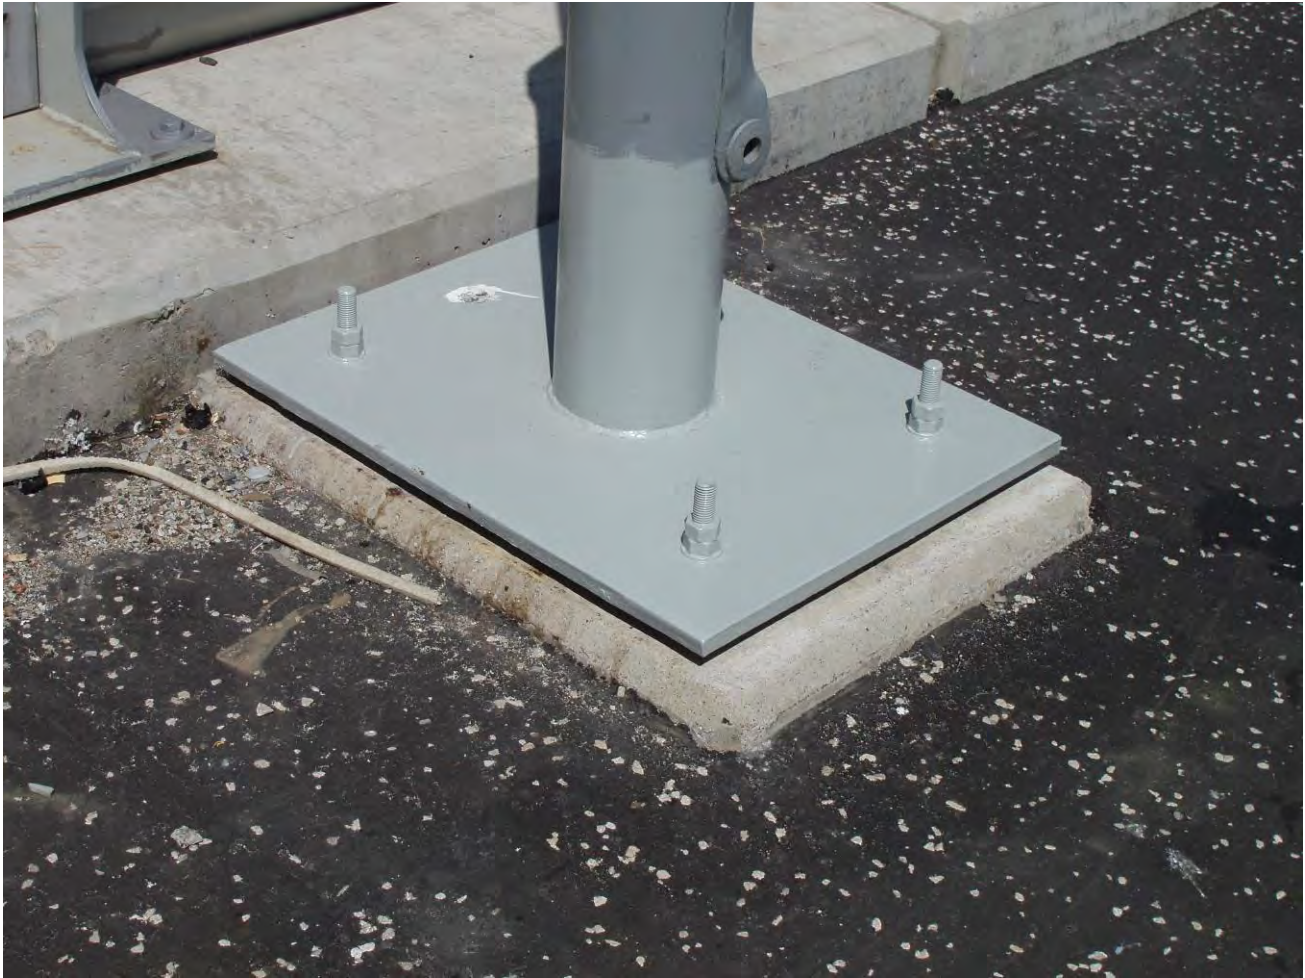
The bases for the lighting columns situated on the cycleway / footway sit above the level of the adjacent surface and have protruding fixing bolts. These would be hazardous to pedestrians and cyclists.

Recommendation. Remove the portion of the bolts protruding above the nuts and bring the footway / cycleway surfacing up to a level to eliminate the possibility of tripping over, or running into, the base plate.

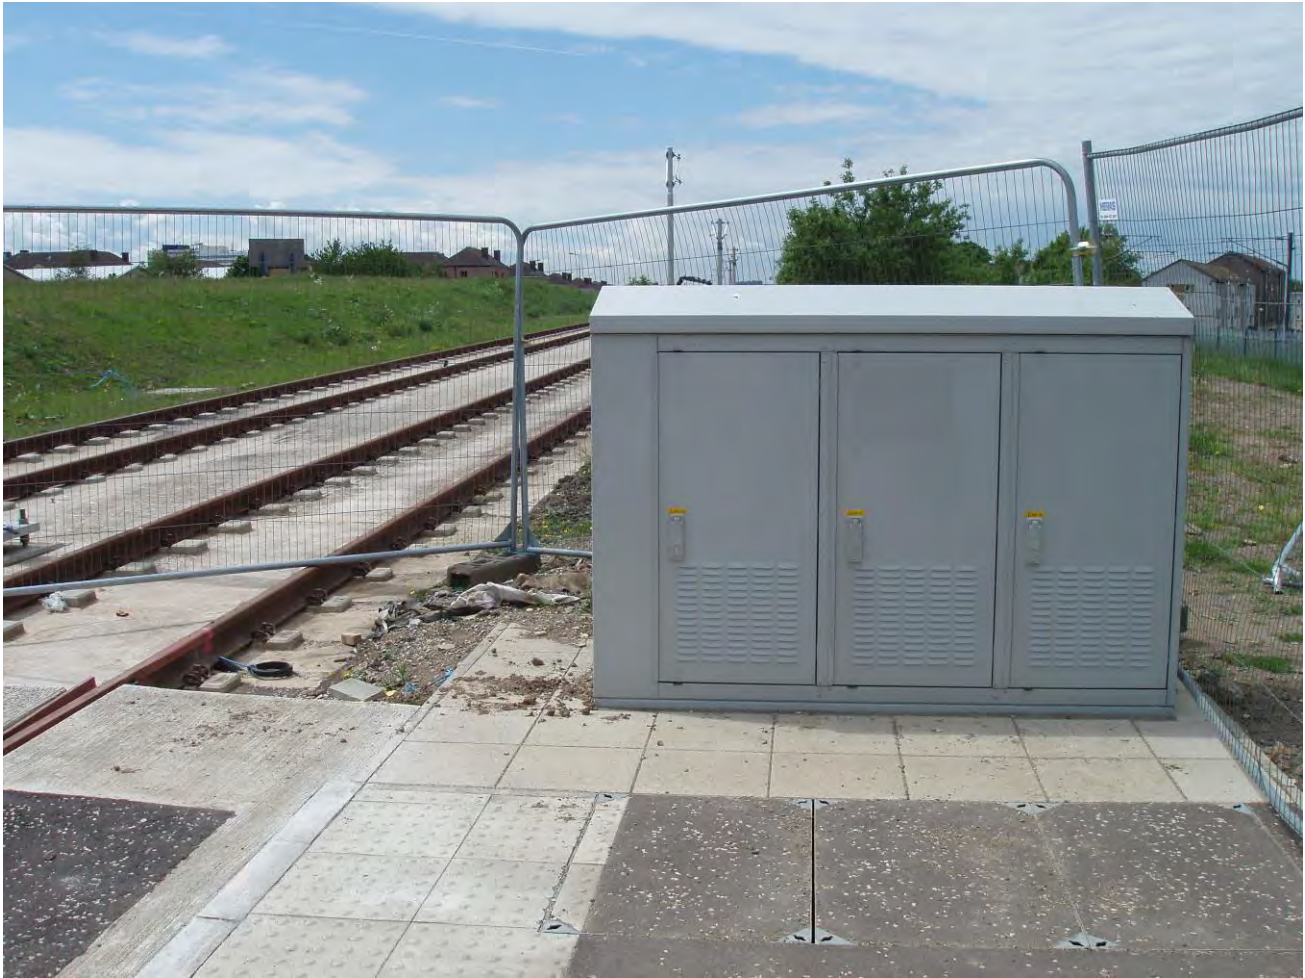
The large electric junction box at the west end of the platform creates a hazard for small children as they try to cross the track as they will not be able to see oncoming trams and tram drivers will not be able to see them.

Recommendation      Relocate junction box to the north side of the platform.

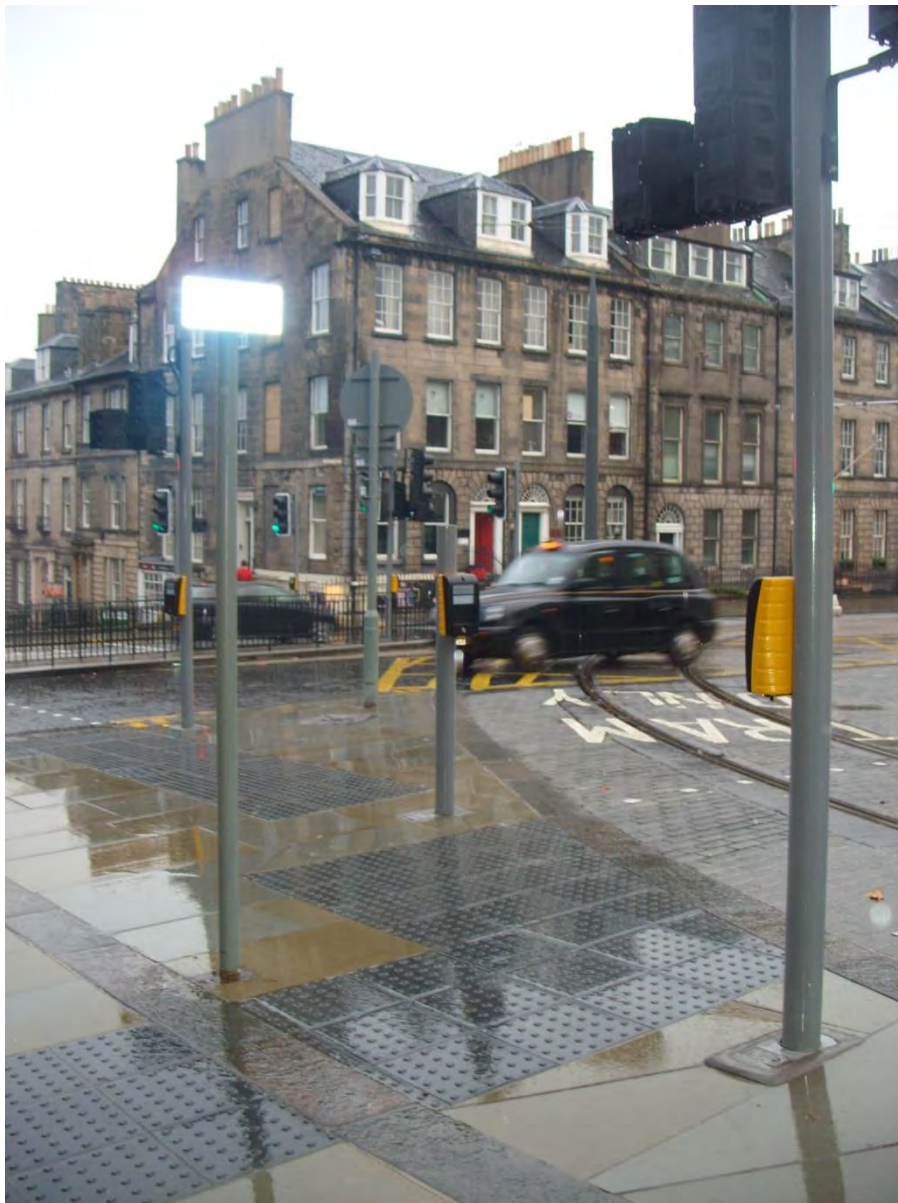
A sign pole carrying a small direction sign for the national cycle route is positioned near to tactile slabs and in the middle of a busy footway. It presents an unnecessary hazard for pedestrians, in particular visually impaired pedestrians who are at most risk of walking into it.

Recommendation. Remove the pole and relocate the sign onto an existing piece of street furniture.
