**From:** [REDACTED]  
**Sent:** 23 December 2025 14:25  
**To:** [REDACTED]  
**Cc:** [REDACTED]  
**Subject:** RE: Saunders Street  
**Attachments:** XXXXX-HAH-XX-XX-D-S-00001.pdf

Please find attached a sketch showing the flatted blocks in question and the gables subject to deterioration and immediate forming of exclusion zones and crash decks. The extents of the crash deck and exclusion zones would be best advised by the contractor to ensure safe distance from any potential falling masonry. We can be on hand tomorrow morning to review and provide our opinion. Closure of footpaths within the immediate vicinity would be reasonable and forcing pedestrians to use the footpath on the other side of the road.

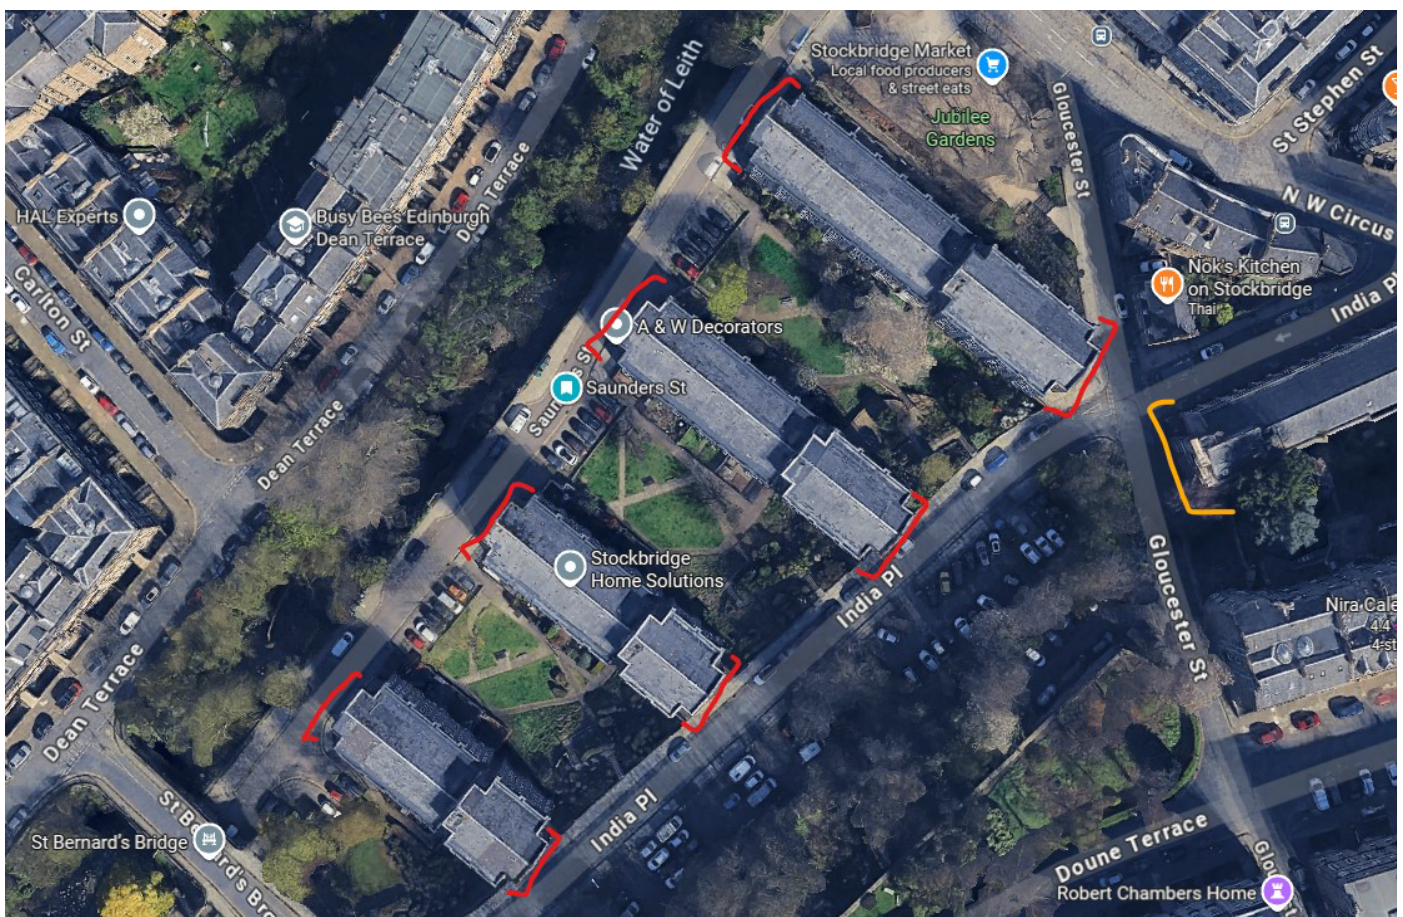
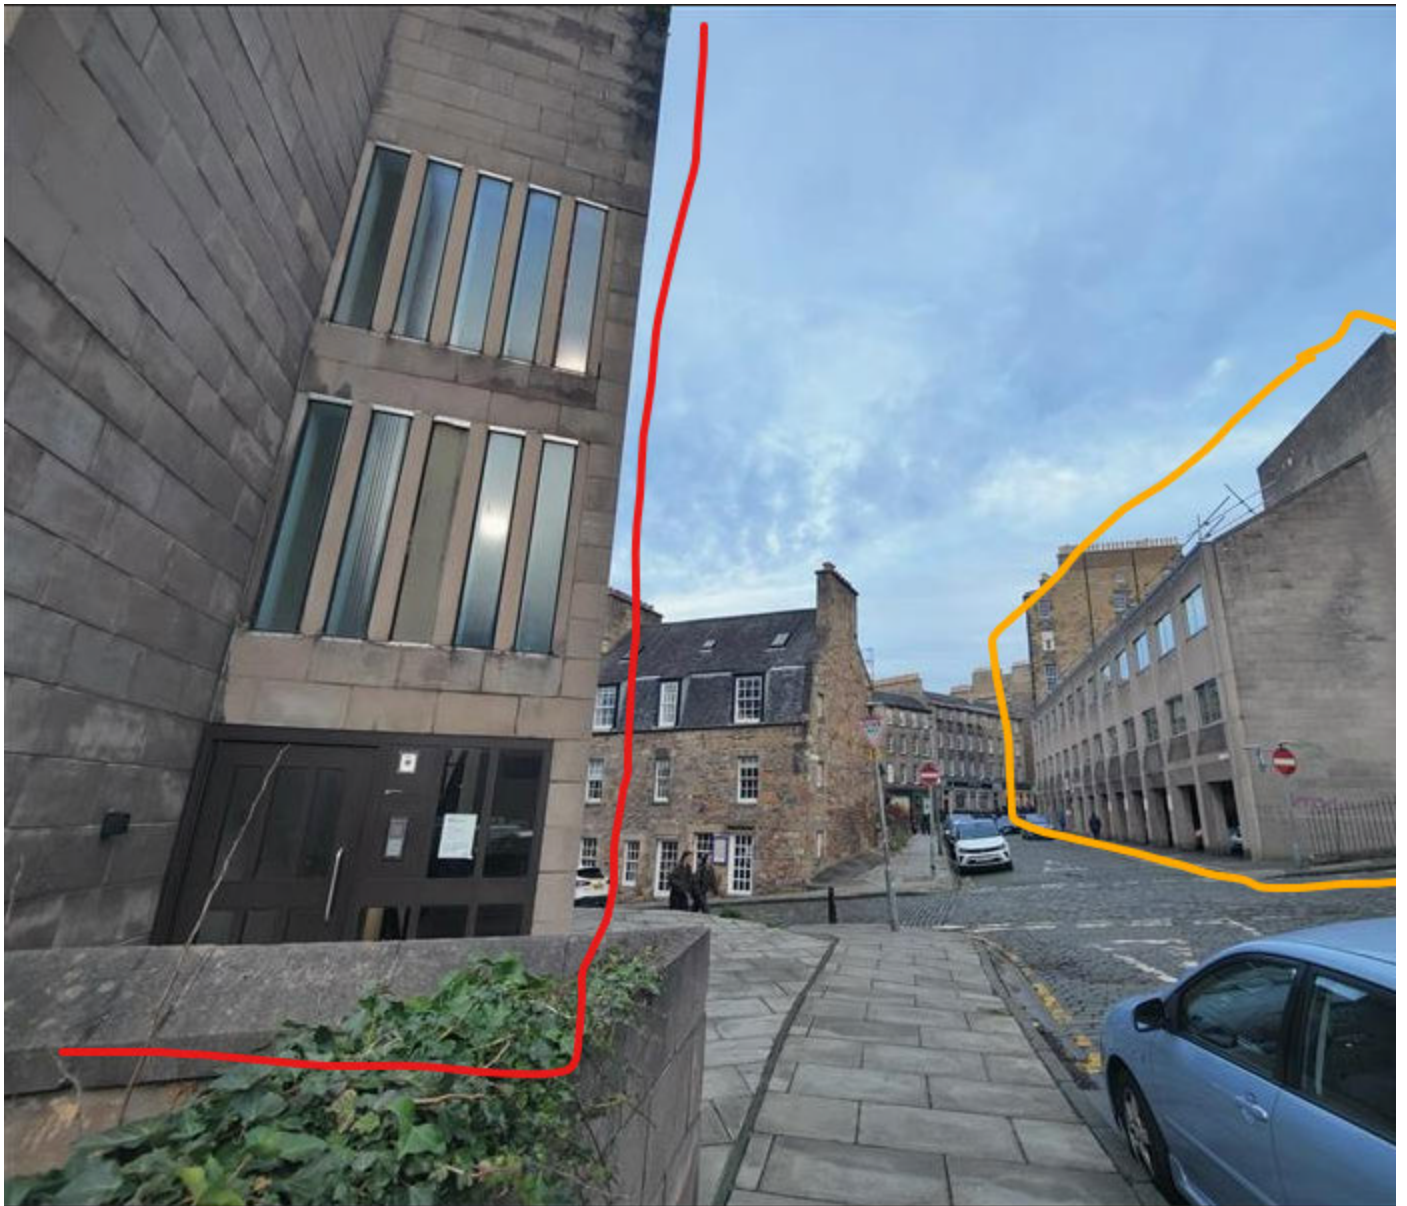
I also need to make you both aware of some damage that has occurred to the 4No blocks of flats at Saunders Street, not explicitly related to the window replacement project. Several gable walls exhibited signs of cracking to the masonry near the corners (shown in red below). These cracks suggest signs of movement, likely as a result of wind loads. In some cases, the movement has caused masonry units to become partially dislodged and which is clearly visible from ground level. I believe this damage to constitute a risk to the general public, with potential falling masonry. I suggest that actions are taken to make the space safe. Thereafter, consideration be given to more investigations to establish the cause of the damage and develop remedials to permanently address the matters. Evidence of historic repairs in the form of steel straps has attempted to tie the masonry together. However, this appears only to be a temporary fix and is isolated to a few locations. I attach a series of photographs documenting said damage.

It's also worth noting that we recently did some work on an adjacent NHS building (shown in orange below). The building appears to consist of identical external cladding and was found to have had similar cracks due to movement, likely caused by wind loading. Upon investigation we discovered that the masonry cladding was insufficiently tied back to the inner leaf due to corrosion of the wall ties. As such, we specified wall tie replacement, masonry unit replacements and some helifix bar repairs in order to more effectively tie the corners together. I suspect your house blocks might require something similar.
