AL/SC/E20955

23<sup>rd</sup> March 2026

## **St Cuthberts RC Primary School, Edinburgh Inspection of 1<sup>st</sup> Floor Structure**

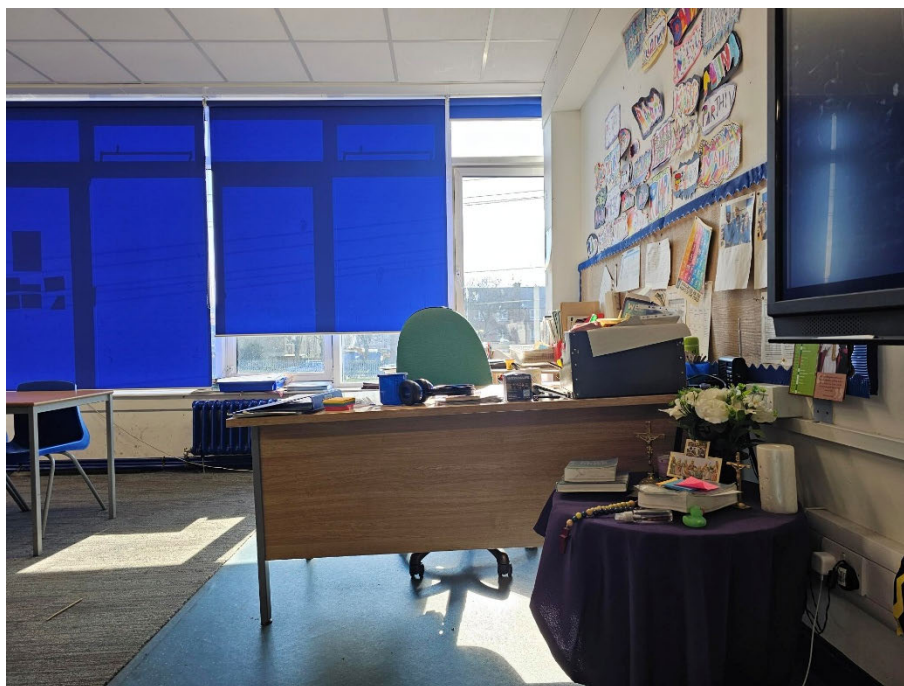
**Photo 1 : View on Teachers Desk With Visible Slope**

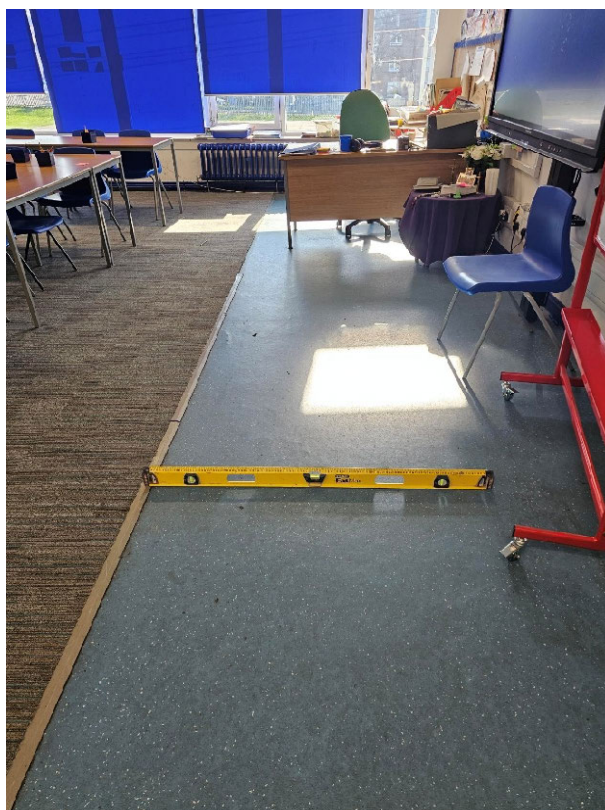
**Photo 2 : Spirit Level to South-East Span End**

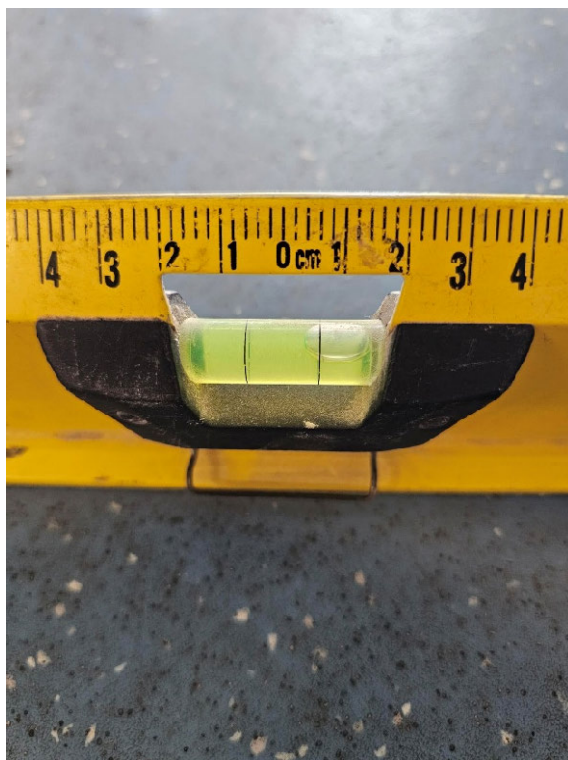
**Photo 3 : View on Spirit Level Bubble at South-East Span End Noting Slope Towards Middle of Room**

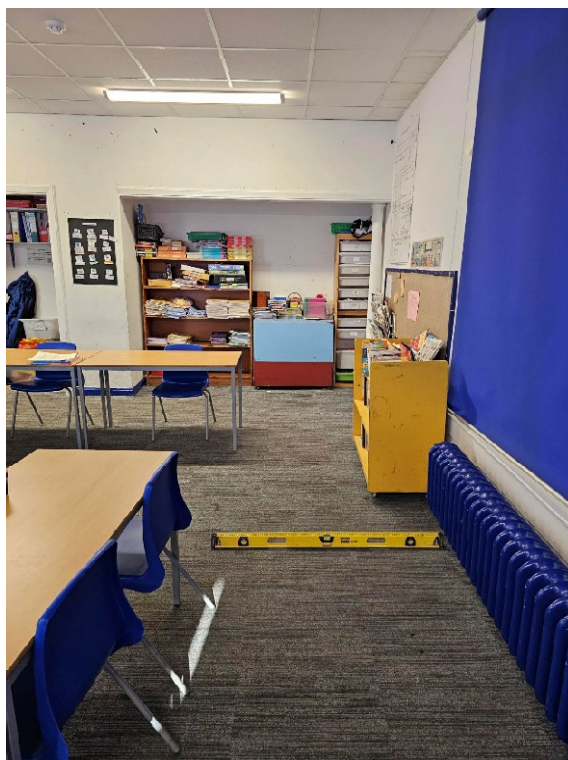
**Photo 4 : View on Spirit Level at North-West Span End**

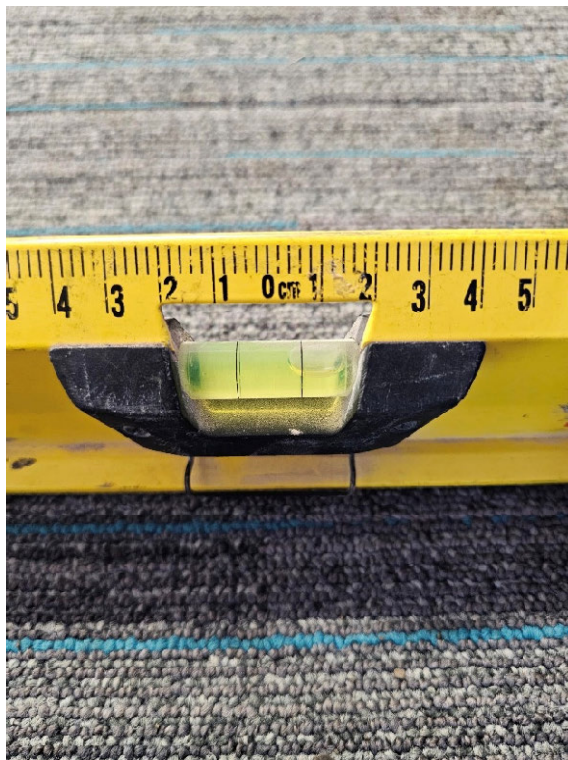
**Photo 5 : View on Spirit Level Bubble at North-West Span End Noting Slope Towards Middle of Room**

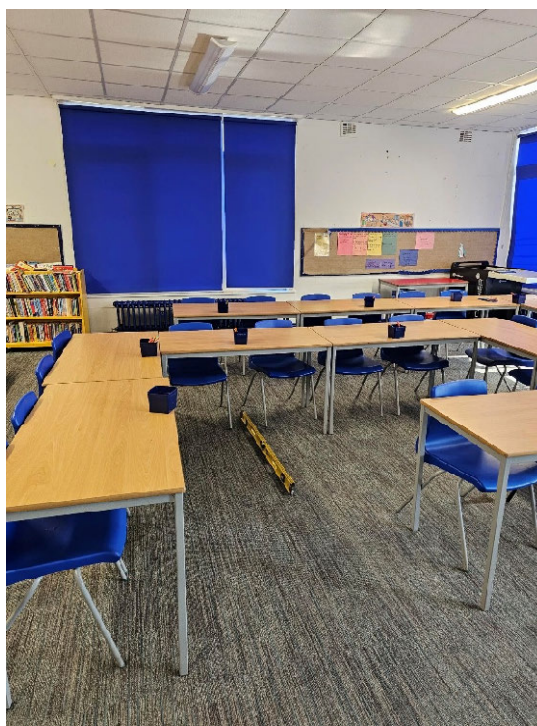
**Photo 6 : View on Spirit Level at Centre of Room**

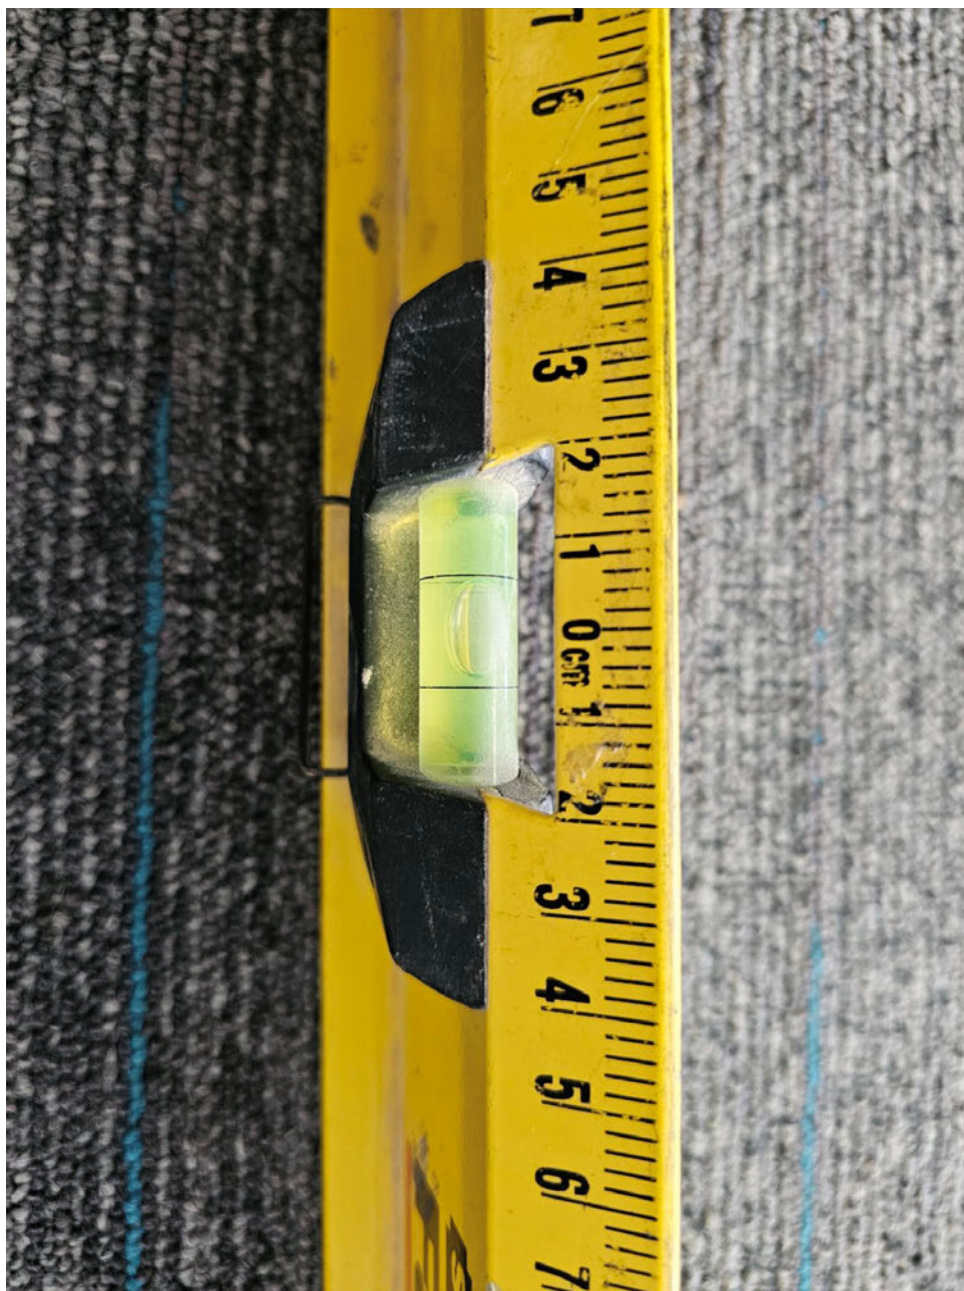
**Photo 7 : View on Spirit Level Bubble at Centre Span. Floor is Flat**

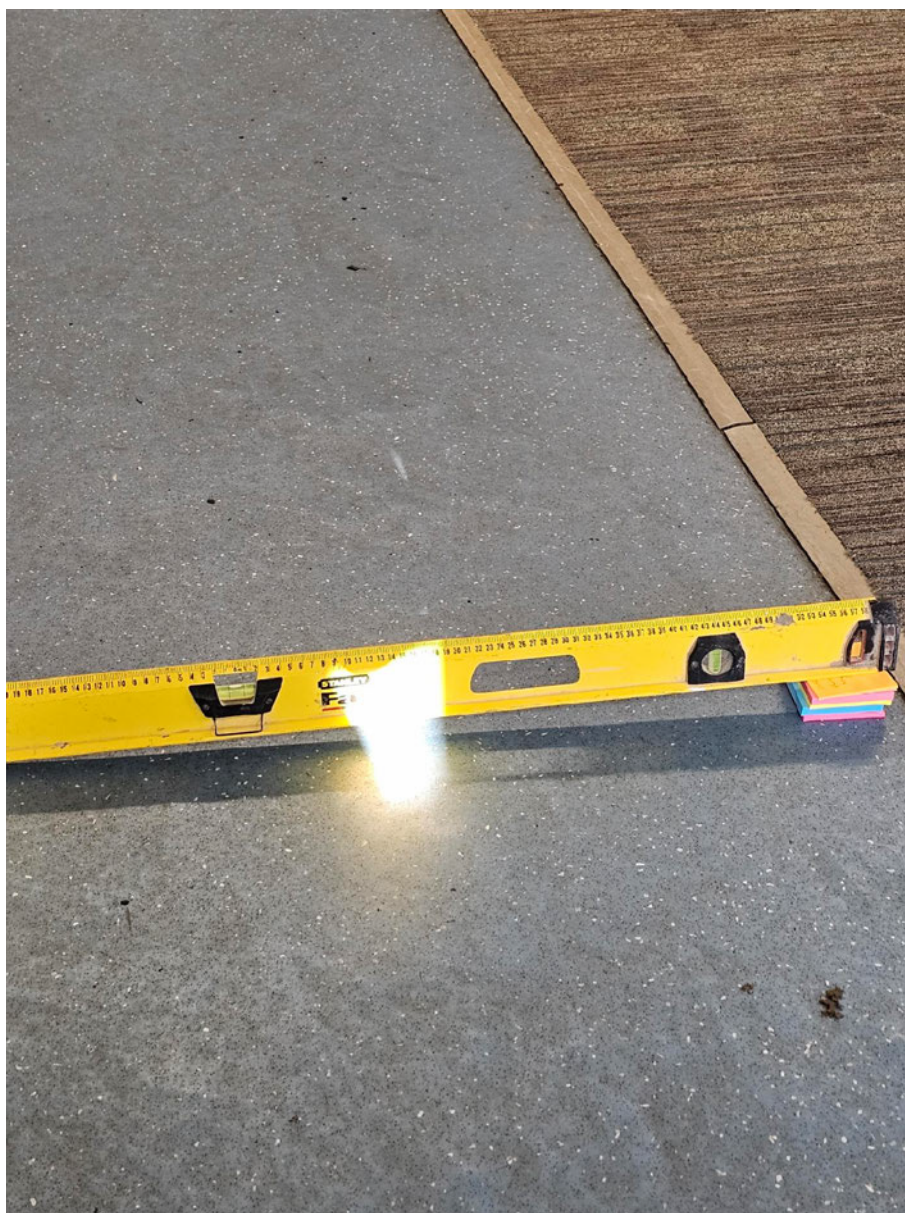
**Photo 8 : View on Spirit Level Measuring Flat at South-East Span**

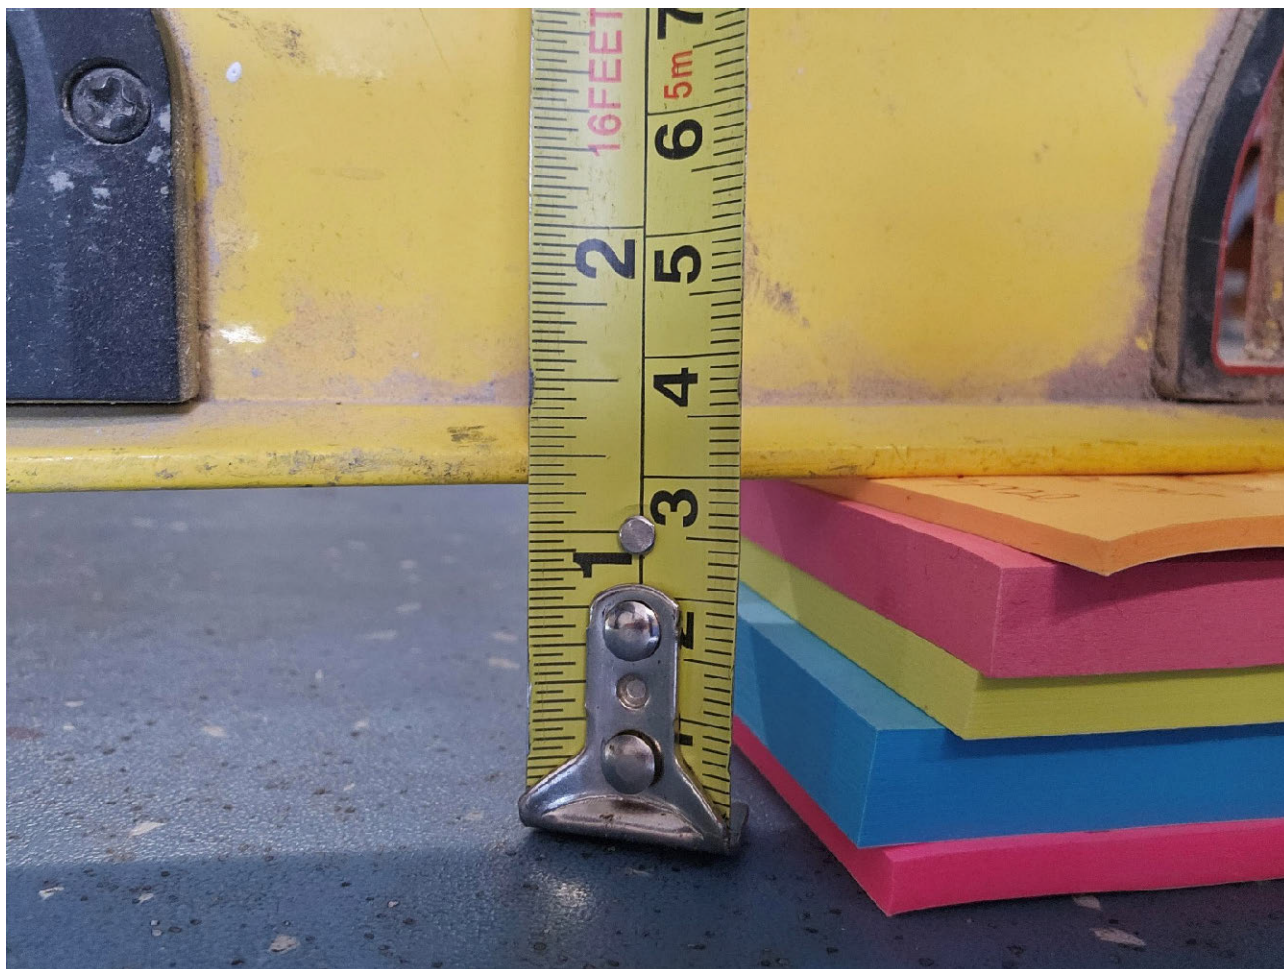
Using spirit levels the deflection within rooms 50 and 54 were measured to be 20mm over a metre length; and 30mm over a metre length in room 53. This results in a likely total deflection of approximately 60-75mm between the support points and centre of the room. For context, normal design limits for a concrete floor structure would expect a total deflection of 15-20mm over the entire floor span, and a deflection of 2-3mm over a metre length, considerably less than what was observed here.

**Photo 9 : 30mm Measurement of Packing Beneath Flat Spirit Level**
