The City of Edinburgh Council  
Facilities Management  
Place Directorate  
Level 1.4, Waverley Court  
4 East Market Street  
Edinburgh  
EH8 8BG

Will Rudd Davidson (Edinburgh) Ltd  
Consulting Civil & Structural Engineers

## **St Cuthberts RC Primary School, Edinburgh Inspection of 1<sup>st</sup> Floor Structure**

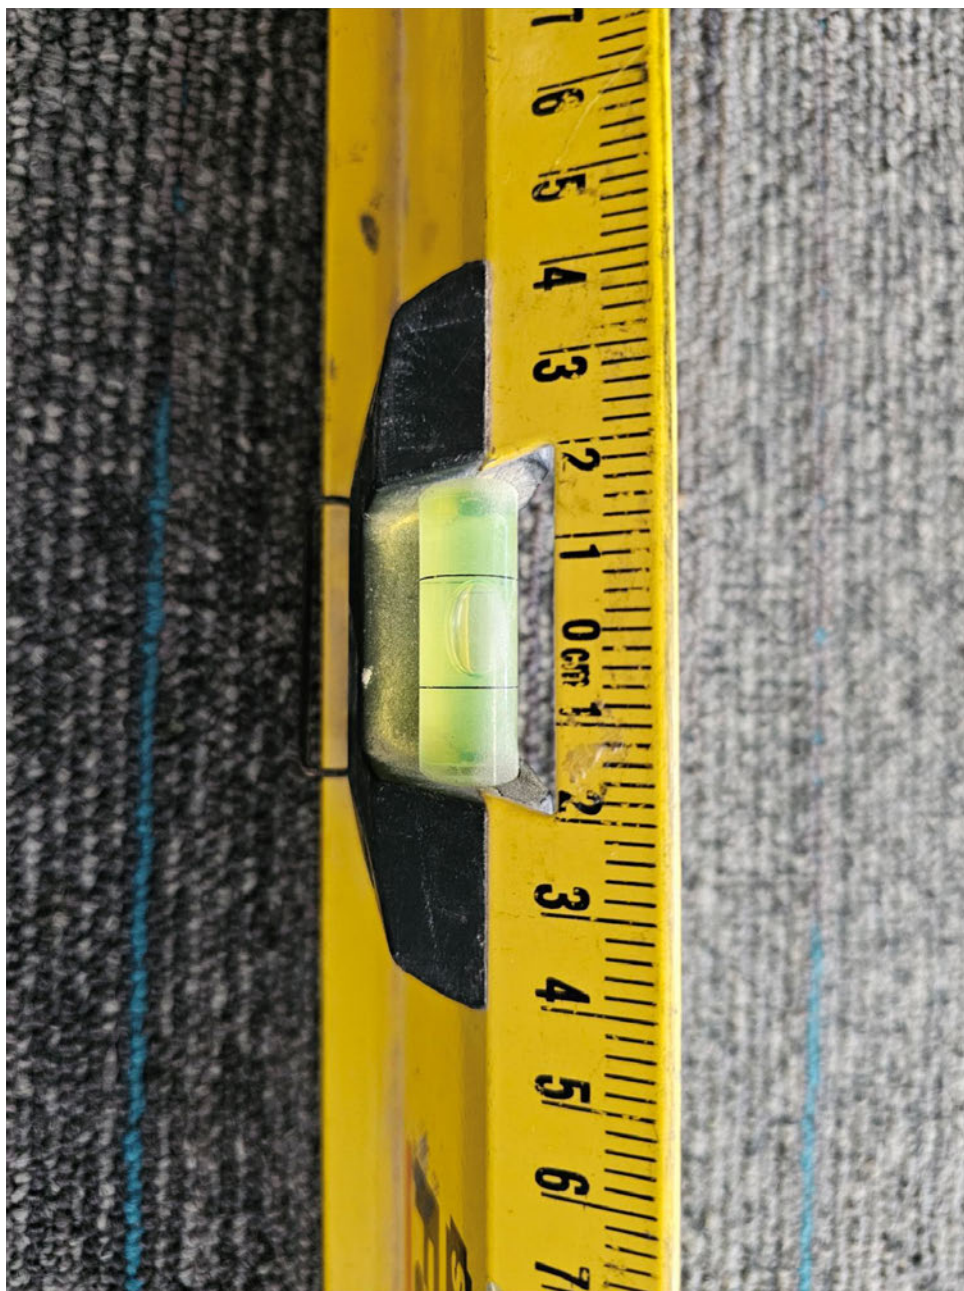
**Photo 7 : View on Spirit Level Bubble at Centre Span. Floor is Flat**

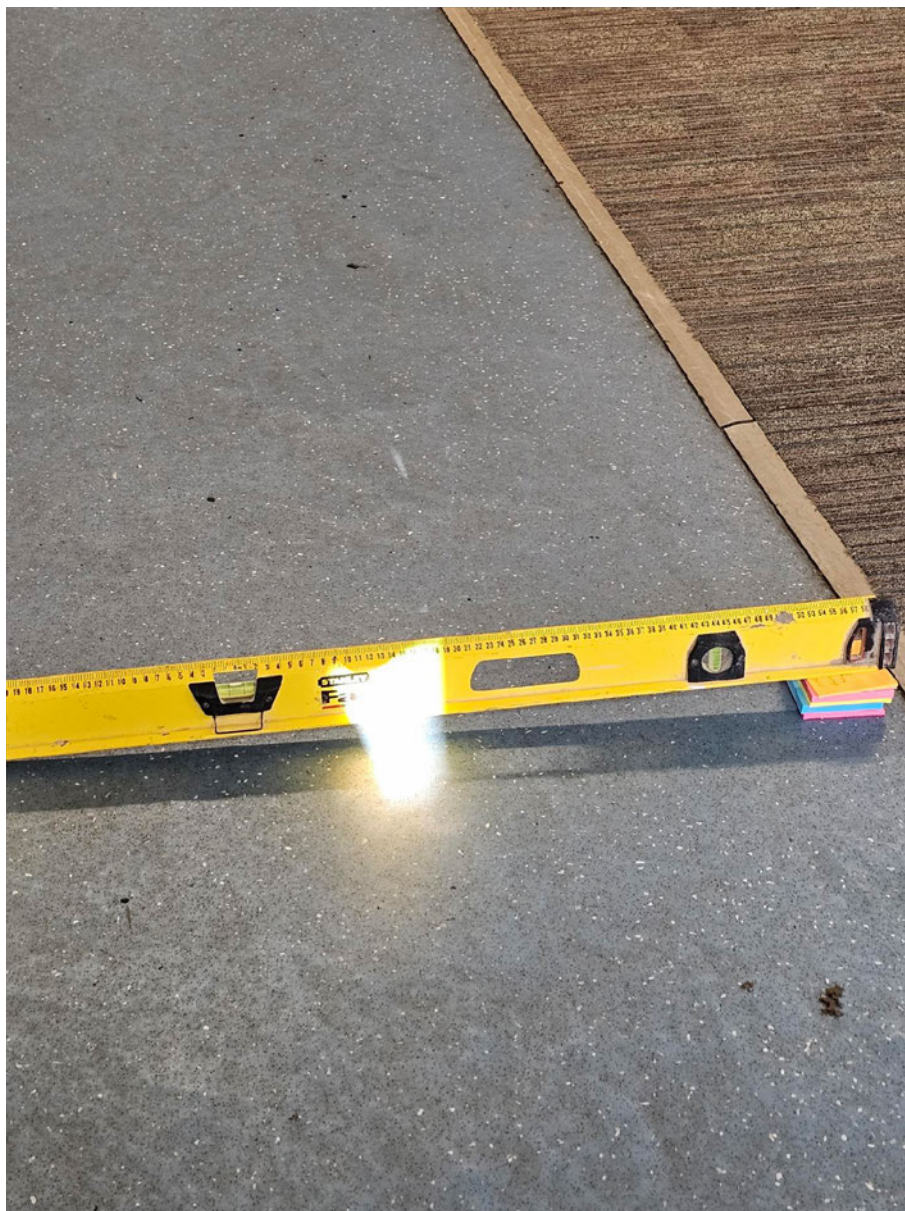
**Photo 8 : View on Spirit Level Measuring Flat at South-East Span**

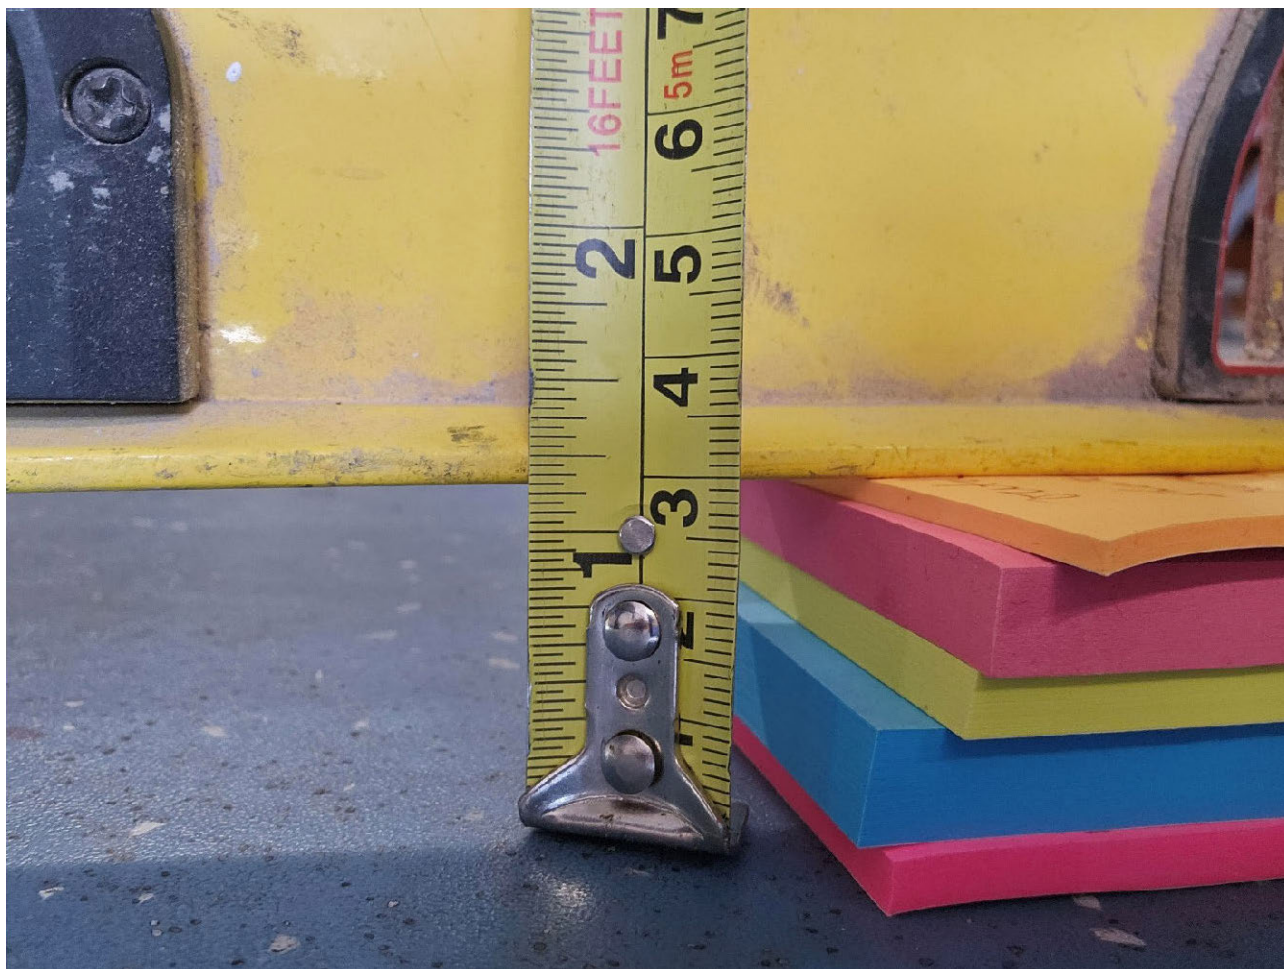
Using spirit levels the deflection within rooms 50 and 54 were measured to be 20mm over a metre length; and 30mm over a metre length in room 53. This results in a likely total deflection of approximately 60-75mm between the support points and centre of the room. For context, normal design limits for a concrete floor structure would expect a total deflection of 15-20mm over the entire floor span, and a deflection of 2-3mm over a metre length, considerably less than what was observed here.

**Photo 9 : 30mm Measurement of Packing Beneath Flat Spirit Level**

1. We would recommend that the underside of floors to rooms 50; 53 and 43 are propped as a precautionary measure in case movement is ongoing. Propping recommendations are as follows;
  - Propping Beams: 178x102x19UB; Max span of 3m
  - Props: Type 3 props @ 2.5 metre centres
  - Prop locations: Maximum 2.7 metre spacing along span (min 2 lines of props)
