**From:** [REDACTED]  
**To:** [REDACTED] [Michael Miller](#); [Sandy Rintoul](#)  
**Cc:**  
**Subject:** RE: E20955.00 - St Cuthbert's RC Primary School  
**Date:** 27 August 2026 09:48:59  
**Attachments:** [image001.png](#)  
[image002.png](#)  
[image003.png](#)  
[image004.png](#)  
[image005.png](#)  
[image006.png](#)  
[image007.png](#)  
[image008.png](#)  
[faac604c-db2d-4730-9a3c-97d7c6212cc3.png](#)  
[St Cuthbert's RC Primary School - Skanska - CPP review.pdf](#)  
[26279 - St Cuthbert's RC Primary School PCIP 2026.pdf](#)

## St Cuthbert's RC Primary School - Construction Phase H&S Plan Review Checklist

## **Structural Strengthening Works**

**ASBESTOS MANAGEMENT SURVEY  
OF  
ST CUTHBERTS PRIMARY SCHOOL, 9 HUTCHISON CROSSWAY, EDINBURGH, EH14 1RP**

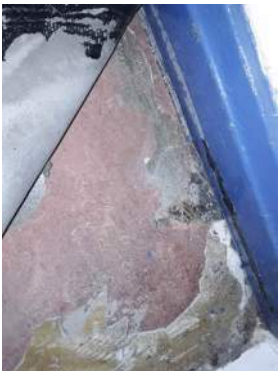
| <b>FLOOR/LOCATION:</b> | Ground Floor 0/001 - Circulation | |

| <b>DESCRIPTION:</b> | Bitumen adhesive beneath red floor covering | |
| <b>RESULT:</b> | Chrysotile | |

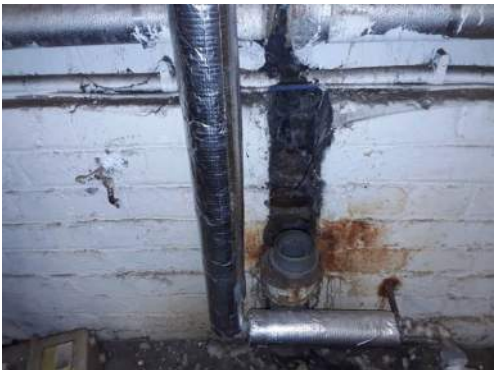
| <b>FLOOR/LOCATION:</b> | Ground Floor 0/012 - Boiler Room | |

| <b>DESCRIPTION:</b> | Insulation residue to wall 2 within channel cut into brickwork | |

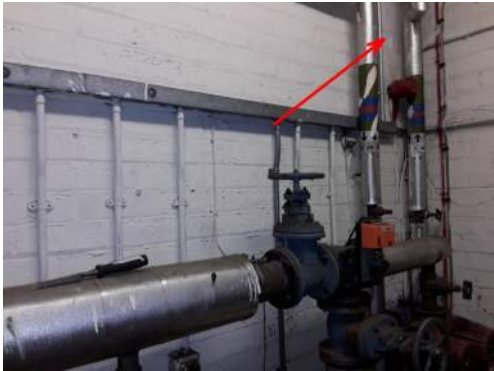
| <b>FLOOR/LOCATION:</b> | Ground Floor 0/012 - Boiler Room | |

| <b>DESCRIPTION:</b> | Insulation residue to wall 3 - sporadic across entire wall | |
| <b>RESULT:</b> | Amosite | |

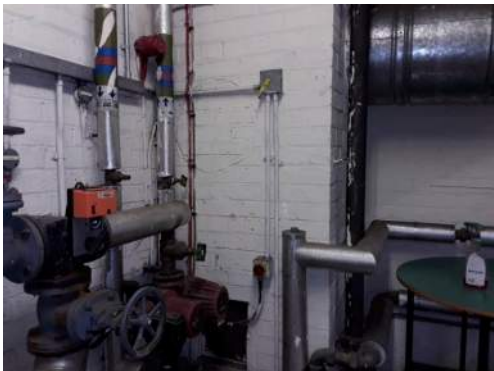
| <b>FLOOR/LOCATION:</b> | Ground Floor 0/012 - Boiler Room | |

| <b>DESCRIPTION:</b> | Insulation residue to chimney breast walls - sporadic across entire chimney breast | |
| <b>RESULT:</b> | Amosite | |

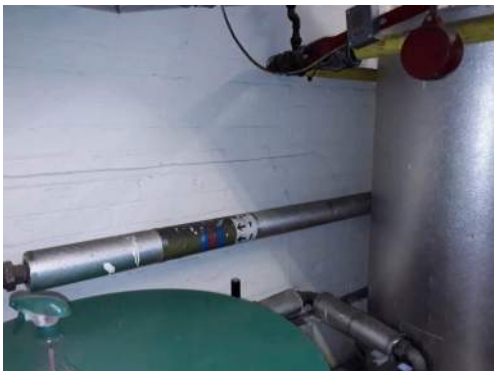
| <b>FLOOR/LOCATION:</b> | Ground Floor 0/012 - Boiler Room | |

| <b>DESCRIPTION:</b> | Insulation residue to wall 4 - sporadic across entire wall | |

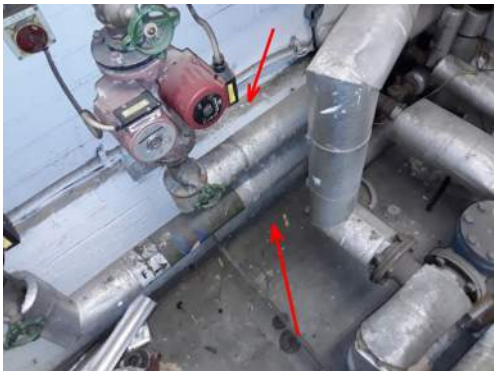
| <b>FLOOR/LOCATION:</b> | Ground Floor 0/012 - Boiler Room | |

| Location | Description | Priority/Risk | Recommendation |
|---|---|---|---|
| Main / 0/012<br>- Boiler<br>Room /<br>Ground Floor | Paper gasket debris to floor and plinth at wall 3 | High | Remove under controlled conditions |

| <b>DESCRIPTION:</b> | Paper gasket debris to floor and plinth at wall 3 | |
| <b>RESULT:</b> | Chrysotile | |

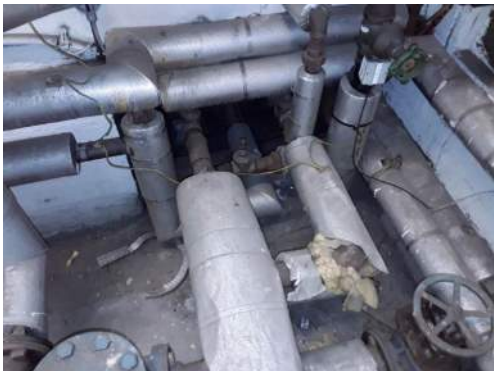
| <b>FLOOR/LOCATION:</b> | Ground Floor 0/012 - Boiler Room | |

| <b>DESCRIPTION:</b> | Insulation debris to floor at entrance to duct | |
| <b>RESULT:</b> | Amosite | |

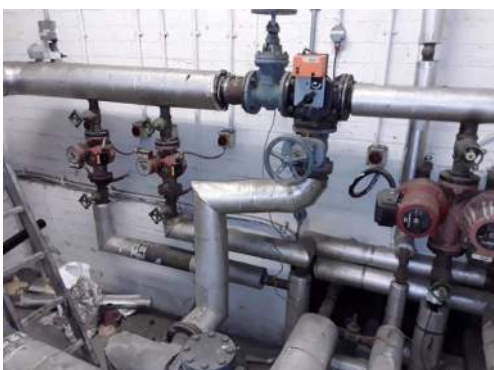
| <b>FLOOR/LOCATION:</b> | Ground Floor 0/012 - Boiler Room | |

| <b>DESCRIPTION:</b> | Paper gaskets to pipe flanges | |

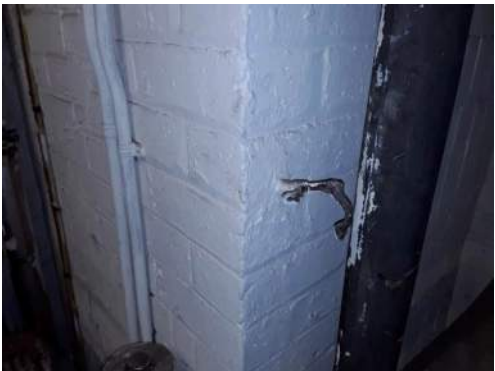
| <b>FLOOR/LOCATION:</b> | Ground Floor 0/012 - Boiler Room | |

| <b>DESCRIPTION:</b> | Insulation residues to old pipe hangers on walls 2, 3 and chimney breast | |
| <b>RESULT:</b> | Amosite | |

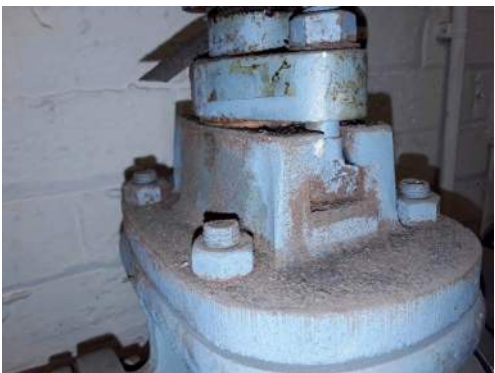
| <b>FLOOR/LOCATION:</b> | Ground Floor 0/012 - Boiler Room | |

| <b>DESCRIPTION:</b> | Insulation residues to exposed pipework and flanges | |
| <b>RESULT:</b> | Amosite | |

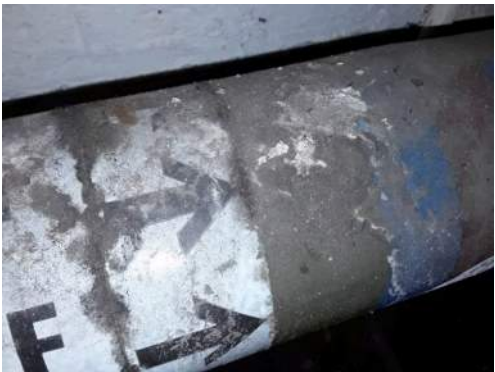
| <b>FLOOR/LOCATION:</b> | Ground Floor 0/012 - Boiler Room | |

| <b>DESCRIPTION:</b> | Paper gasket debris to aluminium pipework casing | |

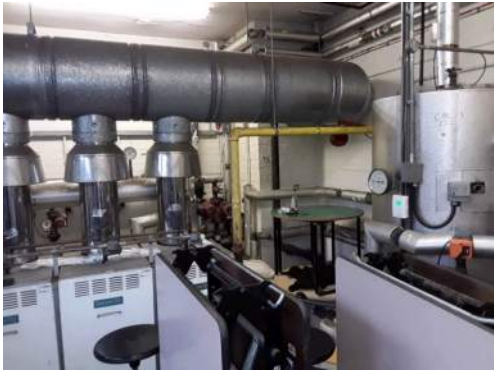
| <b>FLOOR/LOCATION:</b> | Ground Floor 0/012 - Boiler Room | |

| <b>DESCRIPTION:</b> | Presumed asbestos containing materials beneath aluminium casing/MMMF lagging to pipework and calorifier throughout entire area | |
| <b>RESULT:</b> | Presumed Crocidolite (or unknown) | |

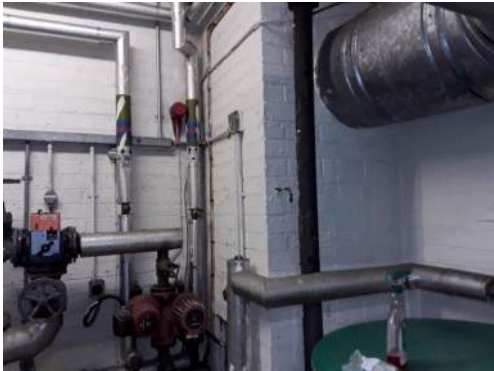
| <b>FLOOR/LOCATION:</b> | Ground Floor 0/012 - Boiler Room | |

| <b>Location</b> | <b>Description</b> | <b>Priority/Risk</b> | <b>Recommendation</b> |
|---|---|---|---|
| Main / 0/012 -<br>Boiler Room /<br>Ground Floor | Presumed asbestos containing materials within chimney breast between walls 3 and 4 - Unable to sample due to damage limitations | Low | Conduct further investigation prior to relevant maintenance / refurbishment works |

| <b>DESCRIPTION:</b> | Presumed asbestos containing materials within chimney breast between walls 3 and 4 - Unable to sample due to damage limitations | |
| <b>RESULT:</b> | Presumed Crocidolite (or unknown) | |

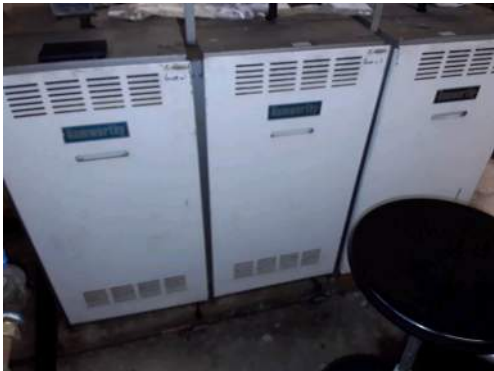
| <b>FLOOR/LOCATION:</b> | Ground Floor 0/012 - Boiler Room | |

| <b>DESCRIPTION:</b> | Presumed asbestos containing materials within Hamworthy boilers - Unable to sample due to being live at time of survey | |

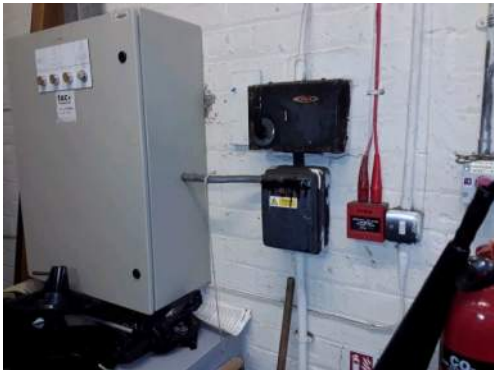
| <b>FLOOR/LOCATION:</b> | Ground Floor 0/012 - Boiler Room | |

| <b>DESCRIPTION:</b> | Presumed asbestos containing material within MEM electrical boxes to wall 1 - Unable to sample due to being live at time of survey | |
| <b>RESULT:</b> | Presumed Crocidolite (or unknown) | |

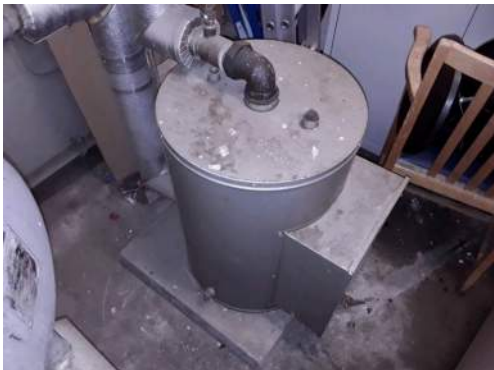
| <b>FLOOR/LOCATION:</b> | Ground Floor 0/012 - Boiler Room | |

| <b>DESCRIPTION:</b> | Presumed asbestos containing materials within water heater - Unable to sample due to being live at time of survey | |
| <b>RESULT:</b> | Presumed Crocidolite (or unknown) | |

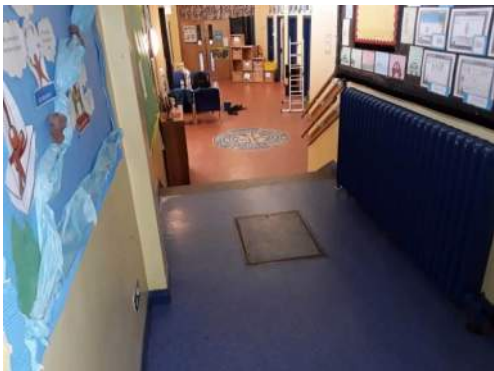
| <b>FLOOR/LOCATION:</b> | Ground Floor 0/029 - Foyer and Cloak Area | |

| <b>DESCRIPTION:</b> | Bitumen adhesive beneath red floor covering | |

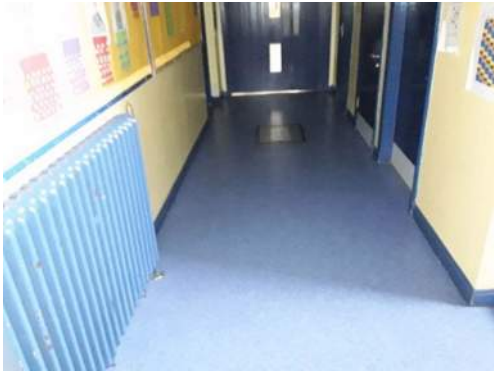
| <b>FLOOR/LOCATION:</b> | Ground Floor 0/029A - Corridor and Stairs | |

| <b>DESCRIPTION:</b> | Bitumen adhesive beneath blue modern floor covering | |
| <b>RESULT:</b> | Chrysotile | |

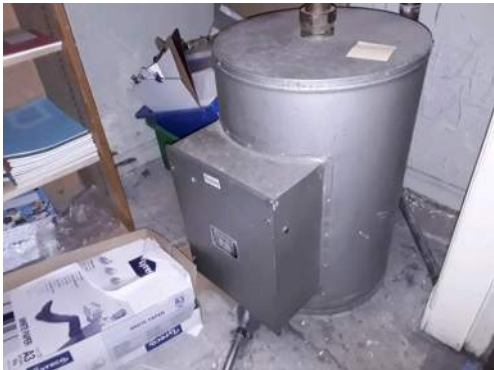
| <b>FLOOR/LOCATION:</b> | Ground Floor 0/030 - Jotter Cupboard | |

| <b>DESCRIPTION:</b> | Presumed asbestos containing materials within electrical water heater - Unable to sample due to being live at time of survey | |
| <b>RESULT:</b> | Presumed Crocidolite (or unknown) | |

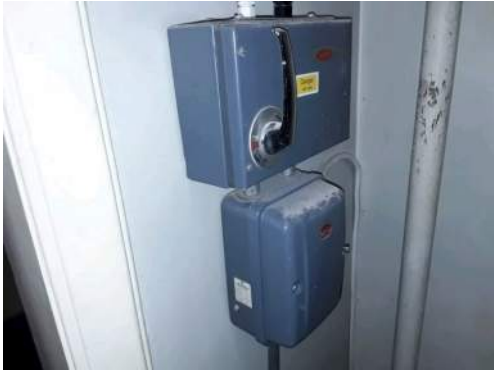
| <b>FLOOR/LOCATION:</b> | Ground Floor 0/030 - Jotter Cupboard | |

| <b>DESCRIPTION:</b> | Presumed asbestos containing materials within MEM electrical boxes - Unable to sample due to being live at time of survey | |

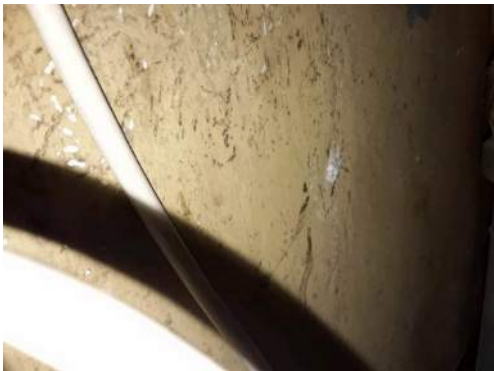
| <b>FLOOR/LOCATION:</b> | Ground Floor 0/031 - Calorifier Room | |

| <b>DESCRIPTION:</b> | Insulation residue to wall 2 | |
| <b>RESULT:</b> | Chrysotile + Amosite | |

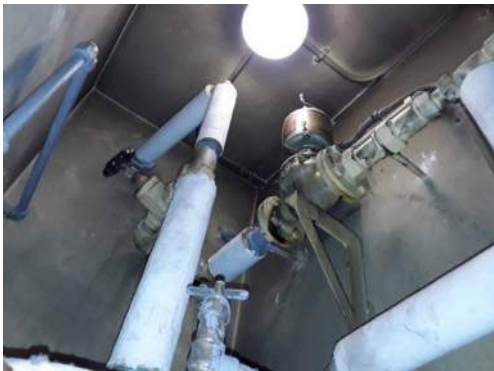
| <b>FLOOR/LOCATION:</b> | Ground Floor 0/031 - Calorifier Room | |

| <b>DESCRIPTION:</b> | Paper gaskets to high level pipe flanges | |
| <b>RESULT:</b> | Chrysotile | |

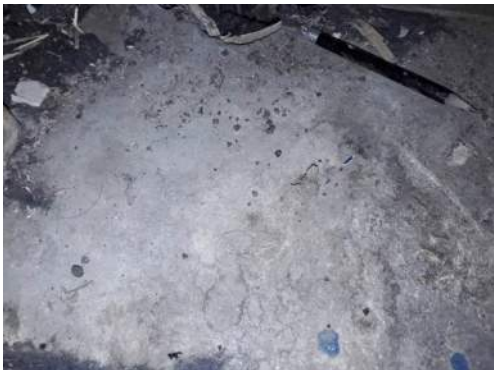
| <b>FLOOR/LOCATION:</b> | Ground Floor 0/031 - Calorifier Room | |

| <b>DESCRIPTION:</b> | Insulation debris to floor | |

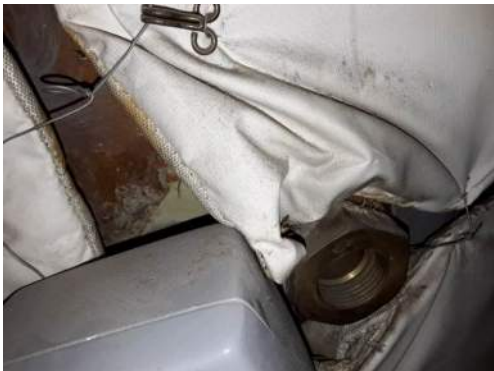
| <b>FLOOR/LOCATION:</b> | Ground Floor 0/031 - Calorifier Room | |

| <b>DESCRIPTION:</b> | Insulation debris to pipe knuckles and calorifier knuckles | |
| <b>RESULT:</b> | Chrysotile + Amosite | |

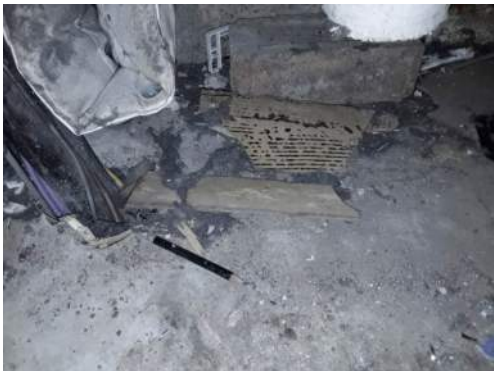
| <b>FLOOR/LOCATION:</b> | Ground Floor 0/031 - Calorifier Room | |

| <b>Location</b> | <b>Description</b> | <b>Priority/Risk</b> | <b>Recommendation</b> |
|---|---|---|---|
| Main / 0/031 - Calorifier Room / Ground Floor | Loose beige floor tiles | Medium | Remove under controlled conditions |

| <b>DESCRIPTION:</b> | Loose beige floor tiles | |
| <b>RESULT:</b> | Chrysotile | |

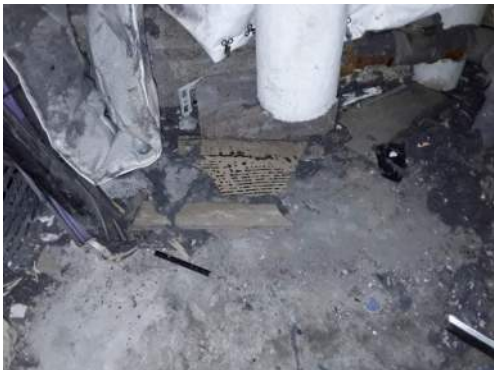
| <b>FLOOR/LOCATION:</b> | Ground Floor 0/031 - Calorifier Room | |

| Location | Description | Priority/Risk | Recommendation |
|---|---|---|---|
| Main / 0/031 - Calorifier Room / Ground Floor | Bitumen adhesive beneath loose floor tiles | Medium | Remove under controlled conditions |

| <b>DESCRIPTION:</b> | Bitumen adhesive beneath loose floor tiles | |

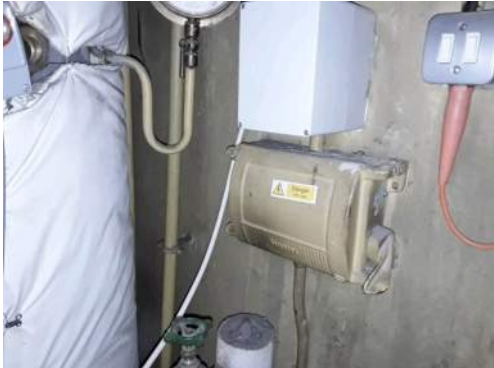
| <b>FLOOR/LOCATION:</b> | Ground Floor 0/031 - Calorifier Room | |

| <b>DESCRIPTION:</b> | Presumed asbestos containing materials within electrics - Unable to sample due to being live at time of survey | |
| <b>RESULT:</b> | Presumed Crocidolite (or unknown) | |

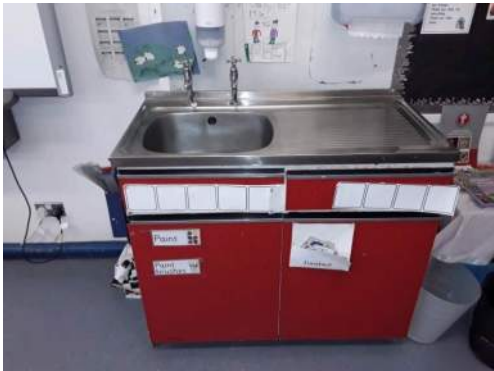
| <b>FLOOR/LOCATION:</b> | Ground Floor 0/038 - P3 Classroom | |

| <b>DESCRIPTION:</b> | Bitumen sink pad | |
