E20955.00 - St Cuthbert's RC Primary School

LM/SC/E20955

14<sup>th</sup> May 2026

## **St Cuthberts RC Primary School, Edinburgh Inspection of Roof Structure**

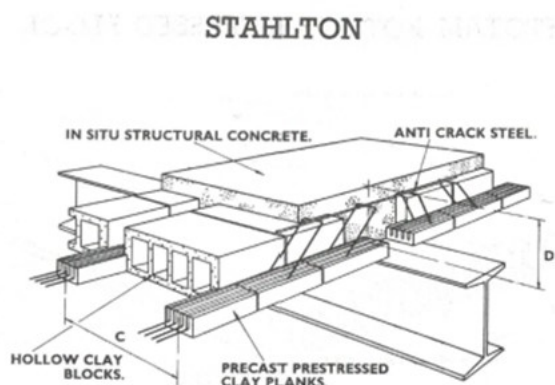
From review of historical information, the floors are understood to comprise a Stahlton prestressed precast concrete system. This consists of hollow concrete blocks being positioned between reinforced precast planks with projecting reinforcement. In-situ concrete is then poured into the spaces between the blocks to form a composite concrete beam, and an in-situ concrete topping above. Please see below for schematic of the system.

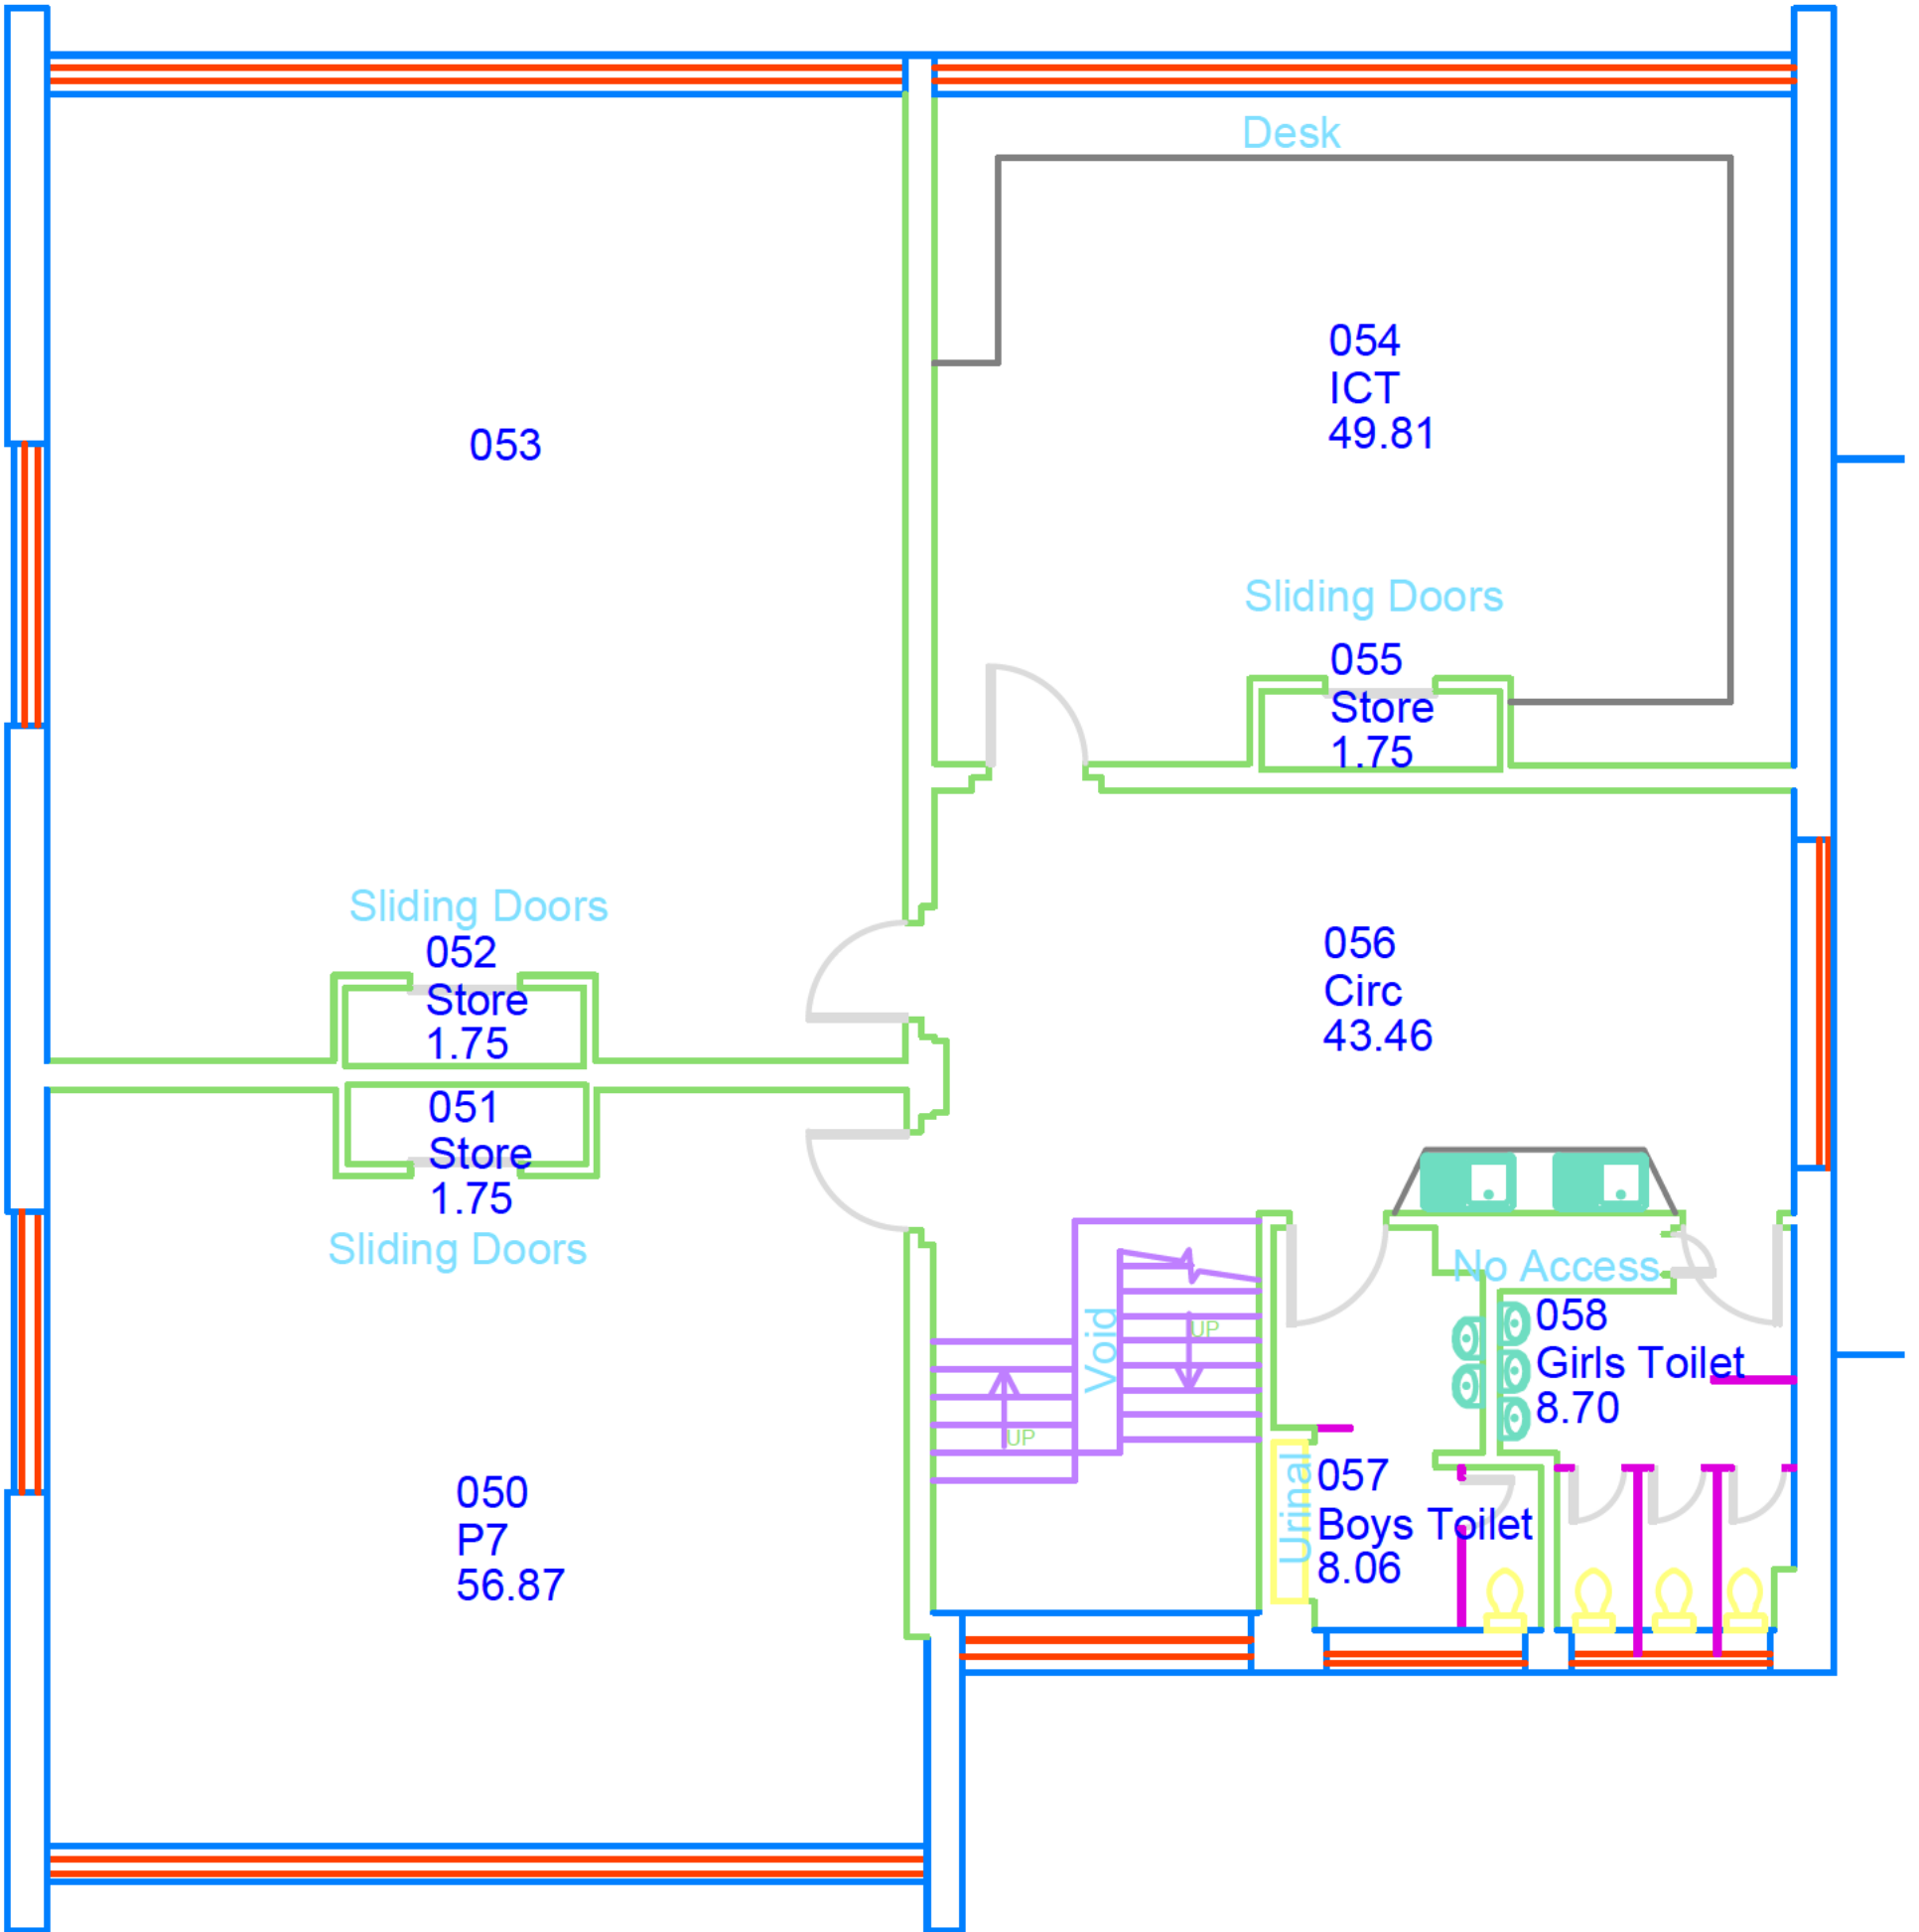
**Appendix A**

The investigations identified similar patterns of deflection and structural behaviour to those previously noted within the floor structure. The level surveys indicate comparable magnitudes of (between 60-70mm) total deflection and profiles of deflection within both the roof and floor systems. Given that the roof structure is subjected to significantly lower imposed loading than the floor structure, it is considered unlikely that the observed deflections are solely loading related.

In our opinion, the behaviour is more likely attributable to the long-term performance of the Stahlton prestressed concrete system, including creep-related deformation of the concrete and potential reductions in effective prestress within the precast beam elements over time.

The similarity in behaviour between the roof and floor structures supports the view that the observed deflections are inherent to the long-term behaviour of the structural system rather than being attributable to localised overloading. Reference should be made to Appendix A for the recorded roof deflections identified during the surveys.

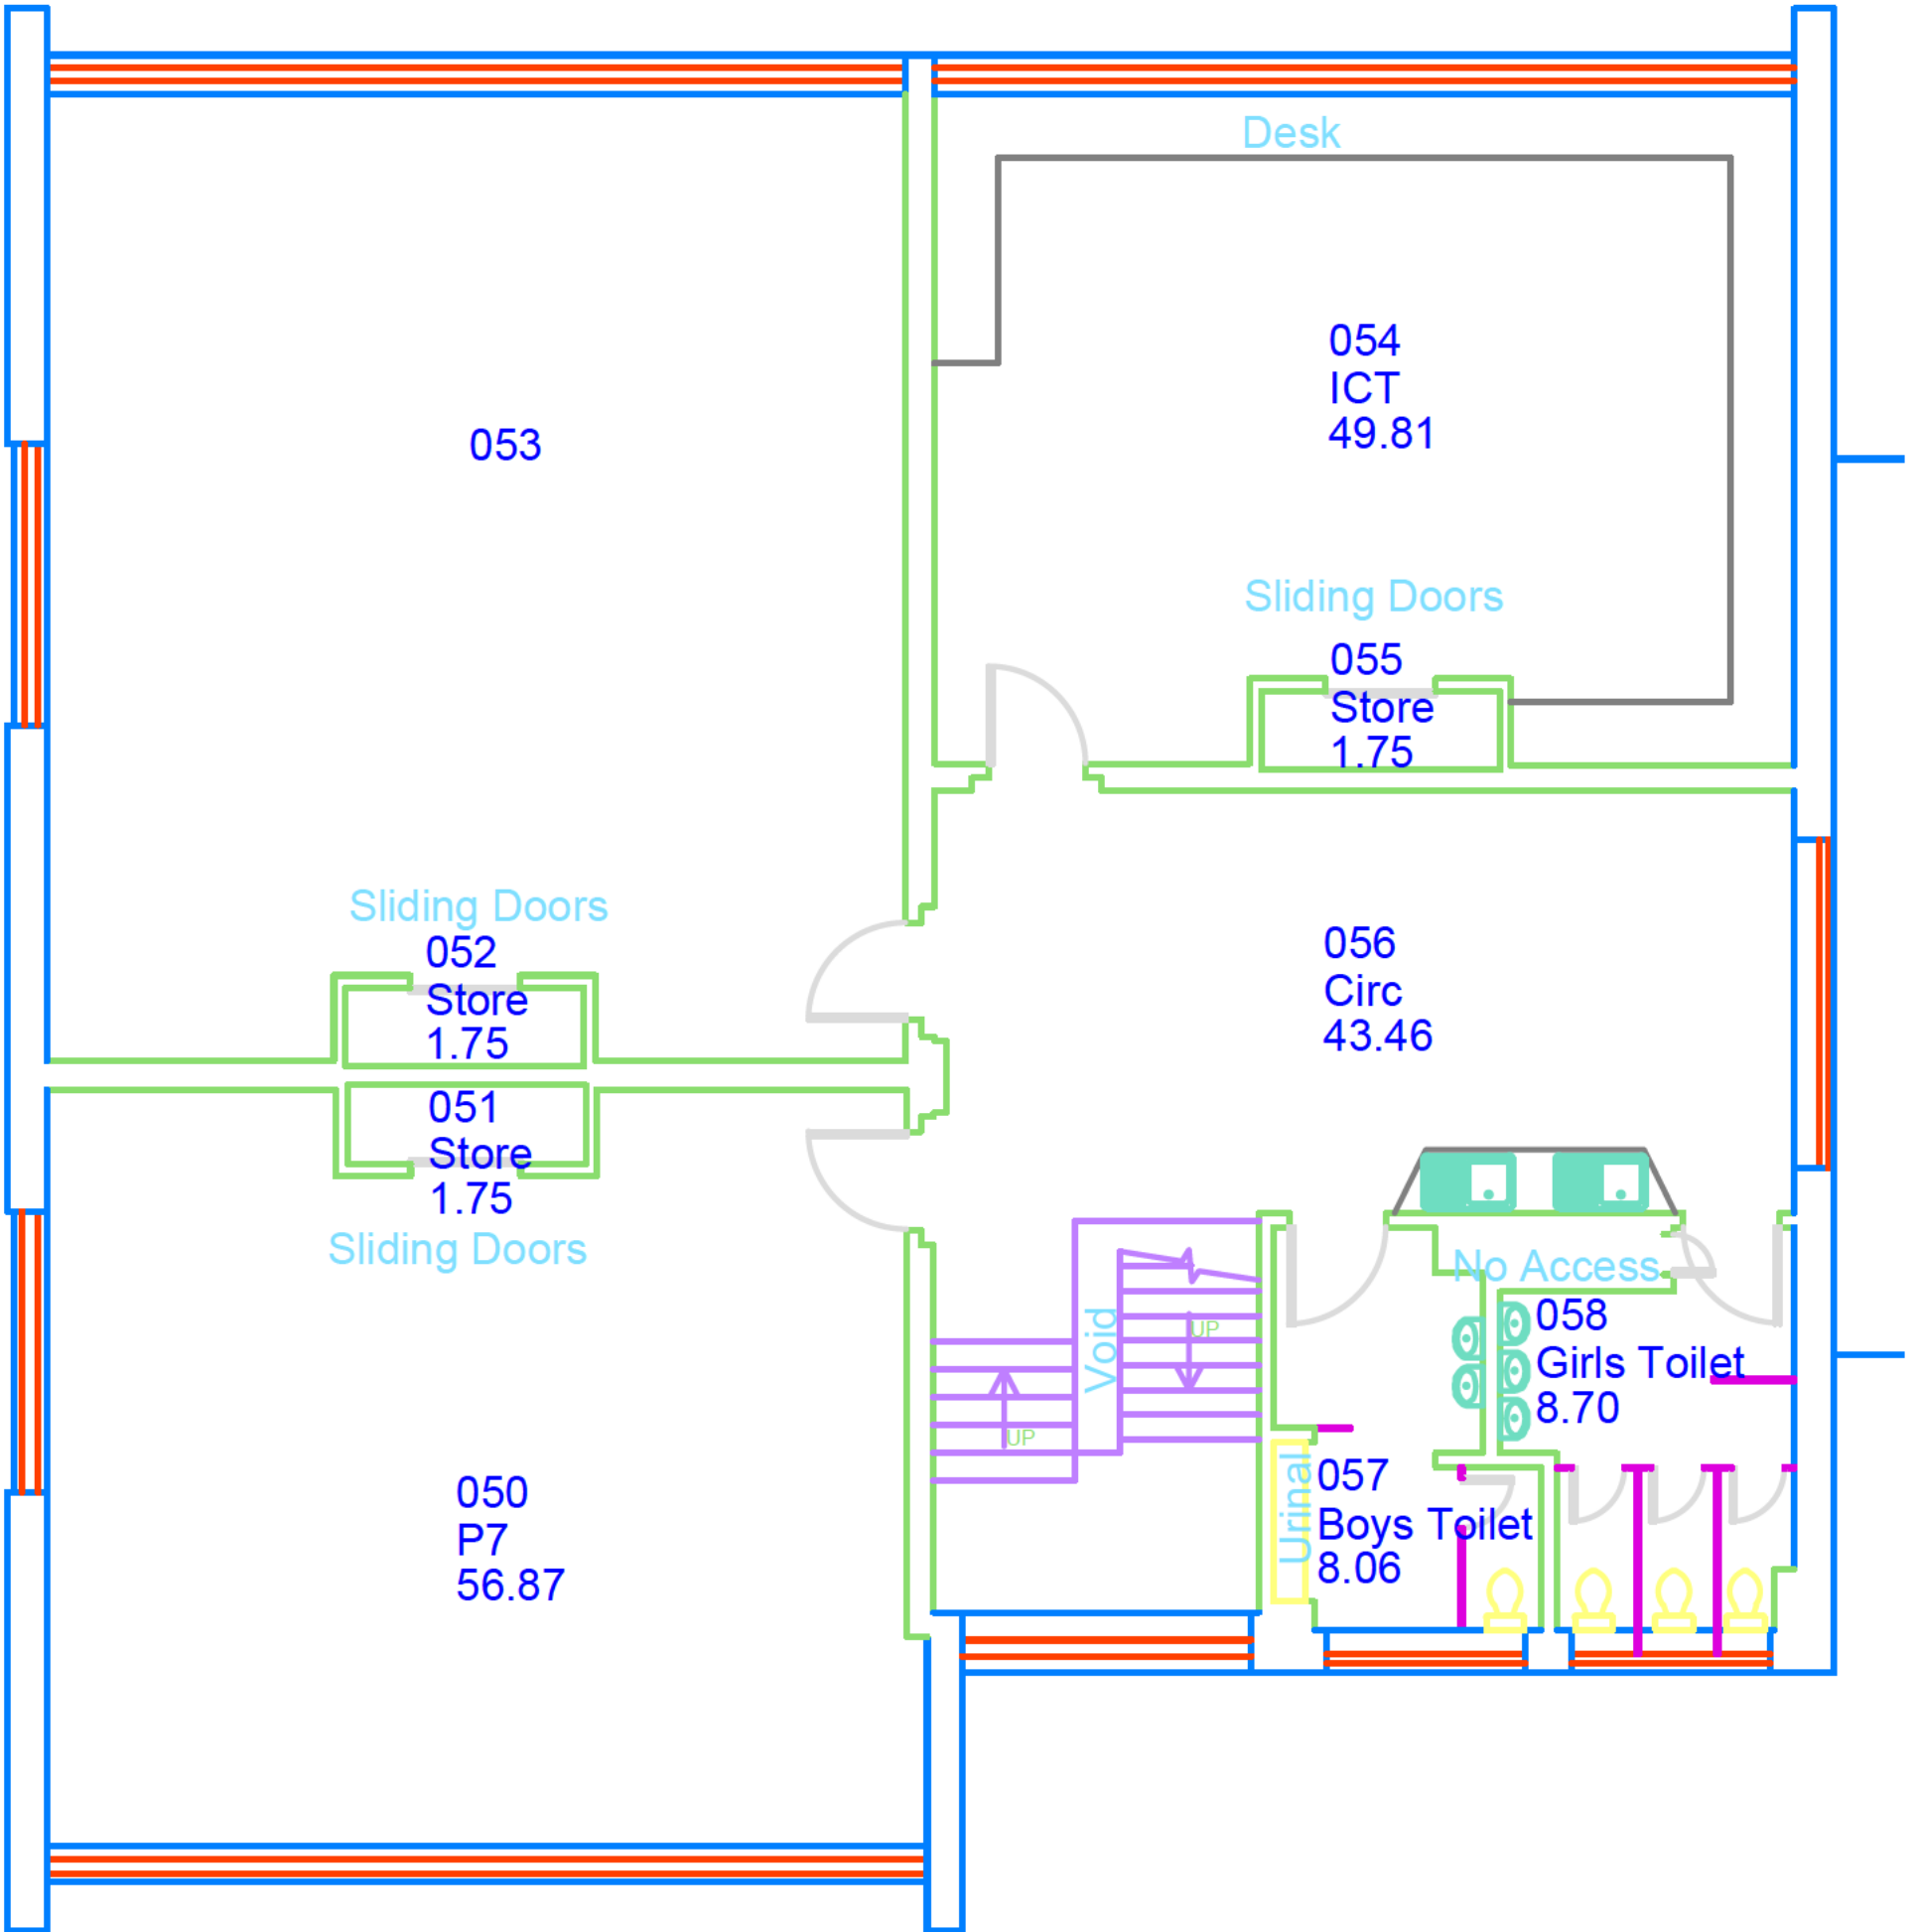
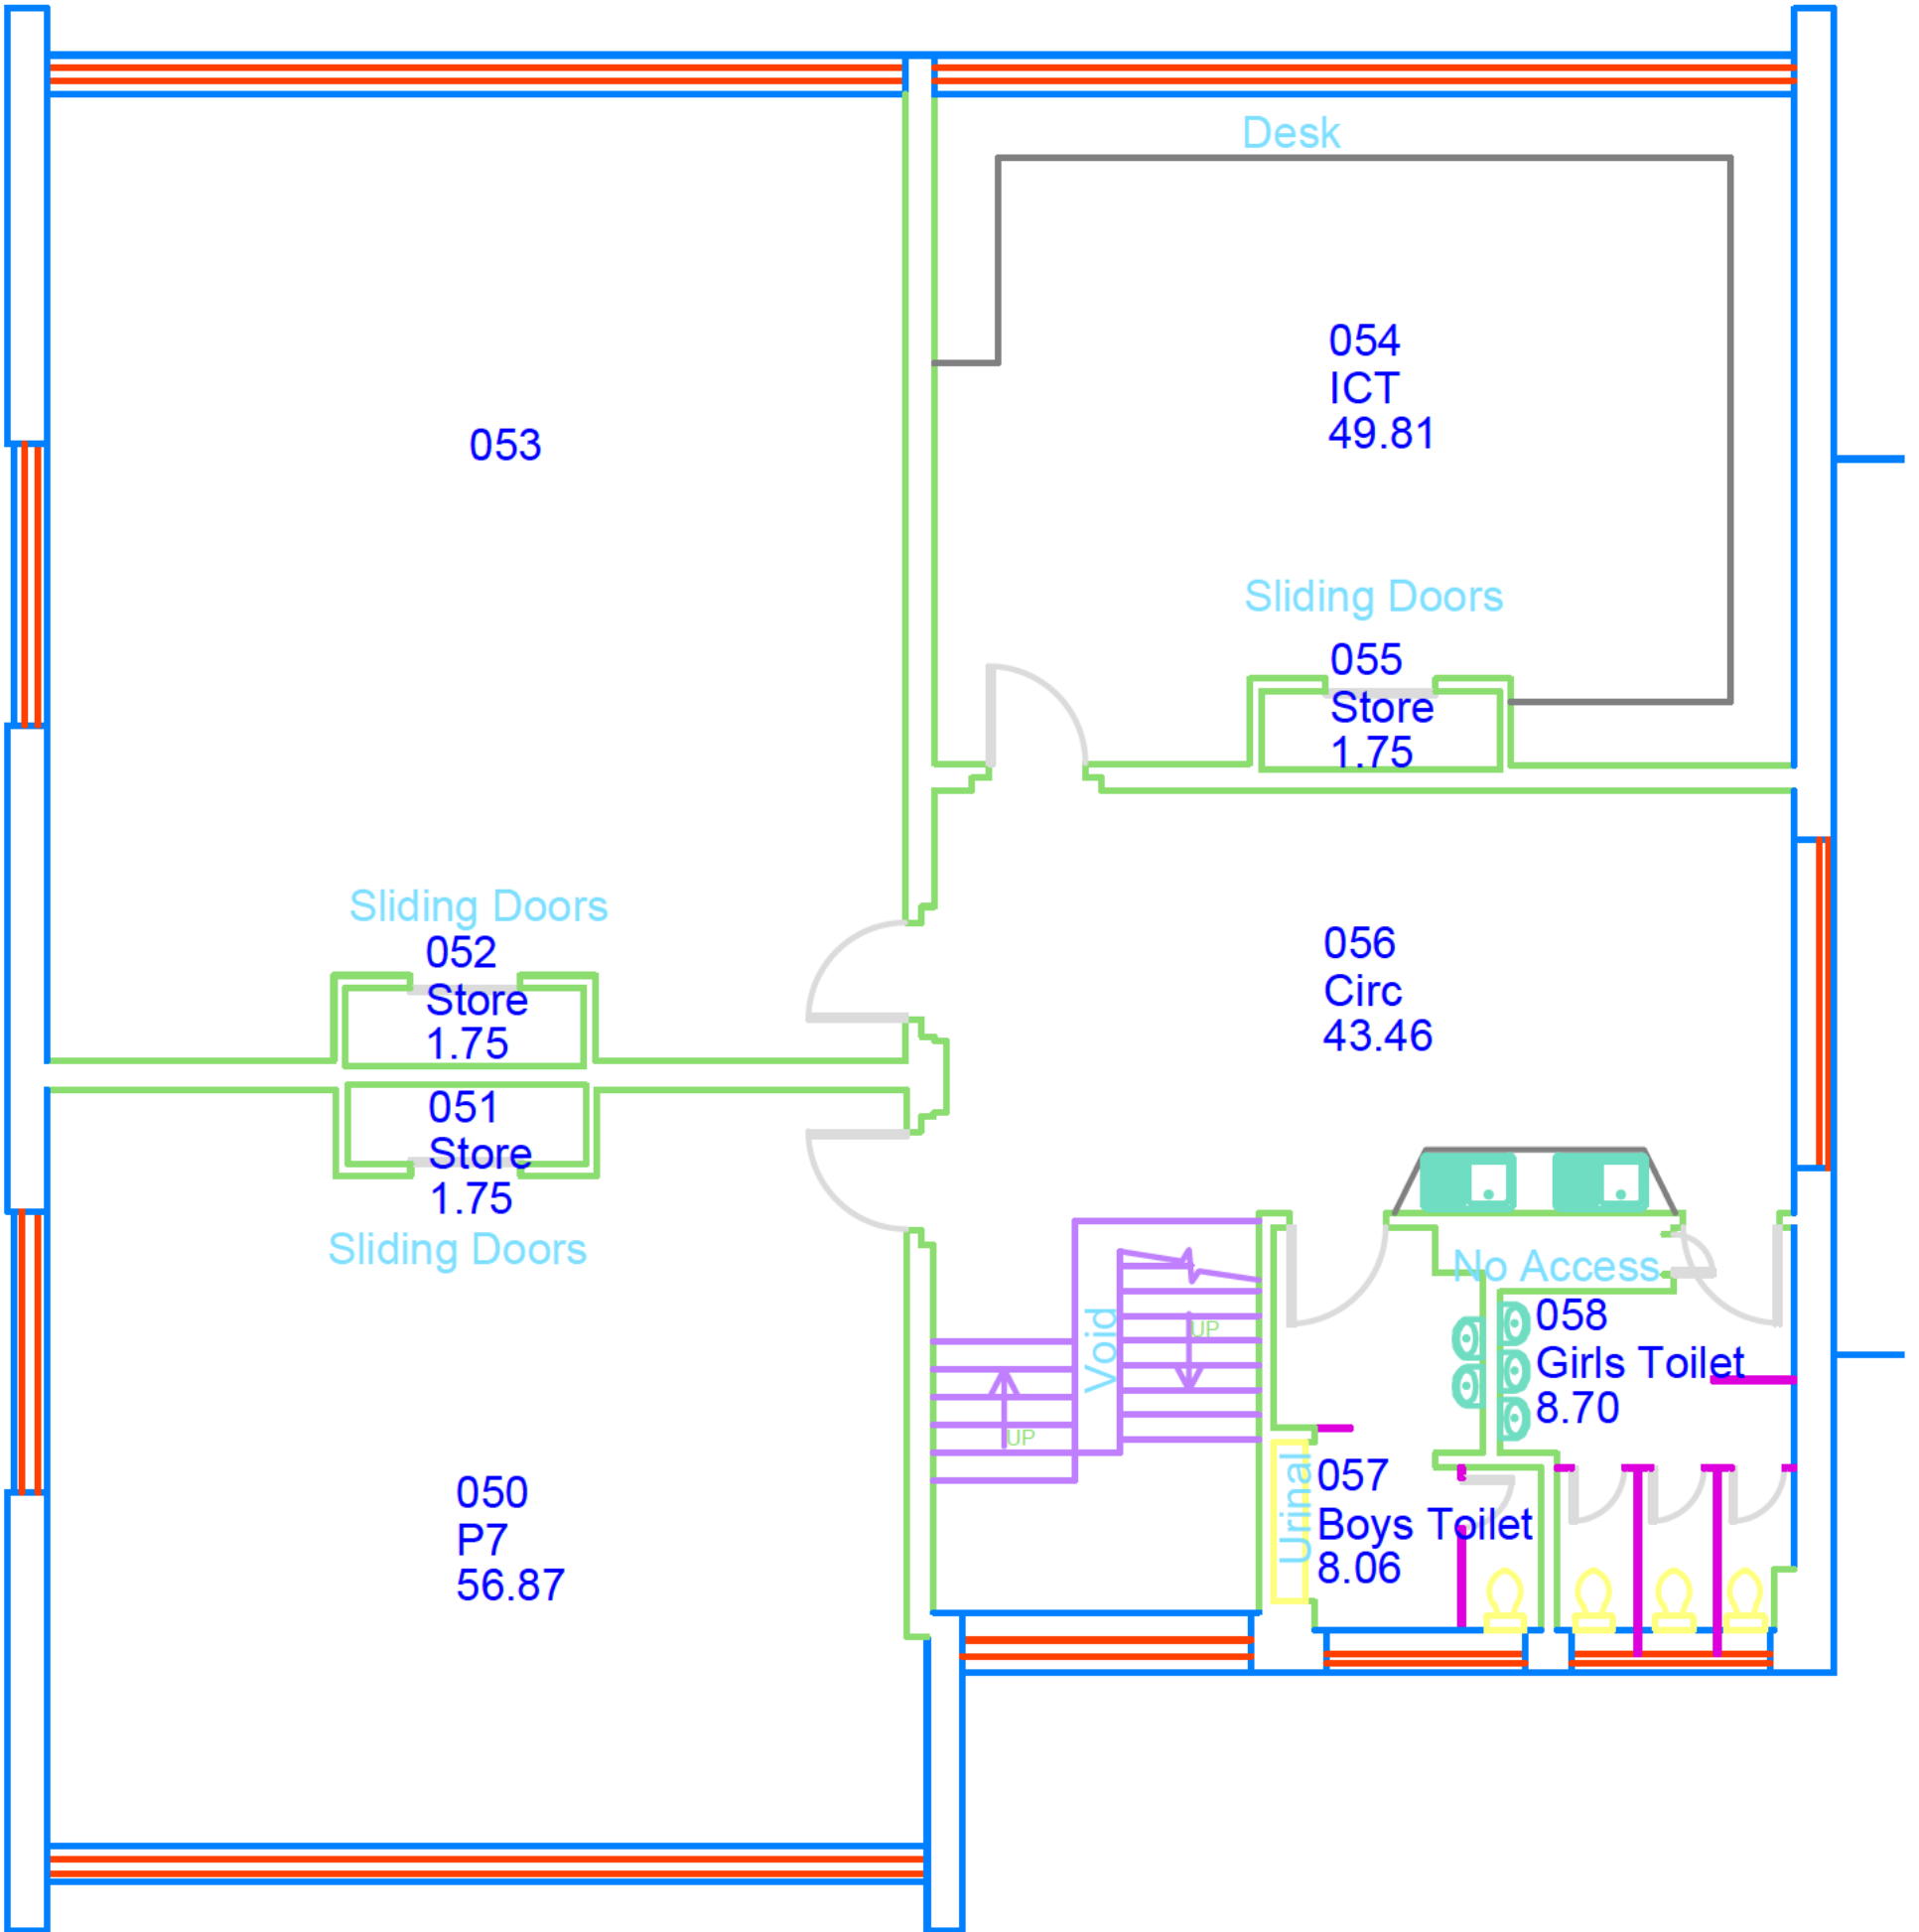
**Appendix C**

At the time of issuing this report, additional intrusive investigations remain outstanding. The proposed scope of these investigations is included within Appendix C.

Further intrusive investigations remain outstanding and are required to allow a more comprehensive assessment of the structural condition and behaviour of the system. Further information is to be gathered following completion of intrusive investigations that have been scoped previously. These can be found in Appendix C.
