**ASBESTOS MANAGEMENT SURVEY  
OF  
ST CUTHBERTS PRIMARY SCHOOL, 9 HUTCHISON CROSSWAY, EDINBURGH, EH14 1RP**

**CLIENT: THE CITY OF EDINBURGH COUNCIL  
WAVERLEY COURT, 4 EAST MARKET STREET, EDINBURGH, EH8 8BG**

**UPRN NO: N/A  
PROJECT NO: J511797  
DATE: APRIL 2019**

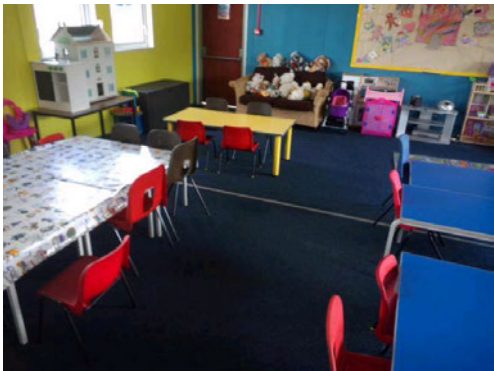
| <b>FLOOR/LOCATION:</b> | Z-Sub Level 1 Floor Void | |

| <b>DESCRIPTION:</b> | Inaccessible | |
| <b>RESULT:</b> | Presumed | |

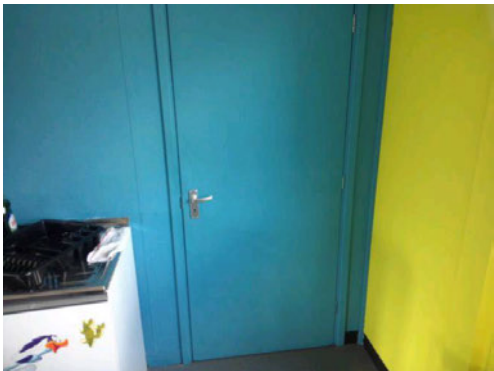
| <b>FLOOR/LOCATION:</b> | Ground Floor 0/005 - Store | |

| <b>DESCRIPTION:</b> | Inaccessible | |
| <b>RESULT:</b> | Presumed | |

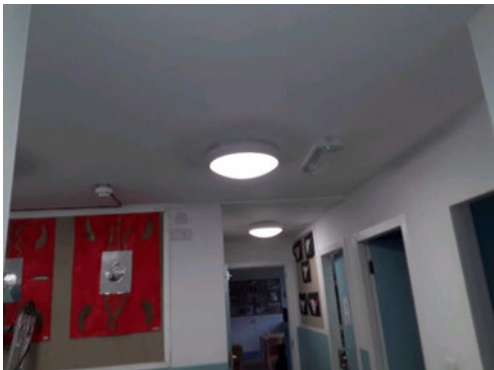
| <b>FLOOR/LOCATION:</b> | Roof Void RV/001 - Roof Void | |

| <b>DESCRIPTION:</b> | Inaccessible | |

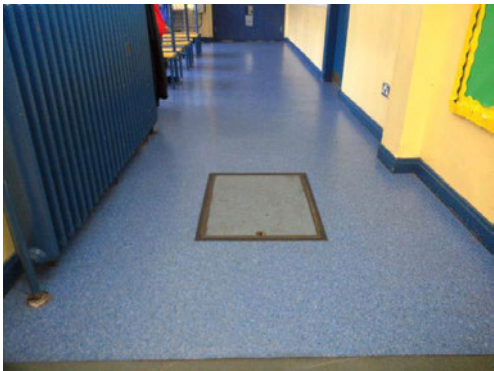
| <b>FLOOR/LOCATION:</b> | Z-Sub Level 1 Z1/002 - Ducts | |

| <b>DESCRIPTION:</b> | Inaccessible | |
| <b>RESULT:</b> | Presumed | |

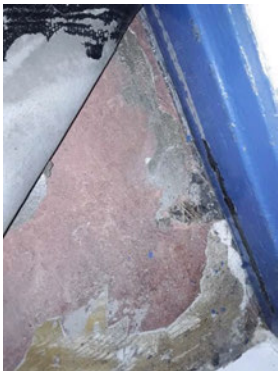
| <b>FLOOR/LOCATION:</b> | Ground Floor 0/001 - Circulation | |

| Location | Description | Priority/Risk | Recommendation |
|---|---|---|---|
| Main / 0/001<br>- Circulation /<br>Ground Floor | Bitumen adhesive beneath red floor covering | Very Low | Manage, monitor and inform maintenance personnel prior to relevant works |

| <b>DESCRIPTION:</b> | Bitumen adhesive beneath red floor covering | |
| <b>RESULT:</b> | Chrysotile | |

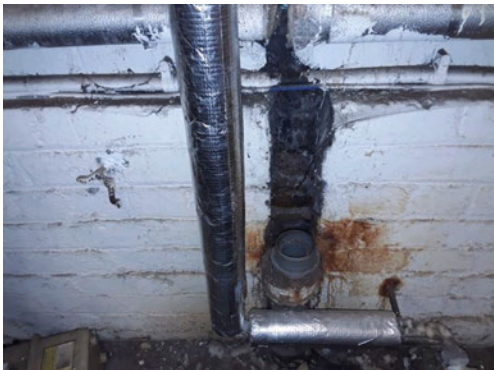
| <b>FLOOR/LOCATION:</b> | Ground Floor 0/012 - Boiler Room | |

| Location | Description | Priority/Risk | Recommendation |
|---|---|---|---|
| Main / 0/012<br>- Boiler<br>Room /<br>Ground Floor | Insulation residue to wall 2 within channel cut into brickwork | High | Encapsulate |

| <b>DESCRIPTION:</b> | Insulation residue to wall 2 within channel cut into brickwork | |

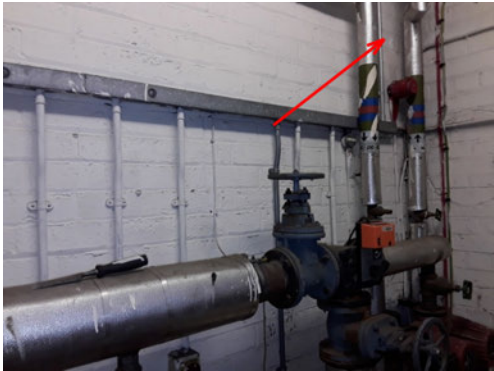
| <b>FLOOR/LOCATION:</b> | Ground Floor 0/012 - Boiler Room | |

| Location | Description | Priority/Risk | Recommendation |
|---|---|---|---|
| Main / 0/012<br>- Boiler<br>Room /<br>Ground Floor | Insulation residue to wall 3 - sporadic across entire wall | Medium | Manage, monitor and inform maintenance personnel prior to relevant works |

| <b>DESCRIPTION:</b> | Insulation residue to wall 3 - sporadic across entire wall | |
| <b>RESULT:</b> | Amosite | |

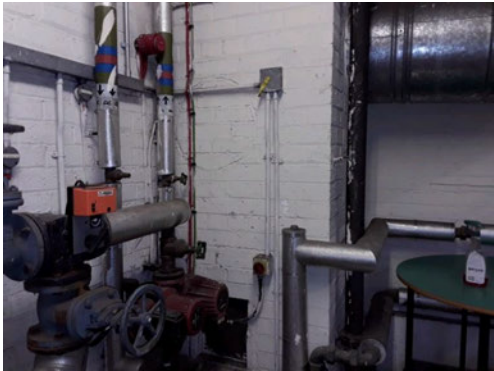
| <b>FLOOR/LOCATION:</b> | Ground Floor 0/012 - Boiler Room | |

| Location | Description | Priority/Risk | Recommendation |
|---|---|---|---|
| Main / 0/012<br>- Boiler<br>Room /<br>Ground Floor | Insulation residue to chimney breast walls - sporadic across entire chimney breast | Medium | Manage, monitor and inform maintenance personnel prior to relevant works |

| <b>DESCRIPTION:</b> | Insulation residue to chimney breast walls - sporadic across entire chimney breast | |
| <b>RESULT:</b> | Amosite | |

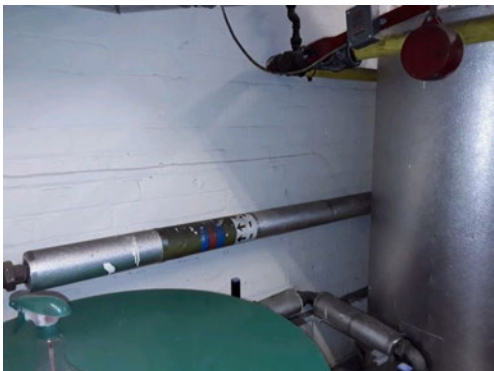
| <b>FLOOR/LOCATION:</b> | Ground Floor 0/012 - Boiler Room | |

| Location | Description | Priority/Risk | Recommendation |
|---|---|---|---|
| Main / 0/012<br>- Boiler<br>Room /<br>Ground Floor | Insulation residue to wall 4 - sporadic across entire wall | Medium | Manage, monitor and inform maintenance personnel prior to relevant works |

| <b>DESCRIPTION:</b> | Insulation residue to wall 4 - sporadic across entire wall | |

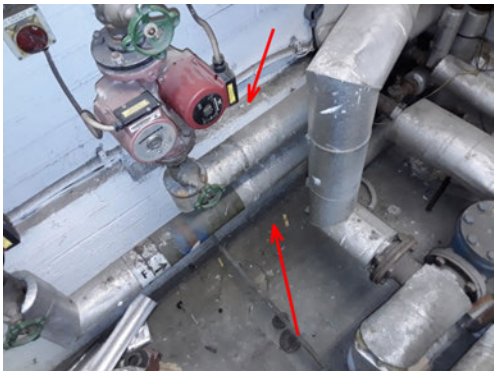
| <b>FLOOR/LOCATION:</b> | Ground Floor 0/012 - Boiler Room | |

| Location | Description | Priority/Risk | Recommendation |
|---|---|---|---|
| Main / 0/012<br>- Boiler<br>Room /<br>Ground Floor | Paper gasket debris to floor and plinth at wall 3 | High | Remove under controlled conditions |

| <b>DESCRIPTION:</b> | Paper gasket debris to floor and plinth at wall 3 | |
| <b>RESULT:</b> | Chrysotile | |

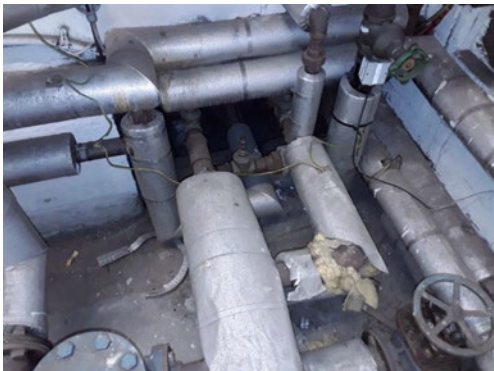
| <b>FLOOR/LOCATION:</b> | Ground Floor 0/012 - Boiler Room | |

| <b>DESCRIPTION:</b> | Insulation debris to floor at entrance to duct | |
| <b>RESULT:</b> | Amosite | |

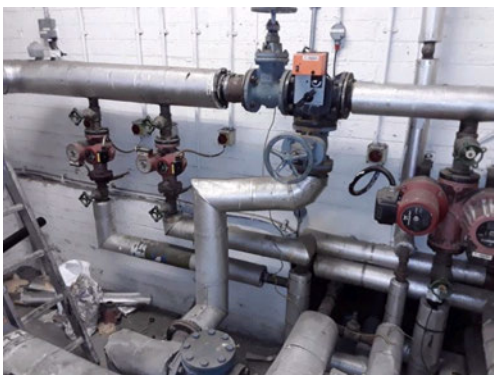
| <b>FLOOR/LOCATION:</b> | Ground Floor 0/012 - Boiler Room | |

| <b>DESCRIPTION:</b> | Paper gaskets to pipe flanges | |

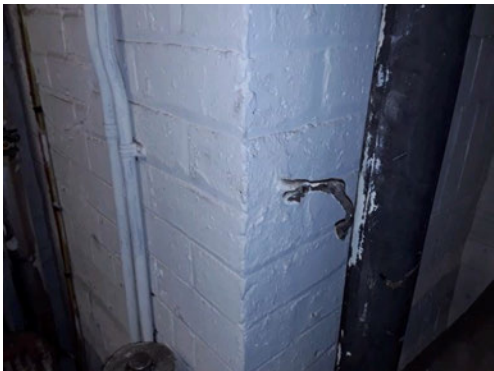
| <b>FLOOR/LOCATION:</b> | Ground Floor 0/012 - Boiler Room | |

| <b>DESCRIPTION:</b> | Insulation residues to old pipe hangers on walls 2, 3 and chimney breast | |
| <b>RESULT:</b> | Amosite | |

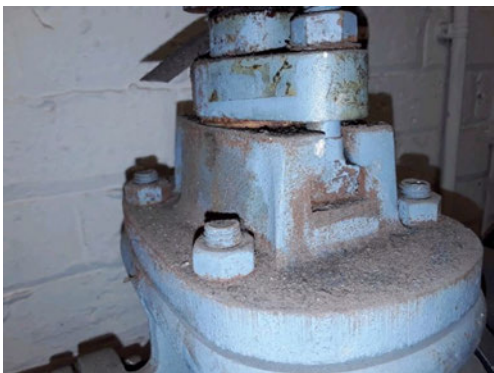
| <b>FLOOR/LOCATION:</b> | Ground Floor 0/012 - Boiler Room | |

| <b>DESCRIPTION:</b> | Insulation residues to exposed pipework and flanges | |
| <b>RESULT:</b> | Amosite | |

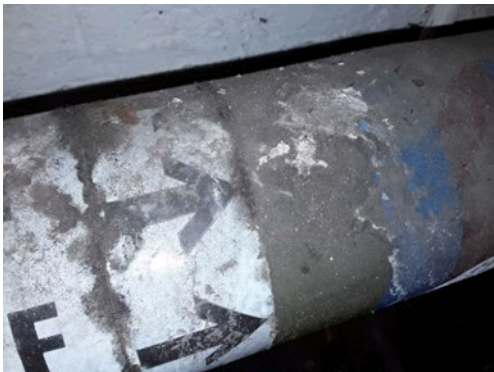
| <b>FLOOR/LOCATION:</b> | Ground Floor 0/012 - Boiler Room | |

| <b>DESCRIPTION:</b> | Paper gasket debris to aluminium pipework casing | |

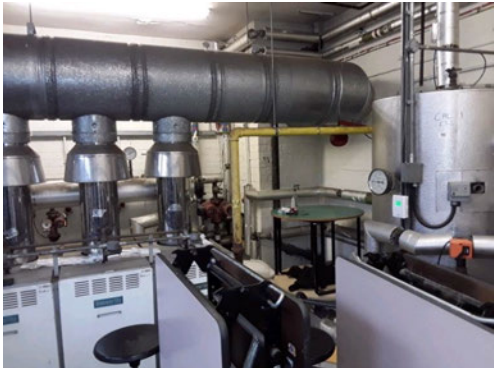
| <b>FLOOR/LOCATION:</b> | Ground Floor 0/012 - Boiler Room | |

| <b>DESCRIPTION:</b> | Presumed asbestos containing materials beneath aluminium casing/MMMF lagging to pipework and calorifier throughout entire area | |
| <b>RESULT:</b> | Presumed Crocidolite (or unknown) | |

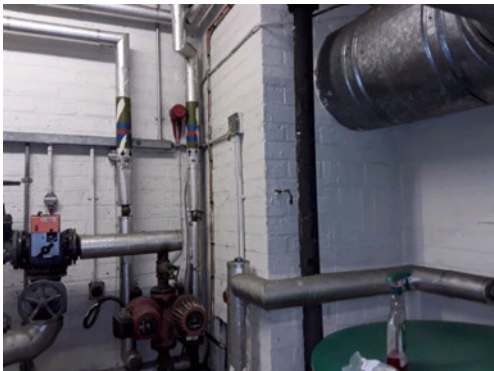
| <b>FLOOR/LOCATION:</b> | Ground Floor 0/012 - Boiler Room | |

| <b>Location</b> | <b>Description</b> | <b>Priority/Risk</b> | <b>Recommendation</b> |
|---|---|---|---|
| Main / 0/012 - Boiler Room / Ground Floor | Presumed asbestos containing materials within chimney breast between walls 3 and 4 - Unable to sample due to damage limitations | Low | Conduct further investigation prior to relevant maintenance / refurbishment works |

| <b>DESCRIPTION:</b> | Presumed asbestos containing materials within chimney breast between walls 3 and 4 - Unable to sample due to damage limitations | |
| <b>RESULT:</b> | Presumed Crocidolite (or unknown) | |

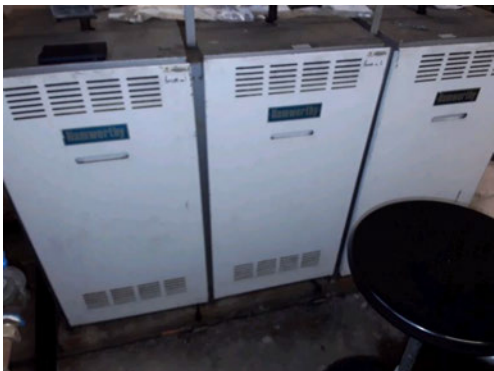
| <b>FLOOR/LOCATION:</b> | Ground Floor 0/012 - Boiler Room | |

| <b>DESCRIPTION:</b> | Presumed asbestos containing materials within Hamworthy boilers - Unable to sample due to being live at time of survey | |

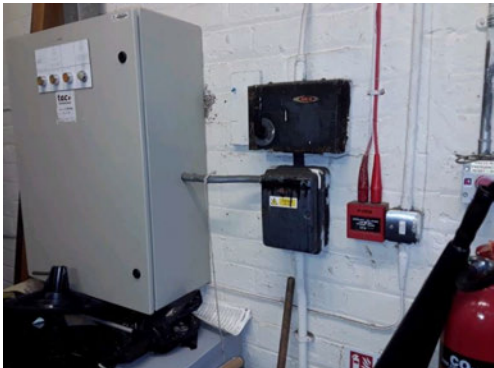
| <b>FLOOR/LOCATION:</b> | Ground Floor 0/012 - Boiler Room | |

| <b>DESCRIPTION:</b> | Presumed asbestos containing material within MEM electrical boxes to wall 1 - Unable to sample due to being live at time of survey | |
| <b>RESULT:</b> | Presumed Crocidolite (or unknown) | |

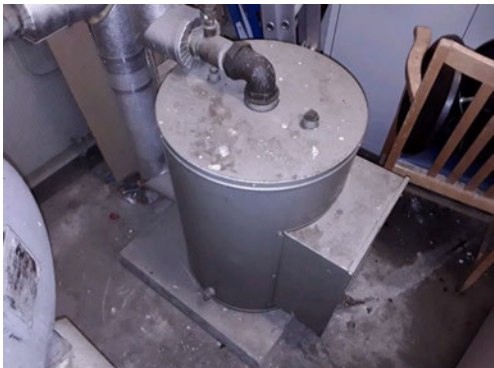
| <b>FLOOR/LOCATION:</b> | Ground Floor 0/012 - Boiler Room | |

| <b>DESCRIPTION:</b> | Presumed asbestos containing materials within water heater - Unable to sample due to being live at time of survey | |
| <b>RESULT:</b> | Presumed Crocidolite (or unknown) | |

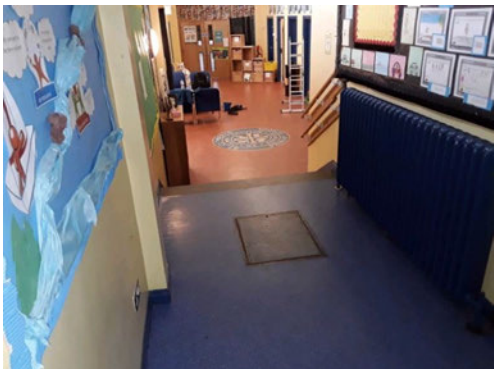
| <b>FLOOR/LOCATION:</b> | Ground Floor 0/029 - Foyer and Cloak Area | |

| <b>DESCRIPTION:</b> | Bitumen adhesive beneath red floor covering | |

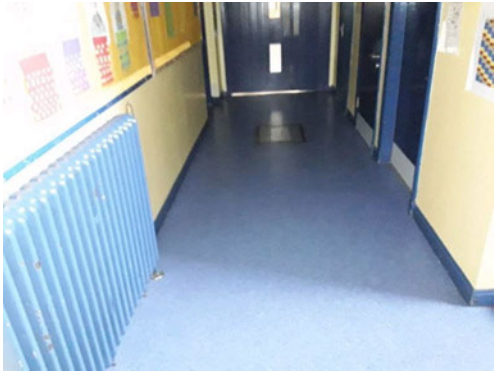
| <b>FLOOR/LOCATION:</b> | Ground Floor 0/029A - Corridor and Stairs | |

| <b>DESCRIPTION:</b> | Bitumen adhesive beneath blue modern floor covering | |
| <b>RESULT:</b> | Chrysotile | |

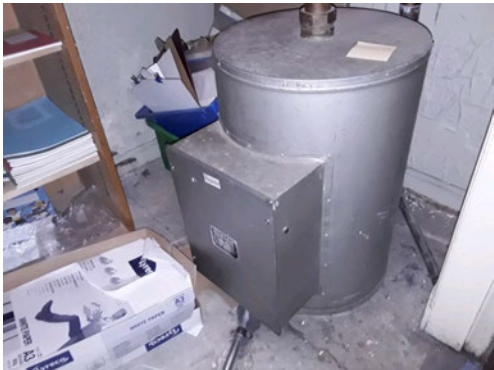
| <b>FLOOR/LOCATION:</b> | Ground Floor 0/030 - Jotter Cupboard | |

| <b>DESCRIPTION:</b> | Presumed asbestos containing materials within electrical water heater - Unable to sample due to being live at time of survey | |
| <b>RESULT:</b> | Presumed Crocidolite (or unknown) | |

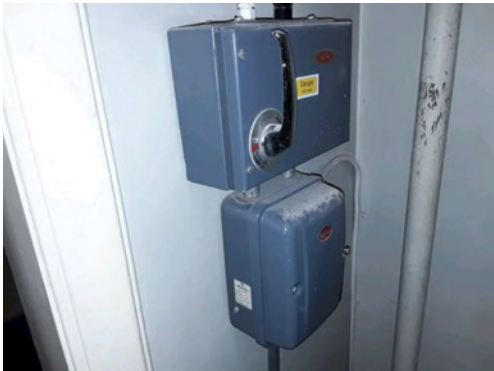
| <b>FLOOR/LOCATION:</b> | Ground Floor 0/030 - Jotter Cupboard | |

| <b>DESCRIPTION:</b> | Presumed asbestos containing materials within MEM electrical boxes - Unable to sample due to being live at time of survey | |

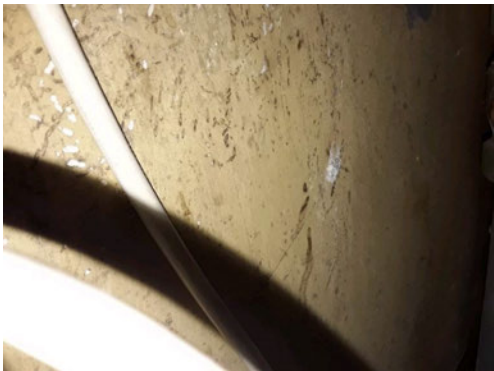
| <b>FLOOR/LOCATION:</b> | Ground Floor 0/031 - Calorifier Room | |

| <b>DESCRIPTION:</b> | Insulation residue to wall 2 | |
| <b>RESULT:</b> | Chrysotile + Amosite | |

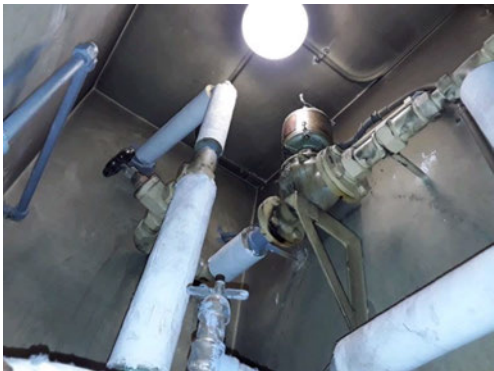
| <b>FLOOR/LOCATION:</b> | Ground Floor 0/031 - Calorifier Room | |

| <b>DESCRIPTION:</b> | Paper gaskets to high level pipe flanges | |
| <b>RESULT:</b> | Chrysotile | |

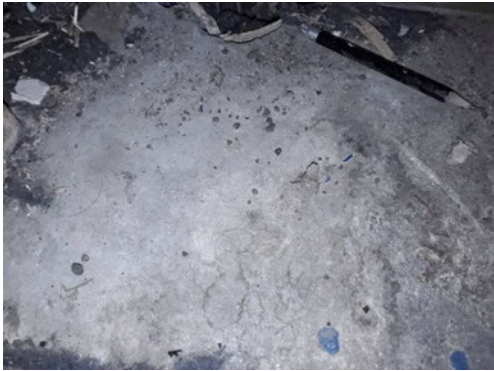
| <b>FLOOR/LOCATION:</b> | Ground Floor 0/031 - Calorifier Room | |

| <b>DESCRIPTION:</b> | Insulation debris to floor | |

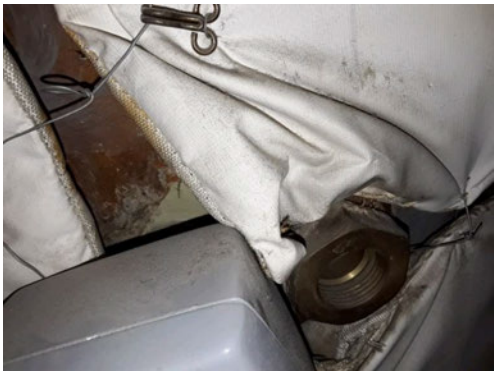
| <b>FLOOR/LOCATION:</b> | Ground Floor 0/031 - Calorifier Room | |

| <b>DESCRIPTION:</b> | Insulation debris to pipe knuckles and calorifier knuckles | |
| <b>RESULT:</b> | Chrysotile + Amosite | |

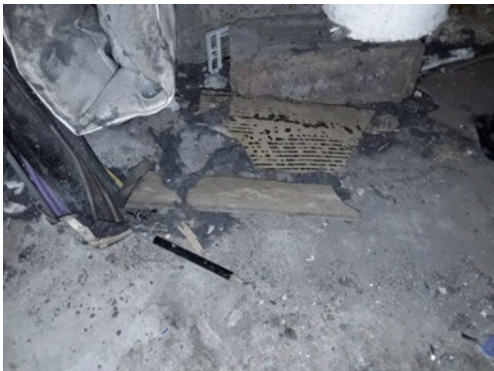
| <b>FLOOR/LOCATION:</b> | Ground Floor 0/031 - Calorifier Room | |

| Location | Description | Priority/Risk | Recommendation |
|---|---|---|---|
| Main / 0/031 - Calorifier Room / Ground Floor | Loose beige floor tiles | Medium | Remove under controlled conditions |

| <b>DESCRIPTION:</b> | Loose beige floor tiles | |
| <b>RESULT:</b> | Chrysotile | |

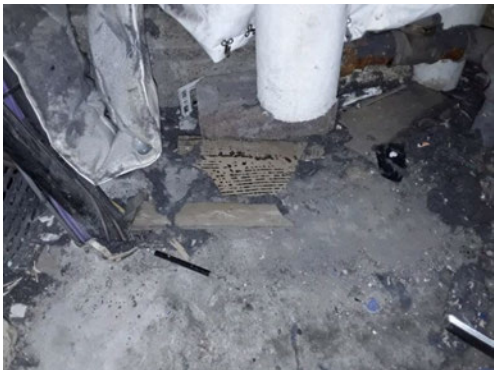
| <b>FLOOR/LOCATION:</b> | Ground Floor 0/031 - Calorifier Room | |

| Location | Description | Priority/Risk | Recommendation |
|---|---|---|---|
| Main / 0/031 - Calorifier Room / Ground Floor | Bitumen adhesive beneath loose floor tiles | Medium | Remove under controlled conditions |

| <b>DESCRIPTION:</b> | Bitumen adhesive beneath loose floor tiles | |

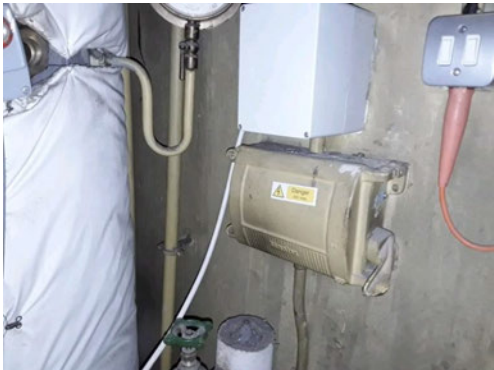
| <b>FLOOR/LOCATION:</b> | Ground Floor 0/031 - Calorifier Room | |

| <b>DESCRIPTION:</b> | Presumed asbestos containing materials within electrics - Unable to sample due to being live at time of survey | |
| <b>RESULT:</b> | Presumed Crocidolite (or unknown) | |

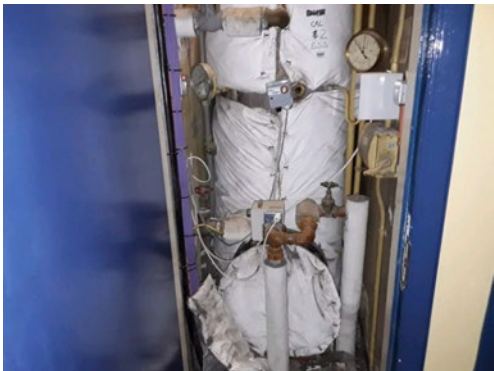
| <b>FLOOR/LOCATION:</b> | Ground Floor 0/031 - Calorifier Room | |

| <b>DESCRIPTION:</b> | Presumed asbestos containing materials within calorifier and pipework beneath modern insulating blankets and MMMF lagging - Unable to sample due to sampling exposed surface areas | |
| <b>RESULT:</b> | Presumed Crocidolite (or unknown) | |

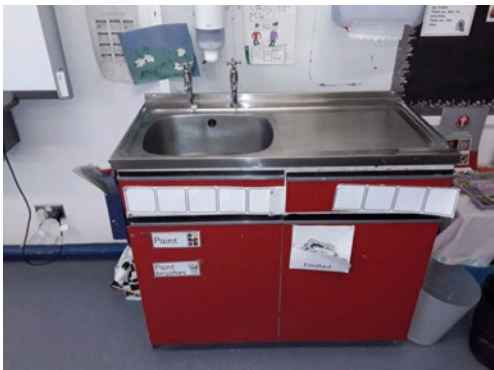
| <b>FLOOR/LOCATION:</b> | Ground Floor 0/038 - P3 Classroom | |

| <b>DESCRIPTION:</b> | Bitumen sink pad | |

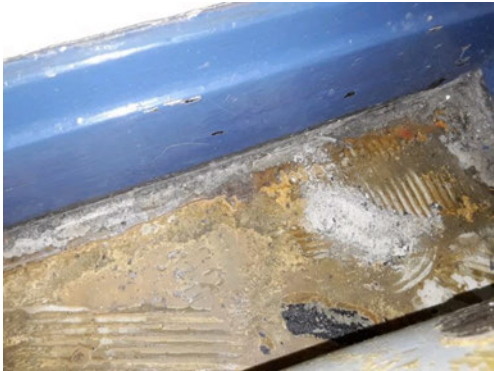
| <b>FLOOR/LOCATION:</b> | Ground Floor 0/042 - Circulation | |

| <b>DESCRIPTION:</b> | Bitumen adhesive beneath carpet and modern floor covering | |
| <b>RESULT:</b> | Chrysotile | |

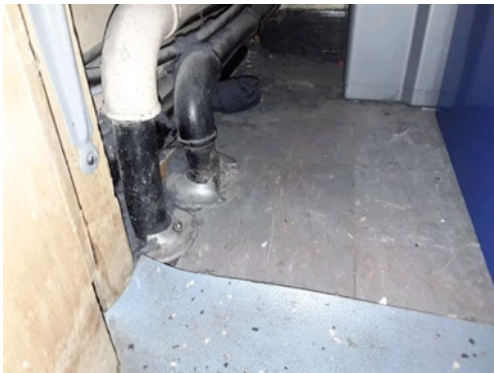
| <b>FLOOR/LOCATION:</b> | Ground Floor 0/043 - Store | |

| <b>DESCRIPTION:</b> | Grey floor tiles | |
| <b>RESULT:</b> | Chrysotile | |

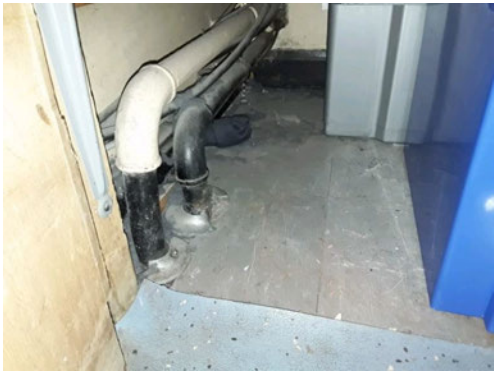
| <b>FLOOR/LOCATION:</b> | Ground Floor 0/043 - Store | |

| <b>DESCRIPTION:</b> | Bitumen adhesive beneath floor tiles | |

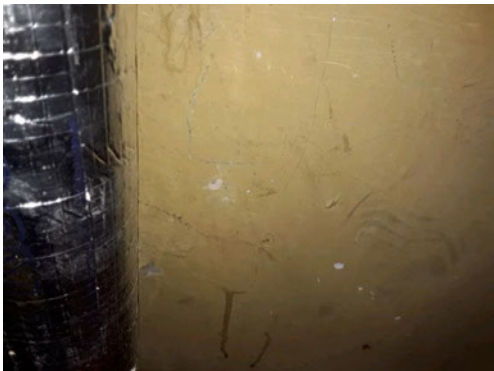
| <b>FLOOR/LOCATION:</b> | Ground Floor 0/044 - Calorifier Room | |

| <b>DESCRIPTION:</b> | Insulation residue to wall 2 | |
| <b>RESULT:</b> | Amosite | |

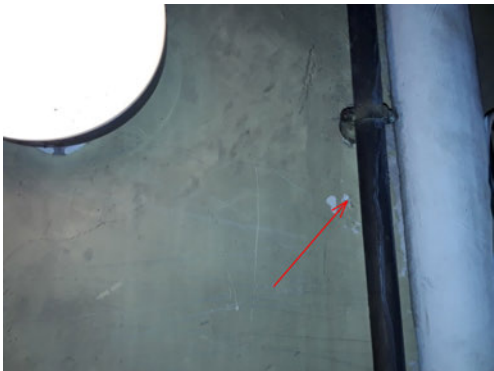
| <b>FLOOR/LOCATION:</b> | Ground Floor 0/044 - Calorifier Room | |

| <b>DESCRIPTION:</b> | Insulation residue to wall 4 | |
| <b>RESULT:</b> | Amosite | |

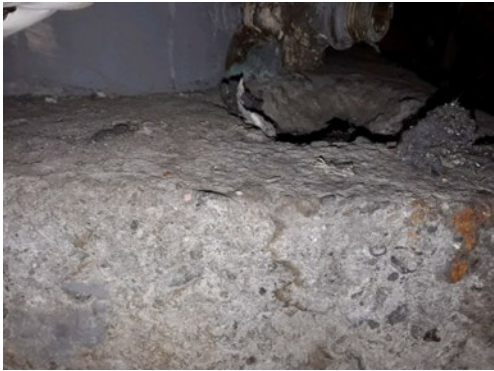
| <b>FLOOR/LOCATION:</b> | Ground Floor 0/044 - Calorifier Room | |

| <b>DESCRIPTION:</b> | Insulation debris to floor and plinth | |

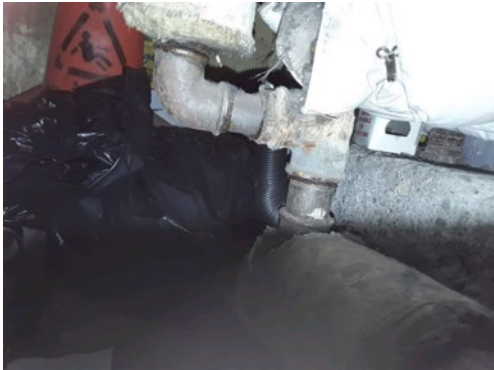
| <b>FLOOR/LOCATION:</b> | Ground Floor 0/044 - Calorifier Room | |

| <b>RESULT:</b> | Amosite | |

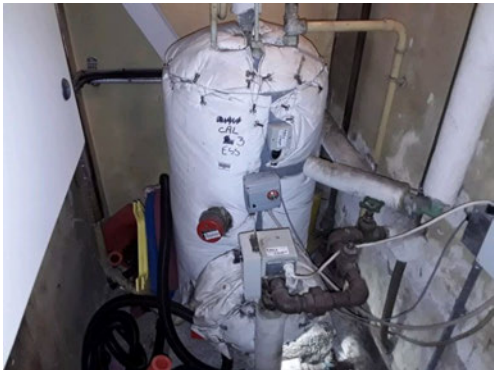
| <b>FLOOR/LOCATION:</b> | Ground Floor 0/044 - Calorifier Room | |

| <b>RESULT:</b> | Presumed Crocidolite (or unknown) | |
