SF/KL/E14804

## 29 - 35 Baberton Mains Avenue, Edinburgh Fire Damage

PROJECT TITLE:  
**BABERTON MAINS AVENUE.  
EXPLOSION INCIDENT  
STRUCTURAL RESPONSE**

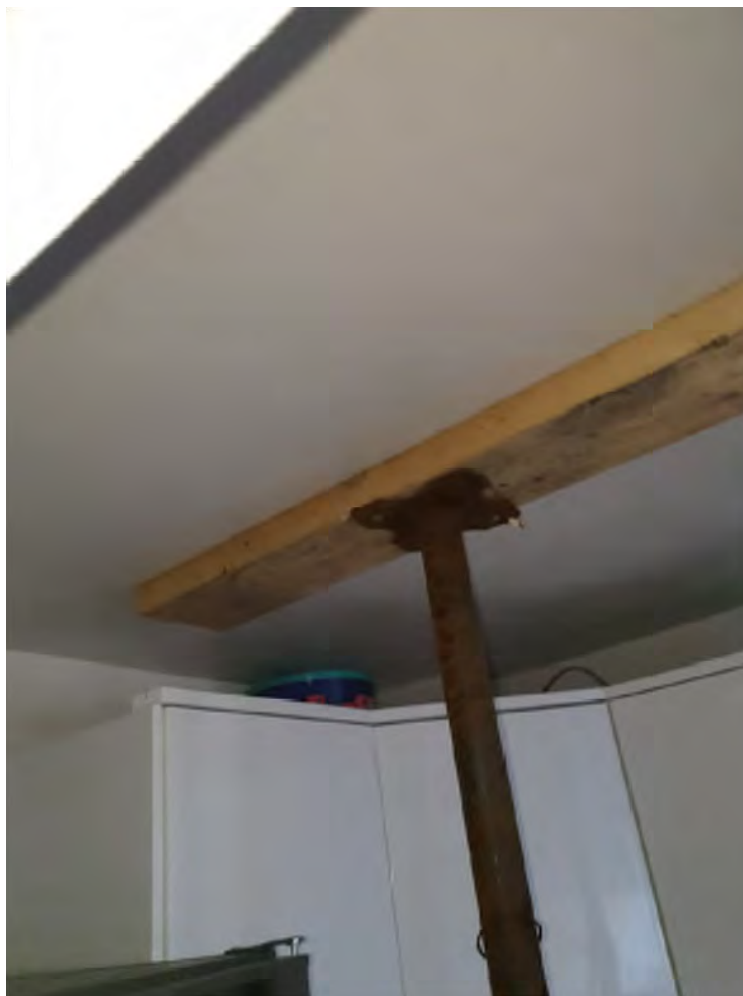
29 Baberton Mains Avenue

This property is located 2 properties away from the explosion location. It has suffered what appears to minor damage with slight cracking at the party wall with No. 31. However, the degree of damage should be fully assessed in the fullness of time by a suitably qualified structural engineer.

When viewed within the roof space, the party wall continues to the underside of the roofline and appears intact.

No. 31 has suffered partial collapse and major structural damage, with significant loss of roof and first floor structure. The party wall between 29 & 31 was substantially obscured by debris and lack of safe access for visual assessment, so the overall stability of the party wall between 29 and 31 could not be assured.

Consequently, the decision was taken, as a precautionary measure, to vertically prop the ends of the roof trusses and the 1<sup>st</sup> floor joists within no 29.

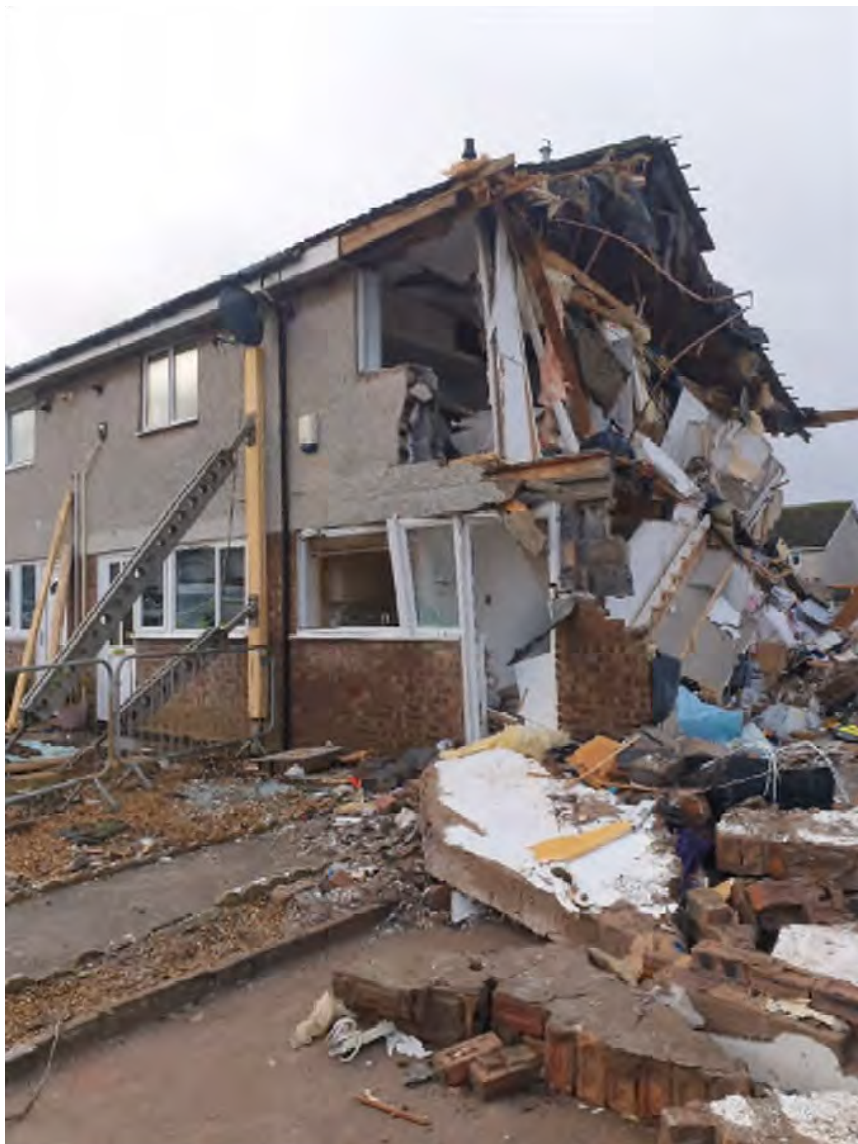
31 Baberton Mains Avenue

This property was directly adjacent to the explosion and suffered significant collapse, with most of the roof, first floor and perimeter and internal wall structure having been lost.

The front elevation remains, which is continuous with the elevation to No. 29, but has substantial cracking and is leaning out, at risk of uncontrolled collapse at first floor level. The Contractor has removed as much loose material as possible, to mitigate this.

The remaining roof trusses and roof covering, over the property at no. 31 are deemed unstable, and will require removal as will the first floor as soon as it is practical to do so. The property is presumed to need careful hand demolition likely from cherry picker access such to that the integrity of 29 is maintained.

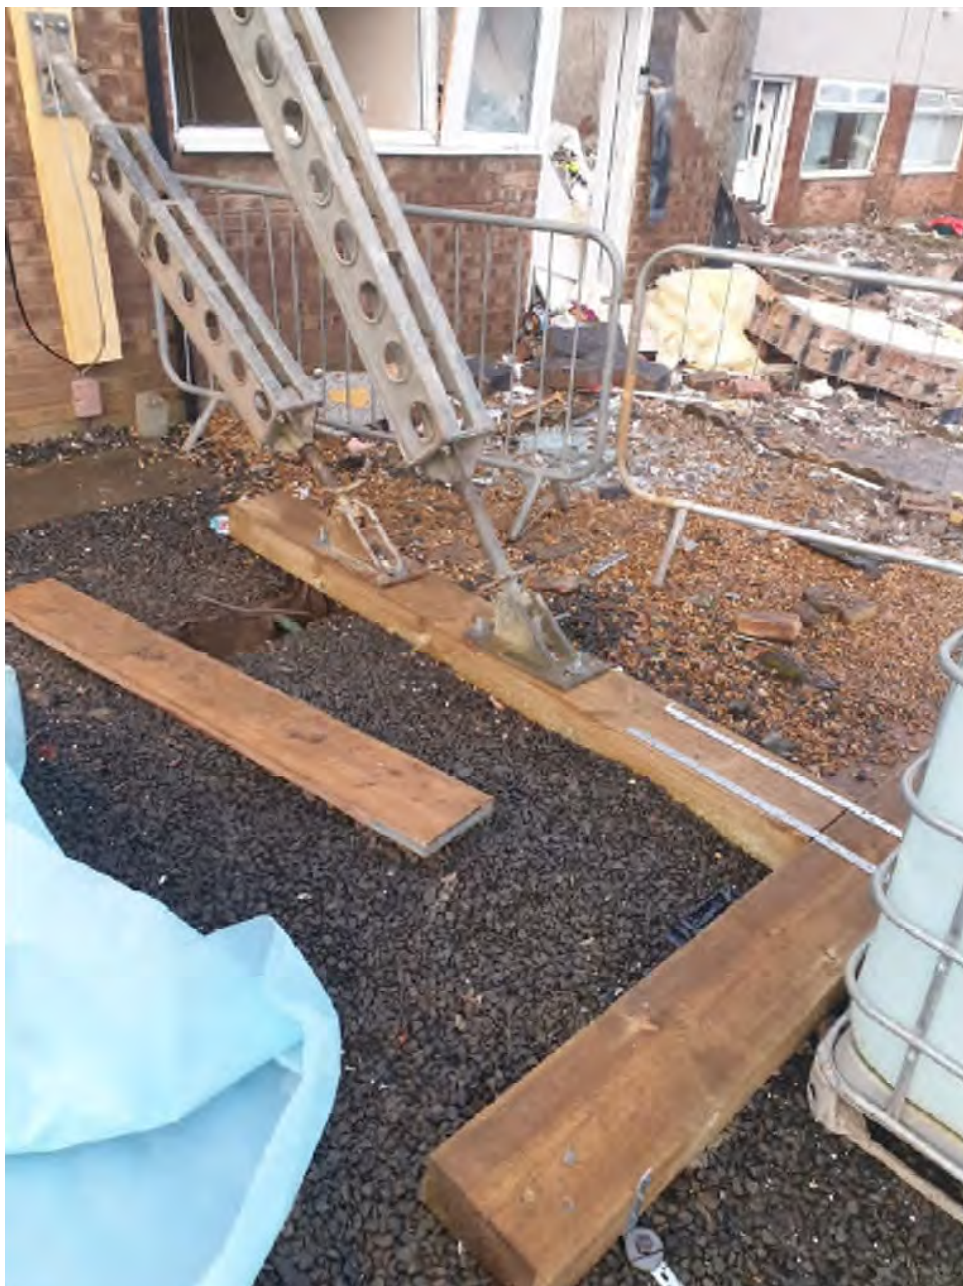
29 – 31 Baberton Mains Avenue  
Temporary Shoring to Front Elevation

As a further precaution a raking shore has been installed at the front to mitigate against the external leaf suffering further damage beyond the extent of no. 31, should any further instability occur to the front elevation to no 31. Eg. in the event of high wind.

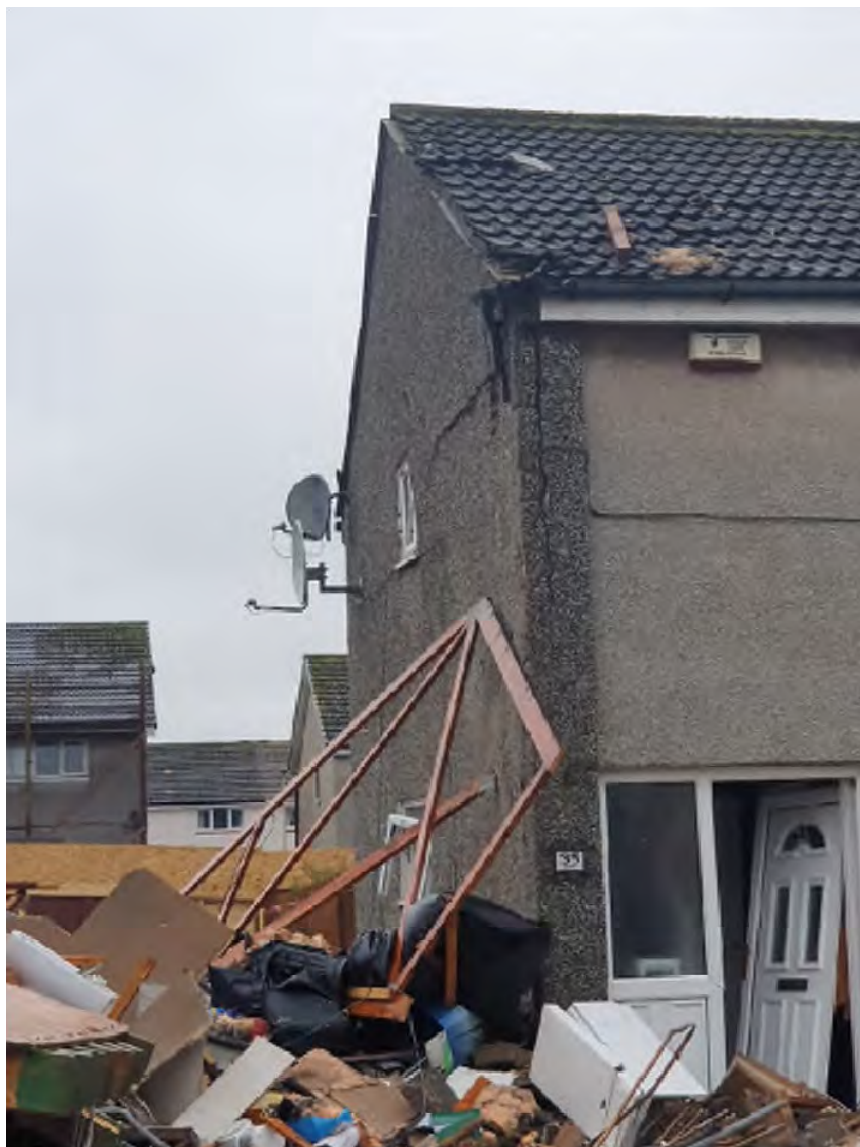
35 Baberton Mains Avenue

The cavity gable wall to the south of No. 35 appears to have absorbed significant energy from the blast and is now deemed unstable. There is major inward bulging to the gable wall by an estimated 100mm and major cracking, which is particularly evident on the inner face of the wall which has become crazed with random panels of size of some 1m<sup>2</sup> being created. This is visible internally within the stairwell, which is adjacent to the gable. We would deem this wall at significant risk of collapse, which causes a risk to anyone in the immediate fall zone facility adjacent to the gable.

Unstable gable wall

The gable should be carefully taken down and other parts of the structure until a time as only sound parts of the structure remain before building back the missing parts of the structure so as to preserve the structural integrity of the remainder of the property and that of the neighbouring property at number 37.

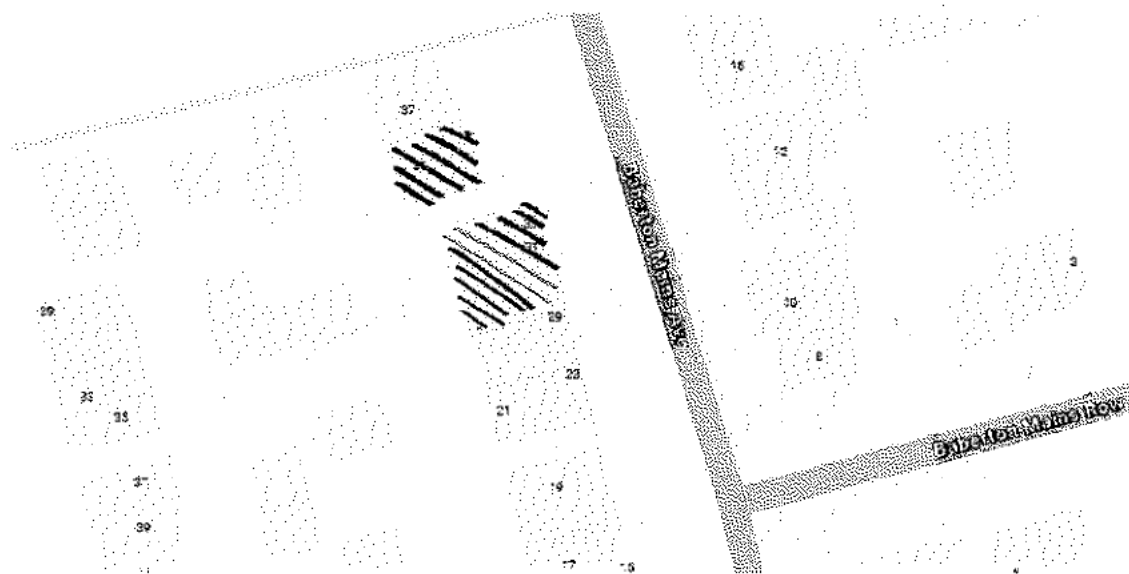
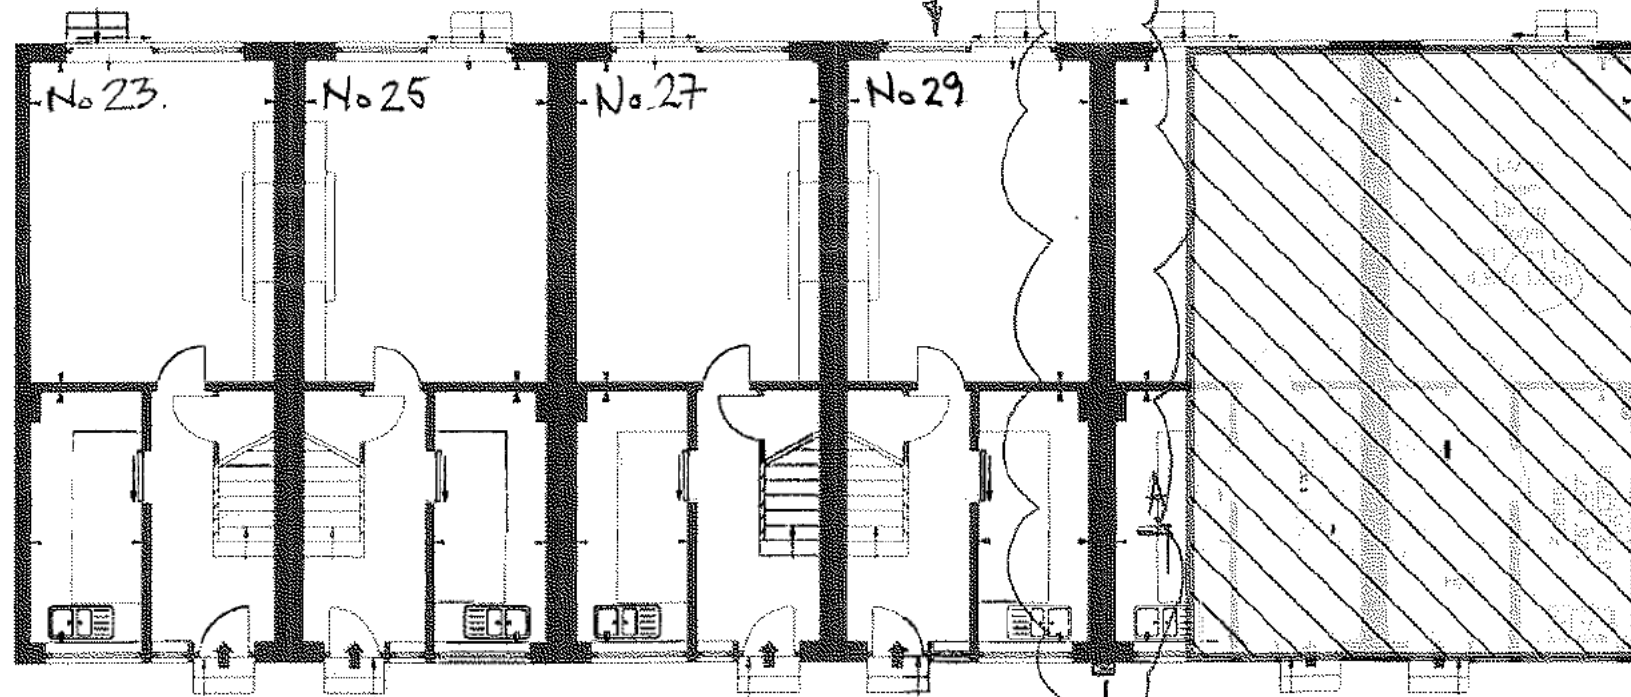
DRG TITLE:  
**EXTERNAL PROPPING  
TO No 29/31.  
PARTY WALL.**

NOTE:  
PARTY WALL TO BE  
EXTERNAL WALL IN  
TEMPORARY CONDITION  
SUPPLEMENTARY LATERAL  
RESTRAINT IS ANTICIPATED  
(BY OTHERS).

NOTE:  
GABLE TO No 35 IS UNSTABLE.  
NO PERSONNEL TO ENTER  
EXCLUSION UNTIL FURTHER RISK  
ASSESSMENT OR MITIGATION  
MEASURES ARE IN PLACE.

The party wall between no. 29 and 31 should be reassessed, in the temporary condition, as it will effectively become an external gable wall, subject to additional external wind pressures. A Structural Engineer should further carry out a detailed structural inspection of the 4 properties listed here and also their immediate neighbours at no 27 and 37 and establish the vertical and horizontal tying of the roof, floor and wall elements and ensure that adequate lateral and horizontal restraints are in place. Additional lateral and vertical strapping should be in line with normal practice for gable and loadbearing masonry construction should be considered. The careful taking down of any damaged elements should be continued such that an assured base can be used for the reconstruction of the damaged and destroyed properties.

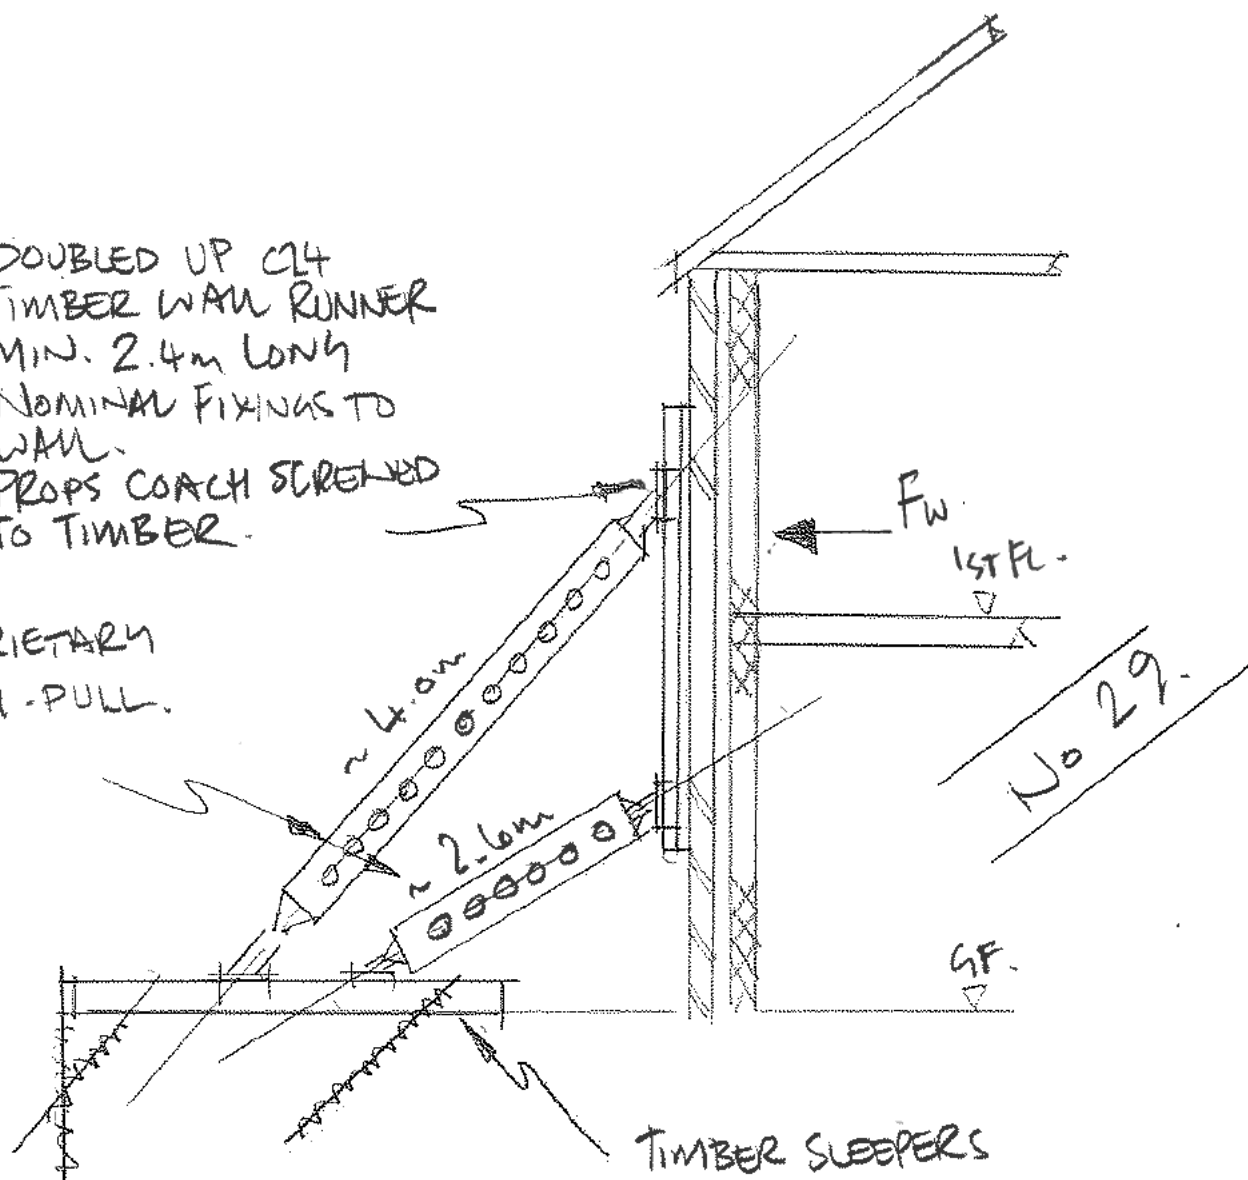
**EXTERNAL PROPPING  
SECTION A-A.**

TEMPORARY  
SHORING LOAD  $F_w = 16 \text{ kN(CHAR)}$

DOUBLED UP C14  
TIMBER WAIL RUNNER  
MIN. 2.4m LONG  
NOMINAL FIXINGS TO  
WALL.  
PROPS COACH SCREWED  
TO TIMBER.

2 No. PROPRIETARY  
STEEL PUSH-PULL  
PROPS.

SHORE BASES BOLTED/  
COACH SCREWED TO  
TIMBER SLEEPERS

TIMBER SLEEPERS  
FORMING BASE TO  
PROPPING ANCHORED  
WITH MIN. 4 No.  
490mm LONG S50-10-0490.  
SPRAXIG GROUND ANCHORS

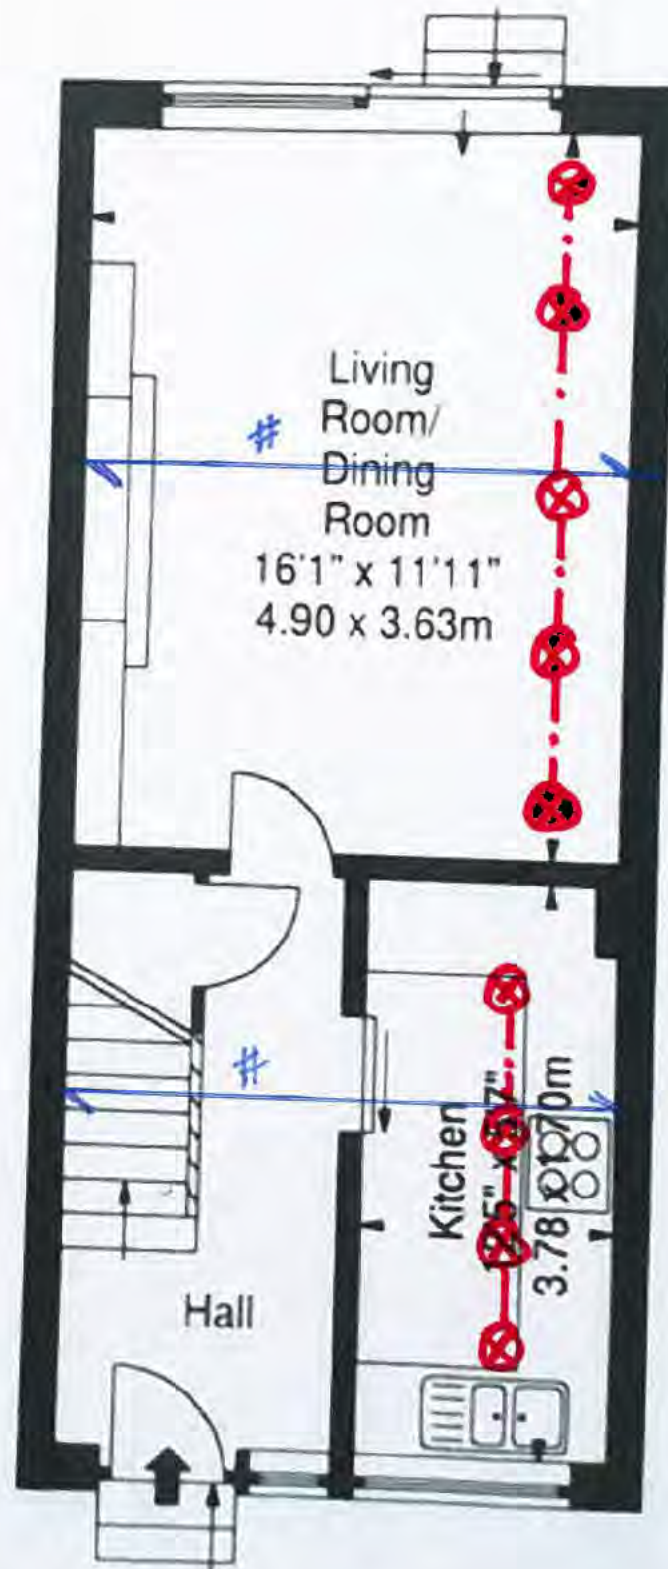
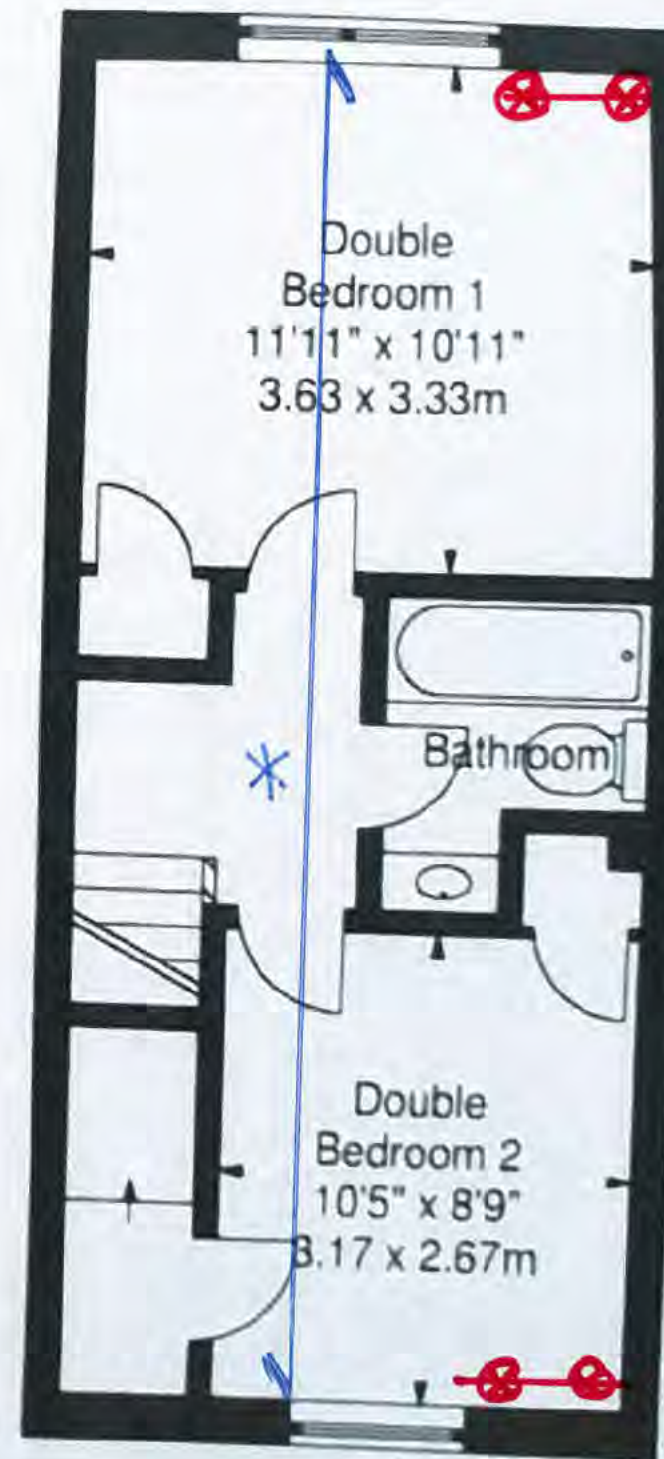
**INTERNAL PROPPING.  
No. 29  
BABERTON MAINS AVENUE**

•  
•  
•  
DENOTES TYPE 2 ACROW  
PROPS WITH DOUBLED 200x50  
TIMBER HEADER BETWEEN.  
NOTE:  
TIMBER SOLS PLATE TO BE  
600mm LONG ORIENTATED  
PERPENDICULAR TO SUPPORTING  
JOISTS BELOW.
