Roof Survey Report

Calderglen Early Learning & Childcare
Wester Hailes Road, EDINBURGH
EH11 4NG, United Kingdom

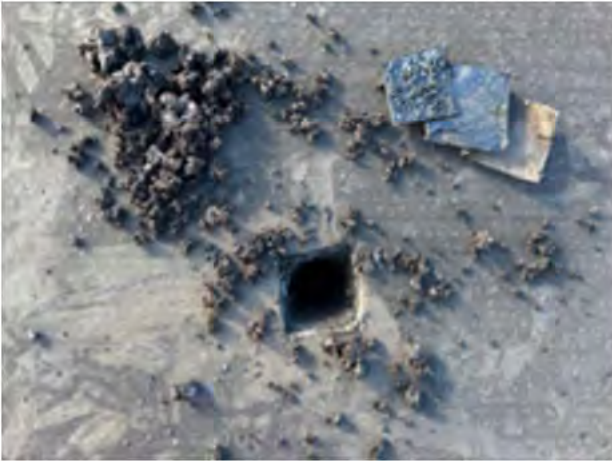
Core on lower roof shows cork saturated

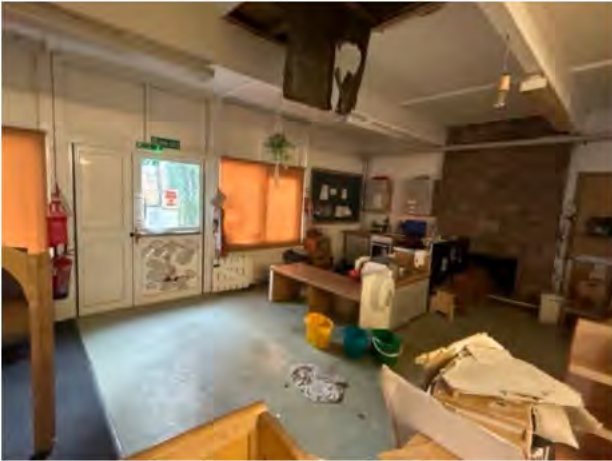
Partial ceiling collapse internally and water ingress shows the existing waterproofing system and drainage has failed

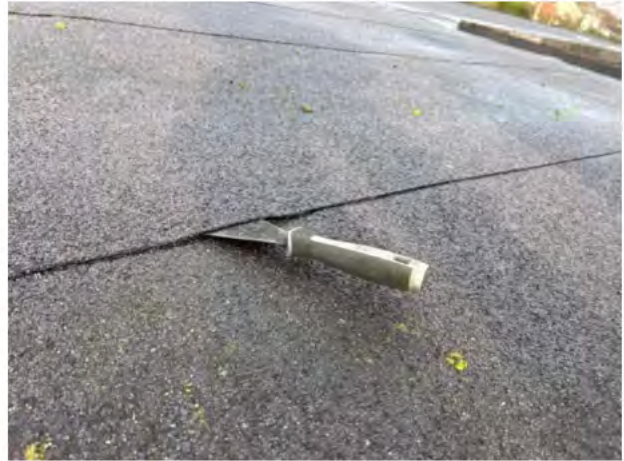
Loose laps were found over the roof area

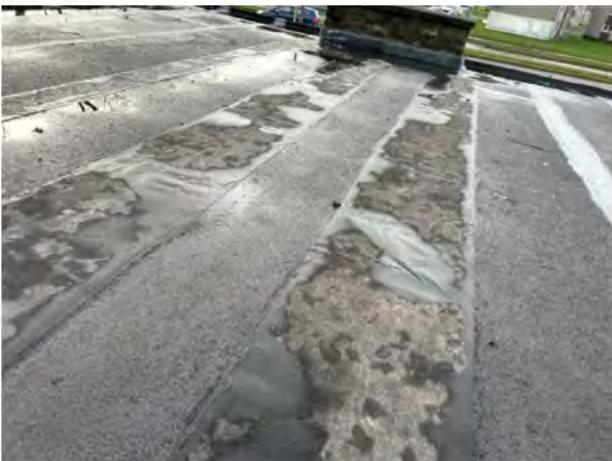
Repairs were noted on both the main and lower roofs to have historically been carried out with many different materials

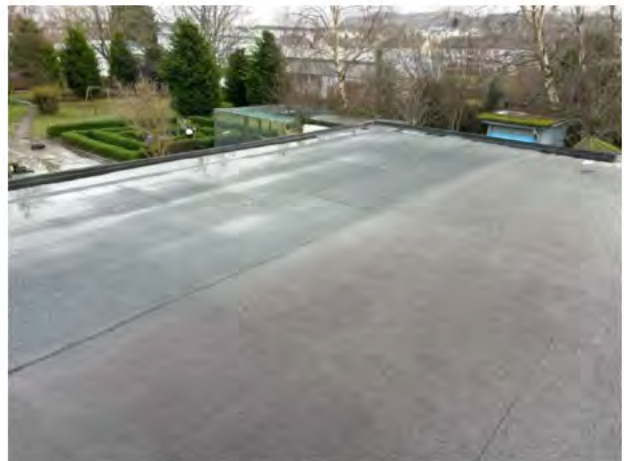
Different mineral cap sheets noted in the picture above shows a historic repair

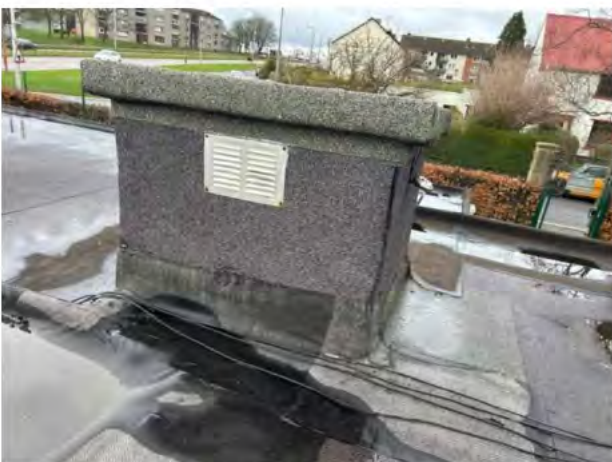
Bare faced felt repairs were also evident to have been carried out on the roof areas

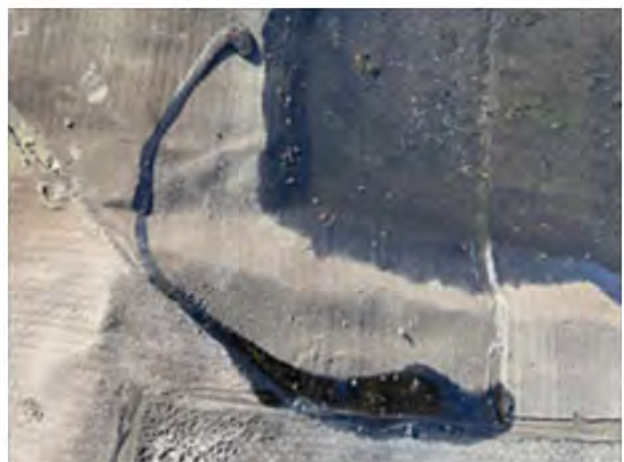
Water was found under some of the repairs, these have also failed

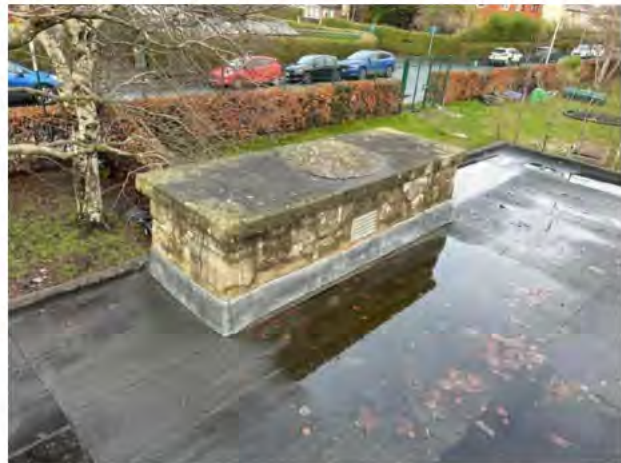
Additional ponding just outside the gutters was also noted

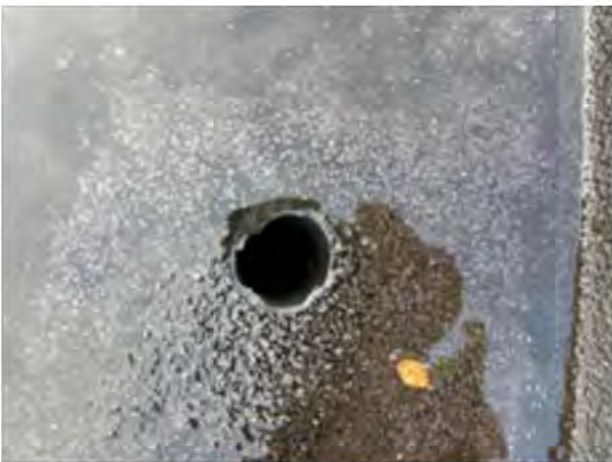
The current outlets are very narrow and poorly detailed
