Spaces for People

Scheme Review Form

Location	Original justification
Morningside Town Centre	To provide safe space for pedestrians to walk, exercise and access local shops. To provide safe cycling routes and prioritise public transport as an alternative to driving.

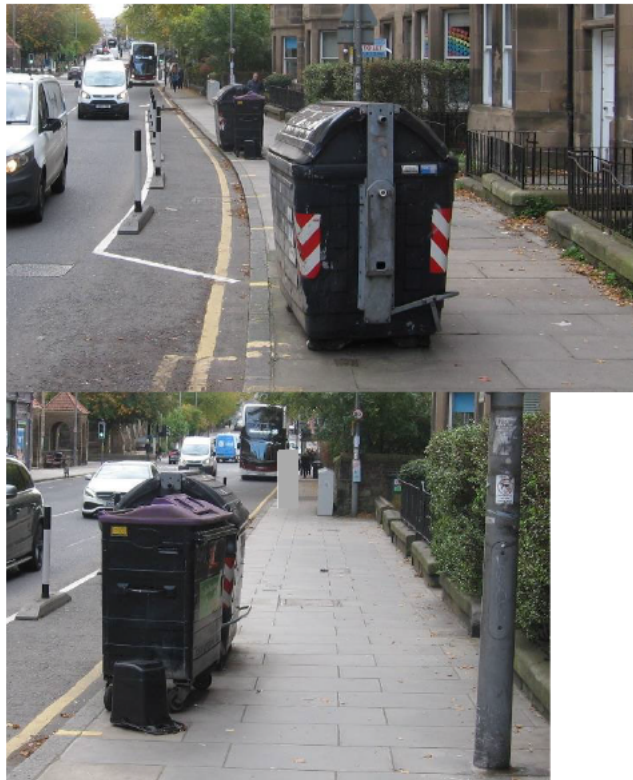
Location 20W (Morningside Road west):

Although the pavement is reasonably wide here (3.2m), its utility is significantly constrained by the placement of communal bins, which reduce the Clear Walking Zone to just 1.2m (ie less than the SDG 'absolute minimum' of 1.5m).

Recommendation: relocate the bins on to the SfP space in order to free up the pavement as a continuous one-level width for both movement and social space.

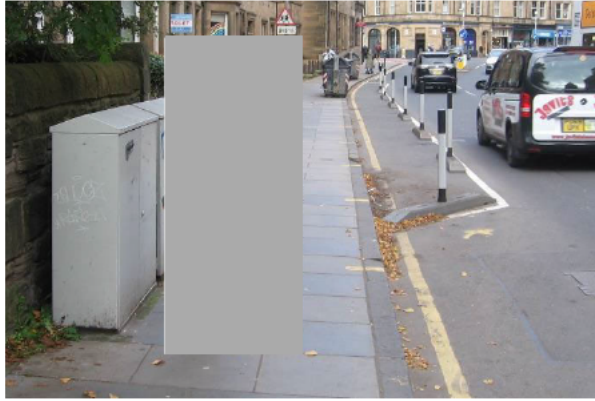
Location 21W (Morningside Road west):

The pavement narrows to only 2.15m here (ie less than the SDG 'absolute minimum' of 2.5m), and the grey utility boxes reduce the Clear Walking Zone to just 1.6m.

Recommendation: extend the Sfp space a short distance towards Holy Corner in order to remove the pedestrian pinchpoint.

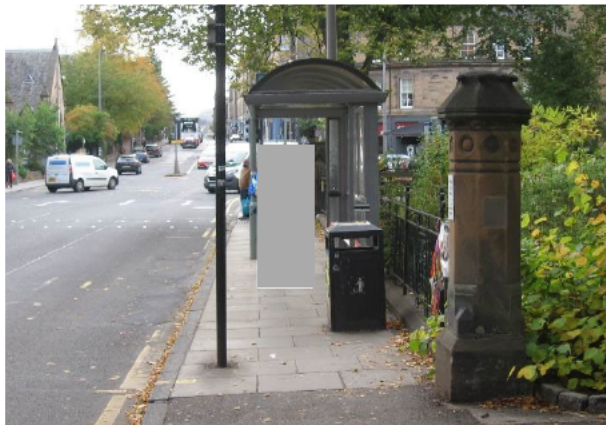
The pavement width here is only 2.15m (ie less than the SDG 'absolute minimum' of 2.5m) at a location where queuing (for buses) is frequent, and the Clear Walking Zone is just 1.35-1.45m (ie less than the SDG 'absolute minimum' of 1.5m).

Recommendation: relocate the litter bin to a more appropriate location, and investigate relocating the signage pole.

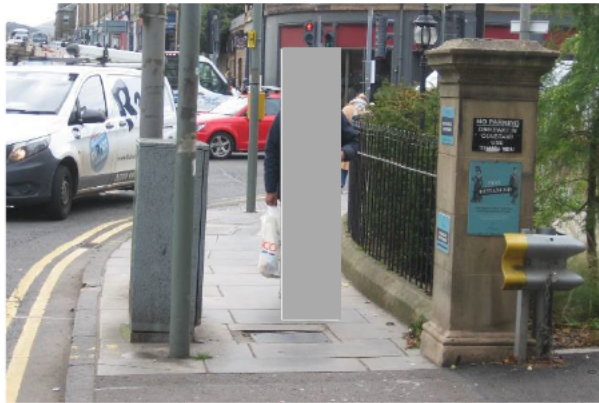
The pavement here is only 2.3m wide (ie less than the SDG 'general minimum' of 2.5m), despite this being one of the busiest pedestrian junctions on the entire corridor) and the poles / grey utility box reduce the Clear Walking Zone to just 1.4m (compared to the SDG 'absolute minimum' of 1.5m).

Recommendation: as per Location 22NW3 above, plus investigate the scope for relocation of the utility box / poles.

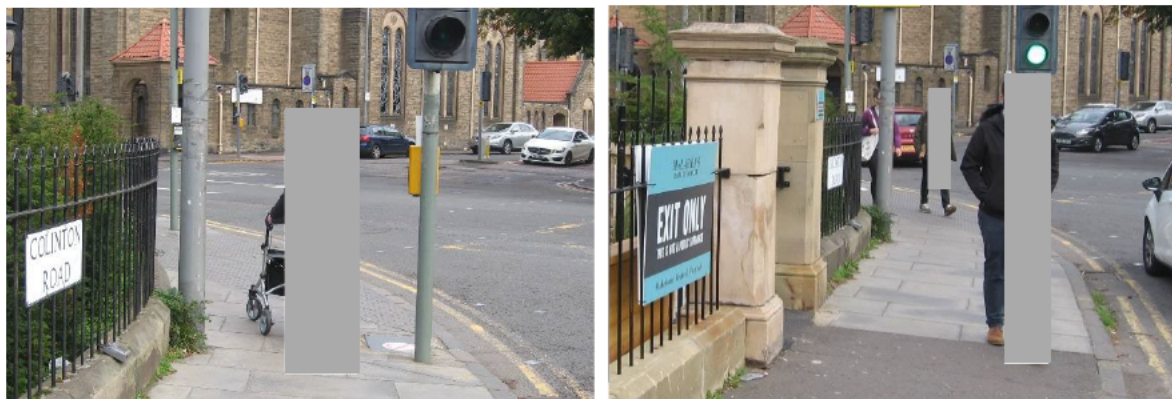
The pavement width at the queuing area for this important pedestrian crossing is only 2.3m (ie less than the SDG 'general minimum' of 2.5m), and the Clear Walking Zone between the two poles (left photo) is just 1.4m, compared to the SDG 'absolute minimum' of 1.5m.

Recommendation: as per Location 22NW3 above, plus instruct McLaren's to remove the misleading sign. The Council and/or ScotWays (the Scottish Rights of Way Society) to erect a sign indicating the Right of Way.

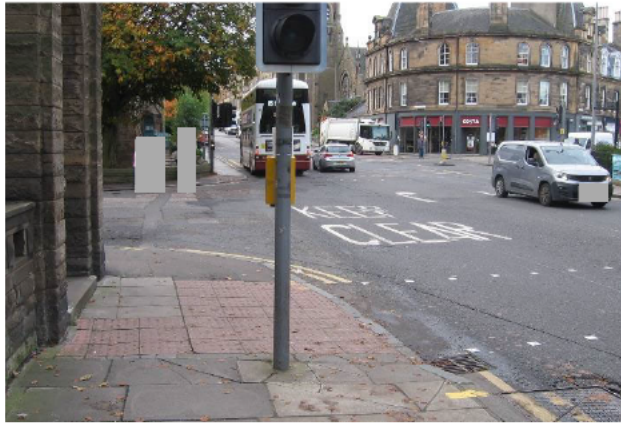
The pavement here is only 2.8m wide (ie less than the SDG 'general minimum' of 3m), and the Clear Walking Zone is just 1.8m.

Recommendation: in the short term, increase the frequency of the Green Man phase.

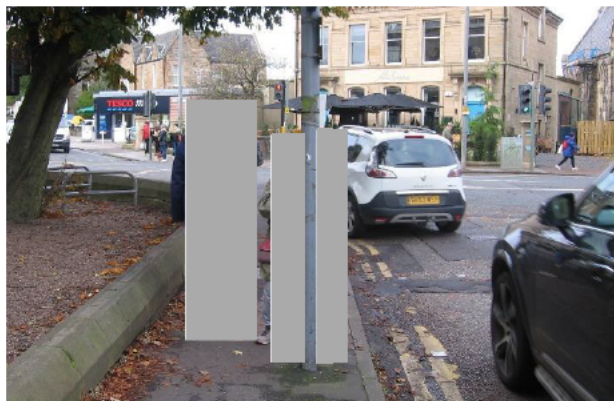
The pavement width here is only 1.7m (ie significantly less than the SDG 'absolute minimum' of 2m), and the Clear Walking Zone is just 1.1m (ie substantially less than the SDG 'absolute minimum' of 1.5m). There are long waits for the Green Man phase, during which large numbers of pedestrians can congregate in a way where it is impossible to maintain social distancing.

Recommendation: as per Location 22SW1/2 above.

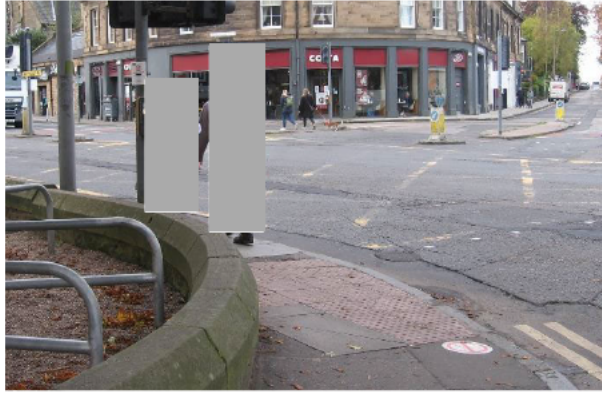
The pavement width here is only 1.65m (ie significantly less than the SDG 'absolute minimum' of 2m), and the Clear Walking Zone is just 1.45m (ie less than the SDG 'absolute minimum' of 1.5m). Pedestrians can feel very vulnerable at this location on such a narrow pavement strip, with southbound vehicles on Morningside Road passing at speed less than a metre away. There are long waits for the Green Man phase, during which large numbers of pedestrians can congregate in a way where it is impossible to maintain social distancing.

Recommendation: as per Location 22SW1/2 above.

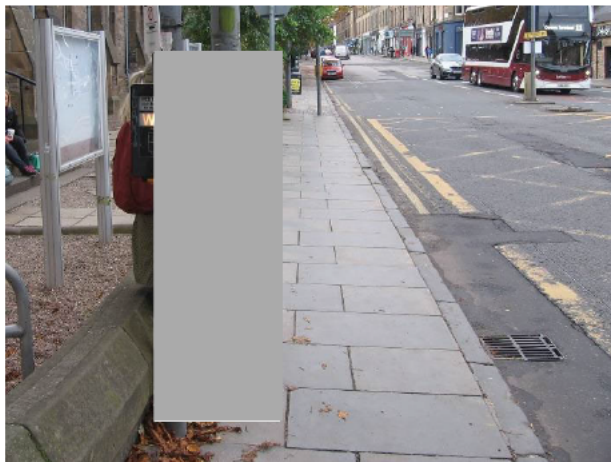
The pavement width here is only 1.8m (ie less than the SDG 'absolute minimum' of 2m). Pedestrians can feel very vulnerable at this location on such a narrow pavement strip, with southbound vehicles on Morningside Road passing at speed less than a metre away. There are long waits for the Green Man phase, during which large numbers of pedestrians can congregate in a way where it is impossible to maintain social distancing.

Recommendation: as per Location 22SW1/2 above.

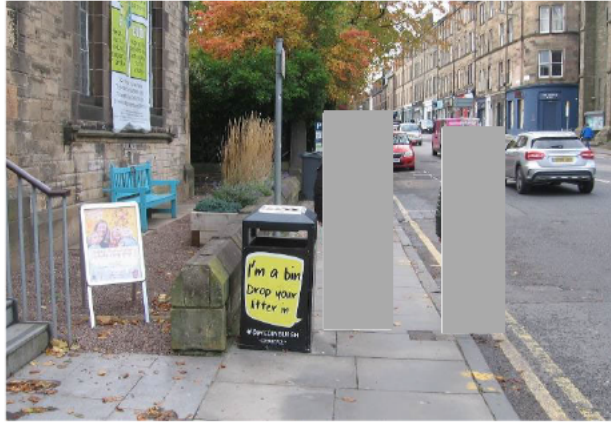
The pavement width here is only 1.85m (ie less than the SDG 'absolute minimum' of 2m), and the thoughtlessly-located litter bin reduces the Clear Walking Zone to just 1.25m (ie less than the SDG 'absolute minimum' of 1.5m) beside a very busy road.

Recommendation: negotiate to relocate the litter bin to the east of the wall (within the Eric Liddell Centre grounds), and – using concrete blocks – create a SfP space for walking between here and the Greenhill Park junction.

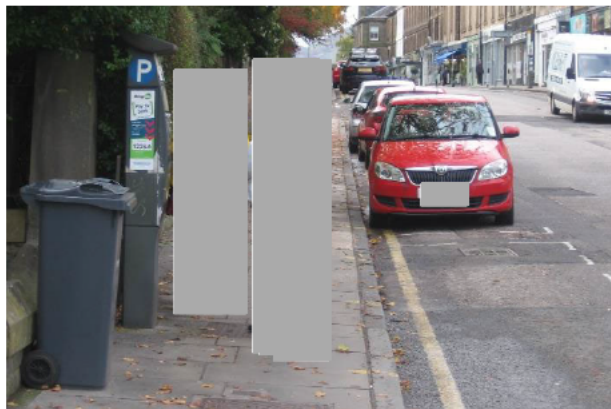
The pavement width here is only 1.9m (ie less than the SDG 'absolute minimum' of 2m), and the parking ticket machine reduces the Clear Walking Zone to just 1.5m.

Recommendation: create a SfP space for walking between the Eric Liddell Centre southern entrance (as in the Location 23E1 photo) and the Greenhill Park junction.

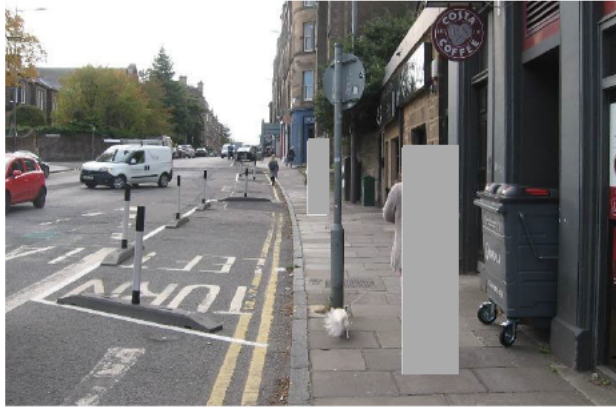
The pavement here is only 2.2m wide (ie less than the SDG 'general minimum' of 2.5m), and the Clear Walking Zone at the pole is just 1.65m. As queuing outside Luca's is common in the summer, the additional SfP space is welcome as a 'social' space and also a 'movement' space.

Recommendation: retain the SfP space, and in the longer term permanently widen the pavement proper to create a continuous one-level space.

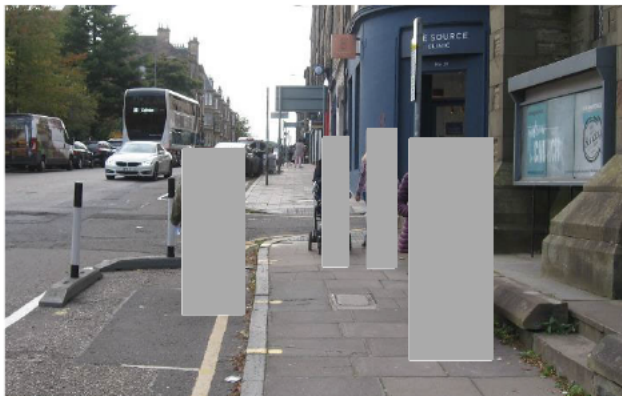
The pavement here is only 2.1m wide (ie less than the SDG 'general minimum' of 2.5m). This is often a busy section of pavement and queuing outside the Post Office is common, therefore the additional SfP space is welcome as a 'social' space and also a 'movement' space.

Recommendation: retain the SfP spaces, and in the longer term permanently widen the pavement proper to create continuous one-level spaces.

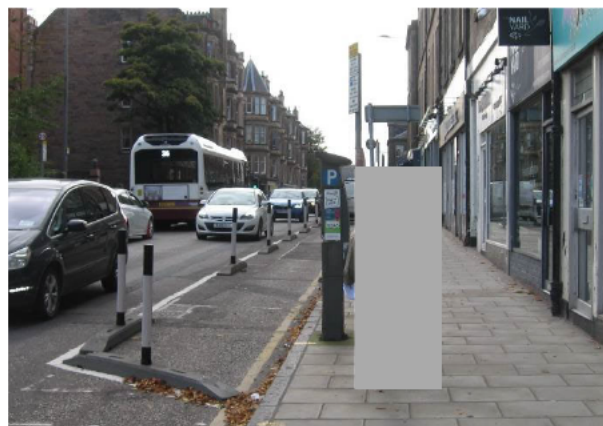
The pavement here is only 2.7m wide (ie less than the SDG 'general minimum' of 3m). This is often a busy section of pavement, therefore the additional SfP space is welcome as a 'social' space and also a 'movement' space.

Recommendation: retain the SfP space, and in the longer term permanently widen the pavement proper to create a continuous one-level space.

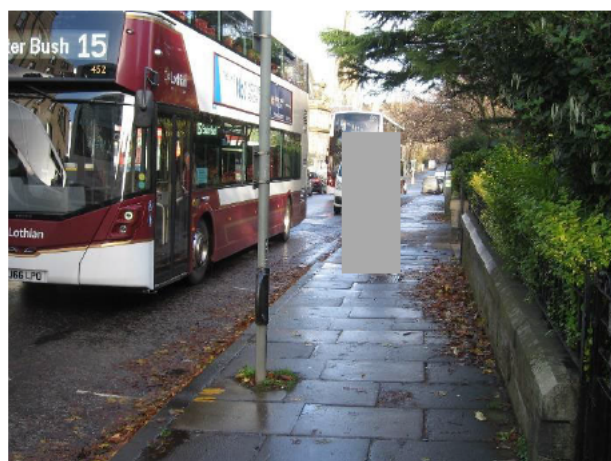
The pavement here is only 2.2m wide (ie less than the SDG 'absolute minimum' of 2.5m, which is 'only allowed in short sections').

Recommendation: in the longer-term review the overall design of this section of Morningside Road to prioritise safe and convenient pedestrian passage.

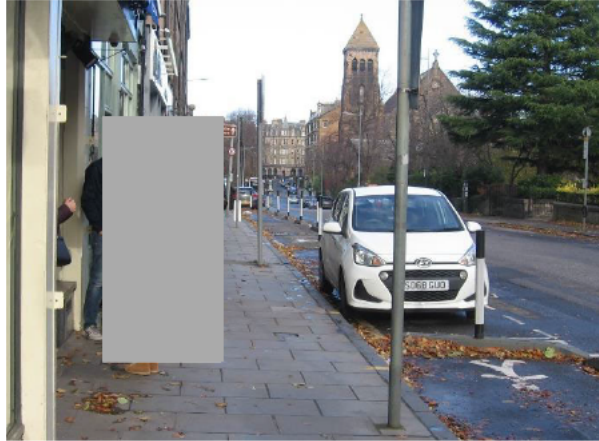
The pavement here is only 2.65m wide (ie less than the SDG 'general minimum' of 3m), and this is a location where queuing on the pavement is common.

Recommendation: extend Sfp space further south from Location 25W.

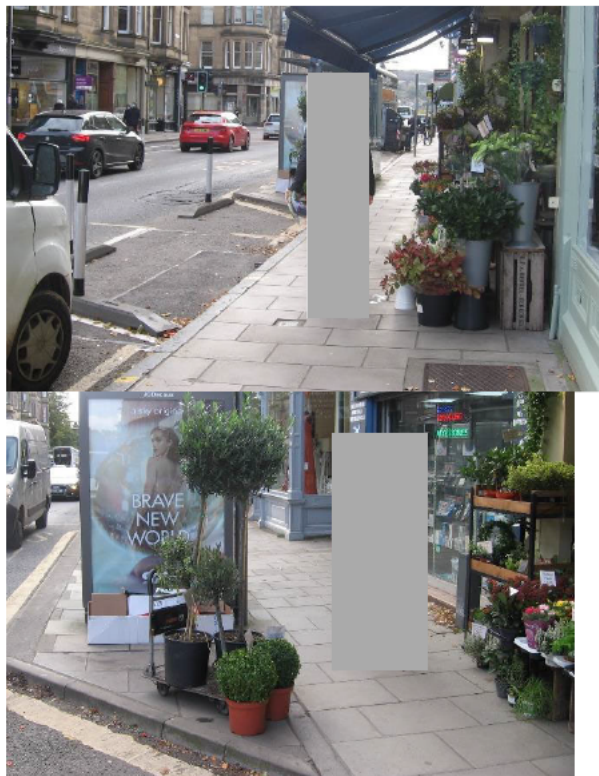
The pavement proper here is only 2.6m wide, and due to the depth of goods on display here, the Clear Walking Zone is only 1.2m in places (ie significantly less than the SDG

Section 129(9) of the Road Scotland Act 1984 forbids the placement of goods for sale on the public sections of the street. If alerted to such a problem, the Council can issue a statutory notice to the offending business and action then taken if they fail to comply.

Recommendation: retain the SfP space, and in the longer term permanently widen the pavement proper to create a continuous one-level space. Encourage the shop owner to convert his frontage to create street access to goods on display without encroaching on the pavement, as in the example on Home Street – or that on Bruntsfield Place (west side), as shown below.

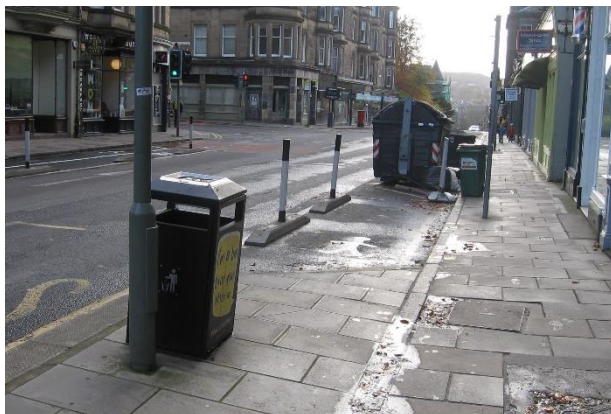
Location 28W (Morningside Road west):

The pavement here is only 1.9m wide (ie substantially less than the SDG ‘absolute minimum’ of 2.5m) and therefore the additional 1.8m SfP space is very welcome as a ‘social’ space and also a ‘movement’ space contiguous with the bus stop ‘build-out’.

Recommendation: retain the SfP space, and in the longer term permanently widen the pavement proper to create a continuous one-level space.

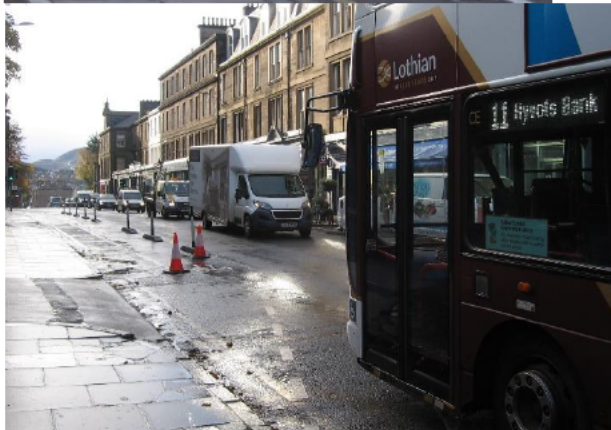
The pavement here is only 2.2m wide (ie significantly less than the SDG 'absolute minimum' of 2.5m), with a Clear Walking Zone of just 1.7m in places, and therefore the additional SfP walking lane (1.35m) is welcome.

There is no permanent physical deterrent to vehicles entering the two lanes from the north (top right photo) and on a number of occasions vehicles have been observed using the 'Active Travel' lanes (bottom left photo).

Recommendation: provide a permanent physical deterrent to vehicles entering the 'Active Travel' lanes (plastic cones are currently in place).

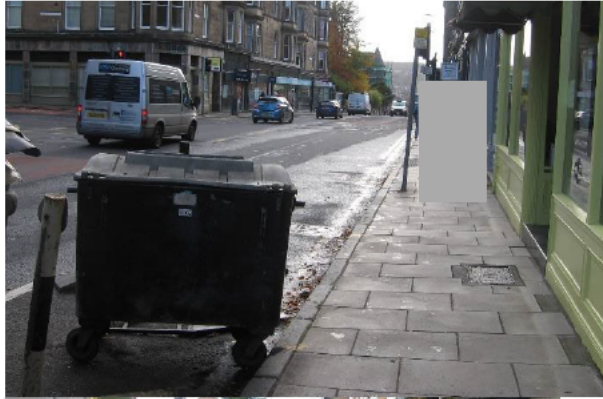
The pavement at the traffic light crossing of Morningside Road on the north side of the junction at Church Hill is only 1.9m wide, with a Clear Walking Zone of just 1.2m at the pole (right photo) – ie both substantially less than the SDG ‘absolute minimum’. Being at a crossing with a long interval between the Green Man phases, this is a location where people unavoidably congregate, in addition to those passing along Morningside Road.

Recommendation: in the short term, increase the frequency of the Green Man phase.

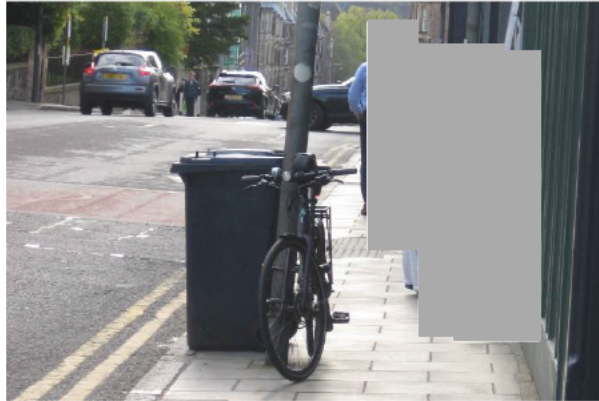
The pavement here is only 1.9m wide (ie substantially less than the SDG 'absolute minimum' of 2.5m), with a Clear Walking Zone of just 1.2m. (ie substantially less than the SDG 'absolute minimum' of 1.5m). There are long waits for the Green Man phase, during which large numbers of pedestrians can congregate in a way where it is impossible to maintain social distancing.

Recommendation: in the short term, increase the frequency of the Green Man phase.

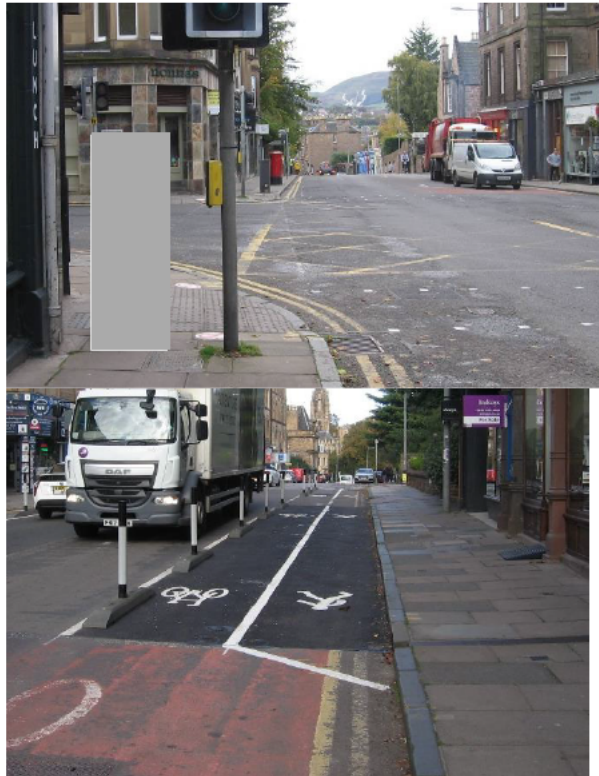
The pavement here is only 2.35m wide (ie less than the SDG 'absolute minimum' of 2.5m), with a Clear Walking Zone of just 1.3m. (ie less than the SDG 'absolute minimum' of 1.5m). There are long waits for the Green Man phase, during which large numbers of pedestrians can congregate in a way where it is impossible to maintain social distancing.

Recommendation: in the short term, increase the frequency of the Green Man phase.

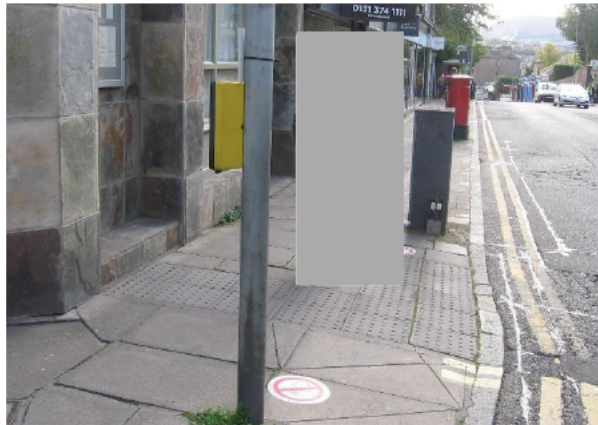
The pavement here is only 2.55m wide with a Clear Walking Zone of just 1.5m. There are long waits for the Green Man phase, during which large numbers of pedestrians can congregate in a way where it is impossible to maintain social distancing.

Recommendation: as per Location 33NE.

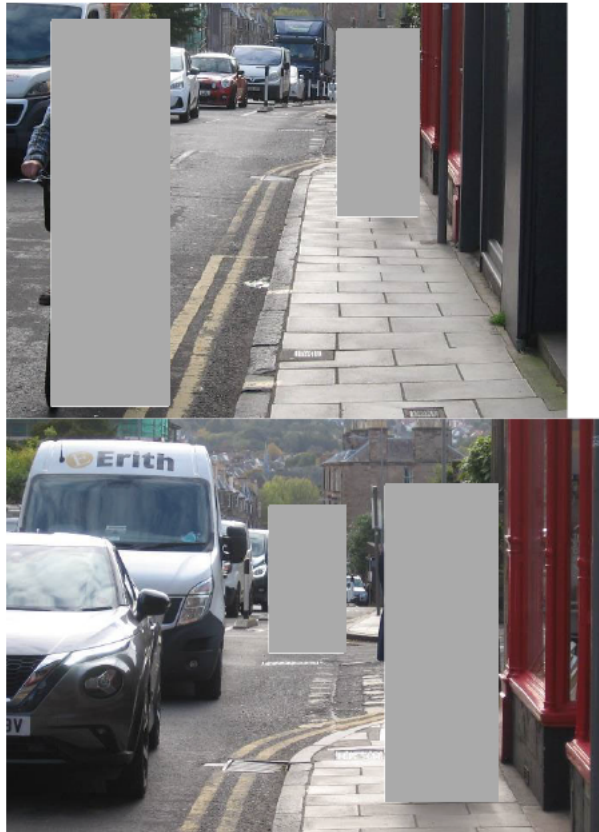
This one of the worst untreated pedestrian pinchpoints on the entire corridor. The pavement here is only 1.4m wide (ie substantially less than the SDG 'absolute minimum' of 2.5m), with vehicular traffic passing (sometimes at speed) less than a metre away from pedestrians. The problem is compounded when people are queuing outside the Shelter shop (right photo). Immediately beyond Shelter, the junction with Abbotsford Park can be difficult for pedestrians to cross, with the eastbound lane of Abbotsford Park 'sweetened' to enable vehicles to turn left on to Morningside Road without stopping.

Recommendation: encourage Shelter to introduce a queuing system which has its head just round the corner on Abbotsford Park (ie not on Morningside Road).

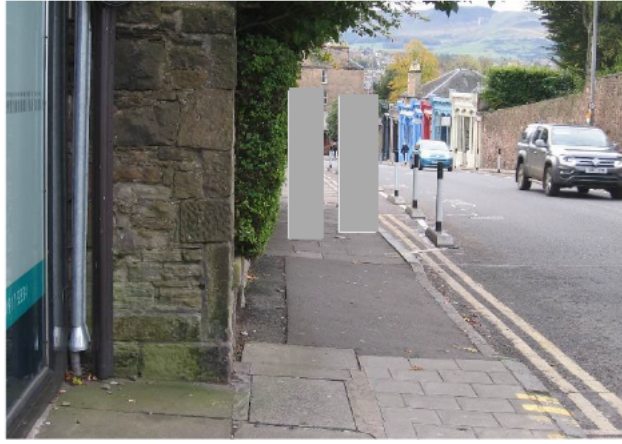
Immediately south of the southbound bus stop at Church Hill, the pavement narrows to just 2.05m, but vehicle access to a property on the left prevented the SFP space measure (see Location 35E2) being extended uphill to reach the wider pavement.

Recommendation: undertake a longer-term review of the whole Church Hill junction to identify more pedestrian-friendly designs.

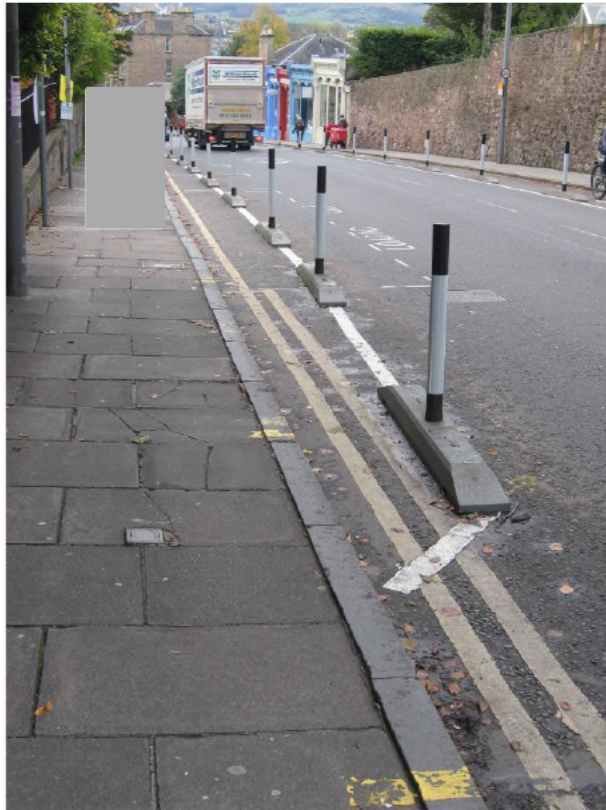
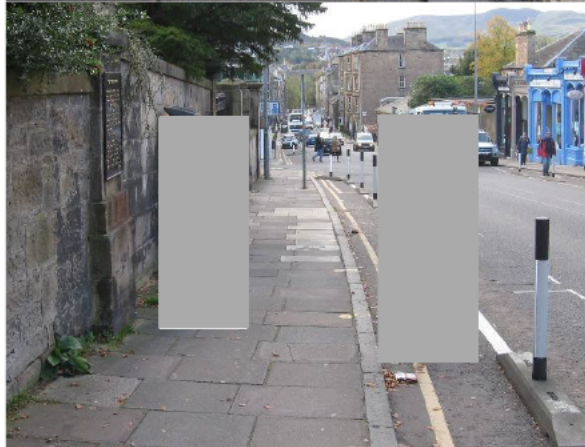
The pavement here is only 2.05m wide (ie significantly less than the SDG 'absolute minimum' of 2.5m) and the Clear Walking Zone is just 1.7m in places – therefore the additional 0.95m SfP space is most welcome.

Recommendation: install a short concrete block at the start of the section and paint a pedestrian logo marking on the lane immediately behind it.

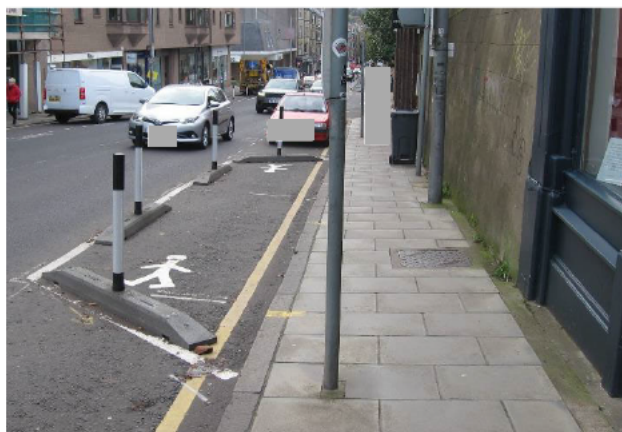
The pavement here is only 1.8m wide (ie substantially less than the SDG 'absolute minimum' of 2.5m) and the Clear Walking Zone is just 1.5m at the pole, therefore the additional SfP space is most welcome.

Recommendation: retain the SfP space, and in the longer term permanently widen the pavement proper to create a continuous one-level space.

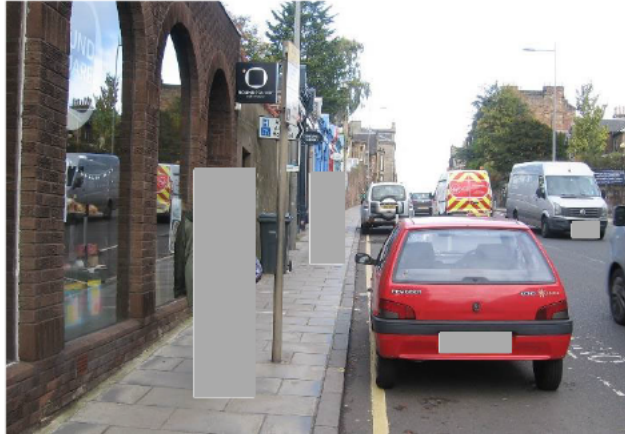
The pavement here is only 1.8m wide (ie substantially less than the SDG 'absolute minimum' of 2.5m) and the Clear Walking Zone is just 1.5m at the pole.

Recommendation: extend the SfP space south from Location 36W1, and in the longer term permanently widen the pavement proper to create a continuous one-level space.

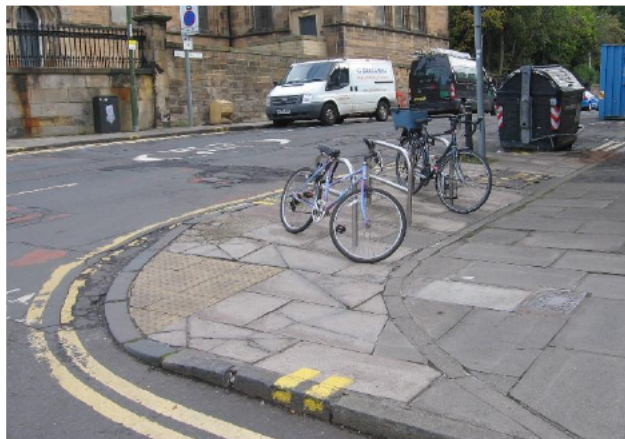
The cycle racks here impinge on the pedestrian area close to the tactile paving at the informal crossing point of Newbattle Terrace. However, the Council's current 'public realm' plan for the latter would relocate the cycle racks a short way further east along Newbattle Terrace (as well as creating a continuous pavement' across Newbattle Terrace at its junction with Morningside Road).

Recommendation: implement the current public realm plan for Newbattle Terrace.

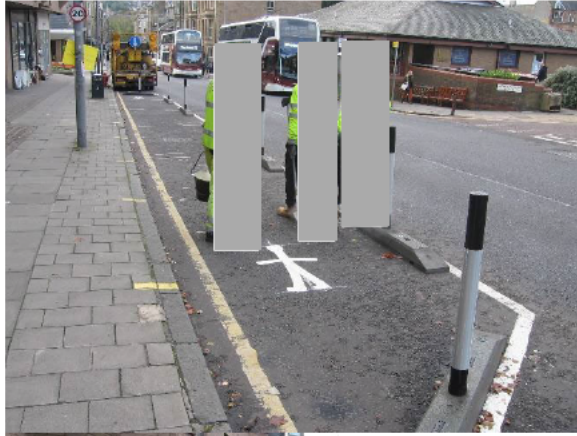
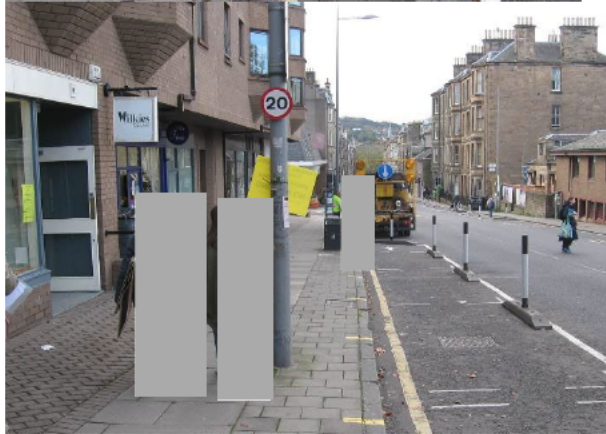
While the pavement here is reasonably wide, much of it is on a slope rising up to the shop entrances (right photo) which is unsuitable for more infirm pedestrians to walk along. On the horizontal pavement, the Clear Walking Zone is as narrow as 1.25m and 1.85m in places, and therefore the additional SfP space is welcome.

Recommendation: retain the SfP space, and in the longer term permanently widen the pavement proper to create a continuous one-level space.

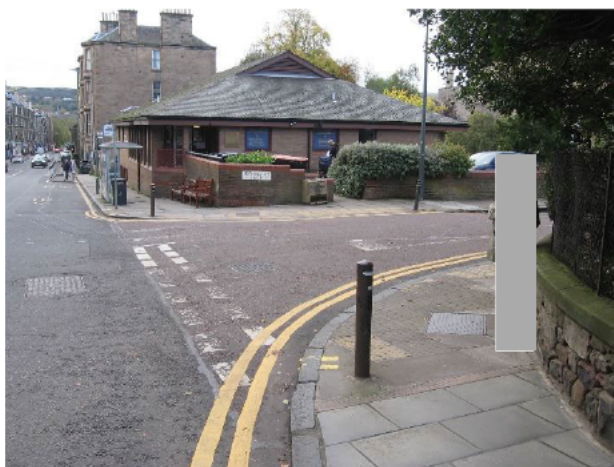
Morningside Place at its junction with Morningside Road is well in excess of two lanes wide, and can be difficult for pedestrians to cross, with the eastbound lane of

Recommendation: in the short-term, reduce the crossing width with concrete blocks (on the north side of Morningside Place) as used elsewhere in the project, and in the longer-term create a continuous pavement across Morningside Place.

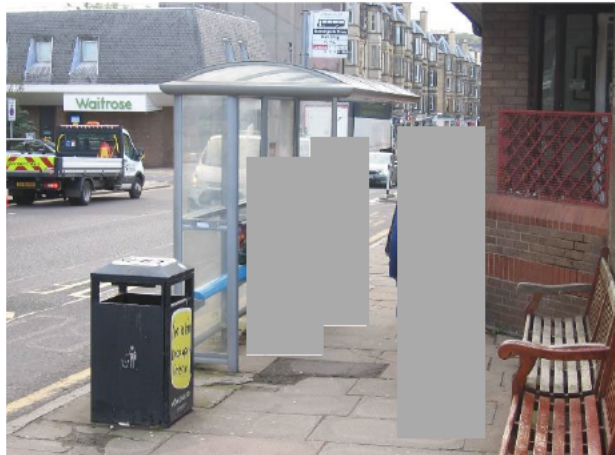
This is one of the most significant pedestrian pinchpoints on the A702 corridor. The pavement is only 2.5 wide (ie the SDG 'absolute minimum') and the Clear Walking Zone at the bus stop is just 1.65m – making it impossible to socially distance for much of the time.

Recommendation: relocate bus stop c. 1-2m to the north (ie closer to the camera).

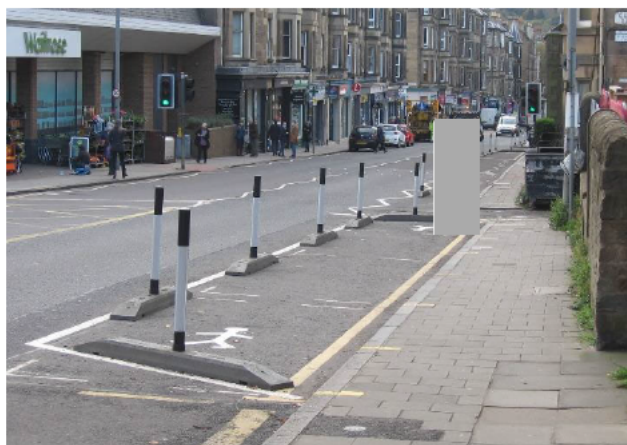
This is one of the most valuable improvements made by the SfP project along the A702 corridor. The pavement proper is only 2.15m wide (ie significantly less than the SDG 2.5m 'absolute minimum') and therefore the additional space is very welcome for pedestrians.

Recommendation: retain the SfP space, and in the longer term permanently widen the pavement proper to create a continuous one-level space.

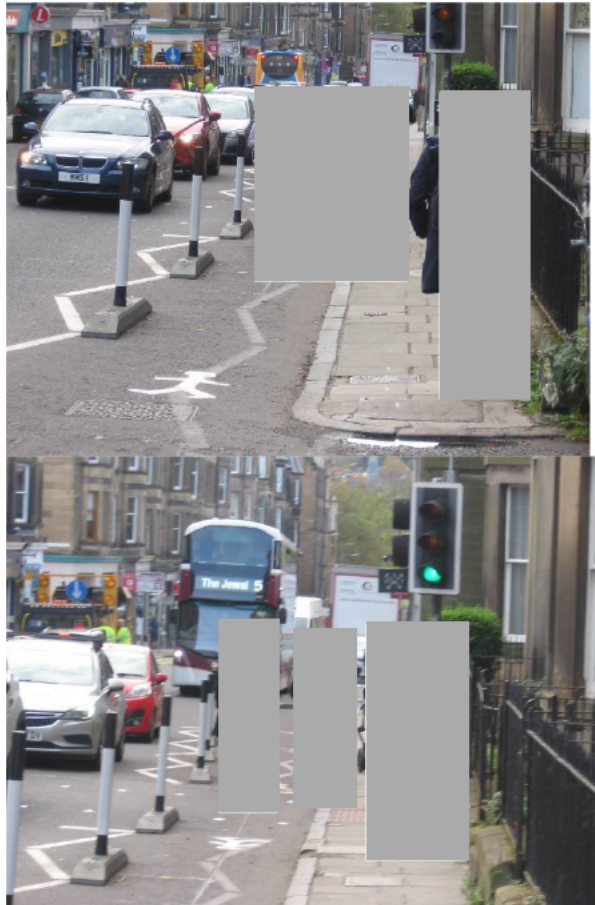
This is one of the most valuable improvements made by the SfP project along the A702 corridor. The pavement proper is only 1.39m wide (ie substantially less than the SDG 2.5m 'absolute minimum') and therefore the additional space beside a very popular pedestrian crossing is most welcome. The extra space reduces the width of the vehicle carriageway – and therefore also reduces the time taken to cross the crossing

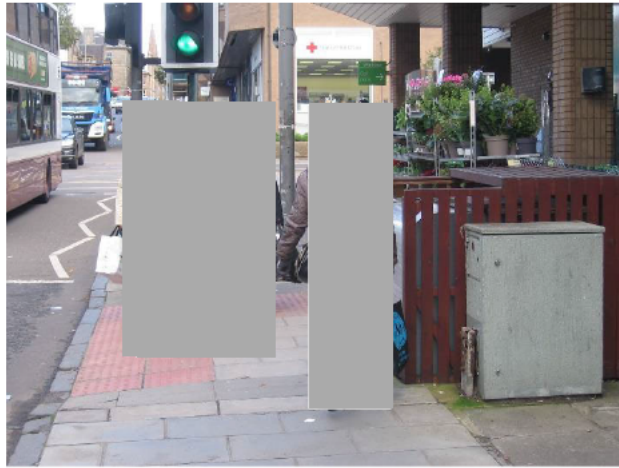
This is a very busy pedestrian location, beside the entrance to Waitrose and where pedestrians congregate waiting for the Green Man at the crossing. The wooden storage unit (right) impinges on to the pavement proper.

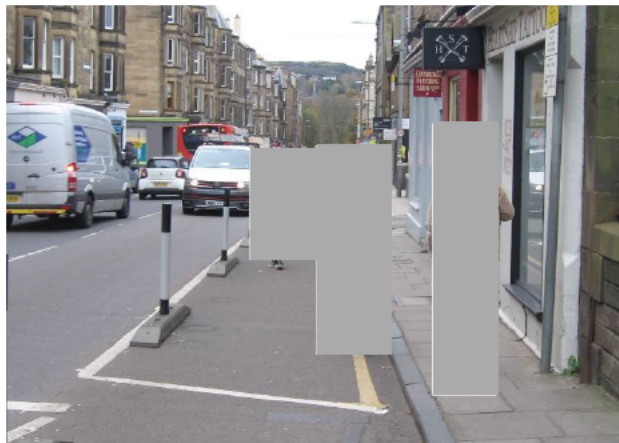
This is one of the most valuable improvements made by the SfP project along the A702 corridor. The pavement proper is only 1.25m wide (ie half the SDG 2.5m 'absolute minimum') and therefore the additional 1.75m SfP space is very welcome, taking the entire pedestrian space width up to the 3m SDG 'general minimum', albeit split in two levels.

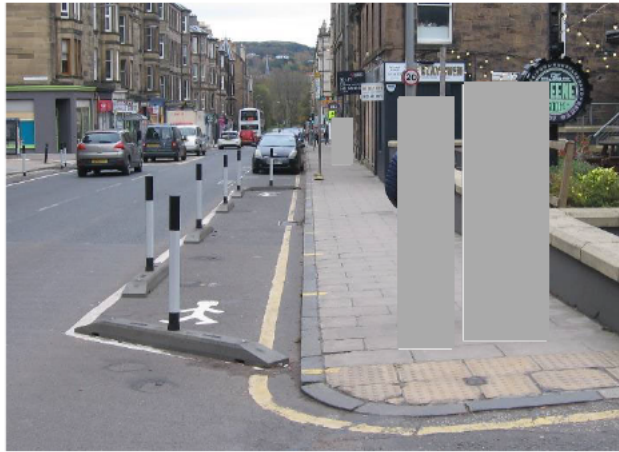
The pavement here is only 2.25m wide (ie significantly less than the SDG 'absolute minimum' of 2.5m) and therefore the additional 1.05m SfP space is welcome.

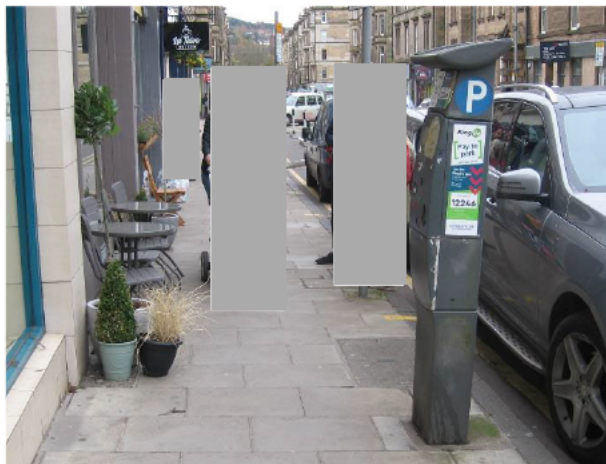
The pavement here is only 2.4m wide (ie less than the SDG 'absolute minimum' of 2.5m) and the parking ticket machine, tables & chairs and poles reduce the Clear Walking Zone in places to 1.45m.

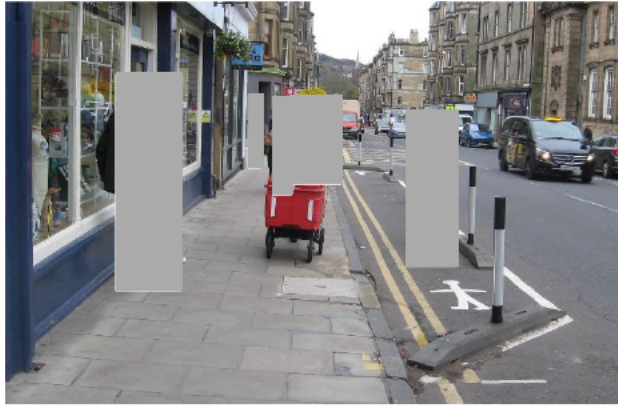
The pavement here is only 2.35m wide (ie less than the SDG 'absolute minimum' of 2.5m) and therefore the additional 1.3m SfP space is very welcome, not least as goods are sometimes on display on the pavement outside this shop. The extra width also narrows the width of (informal) crossing of the Morningside Road carriageway on a long section without formal crossing facilities.

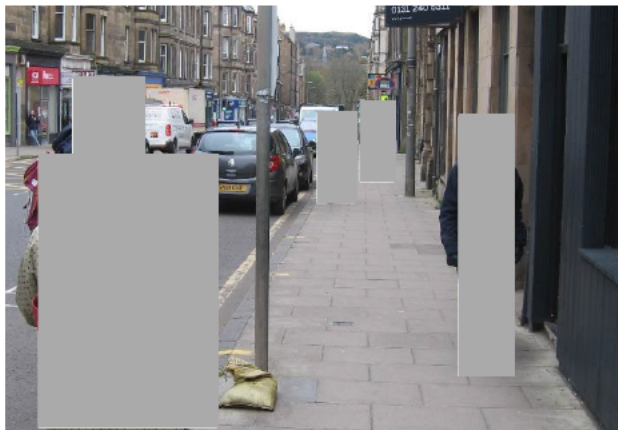
The pavement here is only 2.2m wide (ie significantly less than the SDG 'absolute minimum' of 2.5m) and the Clear Walking Zone is just 1.7m at the pole.

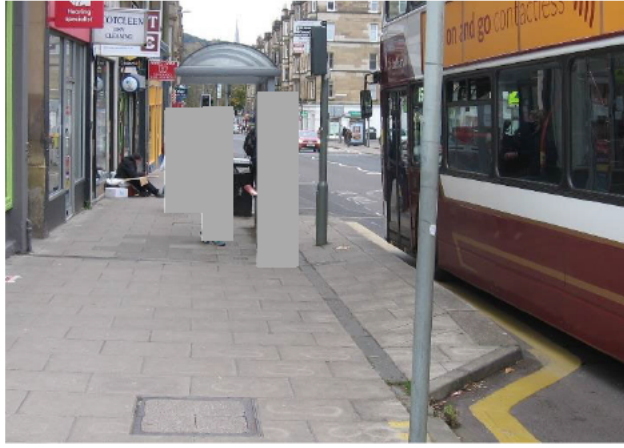
This is a good example of a bus stop build-out, allowing the pavement proper to extend to 4.4m width – one of the very few examples on the corridor where the width satisfies the SDG ‘desirable minimum’ of 4m or wider. The build-out also improves bus reliability, as buses do not have to wait for a gap in traffic to pull out into the main carriageway.

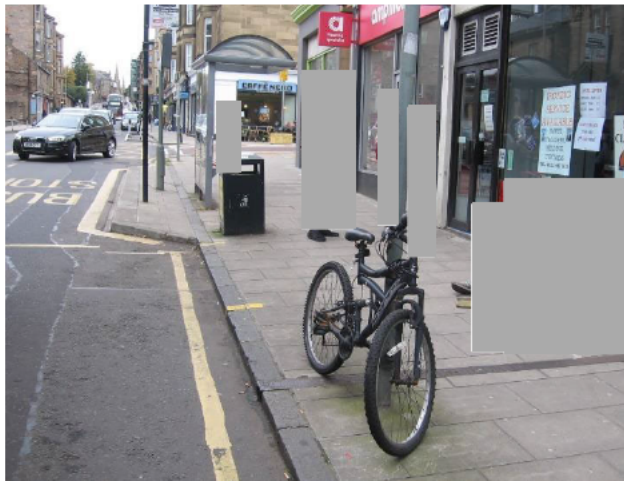
The pavement here is 3.1m wide (ie wider than the SDG ‘general minimum’ of 3m), but this is often a busy location and the Clear Walking Zone is just 2.3m at the signage pole / informally-parked bike and at the litter bin.

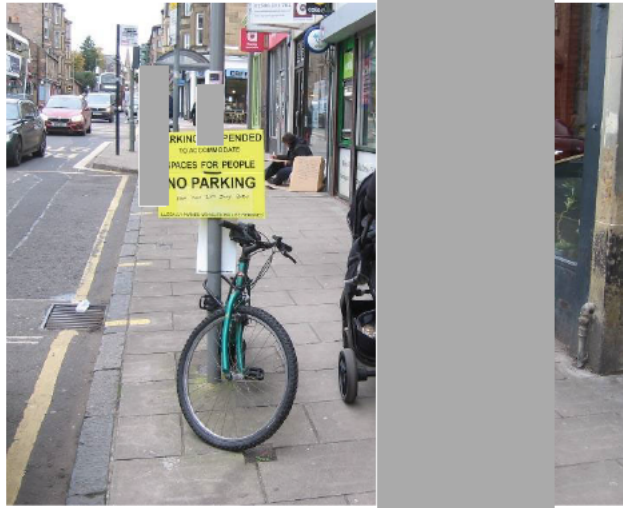
The pavement here is only 2.85m wide (ie less than the SDG 'general minimum' of 3m), and the Clear Walking Zone is reduced to just 2m by the signage pole / informally-parked bike (and the yellow SfP sign!).

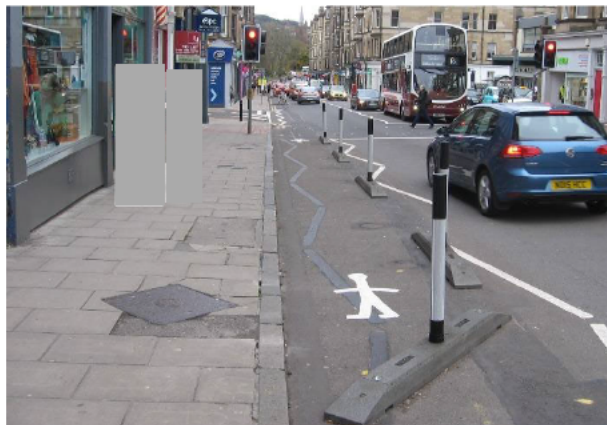
The pavement here is only 2.45m wide (ie less than the SDG 'absolute minimum' of 2.5m) and therefore the additional 1.5m SfP space is welcome. The latter also shortens the distance for pedestrians to cross the vehicle carriageway at the formal crossing in the middle distance. The angled concrete block in the foreground is not delineated by a white line, and this could represent a trip hazard.

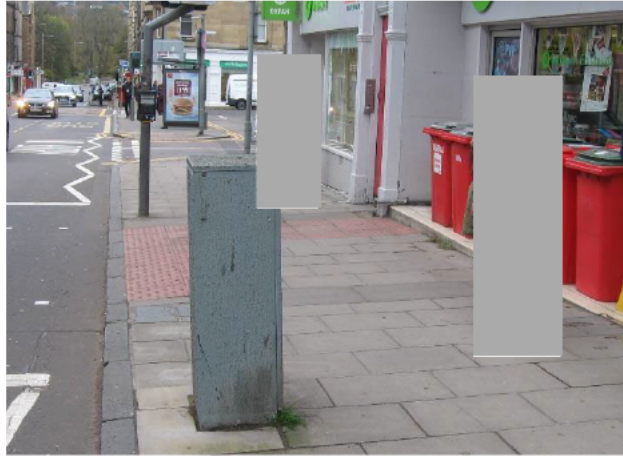
The pavement here is 3.15m wide, but the utility cabinet reduces the Clear Walking Zone to 2.25m.

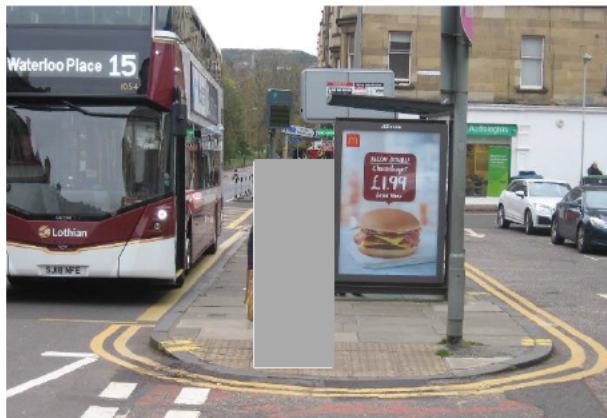
This location is poorly designed for pedestrians, both those walking up or down Morningside Road and those boarding or alighting from buses (this is normally a busy bus

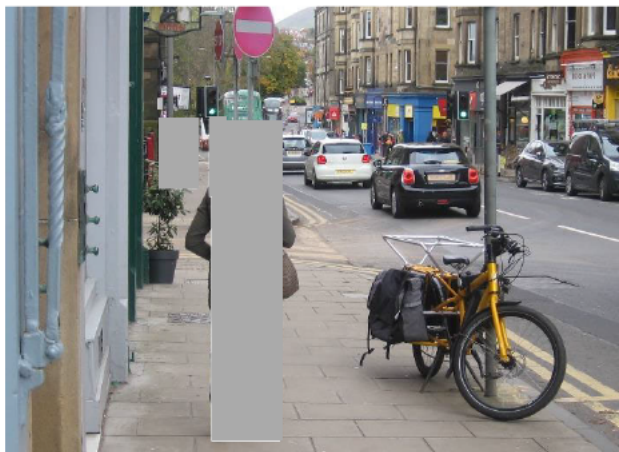
The pavement here is only 2.7m wide and the informally parked bike reduces the Clear Walking Zone to just 1.6m

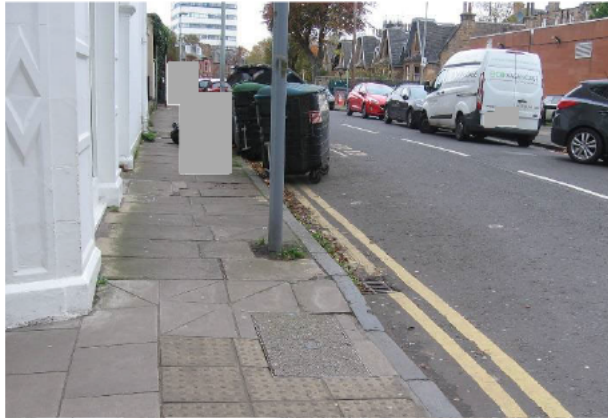
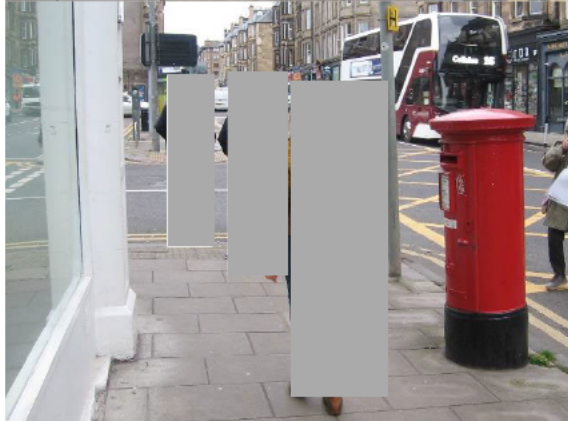
The junction of Morningside Park and Morningside Road has been an accident black-spot and the pavements here are narrow: only 1.8m beside the tactile paving for crossing Morningside Park (left photo) and 2.8m on the main pedestrian route (up Morningside Road, right photo), with a Clear Walking Zone of just 1.8m to the post box.

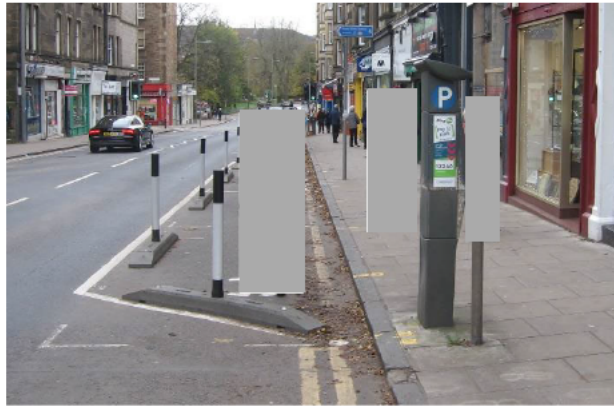
The pavement here is only 2.7m wide (ie only just wider than the SDG 'absolute minimum' of 2.5m) and therefore the additional 2m SfP space is welcome.

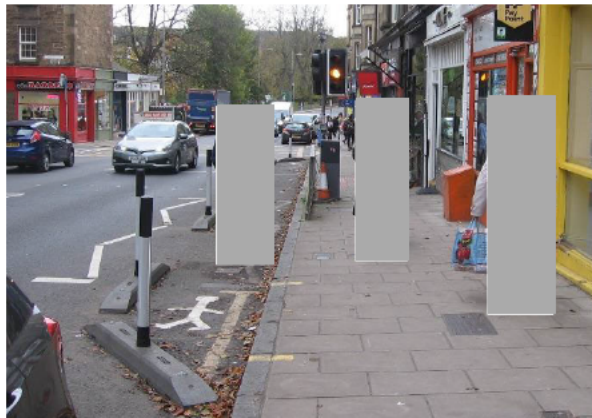
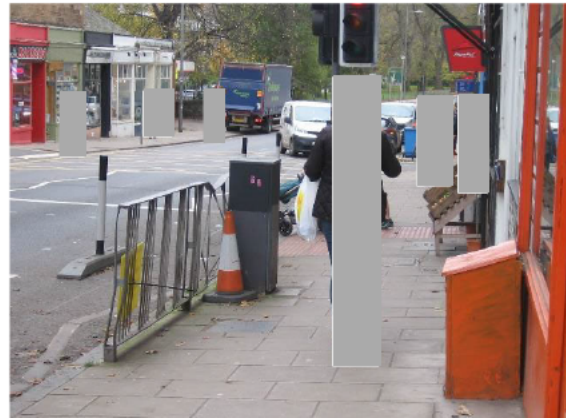
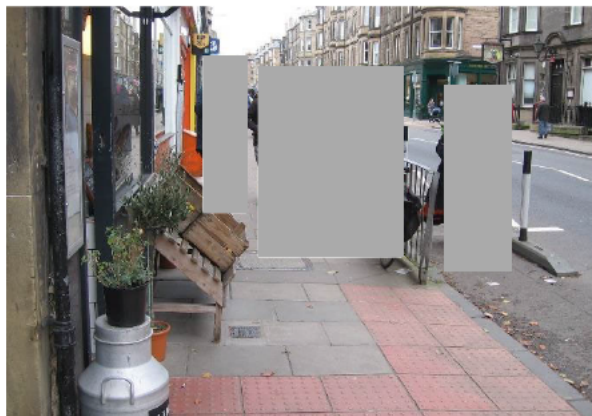
The pavement proper here is only 2.6m wide, and due to various items of pavement clutter (and goods on display) the Clear Walking Zone is reduced to 1.5m in places – and therefore the additional 1.1m SfP space is welcome. The latter also reduces the width of carriageway to cross at the pedestrian crossing. However the total width available for pedestrians is split both horizontally (by the kerb drop) and vertically (by the redundant guard rail). The angled concrete block in the foreground is not delineated by a white line, and this could represent a trip hazard.

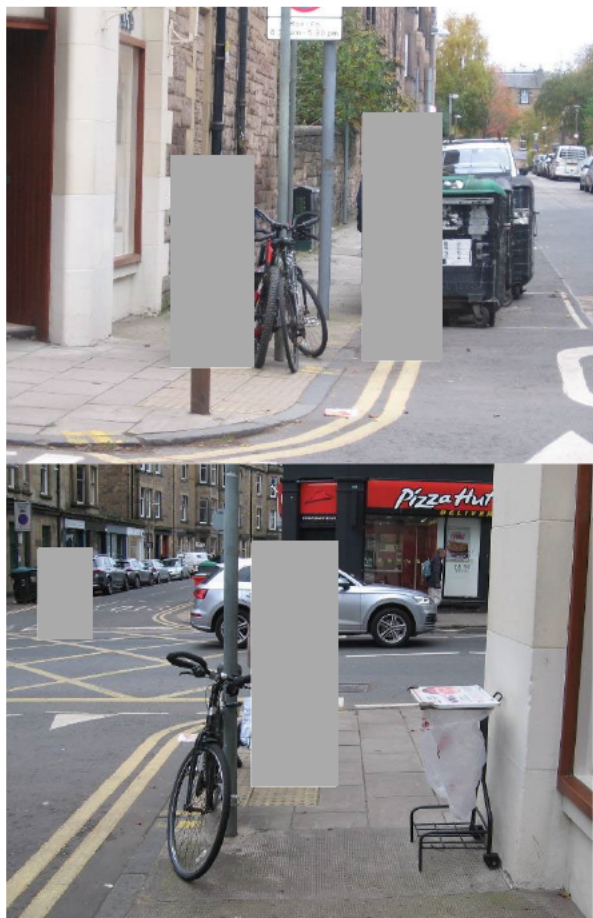
The pavement here is only 1.9m wide (ie substantially less than the SDG 'absolute minimum' of 2.5m) and, due to informal cycle parking and the shoe recycling bin, the Clear Walking Zone is just 0.65m (ie less than half the SDG 'absolute minimum').

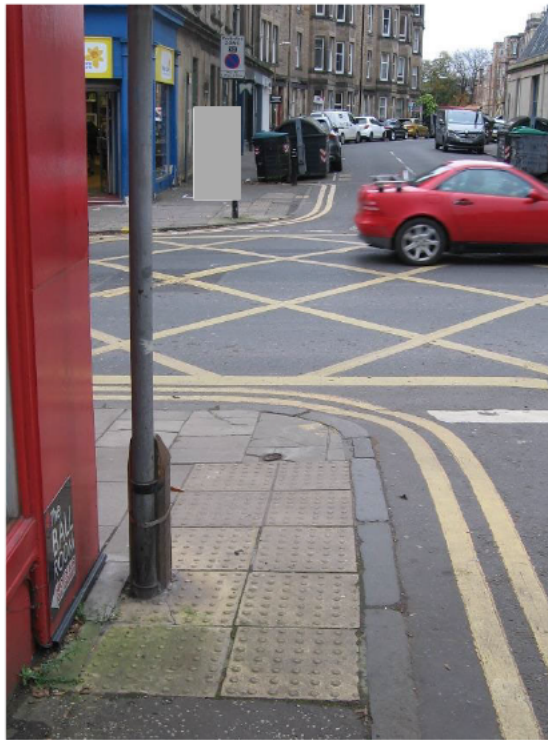
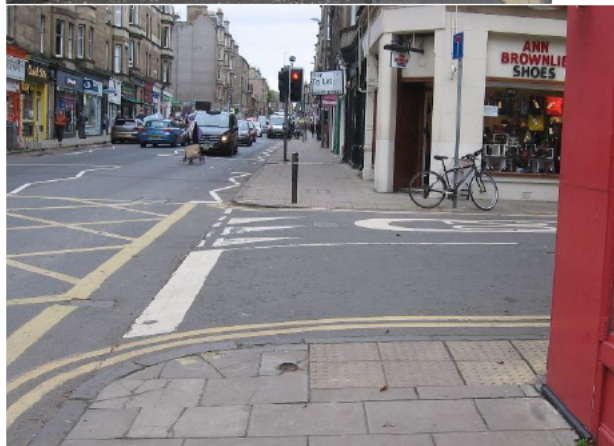
The pavement here is only 1.15m wide (with a Clear Walking Zone of just 0.85m) on Jordan Lane (left photo) and 2.7m wide on Morningside Road (right photo).
