Spaces for People

Scheme Review Form

Location	Original justification
Morningside Town Centre	To provide safe space for pedestrians to walk, exercise and access local shops. To provide safe cycling routes and prioritise public transport as an alternative to driving.

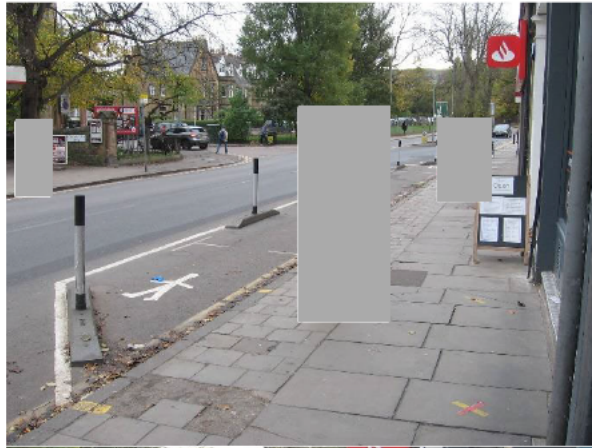
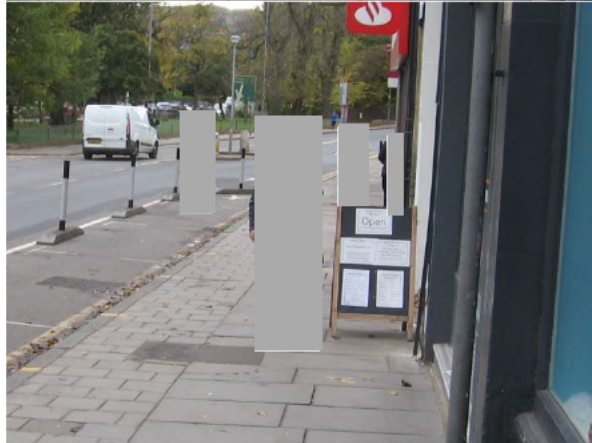
The pavement here is only 2.8m wide (ie less than the SDG 'general minimum' of 3m) and therefore the additional SfP space is welcome. However, an illegally-sited advertising board partly obstructs the pavement proper.

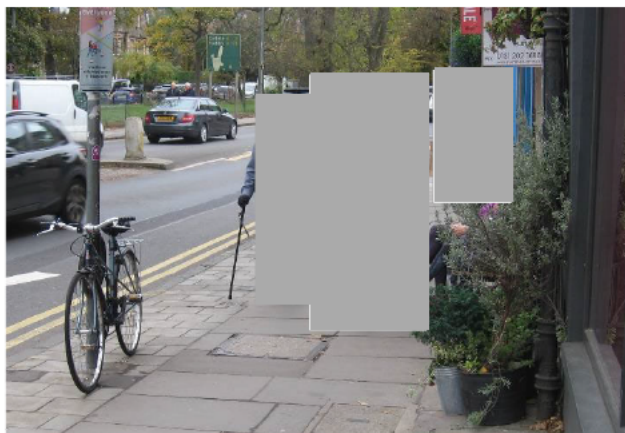
The pavement here is reasonably wide (3.6m) but informal cycle parking and pot plants reduce the Clear Walking Zone to just 1.7m.
