**ROAD LAYOUT  
HOUSING DEVELOPMENT  
FROGSTON ROAD (POD A, SITE 1)  
EDINBURGH**

STAGE 3 ROAD SAFETY AUDIT  
(SPA Ref No: 4282)

Roads Authority: The City of Edinburgh Council

Client: Barratt Homes

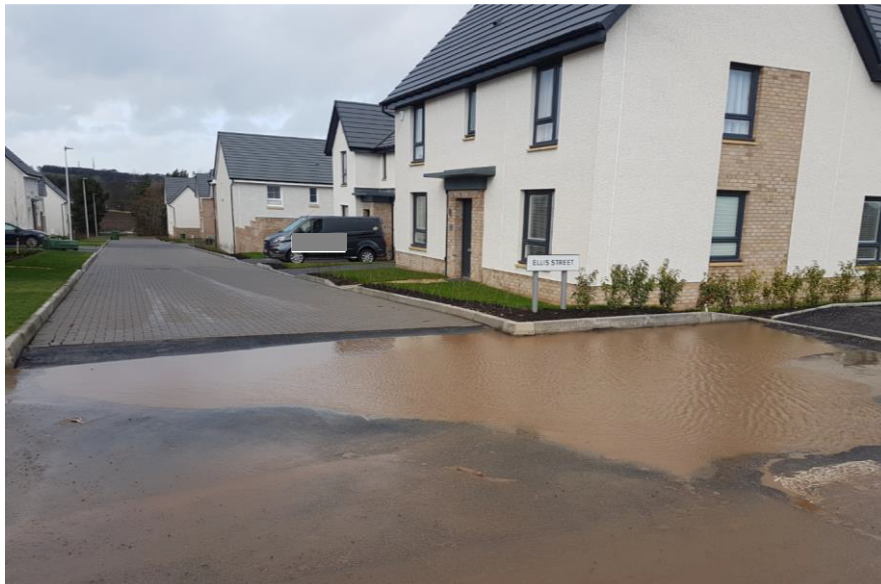
- 1.10 While outwith the area under inspection it was noted that there was extensive ponding at the east end of Ellis Street. This resulted in pedestrians having to walk into the live carriageway and haul route on Greenwell Wynd to avoid the ponding water. It is understood the final surfacing in this area is to be completed towards the end of February, but it should be recognised that the situation is not ideal and that potential short-term improvements should be investigated.

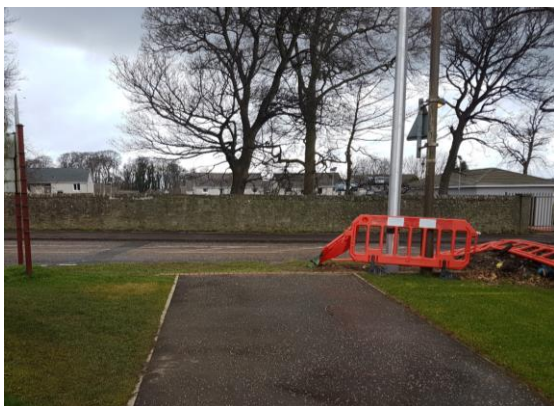
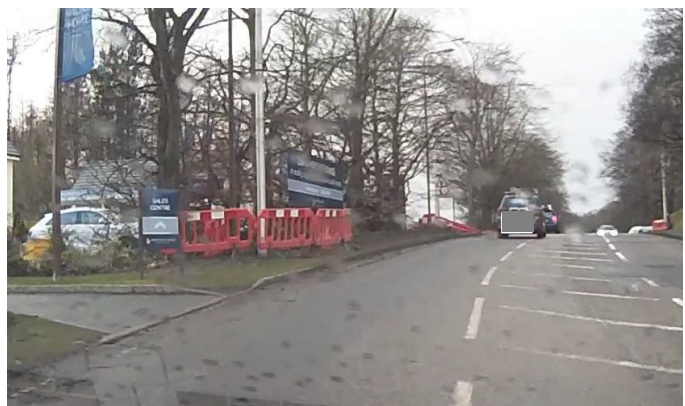
It was noted that the footpath leading from Printonan Crescent to Frogston Road there is no formal surfaced footway connection or crossing point at the north end.

The Audit Team recommends that the path be closed off until appropriate connections and surfacing are provided at Frogston Road.

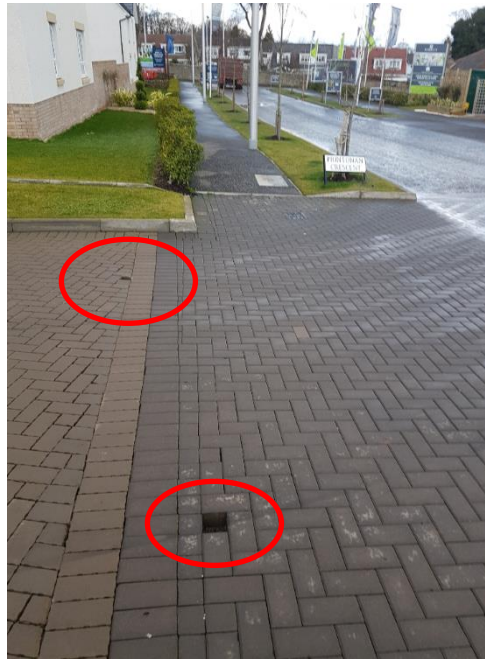
Summary: Missing mono-block in a shared use surface introduces a trip hazard to pedestrians.

It was noted that some mono-block units were missing at the entry to Printonan Crescent.

The Audit Team recommends that the mono-block surfacing is repaired to provide a continuous surface.

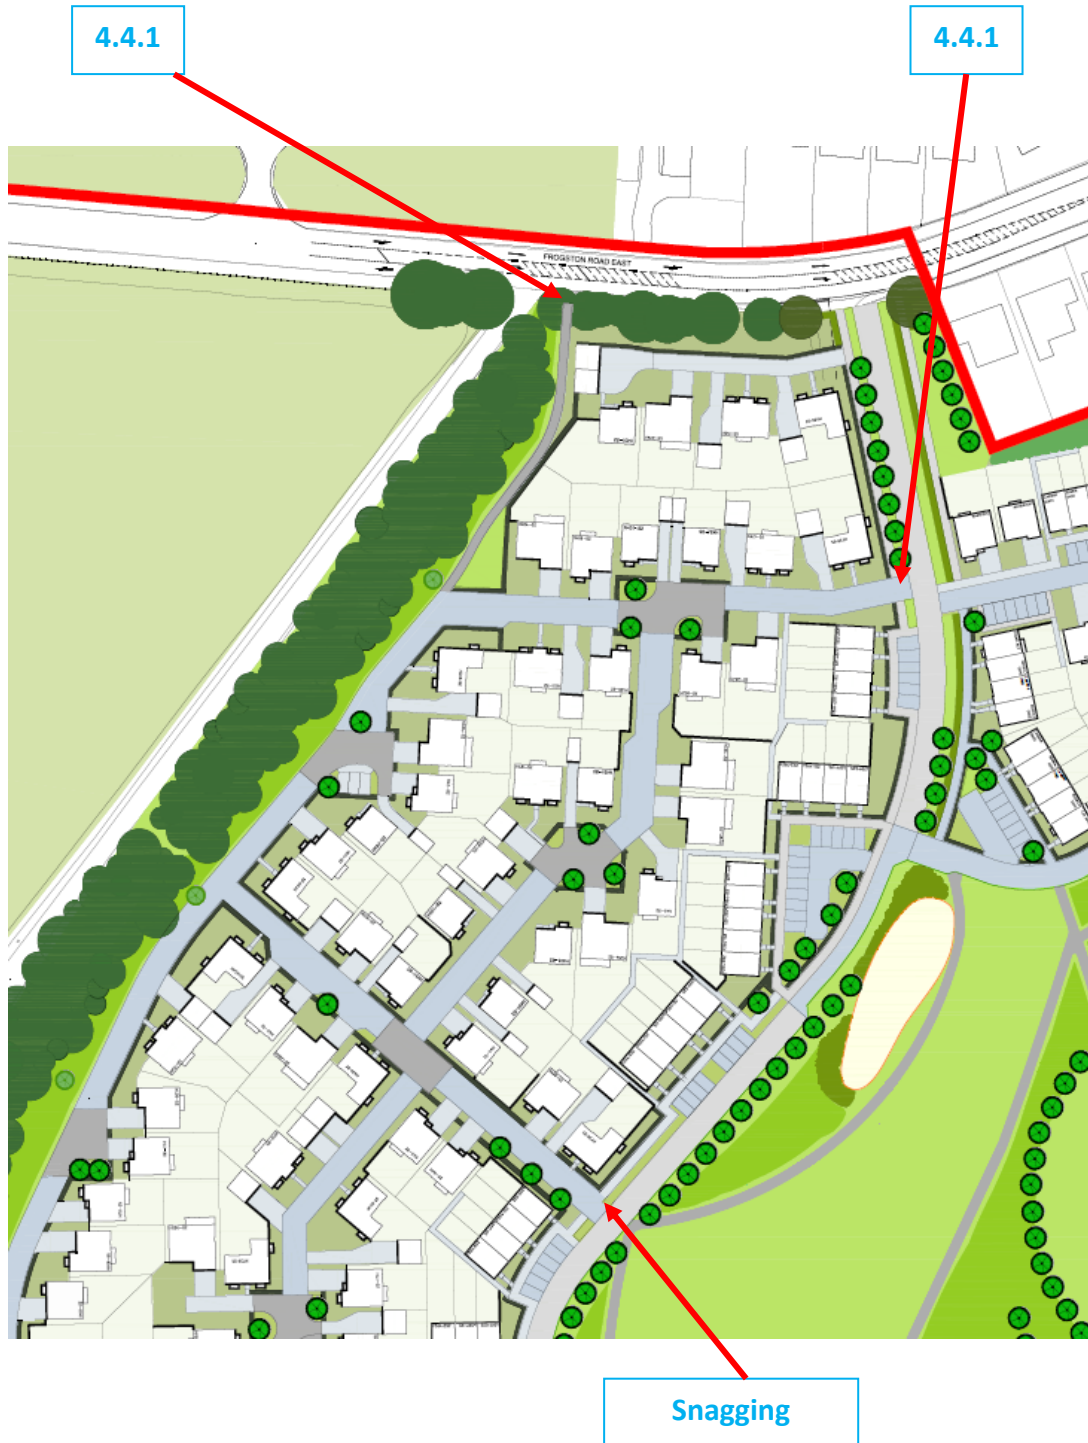
Annex 2 PROBLEM LOCATION PLAN

- Specific problem areas have been identified and referenced by the comment number in the text
- General issues covering multiple areas have not been highlighted on this plan so as to avoid clutter and potential misinterpretation.

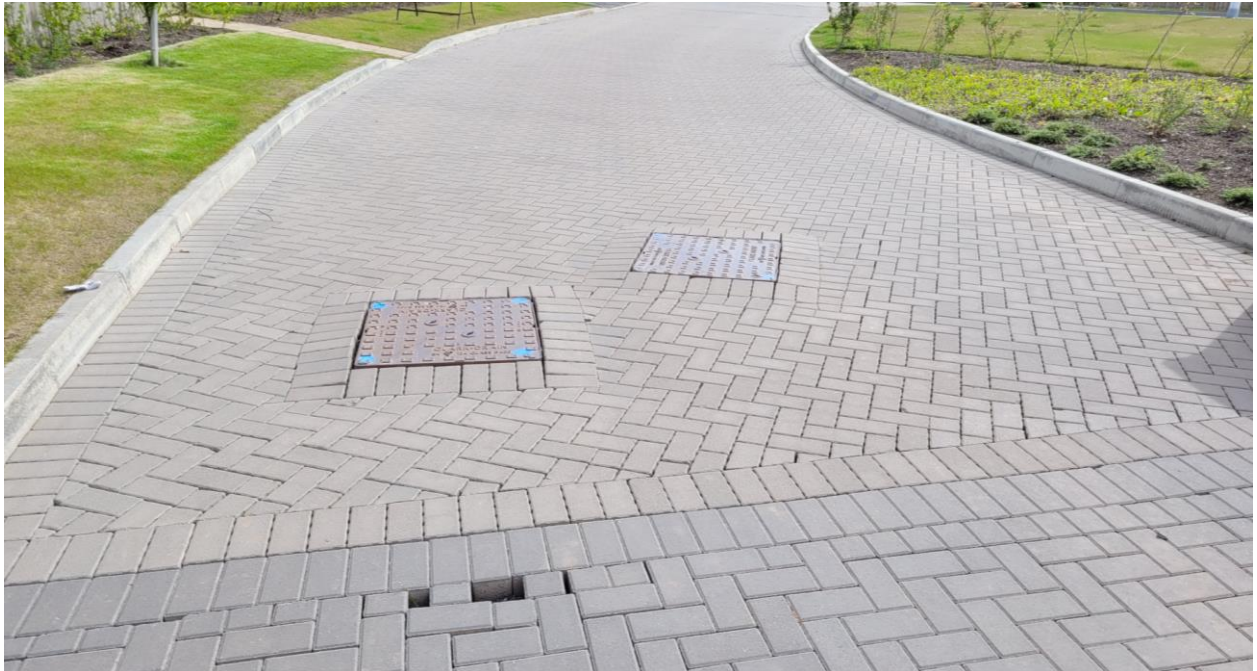
It was noted and understood that a range of ‘snagging issues’ have been identified by the Council’s inspectors during pre-adoption inspections. These included issues such as ironwork being raised and gaps in the surrounding joints. Also, it was noted there were some paving blocks missing from the surface at various points. The image below provides an example of the above issues.

It is recommended that the proposed snagging works be completed as soon as possible being that houses are now occupied and pedestrians and cyclists will be using these shared use streets.

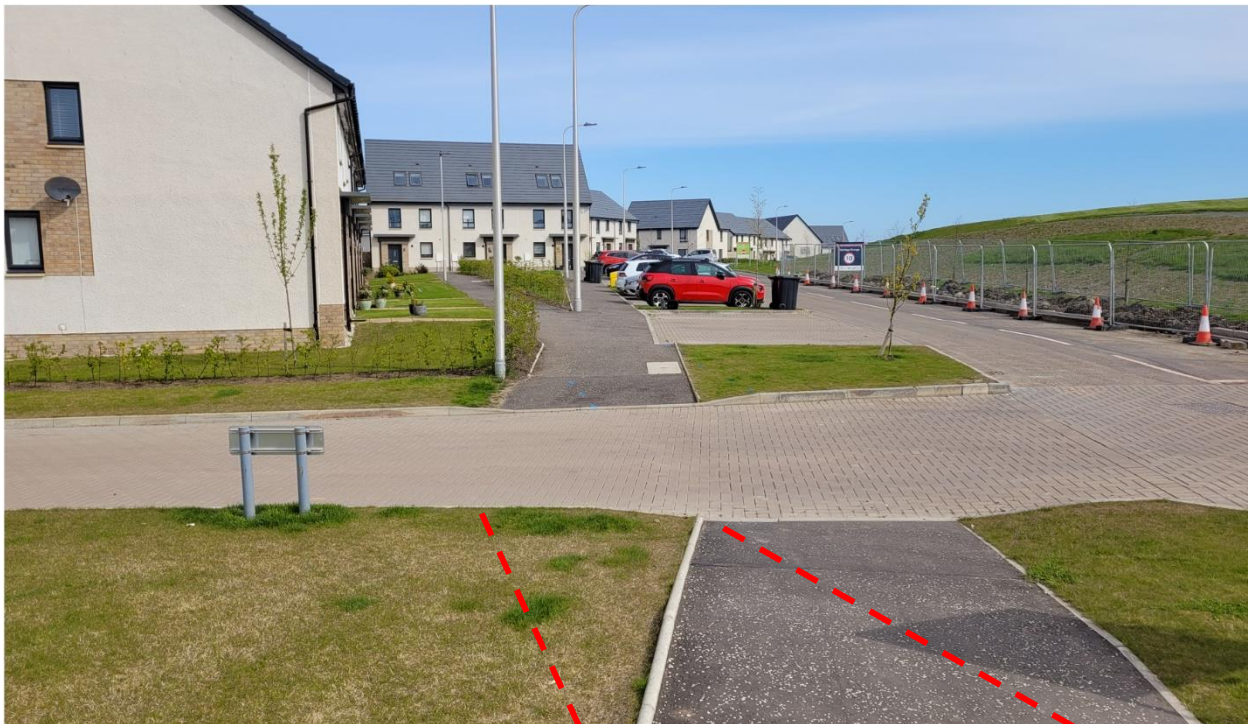
It was however noted that at the existing north side dropped kerb there were a number of services.

The Audit Team would question if it was perhaps more practical to alter the south side footway alignment. Possibly from the lighting column northwards (See image below)

However as both dropped kerbs appeared to be 'high' it may be both sides for the footway will require work.

It is recommended that the proposed snagging works be completed as soon as possible and that the option of altering the south side footway be reviewed by the design team.

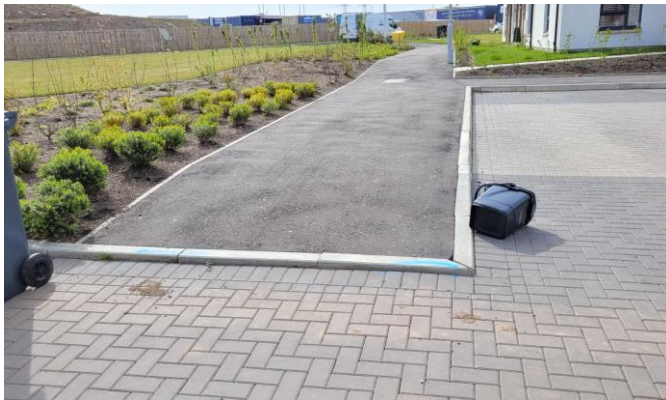
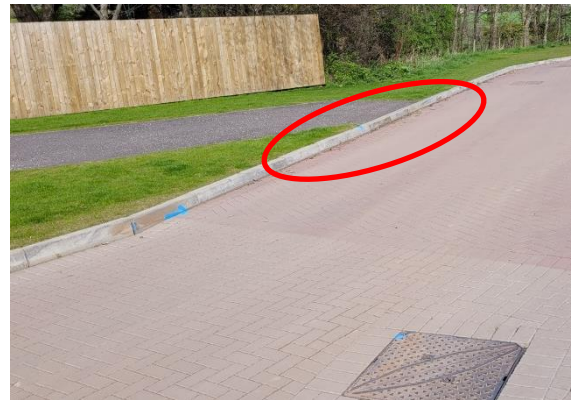
Some examples are below.

It is recommended that the proposed snagging works be completed as soon as possible being that houses are now occupied, and pedestrians and cyclists will be using these routes and dropped kerbs.

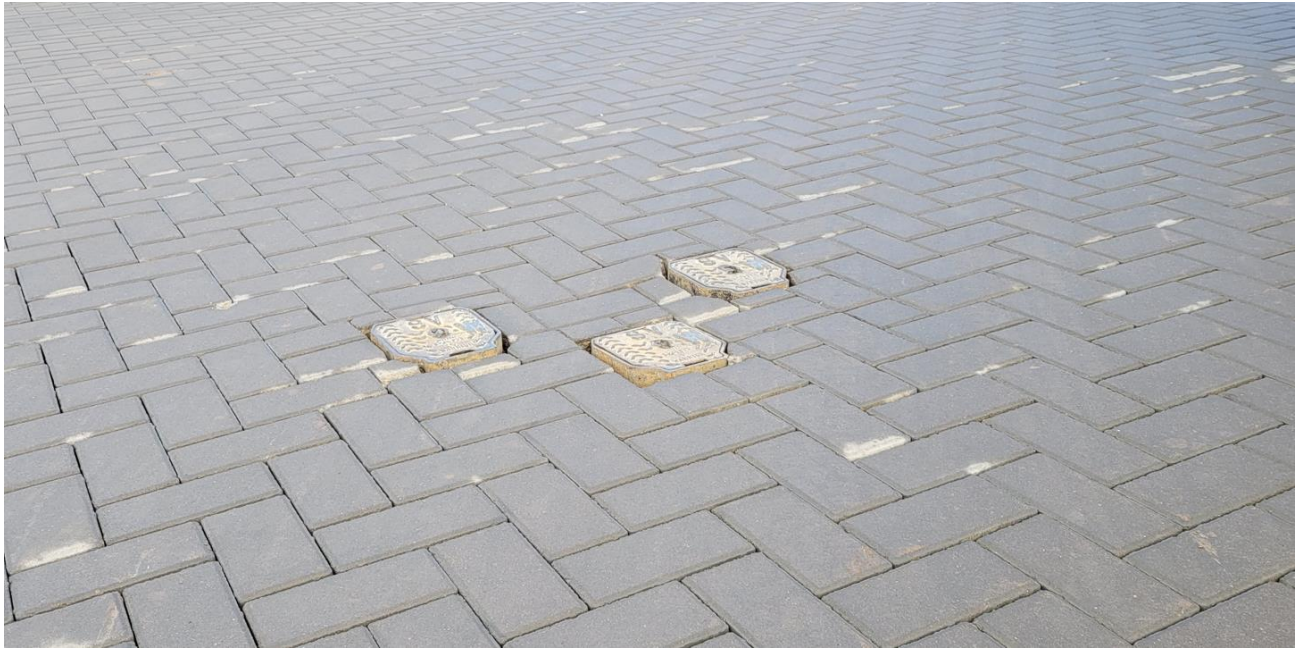
Location: Various  
Drawing(s): E9876~0925  
Summary: Ironwork sitting high in a shared surface area can be a trip hazard to pedestrians.

An example of potential trip hazards due to high ironwork can be seen below.

It is recommended that ironwork within the development area is reviewed to ensure there are no raised elements.

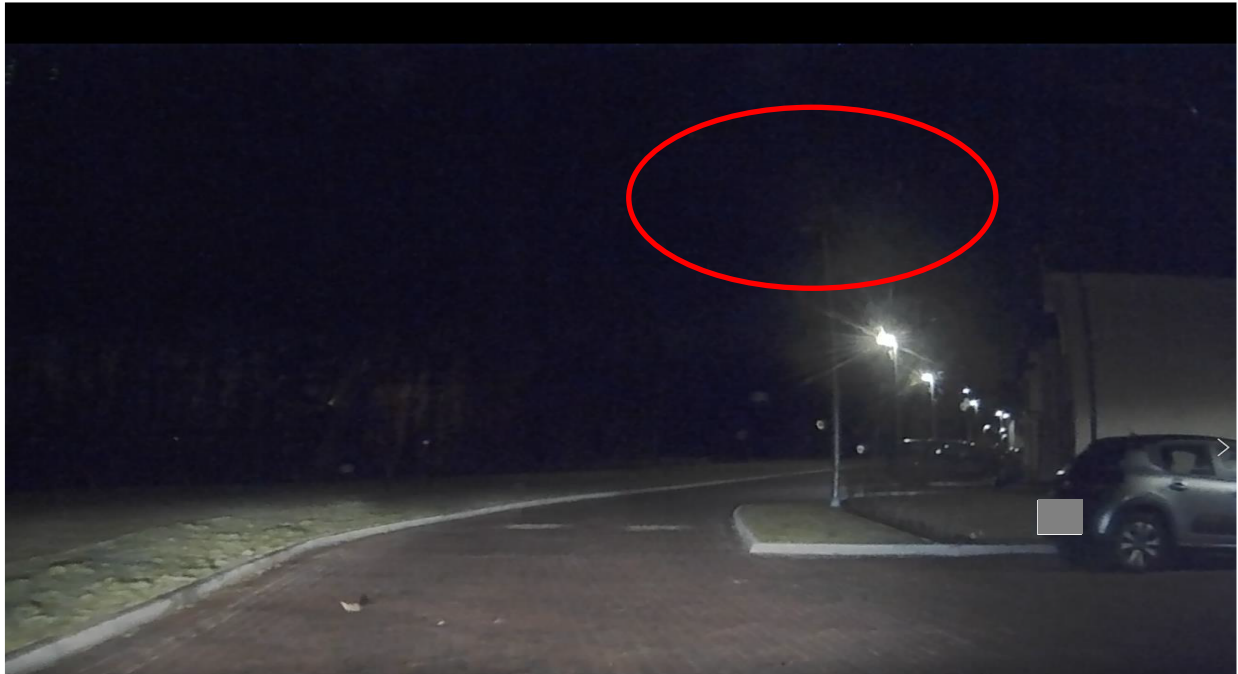
At plot 152 it was noted that the lighting column had a 'dark' head.

It is recommended that the lighting head be examined and repaired as soon as possible.

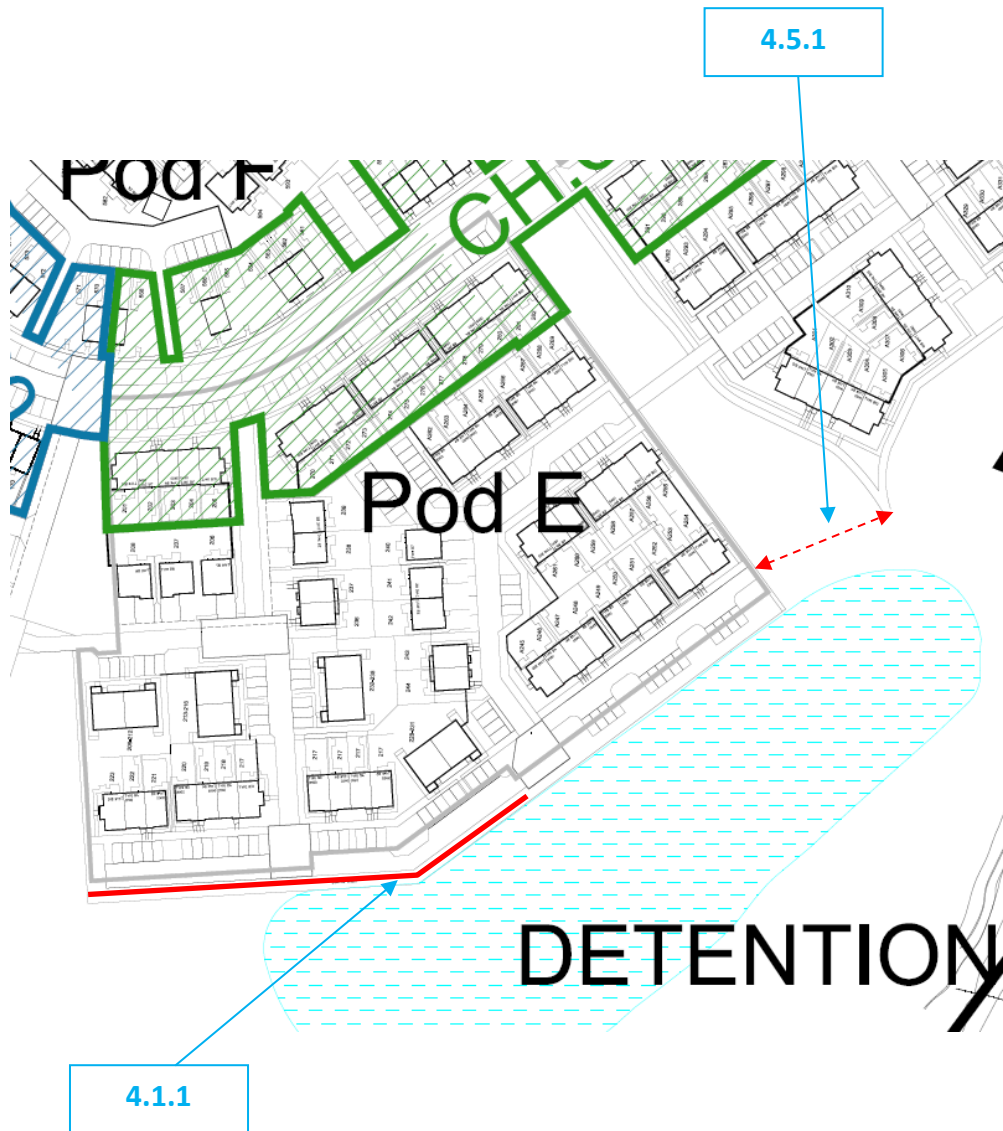
Annex 2 PROBLEM LOCATION PLAN

- Specific problem areas have been identified and referenced by the comment number in the text
- General issues covering multiple areas have not been highlighted on this plan so as to avoid clutter and potential misinterpretation.

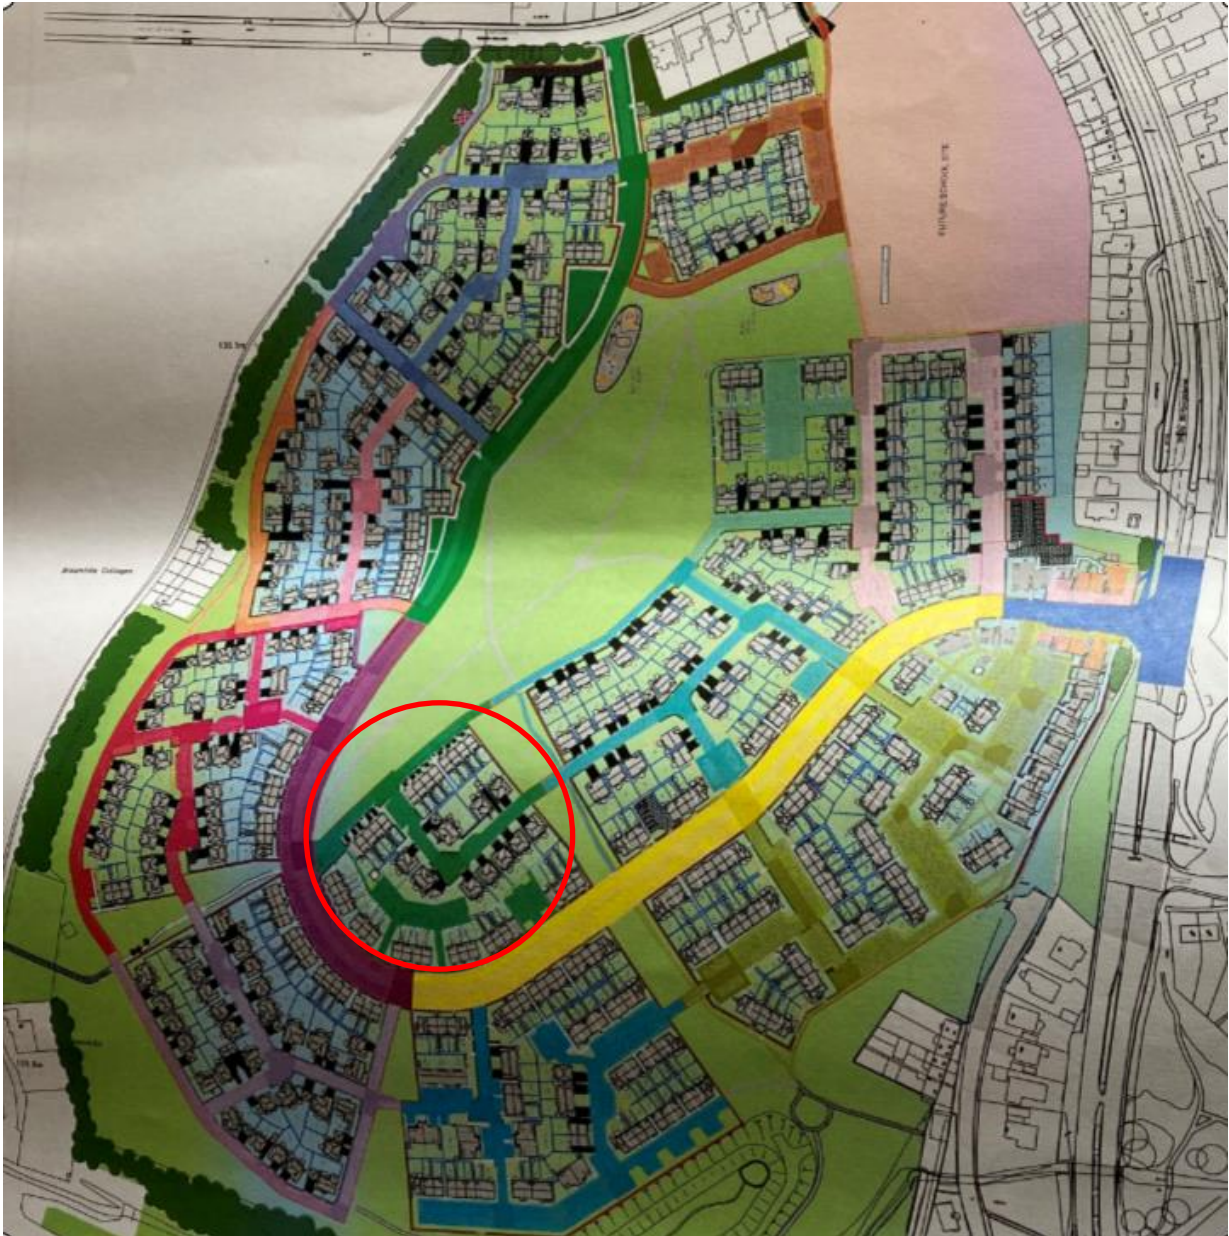
- Specific problem areas have been identified and referenced by the comment number in the text
- General issues covering multiple areas have not been highlighted on this plan so as to avoid clutter and potential misinterpretation.

(Pod F highlighted in red circle below)

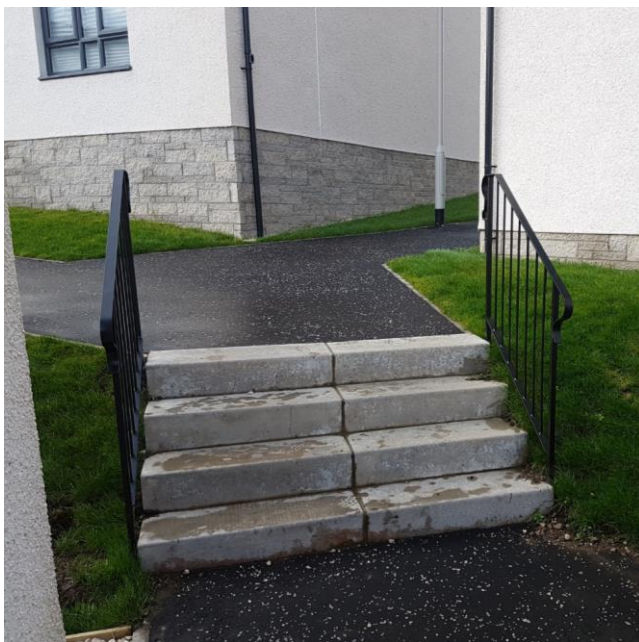
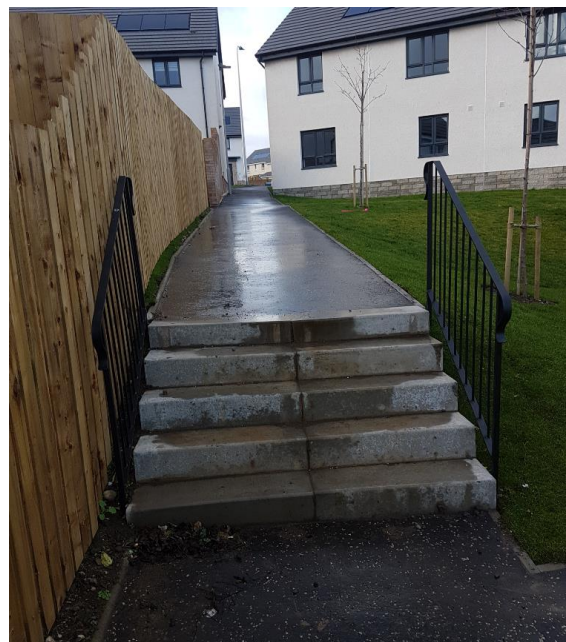
It was noted that there were two sets of steps that had not been provided with tactile paving, at the top and bottom of the steps, to warn users of the change in level on the path network.

This Audit Team recommends that appropriate tactile paving layouts be provided at these locations as soon as possible.

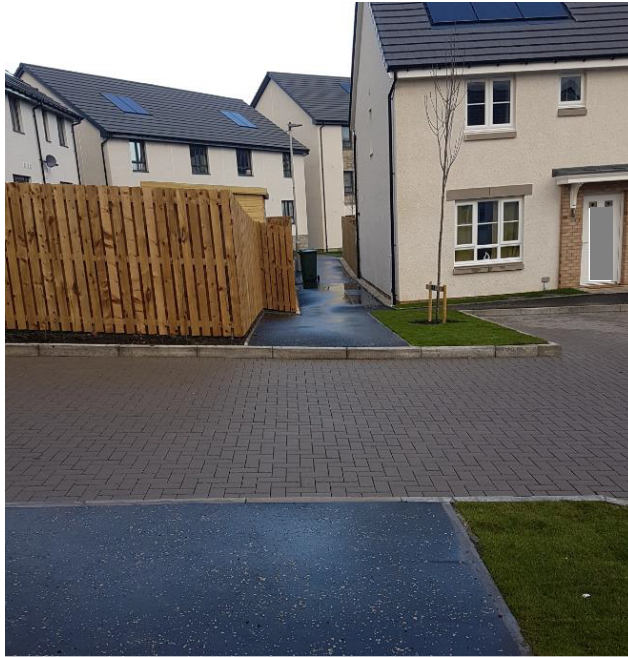
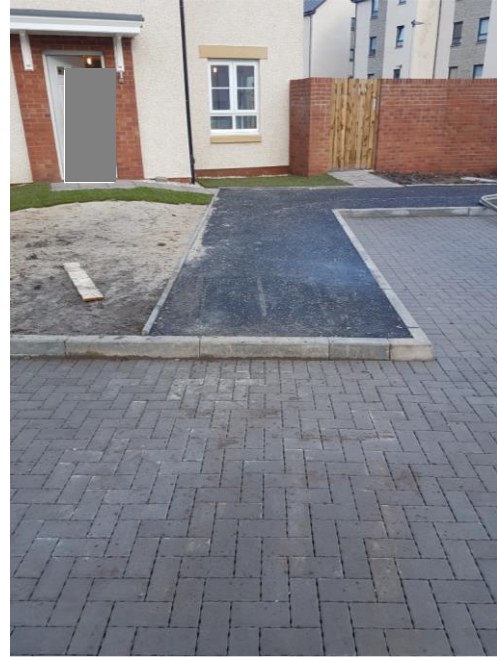
It was noted that there were two locations where footpaths met a shared surface area, but no dropped kerbs were provided.

This Audit Team recommends that dropped kerbs be provided at these locations.

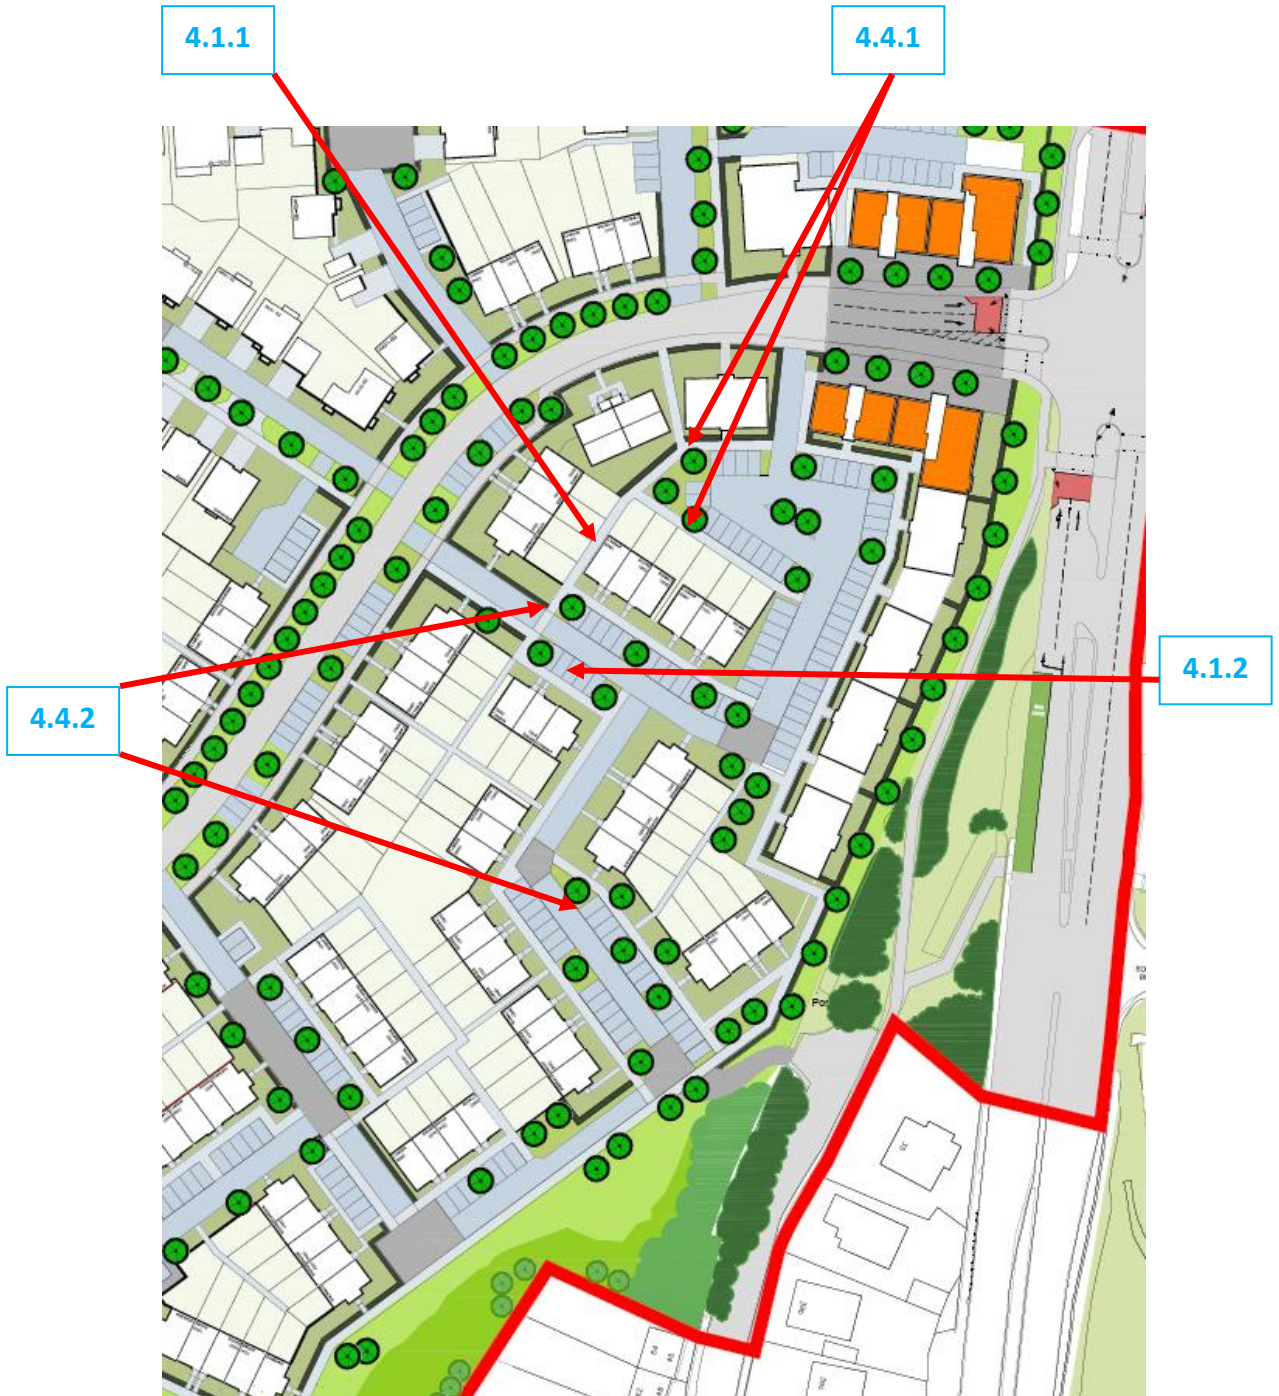
## Annex 2 PROBLEM LOCATION PLAN

- Specific problem areas have been identified and referenced by the comment number in the text
- General issues covering multiple areas have not been highlighted on this plan so as to avoid clutter and potential misinterpretation.

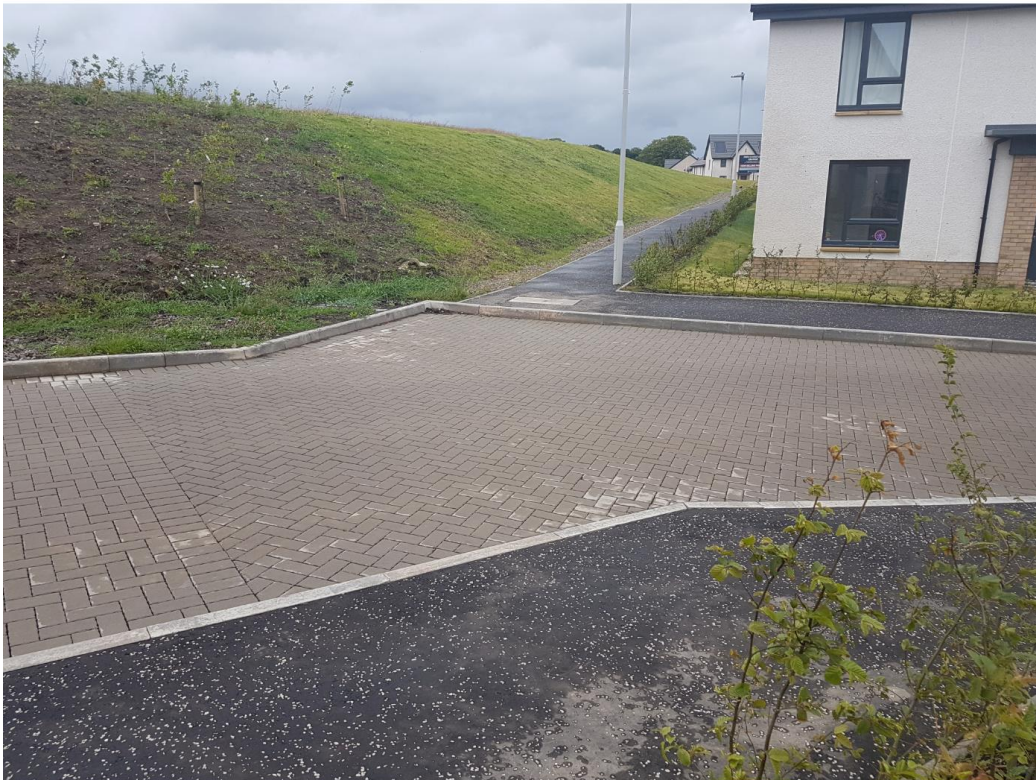
At the west end of Arkaig Gardens the footpath running north to south from plots 490 to 496 meets the carriageway. There is no dropped kerb at this point or at the footway opposite that runs past plots 506 & 507. As such pedestrians seeking to use this pedestrian route will have to negotiate two full height kerbs.

It is recommended that dropped kerbs be provided in a similar manner as to adjacent sections of footways.

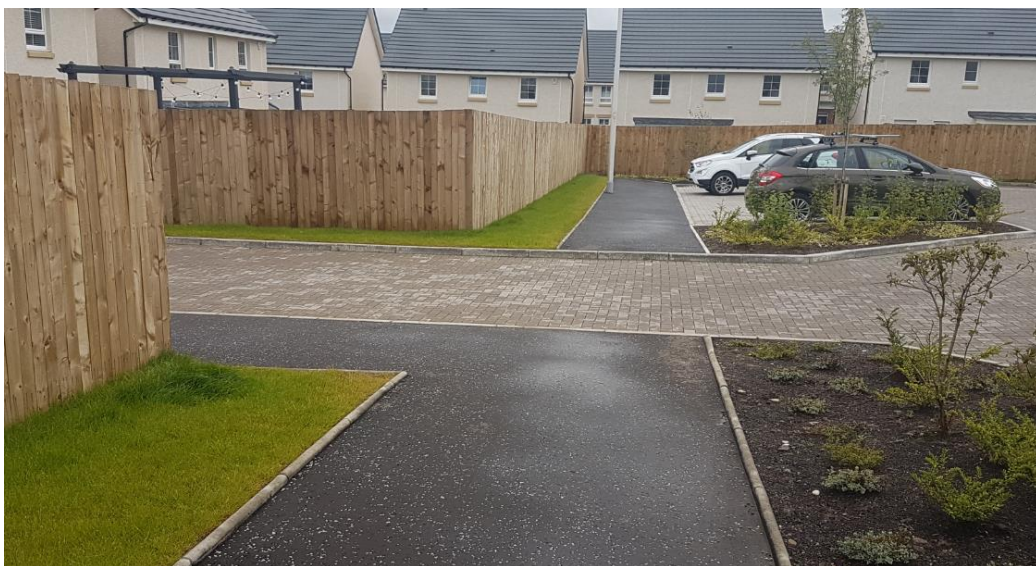
At the south-east run of parking at the parking court there is a footway running south to north. At the north end there is no accessible dropped kerb to assist with access. As such pedestrians seeking to use this pedestrian route will have to negotiate a full height kerb. If people were heading to this run of parking from Hepburn Gardens then they would have to negotiate two full height kerb

It is recommended that dropped kerbs be provided in a similar manner as to adjacent sections of footways.

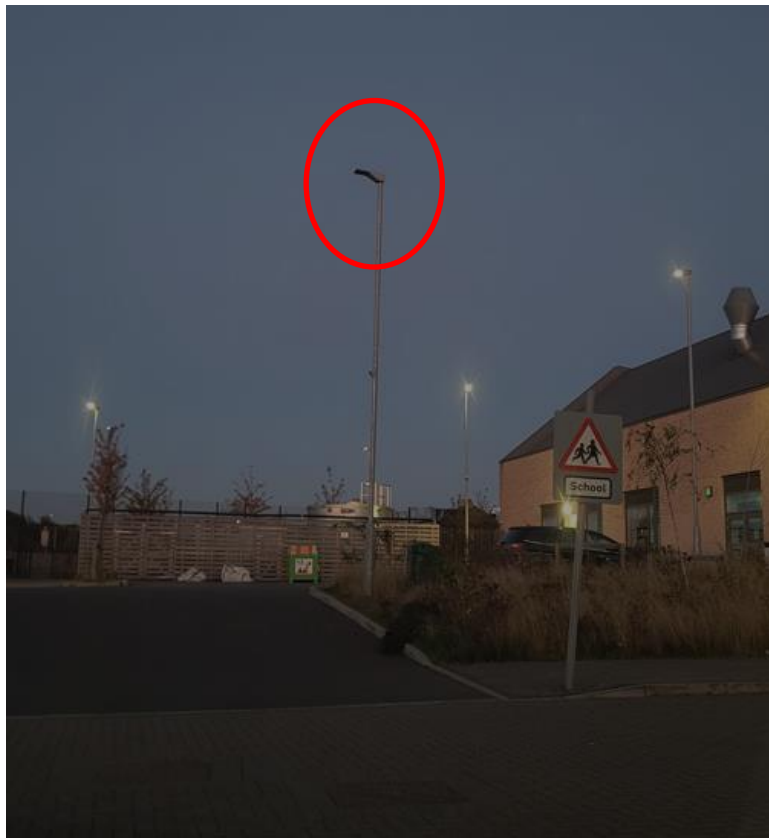
At the night-time inspection it was noted that the lighting column at the entry to the Primary School car park was 'dark'.

It is understood from the latest lighting plans that this lighting column is not part of the Barratts development and purely related to the Primary School. As such it is recommended that this lighting column be made operational by the Council as soon as possible.

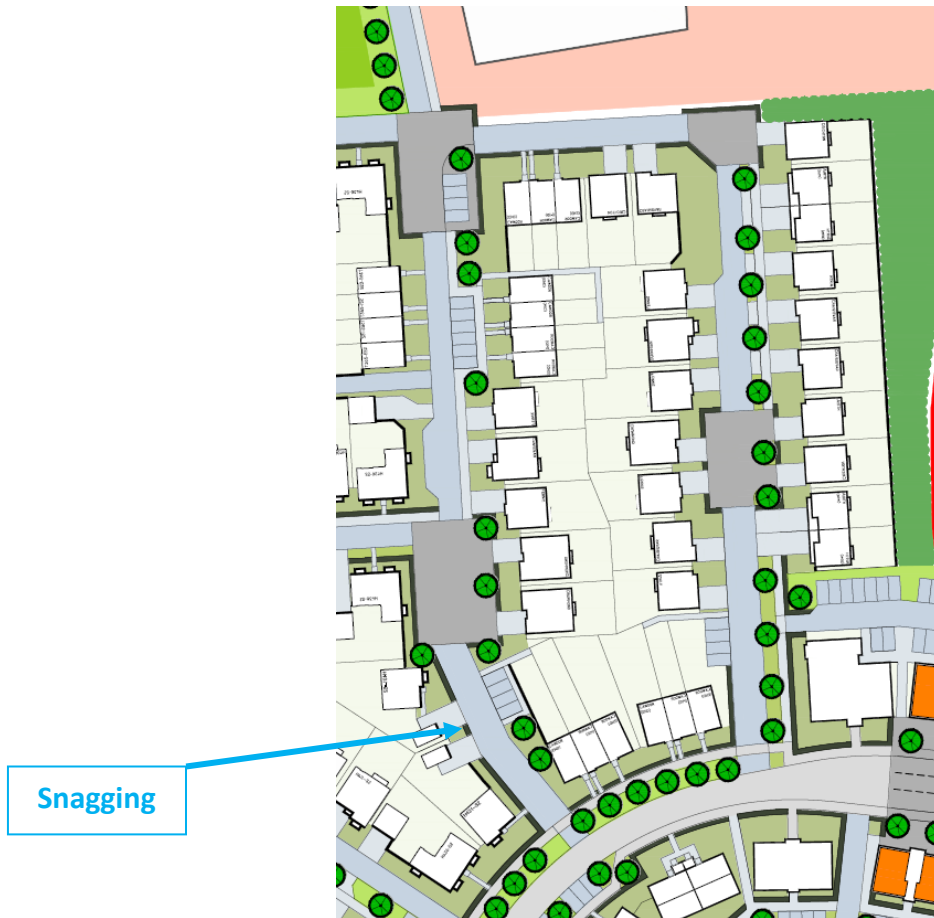
## Annex 2 PROBLEM LOCATION PLAN

- Specific problem areas have been identified and referenced by the comment number in the text
- General issues covering multiple areas have not been highlighted on this plan so as to avoid clutter and potential misinterpretation.

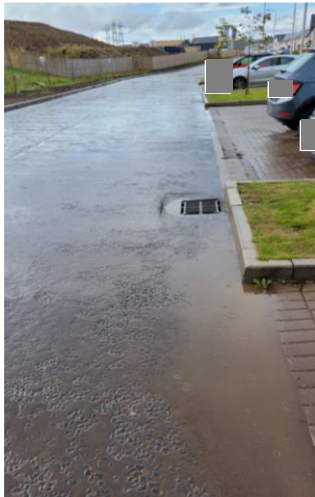
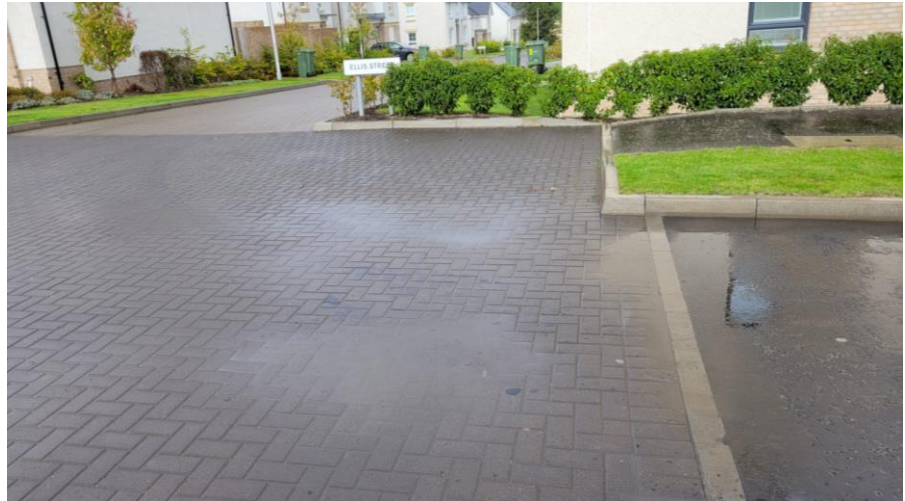
The locations were opposite No 56 (where there is also a gully set low in the carriageway) and at the junction of Ellis Street.

It is recommended that the areas where ponding is occurring are rectified to ensure the carriageway drains as intended.

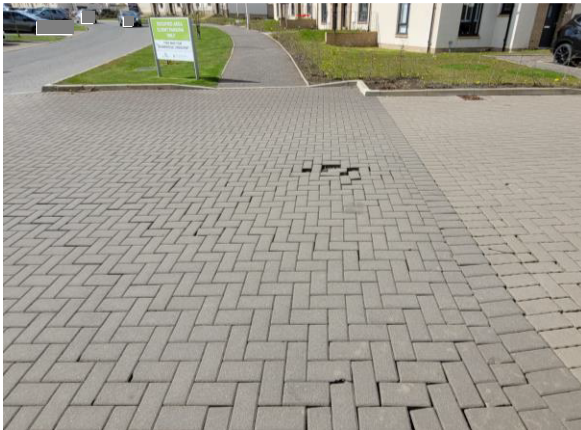
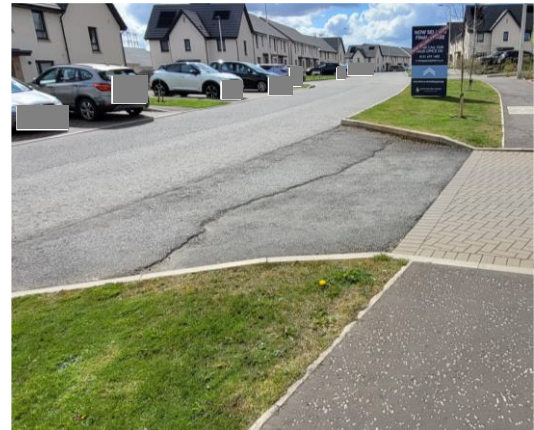
Bowbridge Crescent (two junctions) – poor block work at incomplete surfacing.

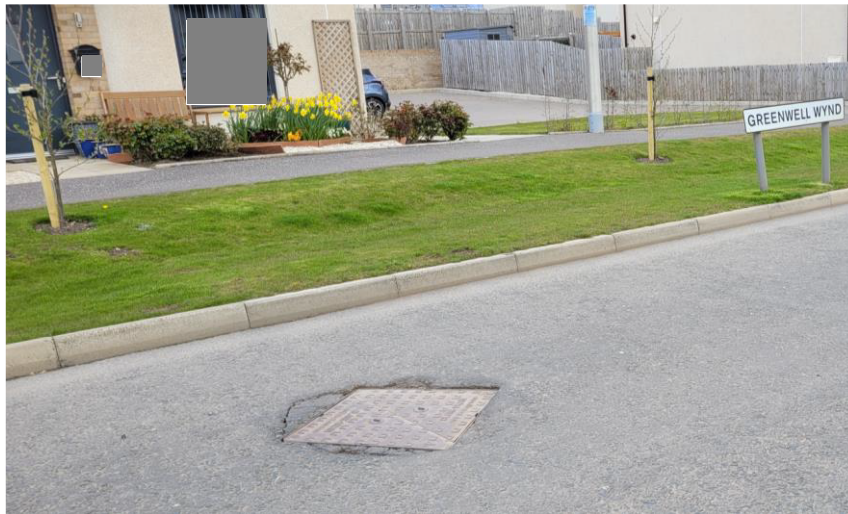
This has the potential to result in a degrading carriageway surface. This can be seen at No 163, below

It is recommended that a review of low ironwork be undertaken and repairs made to provide a level surface.

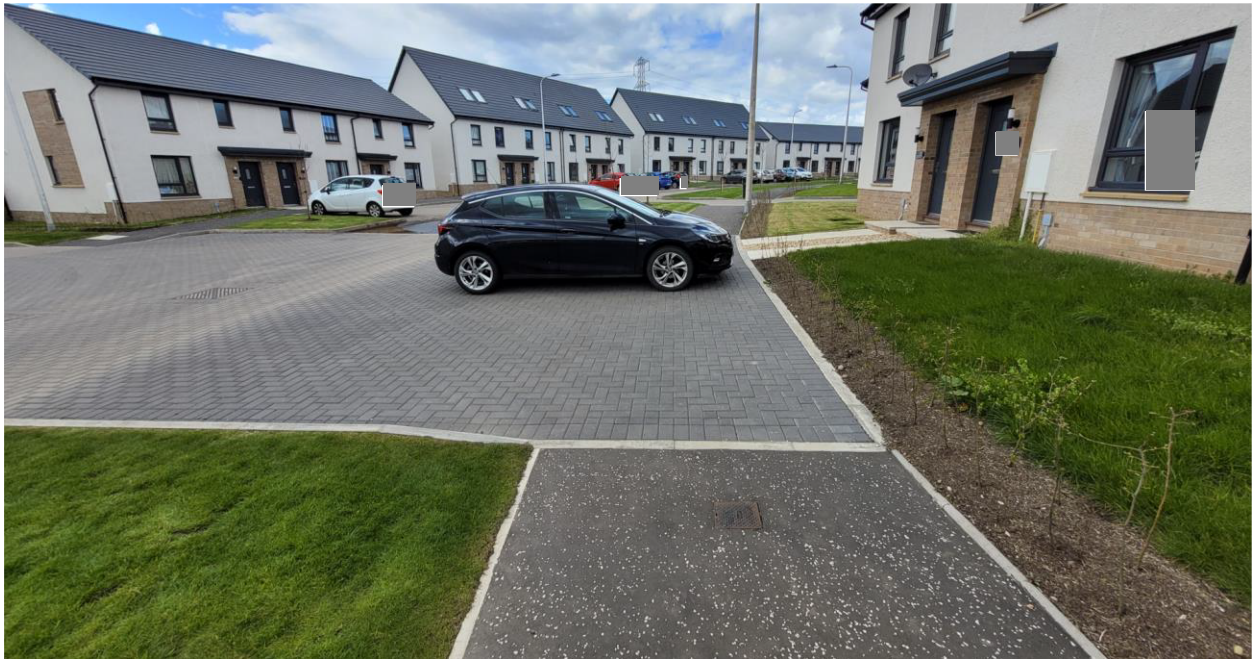
*Dunniker Way*

street parking. This inconsiderate parking then blocks the footway / desire line for pedestrians, especially those with mobility difficulties.

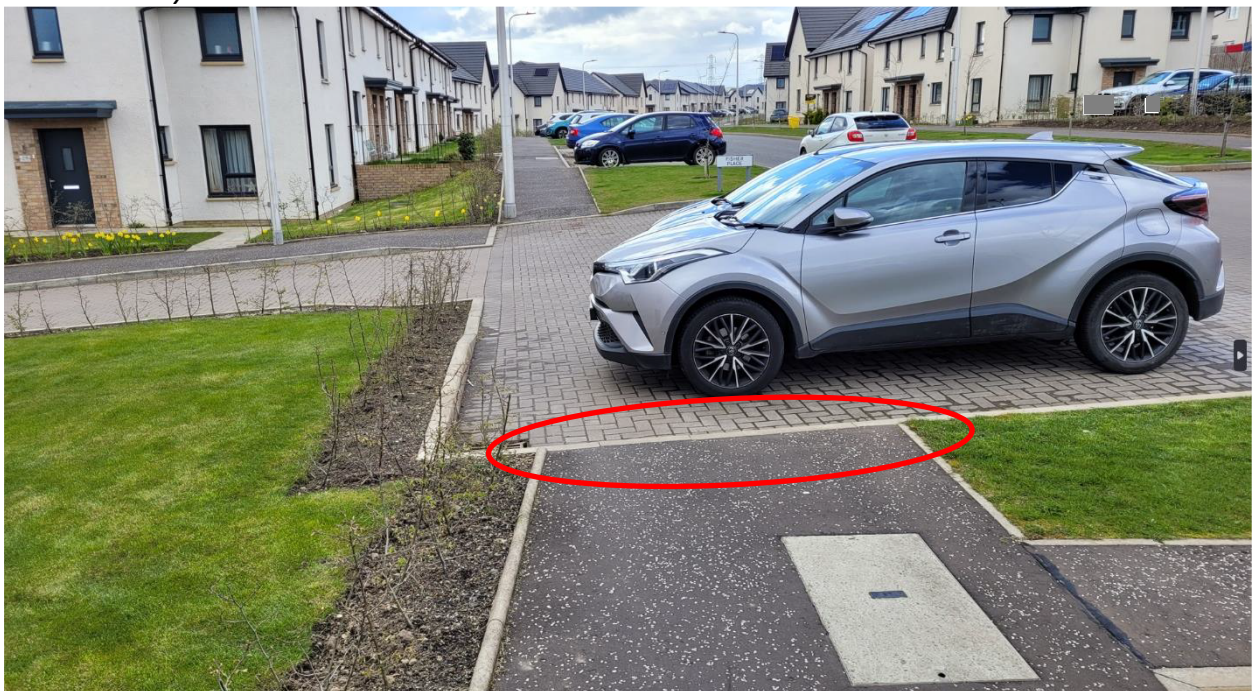
*Fisher Place*

In addition to blocking the pedestrian desire line, the kerb highlighted as Fisher Place has not been dropped.

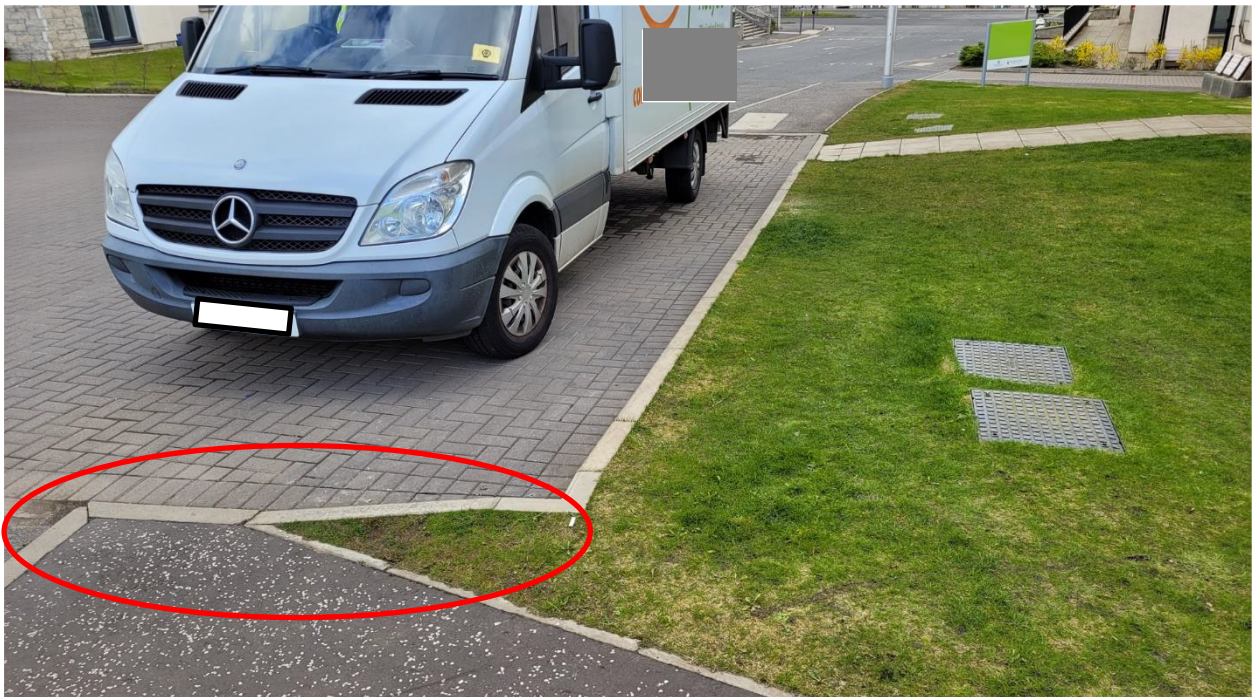
Similar to the comment above inconsiderate parking appears to be taking place at Bowbridge Crescent. In addition to this there is a substandard footway width and a short dropped kerb provided.

It is recommended that steps are taken to ensure the pedestrian route is unobstructed. This may require the footway and kerbing to be extended through the junction. The sub-standard footway layout as highlighted should also be amended to a more 'standard layout, similar to that opposite.
