**ROAD LAYOUT  
HOUSING DEVELOPMENT  
FROGSTON ROAD (POD A, SITE 1)  
EDINBURGH**

STAGE 3 ROAD SAFETY AUDIT  
(SPA Ref No: 4282)

Roads Authority: The City of Edinburgh Council

Client: Barratt Homes

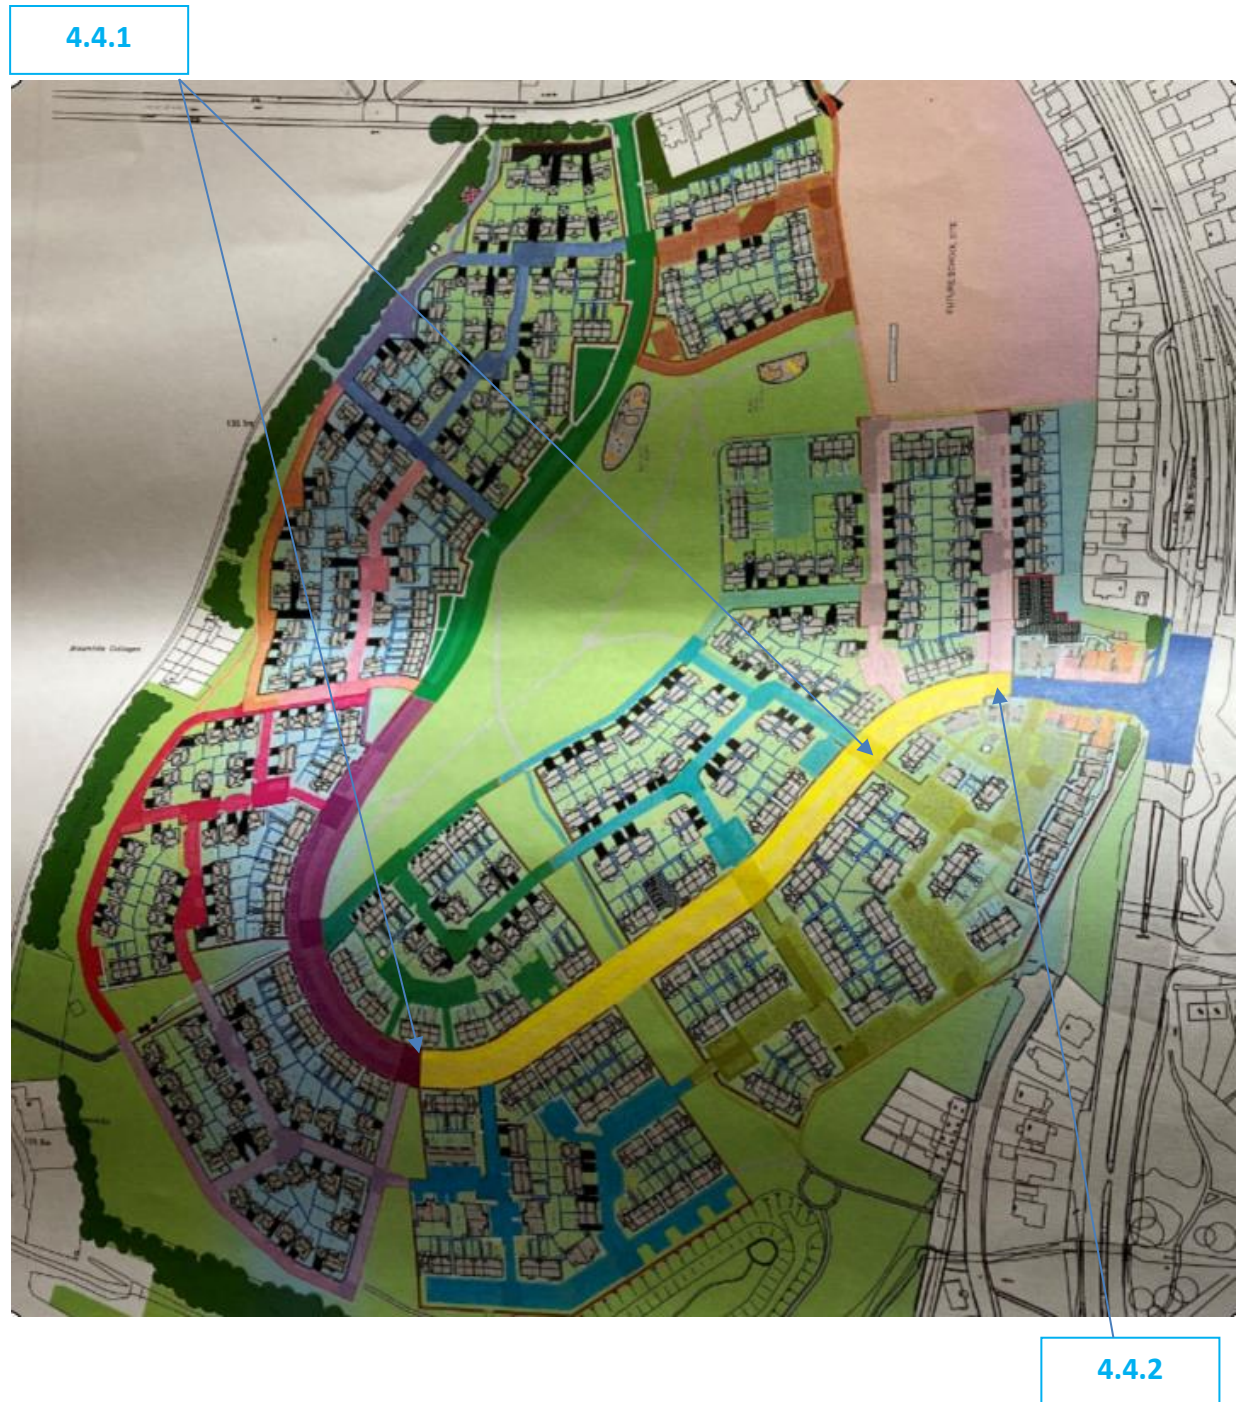
- Specific problem areas have been identified and referenced by the comment number in the text
- General issues covering multiple areas have not been highlighted on this plan so as to avoid clutter and potential misinterpretation.

(Spine Road 3 in yellow below)
