**ROAD LAYOUT
HOUSING DEVELOPMENT
FROGSTON ROAD (POD B)
EDINBURGH**

STAGE 3 ROAD SAFETY AUDIT
(SPA Ref No: 4282)

Roads Authority: The City of Edinburgh Council

Client: Barratt Homes

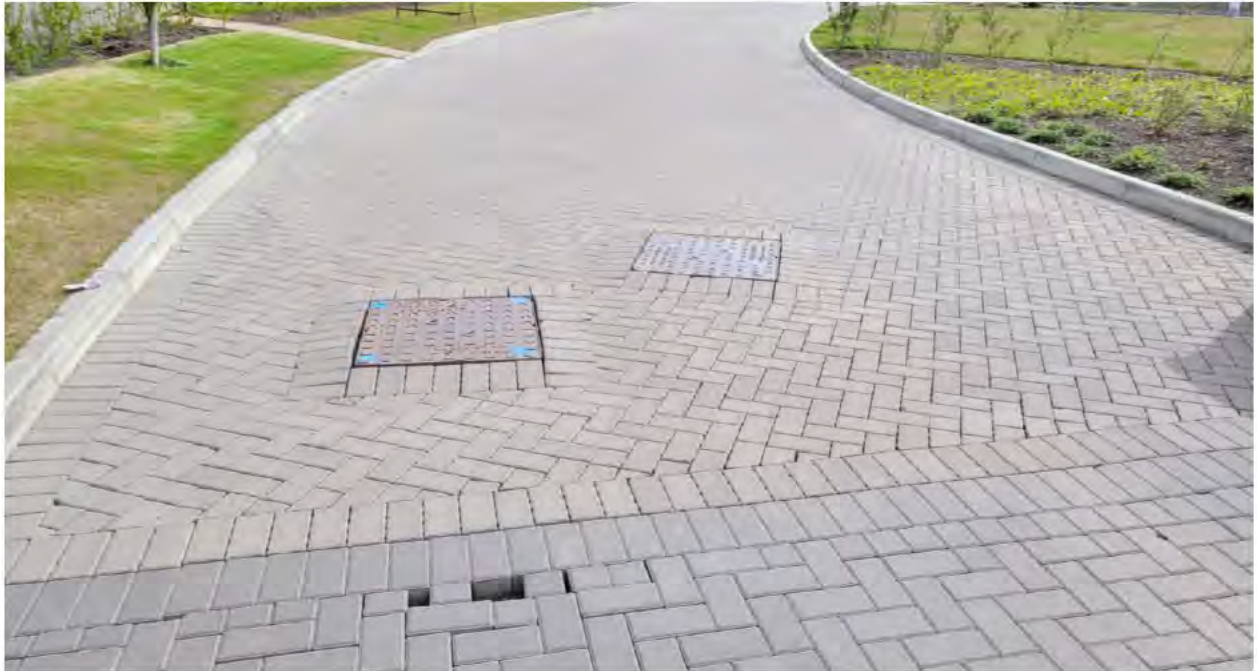
Location: Various
Drawing(s): E9876~0925
Summary: Uneven surfaces and gaps in paved areas can result in trip type accidents in shared space areas.

It was noted and understood that a range of 'snagging issues' have been identified by the Council's inspectors during pre-adoption inspections. These included issues such as ironwork being raised and gaps in the surrounding joints. Also, it was noted there were some paving blocks missing from the surface at various points. The image below provides an example of the above issues.

It is recommended that the proposed snagging works be completed as soon as possible being that houses are now occupied and pedestrians and cyclists will be using these shared use streets.

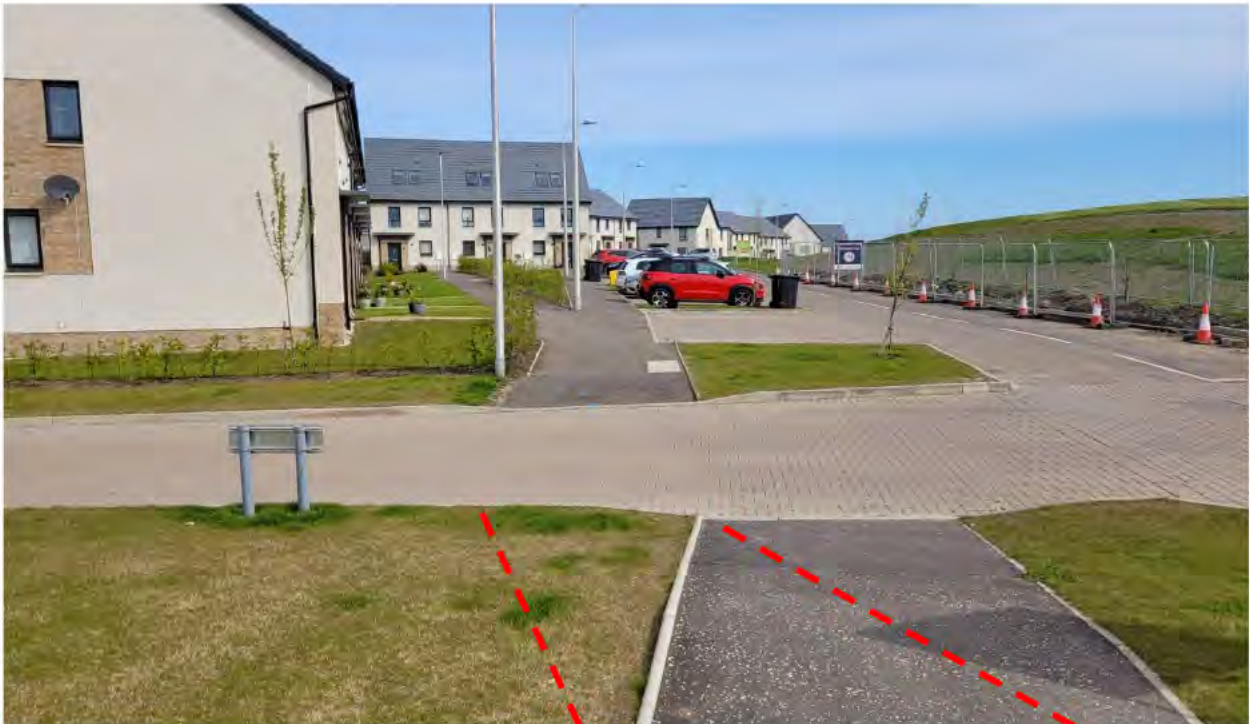
Location: Dunniker Way – East end
Drawing(s): E9876~0925

Summary: Crossing points on desire lines at junctions should ideally match up to help reduce tripping type accidents and improve accessibility.

At the east end of Dunnikier Way the footpath on the north and south of the junction did not tie-in due to being provide in an off-set manner.

Spray paint had been provided to show the potential line of north side footway to provide a crossing point that tied in with the southside footway.

It was however noted that at the existing north side dropped kerb there were a number of services.

The Audit Team would question if it was perhaps more practical to alter the south side footway alignment. Possibly from the lighting column northwards (See image below)

However as both dropped kerbs appeared to be 'high' it may be both sides for the footway will require work.

It is recommended that the proposed snagging works be completed as soon as possible and that the option of altering the south side footway be reviewed by the design team.

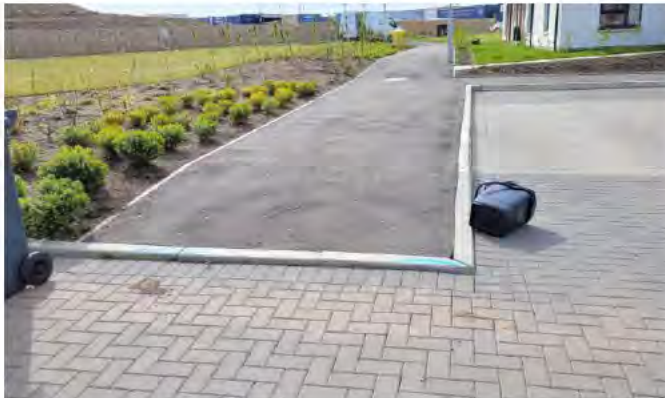
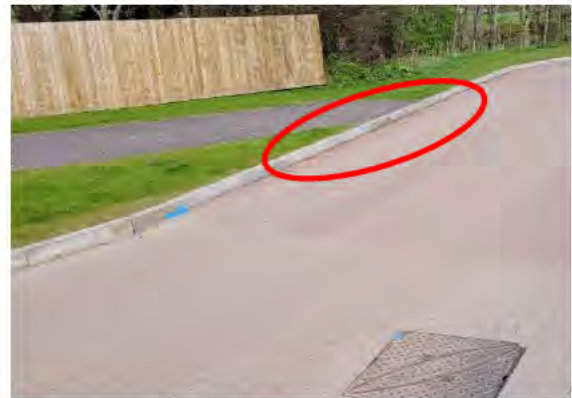
Location: Various Locations including Dunnikier Way and segregated footway on Printonan Crescent
Drawing(s): E9876~0925

Summary: Accessible dropped kerbs at a height of 0-6mm help reduce tripping type accidents and improve accessibility.

As with other snagging works, some kerbs including dropped kerbs were marked for alteration on the bases they were not at the accessible height of 0-6mm.

Some examples are below.

It is recommended that the proposed snagging works be completed as soon as possible being that houses are now occupied, and pedestrians and cyclists will be using these routes and dropped kerbs.

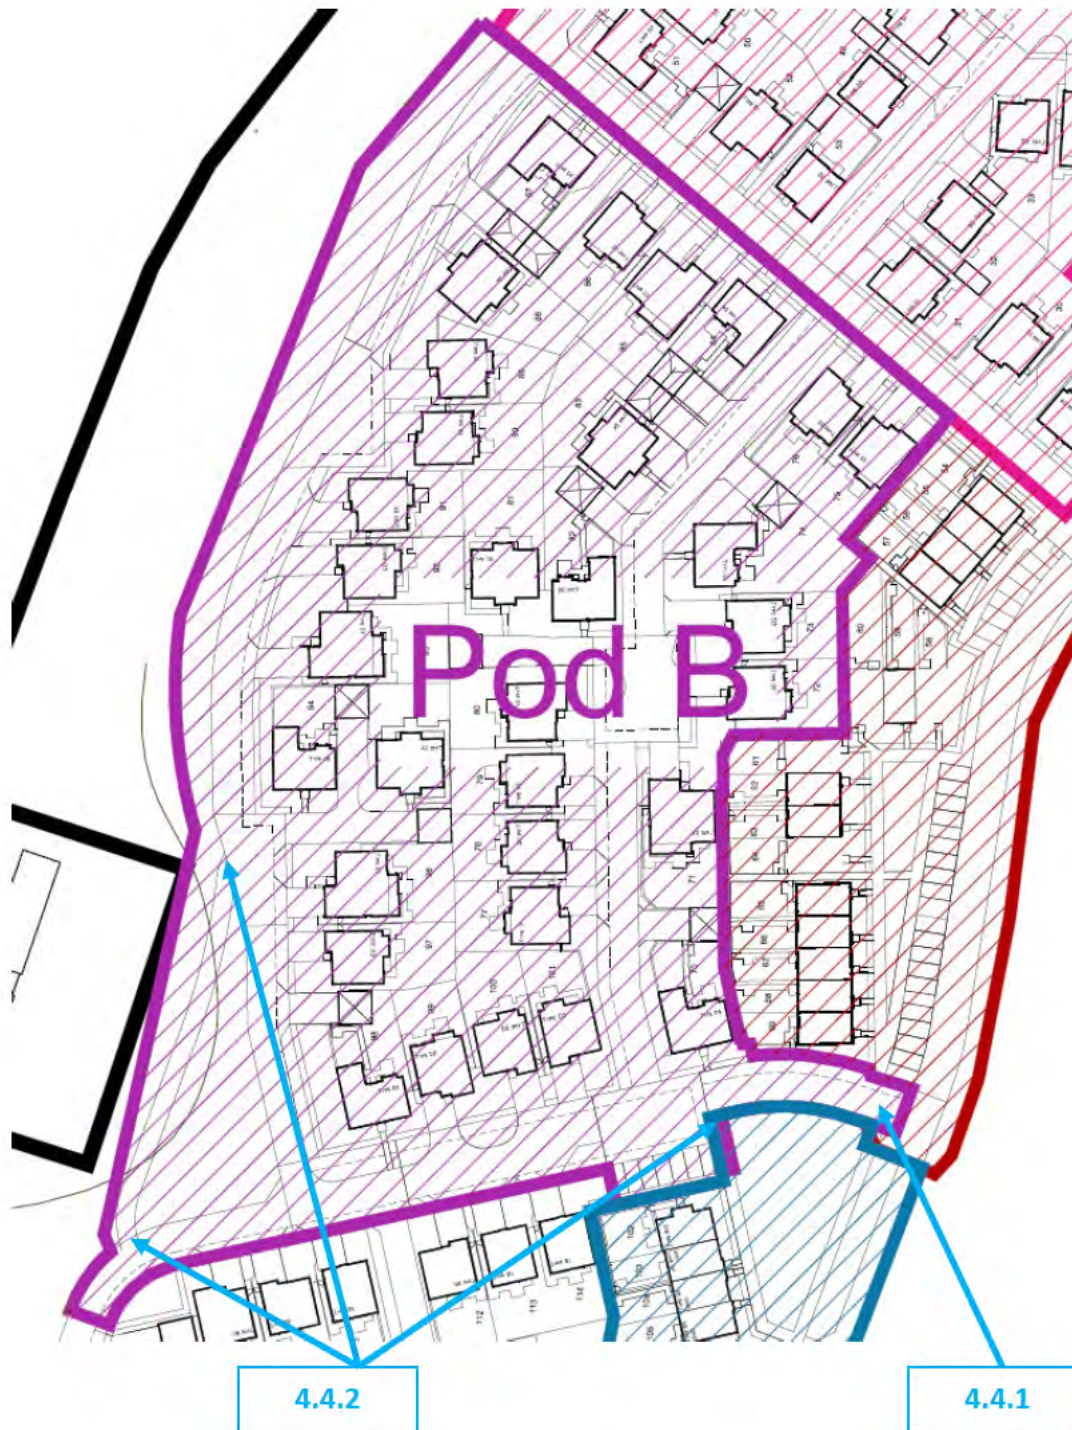
Annex 2 PROBLEM LOCATION PLAN

- Specific problem areas have been identified and referenced by the comment number in the text
- General issues covering multiple areas have not been highlighted on this plan so as to avoid clutter and potential misinterpretation.

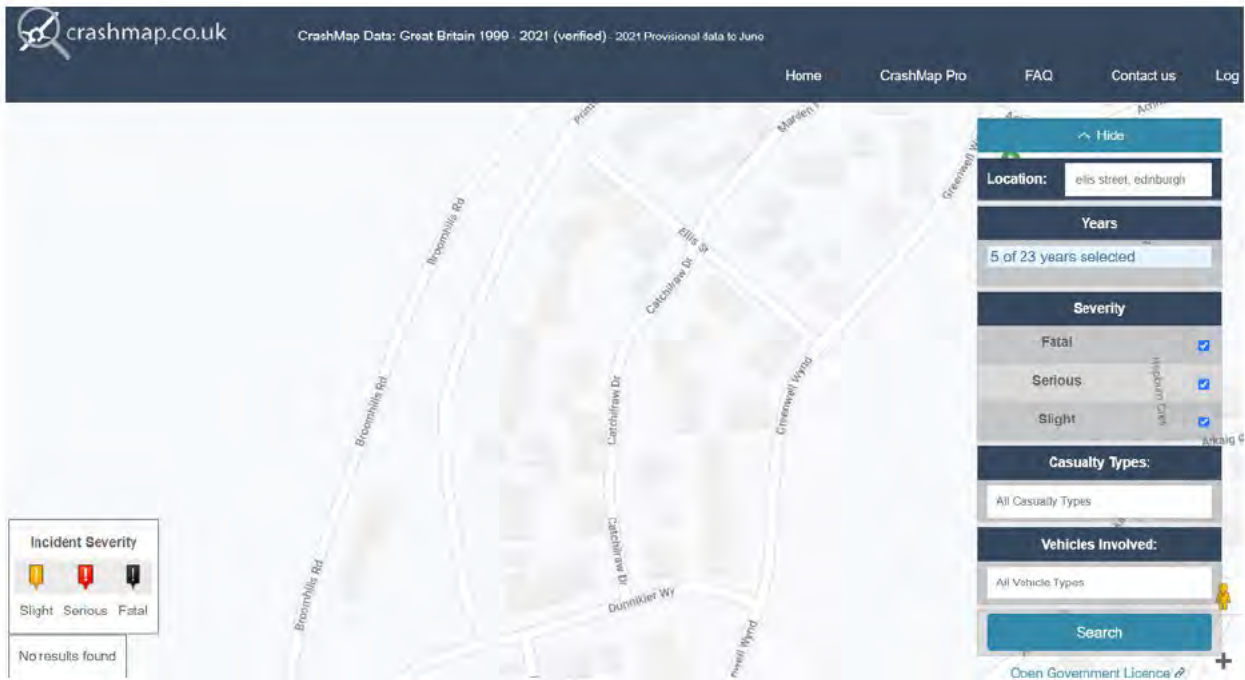
Annex 3 ACCIDENT RECORD

- 2.1 In the absence of any specific accident records being provided the Road Safety Audit Team have examined the website www.crashmap.co.uk for injury accidents recorded at the site.
- 2.2 A map based plan of the accidents have been provided in Annex 3
- 2.3 It is noted that for the five-year period from 2017 -2021 there were no accidents directly related to the area of the new development.

The screenshot shows the CrashMap.co.uk interface. The map displays a residential area with streets including Broomhall Rd, Carrickfrew Dr, and Greenwell Wynd. A search panel on the right is active, showing the following filters:

- Location: ellis street, edinburgh
- Years: 5 of 23 years selected
- Severity: Fatal (checked), Serious (checked), Slight (checked)
- Casualty Types: All Casualty Types
- Vehicles Involved: All Vehicle Types

A search button is visible at the bottom of the panel. The bottom of the panel also includes a 'Open Government Licence' link. In the bottom left corner of the map area, there is a legend for 'Incident Severity' with icons for Slight (yellow), Serious (red), and Fatal (black), and a text box stating 'No results found'.
