**ROAD LAYOUT  
HOUSING DEVELOPMENT  
FROGSTON ROAD (POD C)  
EDINBURGH**

STAGE 3 ROAD SAFETY AUDIT  
(SPA Ref No: 4282)

Roads Authority: The City of Edinburgh Council

Client: Barratt Homes

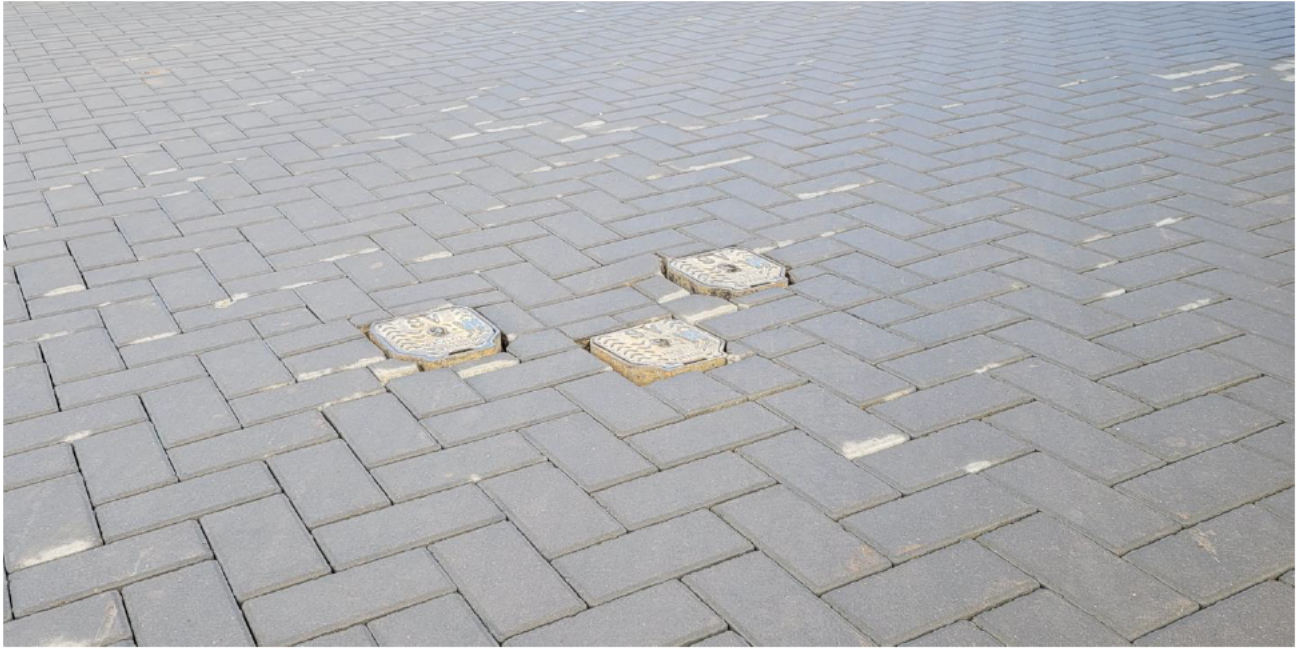
Location: Various  
Drawing(s): E9876~0925  
Summary: Ironwork sitting high in a shared surface area can be a trip hazard to pedestrians.

An example of potential trip hazards due to high ironwork can be seen below.

It is recommended that ironwork within the development area is reviewed to ensure there are no raised elements.

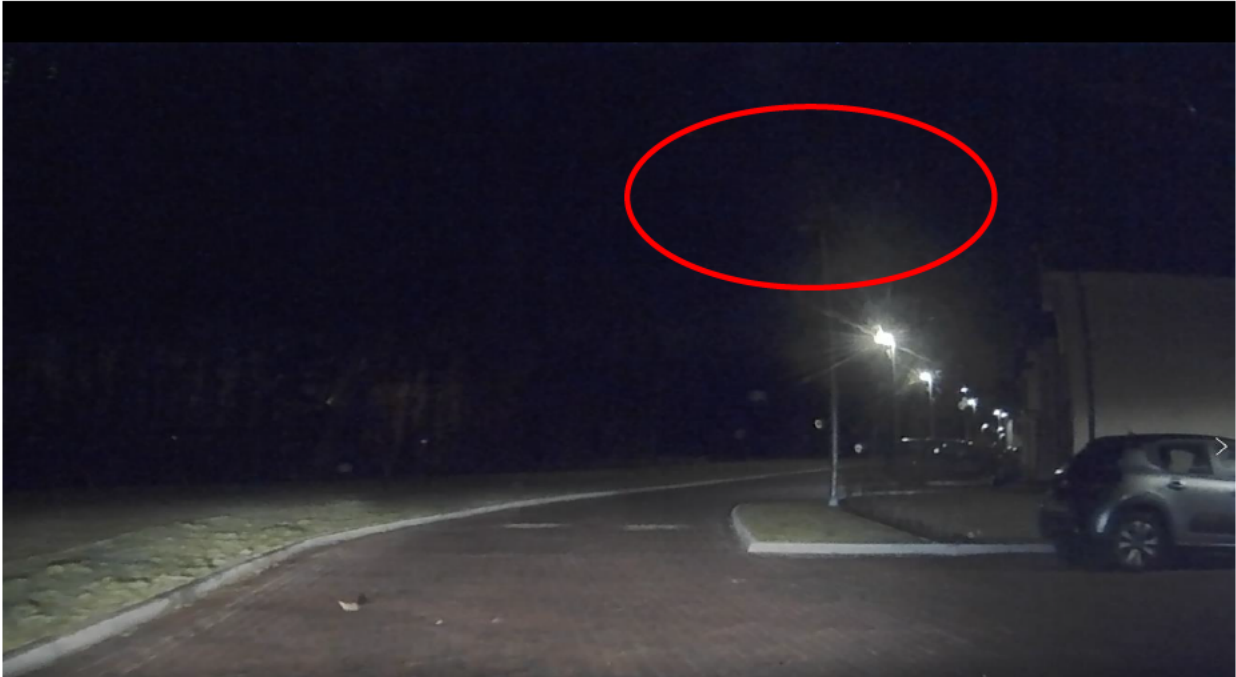
Location: Dunnikier Way at Plot  
Drawing(s): E9876~0925

Summary: A lack of street lighting can increase the potential for road users to miss obstructions or level differences in the surface.

At plot 152 it was noted that the lighting column had a 'dark' head.

It is recommended that the lighting head be examined and repaired as soon as possible.

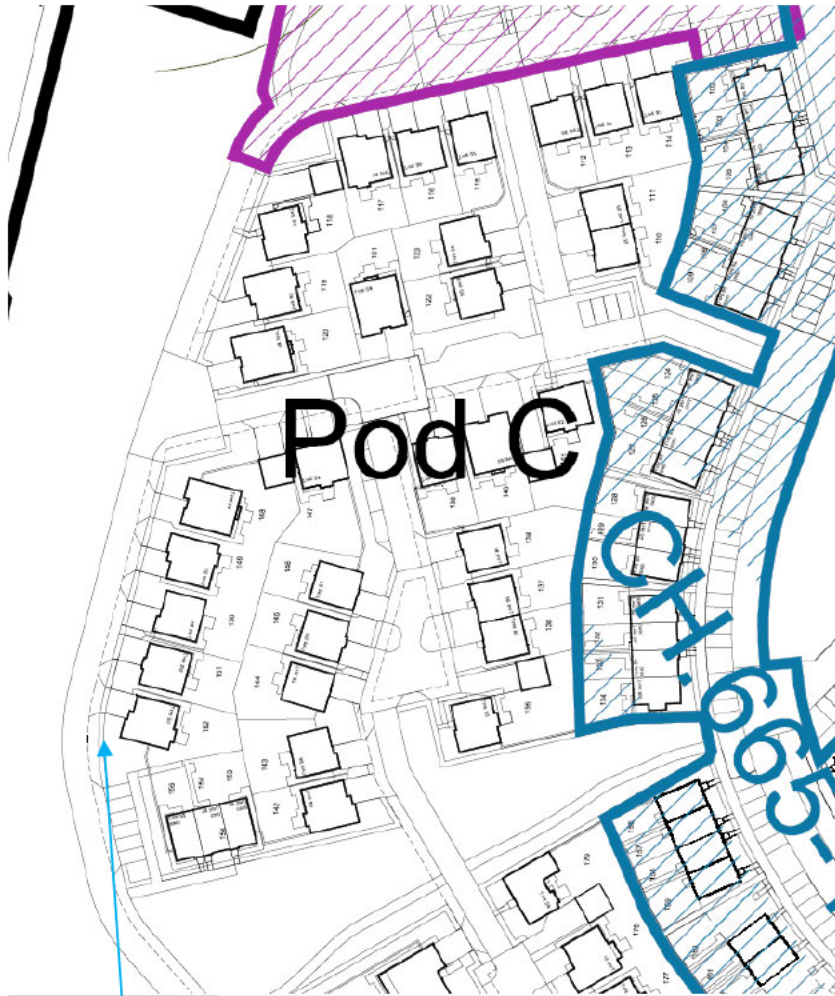
4.4.2

- Specific problem areas have been identified and referenced by the comment number in the text
- General issues covering multiple areas have not been highlighted on this plan so as to avoid clutter and potential misinterpretation.

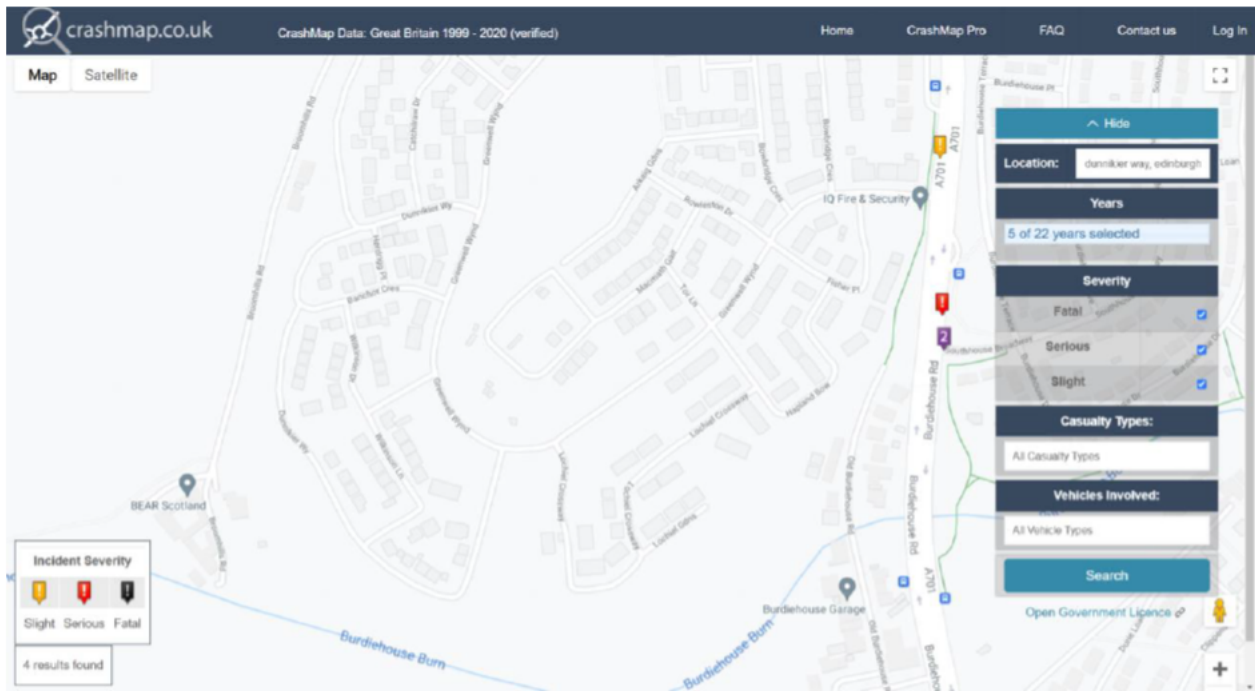
### Annex 3 ACCIDENT RECORD

- 2.1 In the absence of any specific accident records being provided the Road Safety Audit Team have examined the website [www.crashmap.co.uk](http://www.crashmap.co.uk) for injury accidents recorded at the site.
- 2.2 A map based plan of the accidents have been provided in Annex 3
- 2.3 It is noted that for the five-year period from 2016 -2020 there were no accidents directly related to the area of the new development.
