**ROAD LAYOUT
HOUSING DEVELOPMENT
FROGSTON ROAD (POD K, SITE 3),
EDINBURGH**

STAGE 3 ROAD SAFETY AUDIT
(SPA Ref No: 4282)

Roads Authority: The City of Edinburgh Council

Client: Barratt Homes

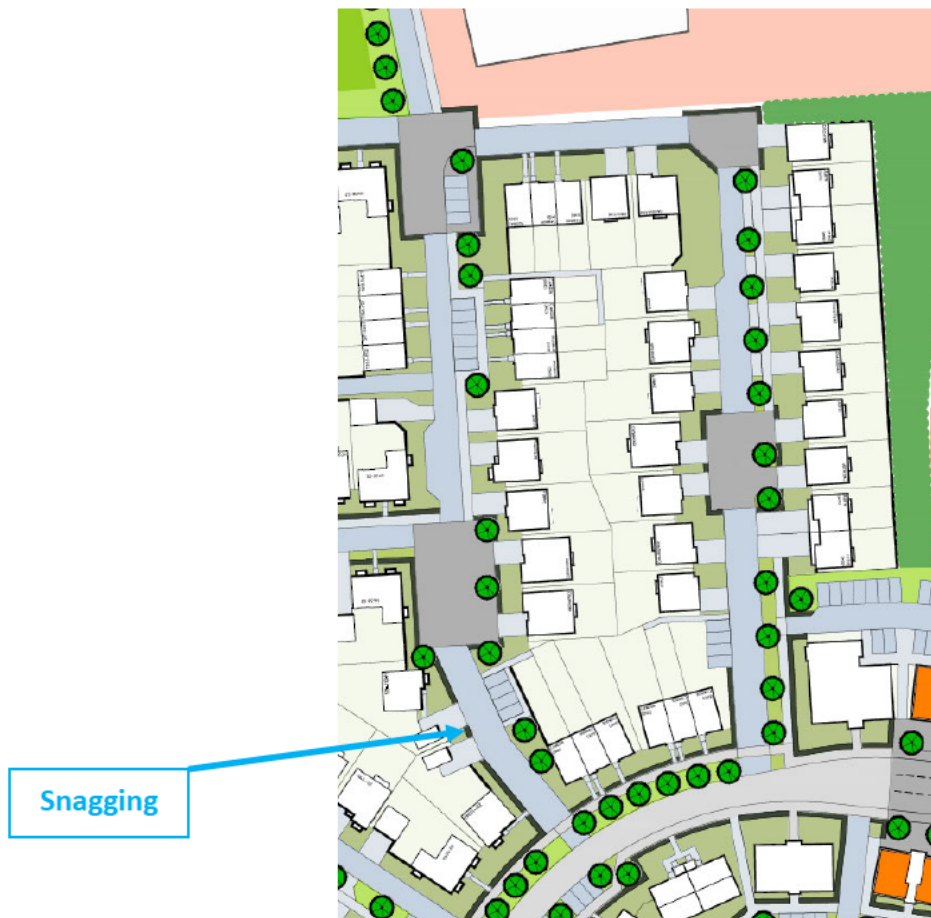
Annex 2 PROBLEM LOCATION PLAN

- Specific problem areas have been identified and referenced by the comment number in the text
- General issues covering multiple areas have not been highlighted on this plan so as to avoid clutter and potential misinterpretation.
