**ROAD LAYOUT
HOUSING DEVELOPMENT
FROGSTON ROAD (SPINE ROAD 1)
EDINBURGH**

STAGE 3 ROAD SAFETY AUDIT
(SPA Ref No: 4282)

Roads Authority: The City of Edinburgh Council

Client: Barratt Homes

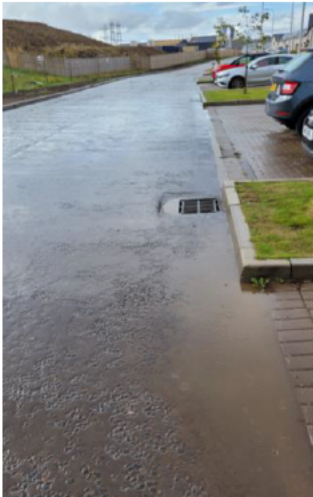
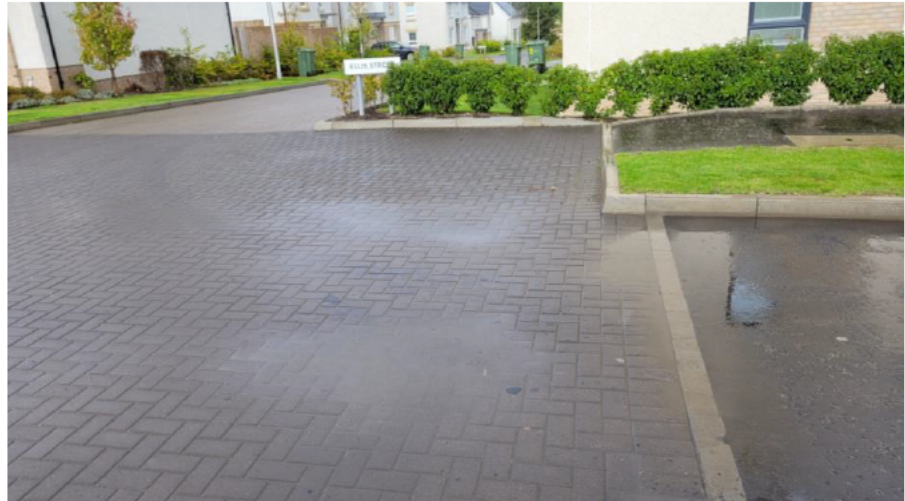
Location: Greenwell Wynd
Drawing(s): E9876~0925
Summary: Ponding on the carriageway can introduce skid / slip hazards to users.

On Greenwell Wynd there were two areas where significant ponding was noted. While it accepted this is not a shared space area and thus pedestrians may be affected in a limited

manner, the ponding could be an issue for cyclists in the winter months if ponding freezes over due to low temperatures..

The locations were opposite No 56 (where there is also a gully set low in the carriageway) and at the junction of Ellis Street.

It is recommended that the areas where ponding is occurring are rectified to ensure the carriageway drains as intended.

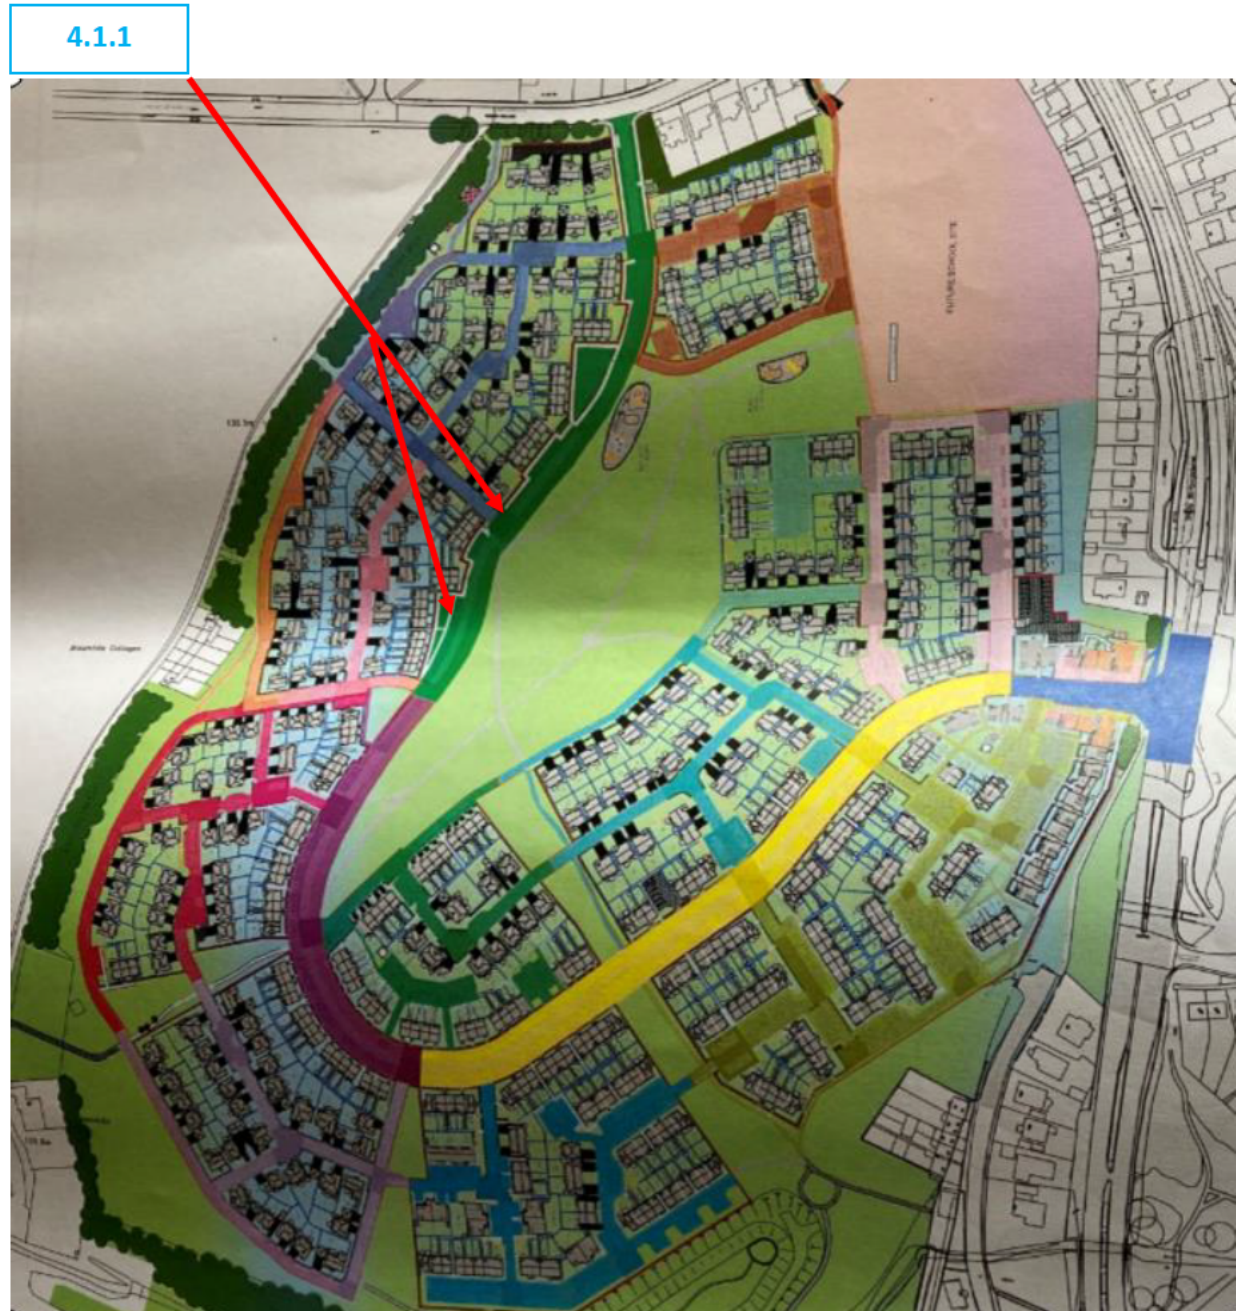
Annex 2 PROBLEM LOCATION PLAN

- Specific problem areas have been identified and referenced by the comment number in the text
- General issues covering multiple areas have not been highlighted on this plan so as to avoid clutter and potential misinterpretation.

(Spine Road 1 in green below)
