**ROAD LAYOUT
HOUSING DEVELOPMENT
FROGSTON ROAD (SPINE ROAD 3)
EDINBURGH**

STAGE 3 ROAD SAFETY AUDIT
(SPA Ref No: 4282)

Roads Authority: The City of Edinburgh Council

Client: Barratt Homes

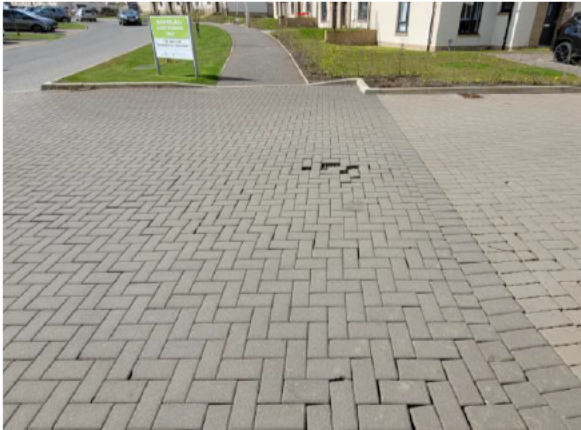
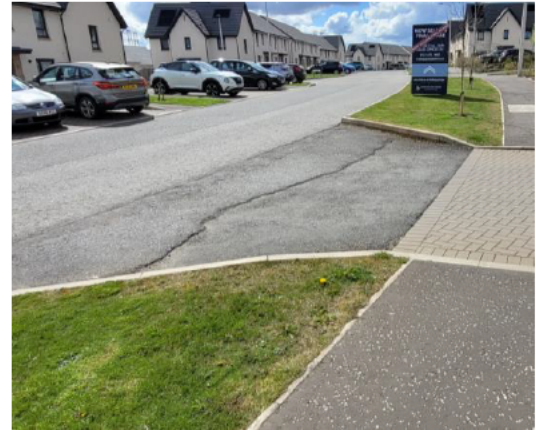
Bowbridge Crescent (two junctions) – poor block work at incomplete surfacing.

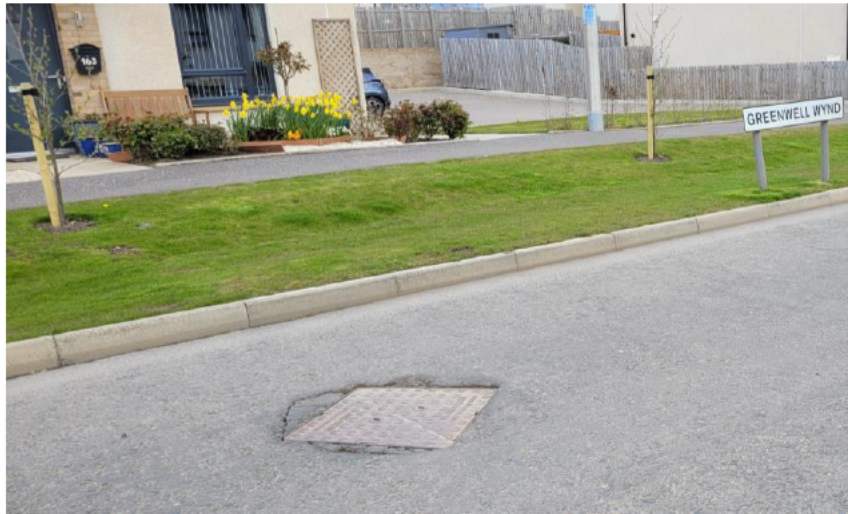
Location: Greenwell Wynd- Junctions with Fisher Place, Hapland Row and at No 163
Drawing(s): E9876~0925
Summary: Low ironwork can result in future degradation of the carriageway. This in turn can result in users making unexpected manoeuvres that can lead to various incident types.

It was noted that at the above locations ironwork siting in the carriageway was 'low'.

This has the potential to result in a degrading carriageway surface. This can be seen at No 163, below

It is recommended that a review of low ironwork be undertaken and repairs made to provide a level surface.

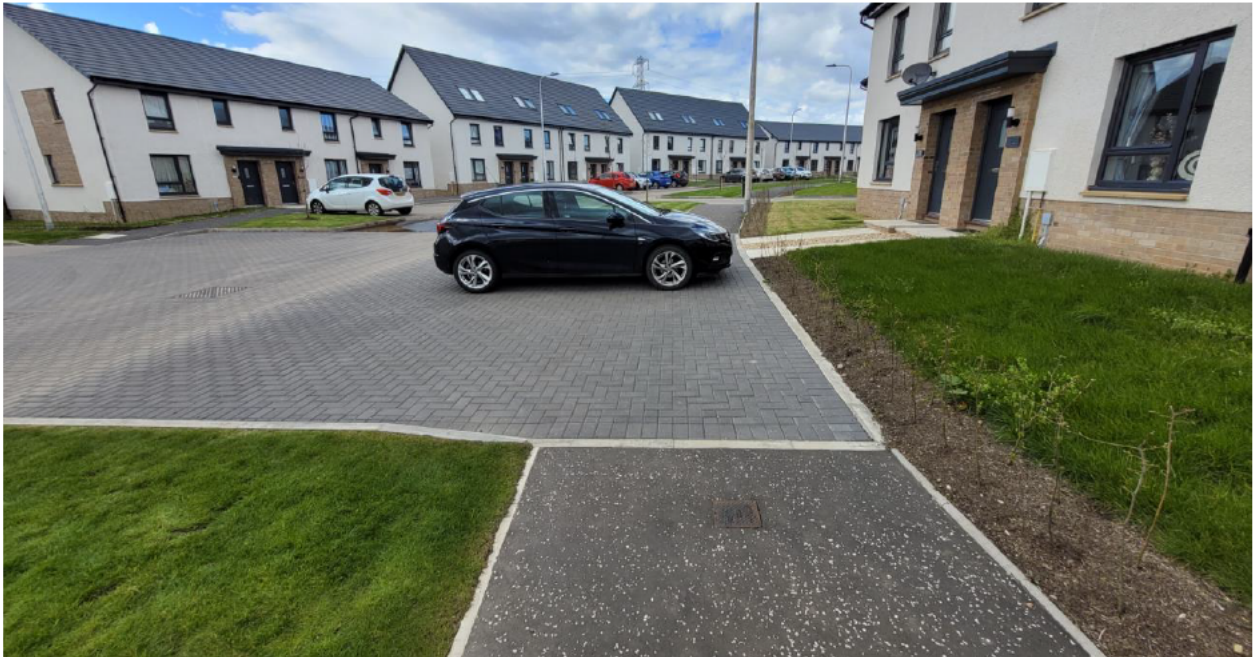
Dunniker Way

Summary: The blocking of pedestrian desire lines can result in pedestrians walking on the carriageway with an increased probability of conflicting with vehicular traffic.

At the two junctions locations a contrasting colour surface has been provided to highlight the junction. However, due to the footway layout, part of the junctions are now being used for on-

street parking. This inconsiderate parking then blocks the footway / desire line for pedestrians, especially those with mobility difficulties.

It is recommended that steps are taken to ensure the pedestrian route is unobstructed. This may require the footway and kerbing to be extended through the junction.

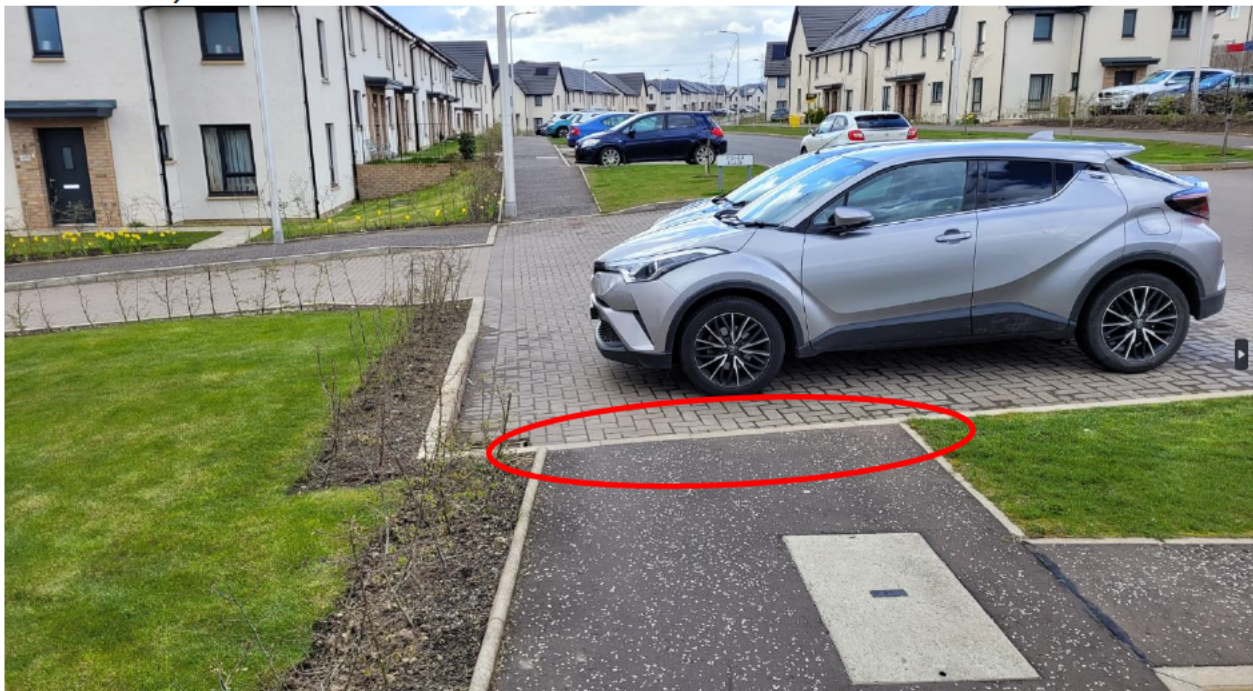
In addition to blocking the pedestrian desire line, the kerb highlighted as Fisher Place has not been dropped.

At Fisher Place a dropped kerb is required.

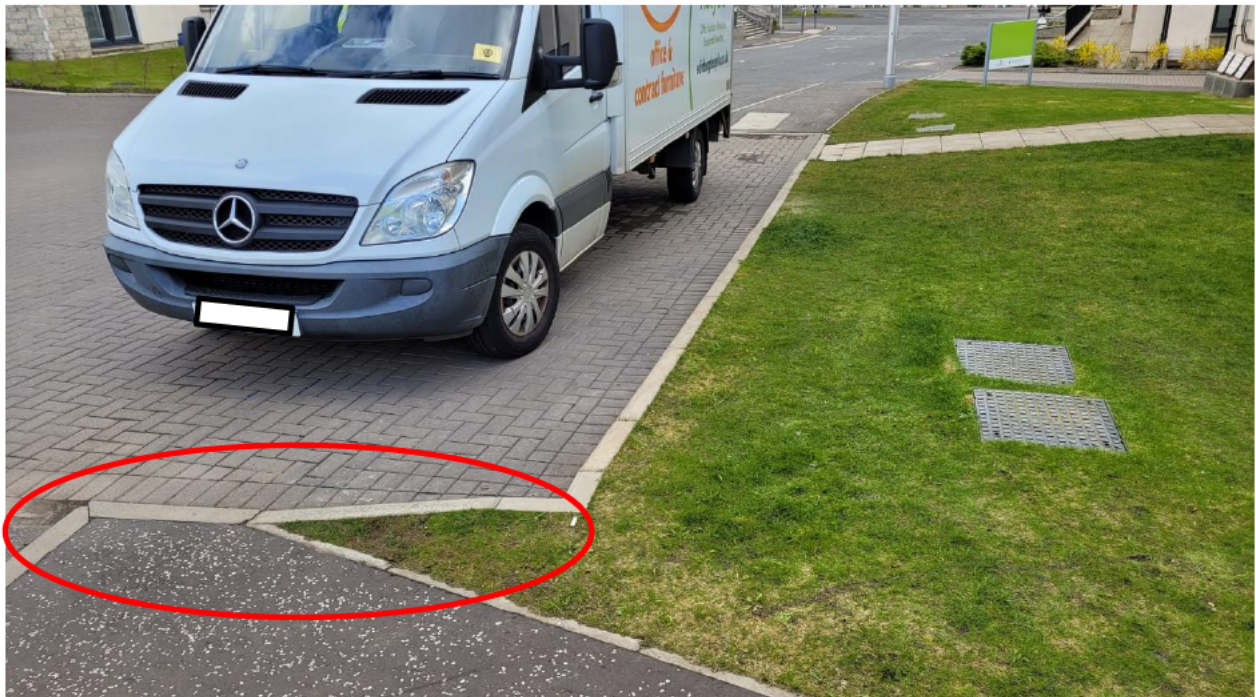
Location: Greenwell Wynd- Junction with Bowbridge Crescent (East)

Summary: The blocking of pedestrian desire lines can result in pedestrians walking on the carriageway with an increased probability of conflicting with vehicular traffic.

Similar to the comment above inconsiderate parking appears to be taking place at Bowbridge Crescent. In addition to this there is a substandard footway width and a short dropped kerb provided.

It is recommended that steps are taken to ensure the pedestrian route is unobstructed. This may require the footway and kerbing to be extended through the junction. The sub-standard footway layout as highlighted should also be amended to a more 'standard layout, similar to that opposite.

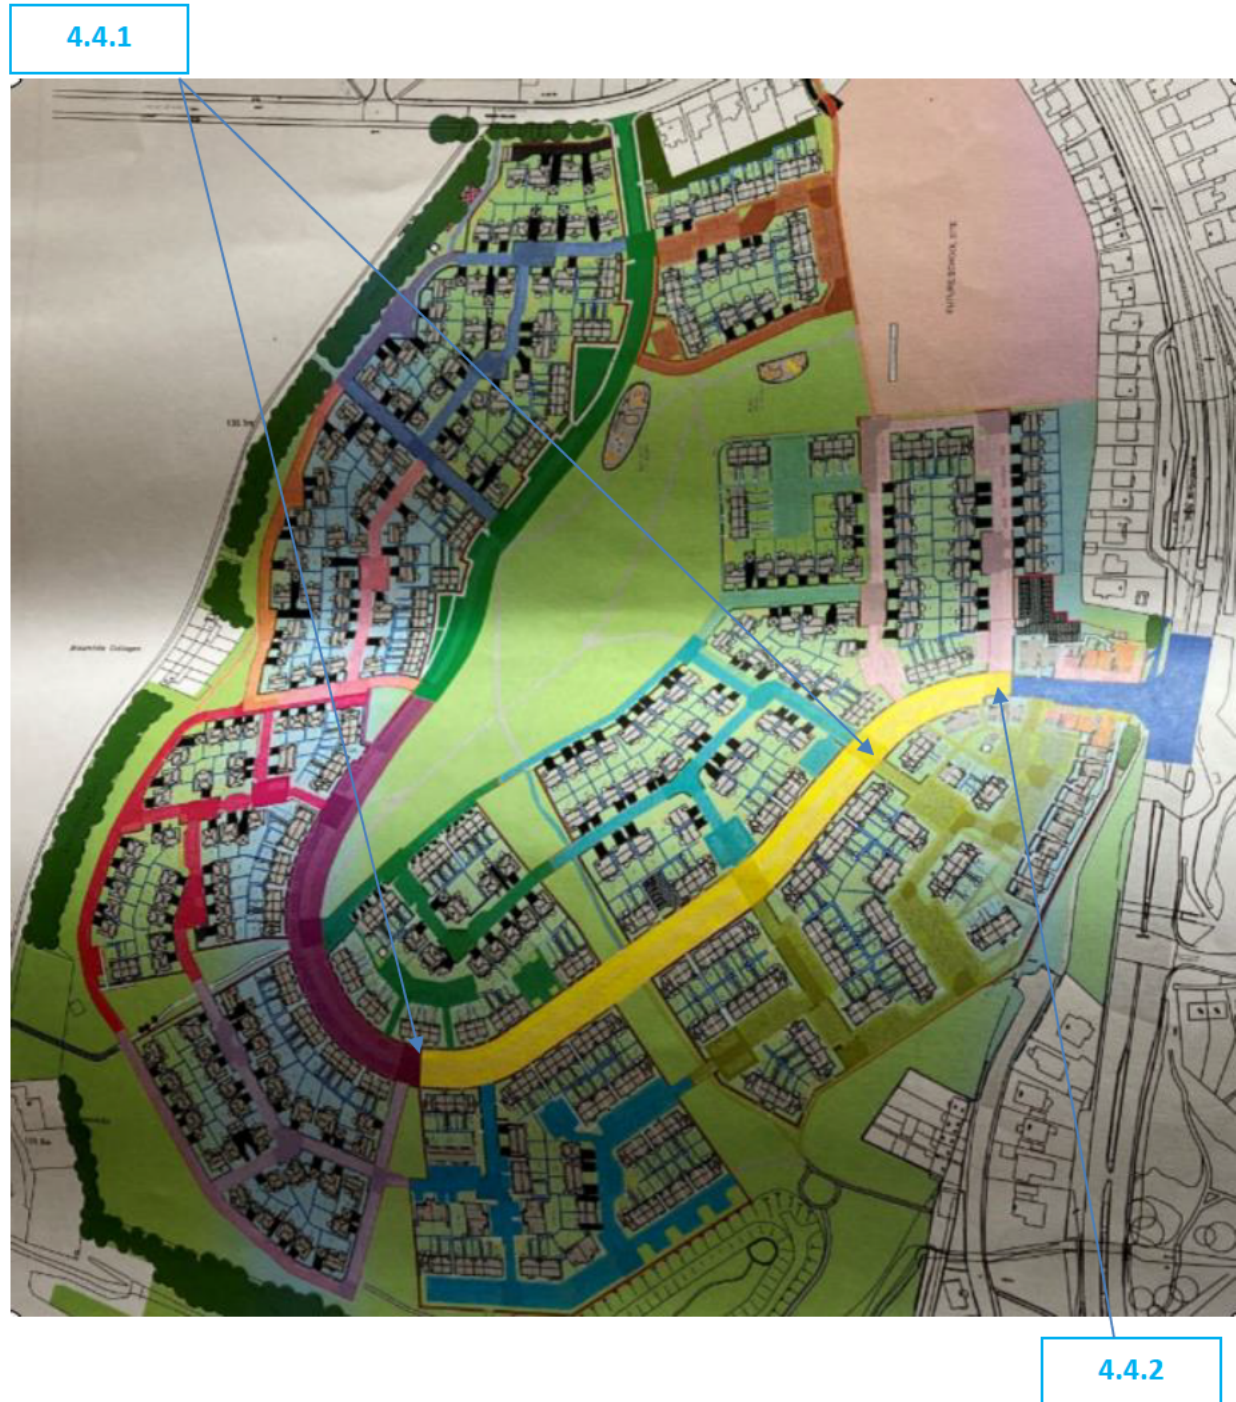
Annex 2 PROBLEM LOCATION PLAN

- Specific problem areas have been identified and referenced by the comment number in the text
- General issues covering multiple areas have not been highlighted on this plan so as to avoid clutter and potential misinterpretation.

(Spine Road 3 in yellow below)

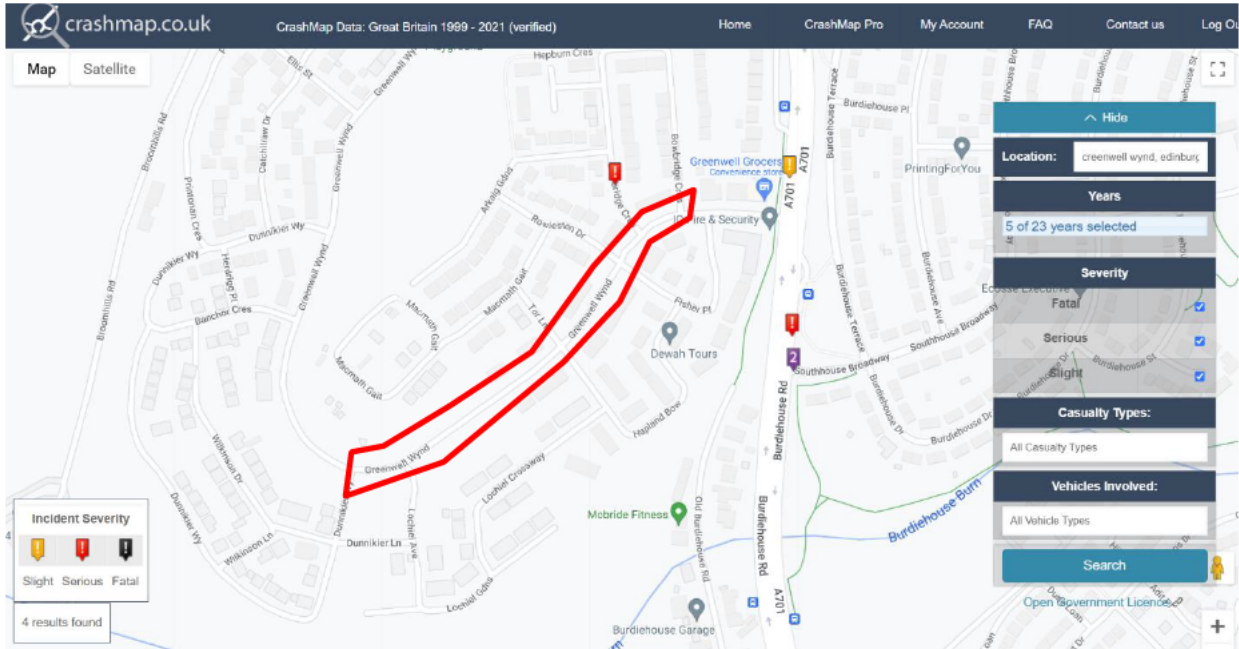
Annex 3 ACCIDENT RECORD

- 2.1 In the absence of any specific accident records being provided the Road Safety Audit Team have examined the website www.crashmap.co.uk for injury accidents recorded at the site.
- 2.2 A map based plan of the accidents have been provided in Annex 3
- 2.3 It is noted that for the five-year period from 2017 -2021 there were no accidents directly related to the area of the new development.
