Asbestos Refurbishment Survey SR 012-2026-K

**KAIMES SCHOOL
138 LASSWADE ROAD
EDINBURGH
EH16 6RT**

Project Reference: P-520658

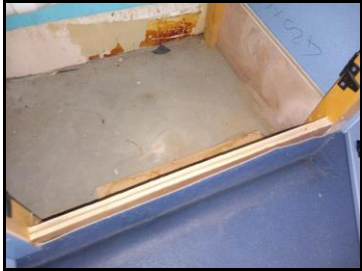
Building:	KAIMES SCHOOL	Floor:	Ground Floor				
Location:	001 - 002 - Toilets	Sample No / ID (Type):	P-520658/001 (Sampled)				
Surveyor:	Kyle Clark	Survey date:	16/02/2026				
Sample Details

Item description:	Screed to concrete floor					
	Material description:	Floor screed					
	Quantity / Extent:	6 m²					
	Accessibility	Easy Access					
	Analysis:	No asbestos detected					
	Material identification:	Non-asbestos material					
Material Assessment Scoring:							
Product Type:	-	Condition:	-	Surface Treatment:	-	Asbestos Type:	-
Priority Assessment Scoring:							
Occupant Activity:	-	Disturbance:	-	Human Exposure:	-	Maintenance Activity:	-
Total Scores:							
Material Score:	-	Priority Score	-	Total Score:	0	Risk Rating:	N/A
Recommended action:	-						
Recommendation comments:	-						
Comments:	-

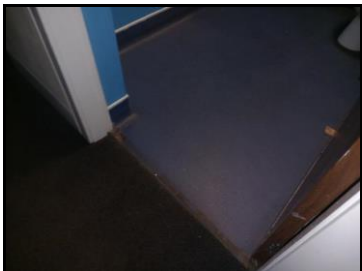
Building:	KAIMES SCHOOL	Floor:	Ground Floor				
Location:	002 - 006 - Toilet	Sample No / ID (Type):	P-520658/002 (Sampled)				
Surveyor:		Survey date:	16/02/2026				
Sample Details

Item description:	Screed to concrete floor below vinyl					
	Material description:	Floor screed					
	Quantity / Extent:	4 m²					
	Accessibility	Easy Access					
	Analysis:	No asbestos detected					
	Material identification:	Non-asbestos material					
Material Assessment Scoring:							
Product Type:	-	Condition:	-	Surface Treatment:	-	Asbestos Type:	-
Priority Assessment Scoring:							
Occupant Activity:	-	Disturbance:	-	Human Exposure:	-	Maintenance Activity:	-
Total Scores:							
Material Score:	-	Priority Score	-	Total Score:	0	Risk Rating:	N/A
Recommended action:	-						
Recommendation comments:	-						
Comments:	-

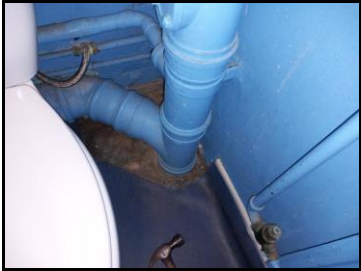
Building:	KAIMES SCHOOL	Floor:	Ground Floor				
Location:	002 - 006 - Toilet	Sample No / ID (Type):	P-520658/003 (Sampled)				
Surveyor:		Survey date:	16/02/2026				
Sample Details

Item description:	Patterned vinyl to floor					
	Material description:	Vinyl product					
	Quantity / Extent:	0.2 m²					
	Accessibility	Easy Access					
	Analysis:	No asbestos detected					
	Material identification:	Non-asbestos material					
Material Assessment Scoring:							
Product Type:	-	Condition:	-	Surface Treatment:	-	Asbestos Type:	-
Priority Assessment Scoring:							
Occupant Activity:	-	Disturbance:	-	Human Exposure:	-	Maintenance Activity:	-
Total Scores:							
Material Score:	-	Priority Score	-	Total Score:	0	Risk Rating:	N/A
Recommended action:	-						
Recommendation comments:	-						
Comments:	-

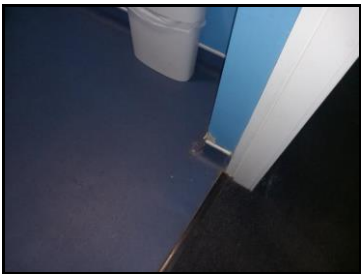
Building:	KAIMES SCHOOL	Floor:	Ground Floor				
Location:	003 - 007 - Toilet	Sample No / ID (Type):	P-520658/As 002 (Cross Referenced)				
Surveyor:		Survey date:	16/02/2026				
Sample Details

Item description:	Screed to concrete floor below vinyl					
	Material description:	Floor screed					
	Quantity / Extent:	4 m²					
	Accessibility	Easy Access					
	Analysis:	No asbestos detected					
	Material identification:	Non-asbestos material					
Material Assessment Scoring:							
Product Type:	-	Condition:	-	Surface Treatment:	-	Asbestos Type:	-
Priority Assessment Scoring:							
Occupant Activity:	-	Disturbance:	-	Human Exposure:	-	Maintenance Activity:	-
Total Scores:							
Material Score:	-	Priority Score	-	Total Score:	0	Risk Rating:	N/A
Recommended action:	-						
Recommendation comments:	-						
Comments:	-

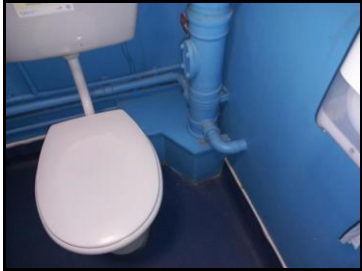
Building:	KAIMES SCHOOL	Floor:	Ground Floor				
Location:	003 - 007 - Toilet	Sample No / ID (Type):	P-520658/As 003 (Cross Referenced)				
Surveyor:		Survey date:	16/02/2026				
Sample Details

Item description:	Patterned vinyl to floor behind timber boxing					
	Material description:	Vinyl product					
	Quantity / Extent:	0.2 m²					
	Accessibility	Easy Access					
	Analysis:	No asbestos detected					
	Material identification:	Non-asbestos material					
Material Assessment Scoring:							
Product Type:	-	Condition:	-	Surface Treatment:	-	Asbestos Type:	-
Priority Assessment Scoring:							
Occupant Activity:	-	Disturbance:	-	Human Exposure:	-	Maintenance Activity:	-
Total Scores:							
Material Score:	-	Priority Score	-	Total Score:	0	Risk Rating:	N/A
Recommended action:	-						
Recommendation comments:	-						
Comments:	-

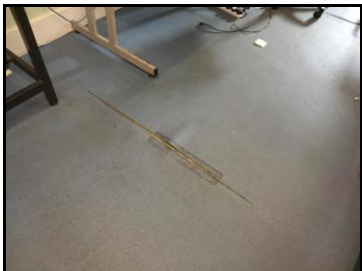
Building:	KAIMES SCHOOL	Floor:	Ground Floor				
Location:	004 - 014 - Classroom	Sample No / ID (Type):	P-520658/004 (Sampled)				
Surveyor:		Survey date:	16/02/2026				
Sample Details

Item description:	Screed with bitumen to concrete floor behind vinyl					
	Material description:	Bituminous products					
	Quantity / Extent:	96 m²					
	Accessibility	Easy Access					
	Analysis:	Chrysotile					
	Material identification:	Asbestos bitumen					
Material Assessment Scoring:							
Product Type:	1	Condition:	0	Surface Treatment:	0	Asbestos Type:	1
Priority Assessment Scoring:							
Occupant Activity:	1	Disturbance:	2	Human Exposure:	3	Maintenance Activity:	1
Total Scores:							
Material Score:	2	Priority Score	7	Total Score:	9	Risk Rating:	Very Low
Recommended action:	Remove if likely to be disturbed by the refurbishment, otherwise monitor condition.						
Recommendation comments:	-						
Comments:	-

Location No.	Location Name	Sample No.	Item / Position	Material
004	KAIMES SCHOOL - Ground Floor - 014 - Classroom	P-520658/004	Screed with bitumen to concrete floor behind vinyl	Asbestos bitumen
005	KAIMES SCHOOL - Ground Floor - 038 - Classroom	P-520658/005	Screed with bitumen to concrete floor behind vinyl	Asbestos bitumen

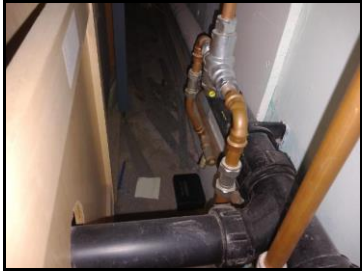
Building:	KAIMES SCHOOL	Floor:	Ground Floor				
Location:	004 - 014 - Classroom	Sample No / ID (Type):	P-520658/As 003 (Cross Referenced)				
Surveyor:		Survey date:	16/02/2026				
Sample Details

Item description:	Patterned vinyl to floor behind timber units					
	Material description:	Vinyl product					
	Quantity / Extent:	7 m²					
	Accessibility	Easy Access					
	Analysis:	No asbestos detected					
	Material identification:	Non-asbestos material					
Material Assessment Scoring:							
Product Type:	-	Condition:	-	Surface Treatment:	-	Asbestos Type:	-
Priority Assessment Scoring:							
Occupant Activity:	-	Disturbance:	-	Human Exposure:	-	Maintenance Activity:	-
Total Scores:							
Material Score:	-	Priority Score	-	Total Score:	0	Risk Rating:	N/A
Recommended action:	-						
Recommendation comments:	-						
Comments:	-

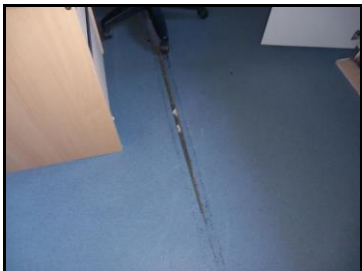
Building:	KAIMES SCHOOL	Floor:	Ground Floor				
Location:	005 - 038 - Classroom	Sample No / ID (Type):	P-520658/005 (Sampled)				
Surveyor:		Survey date:	16/02/2026				
Sample Details

Item description:	Screed with bitumen to concrete floor behind vinyl					
	Material description:	Bituminous products					
	Quantity / Extent:	72 m²					
	Accessibility	Easy Access					
	Analysis:	Chrysotile					
	Material identification:	Asbestos bitumen					
Material Assessment Scoring:							
Product Type:	1	Condition:	0	Surface Treatment:	0	Asbestos Type:	1
Priority Assessment Scoring:							
Occupant Activity:	1	Disturbance:	2	Human Exposure:	3	Maintenance Activity:	1
Total Scores:							
Material Score:	2	Priority Score	7	Total Score:	9	Risk Rating:	Very Low
Recommended action:	Remove if likely to be disturbed by the refurbishment, otherwise monitor condition.						
Recommendation comments:	-						
Comments:	-

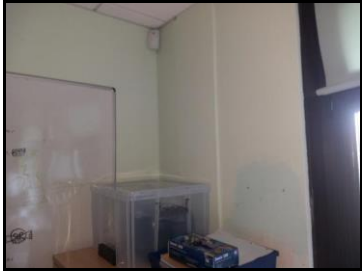
Building:	KAIMES SCHOOL	Floor:	Ground Floor				
Location:	005 - 038 - Classroom	Sample No / ID (Type):	P-520658/006 (Sampled)				
Surveyor:		Survey date:	16/02/2026				
Sample Details

Item description:	Insulating board panels to wall					
	Material description:	Insulating board					
	Quantity / Extent:	3 m linear					
	Accessibility	Easy Access					
	Analysis:	No asbestos detected					
	Material identification:	Non-asbestos material					
Material Assessment Scoring:							
Product Type:	-	Condition:	-	Surface Treatment:	-	Asbestos Type:	-
Priority Assessment Scoring:							
Occupant Activity:	-	Disturbance:	-	Human Exposure:	-	Maintenance Activity:	-
Total Scores:							
Material Score:	-	Priority Score	-	Total Score:	0	Risk Rating:	N/A
Recommended action:	-						
Recommendation comments:	-						
Comments:	-

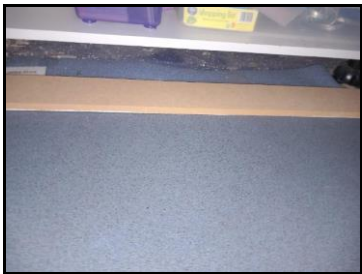
Building:	KAIMES SCHOOL	Floor:	Ground Floor				
Location:	005 - 038 - Classroom	Sample No / ID (Type):	P-520658/As 003 (Cross Referenced)				
Surveyor:		Survey date:	16/02/2026				
Sample Details

Item description:	Patterned vinyl to floor behind timber units					
	Material description:	Vinyl product					
	Quantity / Extent:	2 m ²					
	Accessibility	Easy Access					
	Analysis:	No asbestos detected					
	Material identification:	Non-asbestos material					
Material Assessment Scoring:							
Product Type:	-	Condition:	-	Surface Treatment:	-	Asbestos Type:	-
Priority Assessment Scoring:							
Occupant Activity:	-	Disturbance:	-	Human Exposure:	-	Maintenance Activity:	-
Total Scores:							
Material Score:	-	Priority Score	-	Total Score:	0	Risk Rating:	N/A
Recommended action:	-						
Recommendation comments:	-						
Comments:	-

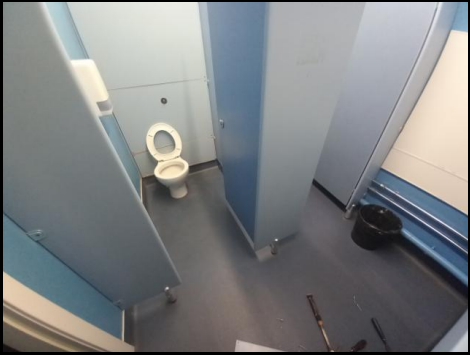
Building Name:	KAIMES SCHOOL	Floor Level:	Ground Floor
Location Number:	001	Location Description:	002 - Toilets
Surveyor:		Survey Date:	16/02/2026

General Comments:
	Walls - plasterboard, plaster finish, brick
	Floor - modern vinyl, concrete
	Items - timber facings, vinyl skirting, timber units, copper/upvc pipework

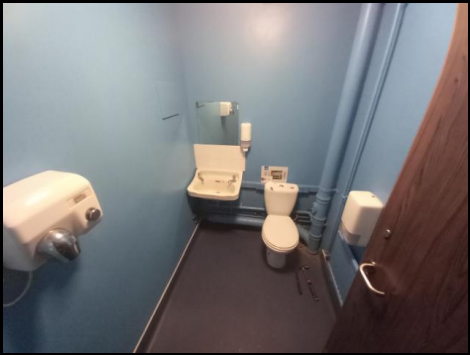
Building Name:	KAIMES SCHOOL	Floor Level:	Ground Floor
Location Number:	002	Location Description:	006 - Toilet
Surveyor:		Survey Date:	16/02/2026

General Comments:
	Walls - plaster finish, brick
	Floor - modern vinyl, concrete
	Items - timber facings, vinyl skirting, copper/upvc pipework, upvc wastepipe

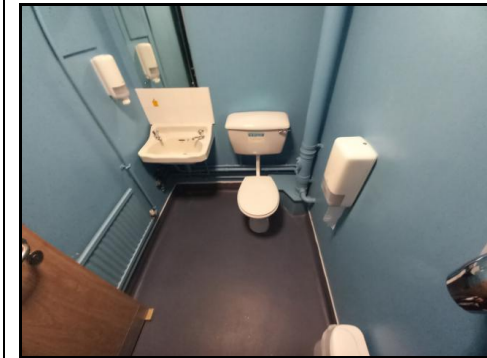
Building Name:	KAIMES SCHOOL	Floor Level:	Ground Floor
Location Number:	003	Location Description:	007 - Toilet
Surveyor:		Survey Date:	16/02/2026

Walls - plaster finish, brick

Floor - modern vinyl, concrete

Items - timber facings, vinyl skirting, copper/upvc pipework, upvc wastepipe, timber boxing

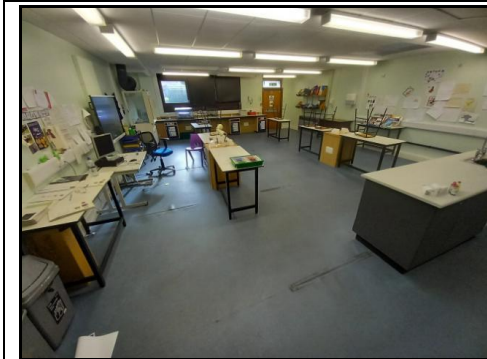
Building Name:	KAIMES SCHOOL	Floor Level:	Ground Floor
Location Number:	004	Location Description:	014 - Classroom
Surveyor:		Survey Date:	16/02/2026

Walls - plasterboard, plaster finish, brick

Floor - modern vinyl, concrete

Items - timber facings/skirtings, copper/upvc pipework, timber/metal boxing, metal radiator, Timber units

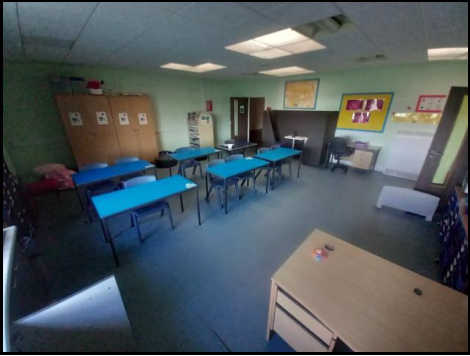
Building Name:	KAIMES SCHOOL	Floor Level:	Ground Floor
Location Number:	005	Location Description:	038 - Classroom
Surveyor:		Survey Date:	16/02/2026
Room Data / Observations:

<p>General Comments:</p> <p>Walls - plasterboard, plaster finish, brick</p> <p>Floor - modern vinyl, concrete</p> <p>Items - timber facings/skirtings, copper/upvc pipework, timber/plasterboard/metal boxing, Timber units, metal radiator</p>
