**REDFORD ROAD, EDINBURGH
STAGE 1/2 ROAD SAFETY AUDIT**

65208321-000-T-Z-0007

02 February 2023

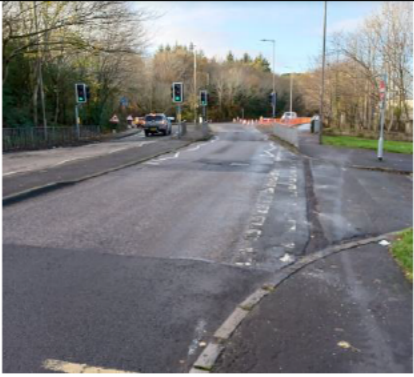
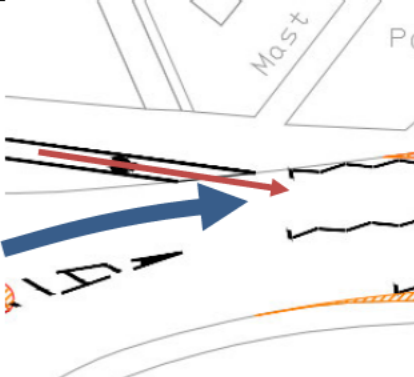
Reference	Location	Collision type	Description	Recommendation	Photographs / Plan
3.1	General				
3.1.1	At merge of cycle path with Redford Road eastbound.	Side swipes between cycles and motor vehicles.	<p>The cycle path merges onto the carriageway prior to the crossing point and at angle which may be difficult for cyclists to see vehicles closing from the rear quarter.</p> <p>This could lead to side swipes between cyclists and motor vehicles.</p>	It is recommended that the cycle path merges into a cycle lane on the carriageway before blending with the carriageway.

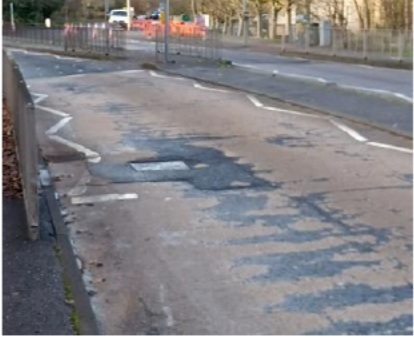
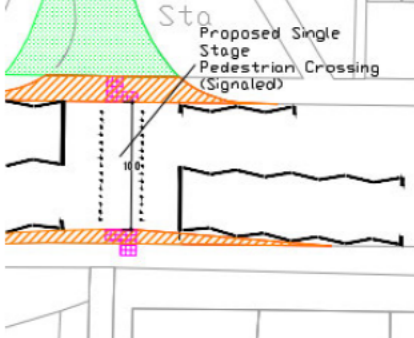
3.2	Drainage				
3.2.1	On westbound approach to propose crossing.	Overshoot and collision with crossing users.	<p>A manhole cover is located on the approach to the proposed crossing.</p> <p>The metal manhole cover provides a skid risk to vehicles braking for the crossing, which could result in an overshoot of the stop line and potential collision with a crossing user.</p> <p>The metal cover can also lead to falls by motorcyclists and cyclists.</p>	It is recommended that the manhole cover is replaced with a cover that features similar grip properties to the surrounding road surface.

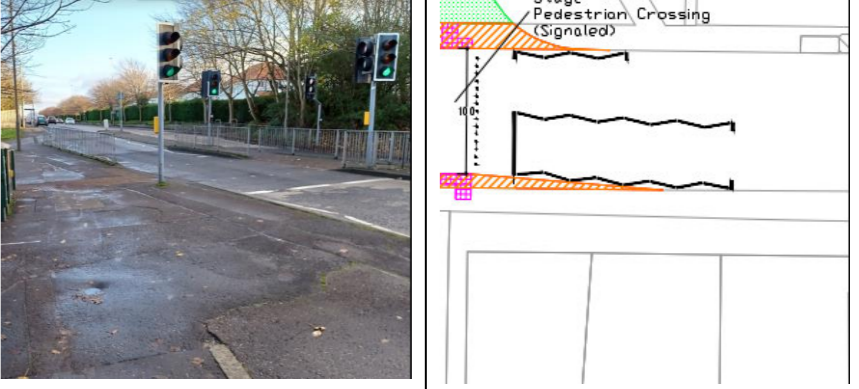
Reference	Location	Collision type	Description	Recommendation	Photographs / Plan
3.3	Pavement				
3.3.1	Westbound approach to proposed crossing.	Overshoots and collisions with crossing users.	<p>The westbound approach is downhill on a straight wide carriageway which is more susceptible to higher speeds.</p> <p>This may result in greater braking stresses for the crossing leading to possible skid risks, overshooting the crossing and striking crossing users.</p>	It is recommended that the road surface grip levels are enhanced on this approach.

<p>The photograph shows a wide, straight road with a traffic light at the intersection. The plan view diagram illustrates the road layout, including the 'Pedestrian Crossing (Signaled)' area, and highlights the specific approach area mentioned in the text.</p>

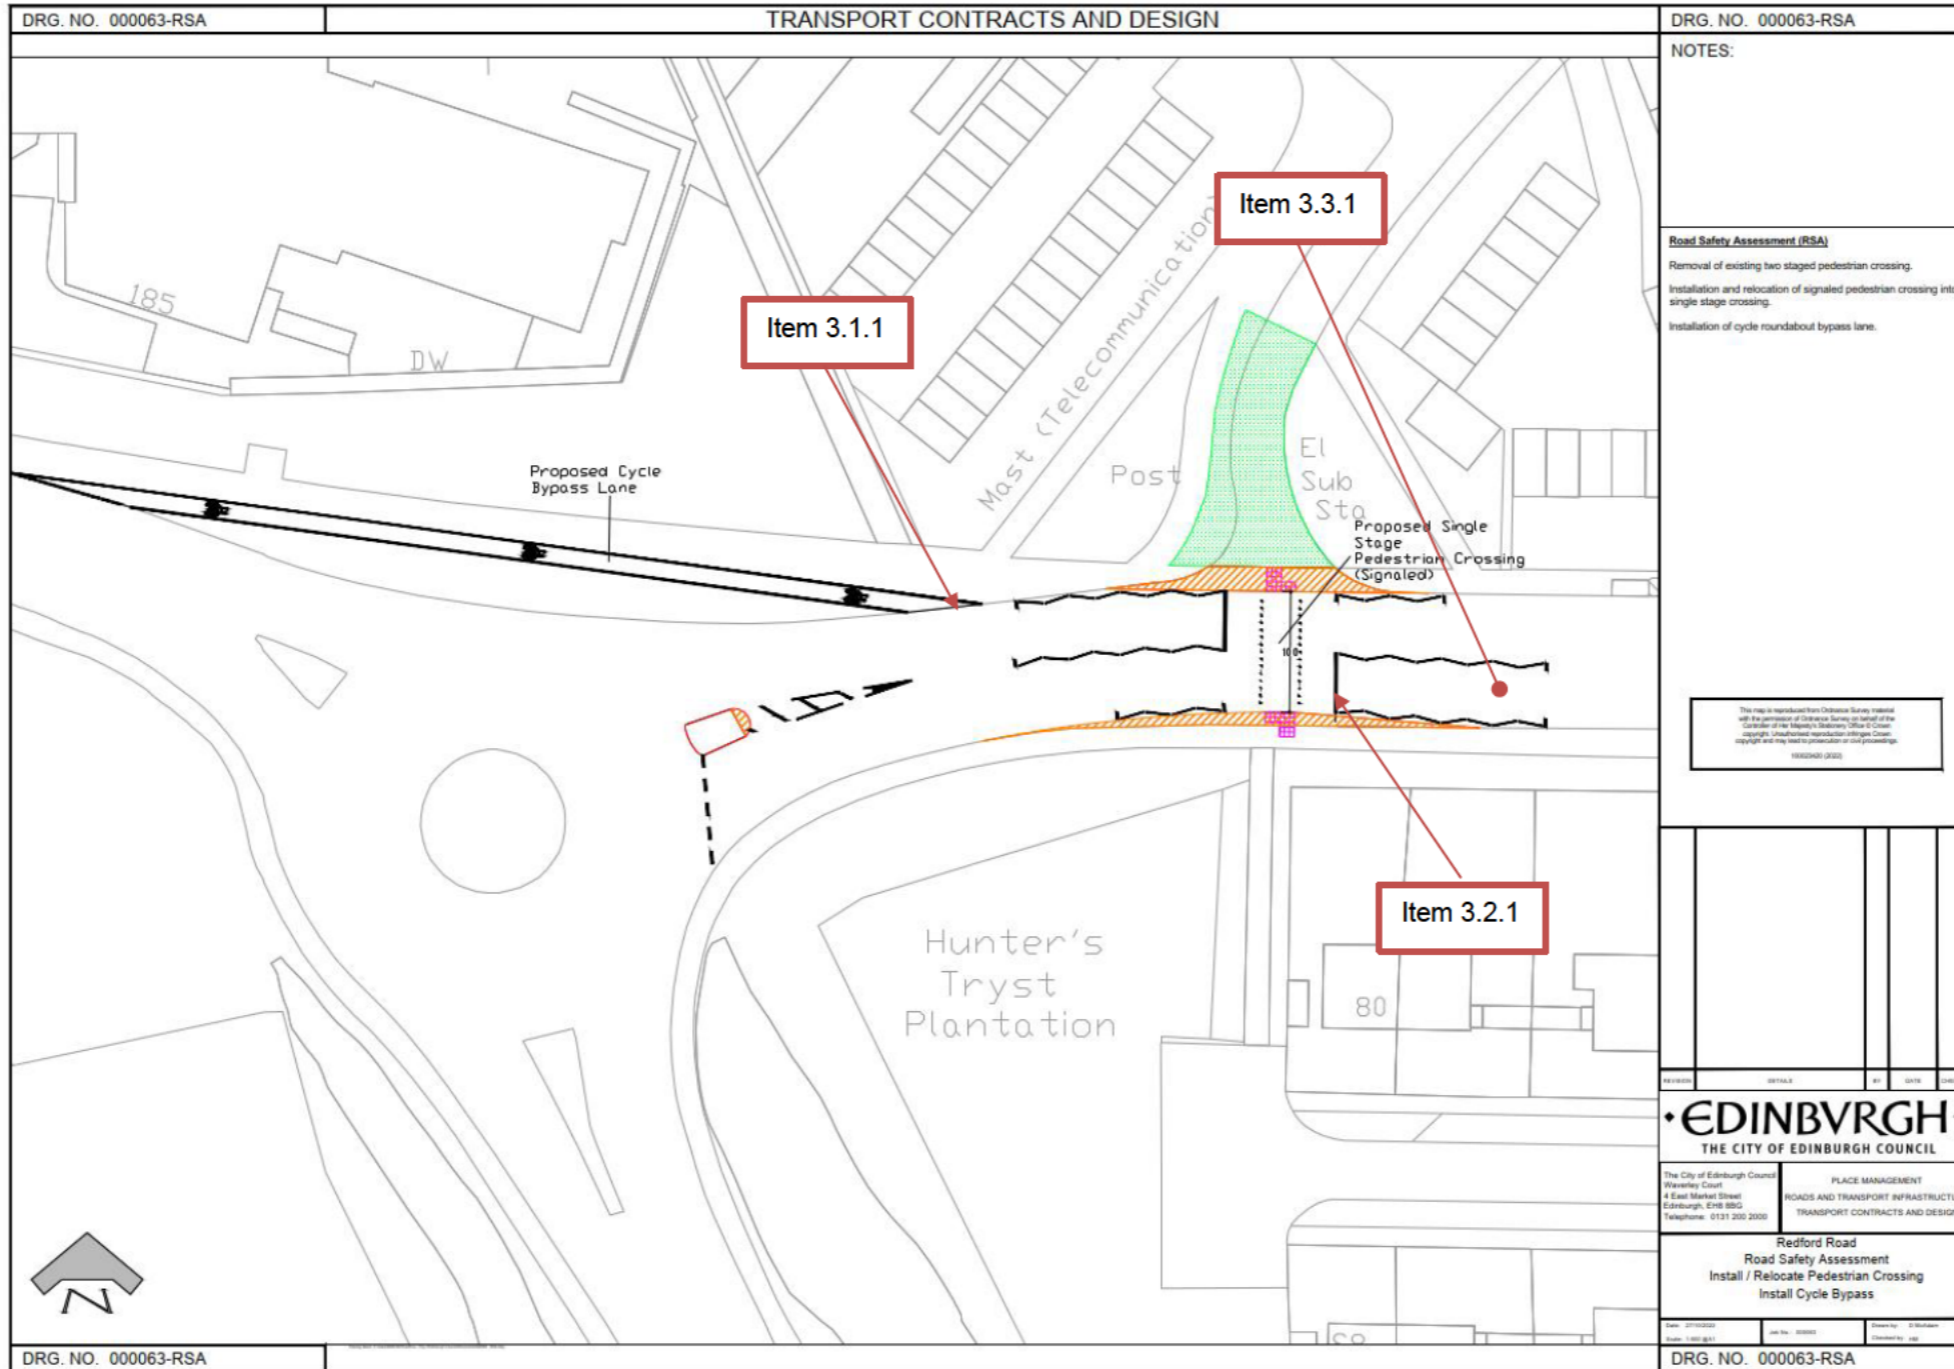
Appendix B – Annotated scheme drawing

All comments and recommendations are referenced to the detailed design drawings and the locations have been indicated on the plan supplied with the Road Safety Audit Brief in Appendix B.
