## Meadows to George Street - Hanover Street & Market Street

### Stage 1 Road Safety Audit

City of Edinburgh Council

September 2022

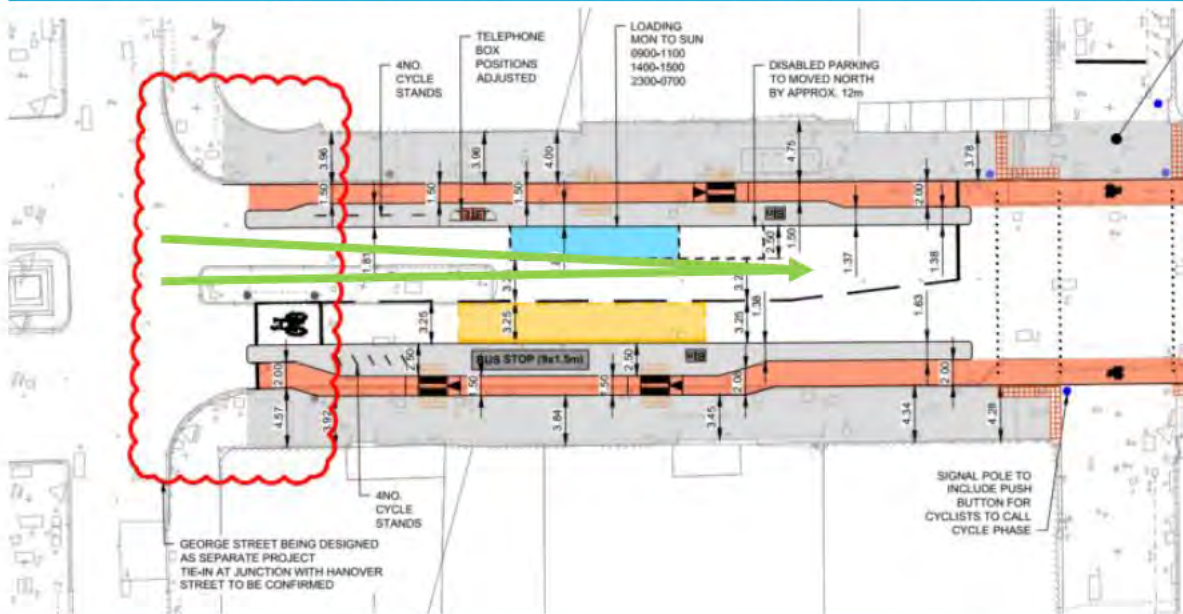
| <b>Problem:</b> | 3.2 |

| <b>Summary:</b> | Risk of side swipe collisions resulting from carriageway narrowing. |

The southbound carriageway width at Hanover Street, extending from the junction with George Street is 5.75m, before narrowing on the approach to the signalised crossing facilities at the Rose Street junction. It is anticipated that two vehicles may enter Hanover Street side by side, unaware of the lane narrowing, and need to merge ahead. This presents a risk of sudden braking and side swipe collisions.

It is recommended that the southbound carriageway is reduced to one running lane upon entering Hanover Street to remove the need for vehicles to merge.

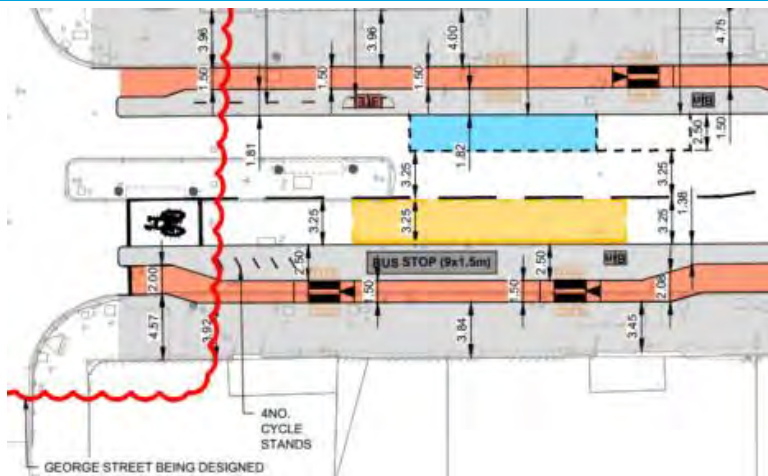
| <b>Problem:</b> | <b>3.3</b> |

| <b>Summary:</b> | Risk of traffic signals being obscured. |

A Response Report was submitted in response to the previous Stage 1 RSA, specifically in relation to the problem raised (Problem 4.2.2) regarding a stationary bus obscuring forward visibility of the traffic signals. Concerns remain regarding the potential for a waiting/loading bus to obstruct forward visibility to the traffic signals and junction ahead.

Insufficient forward visibility may result in vehicles inadvertently overtaking a stationary bus and being unable to proceed and/or re-join their lane due to queuing vehicles or a red traffic signal. This increases the likelihood of vehicles being stranded in the opposing running lane, which may give rise to head on collisions.

It is recommended that the bus stop is relocated and/or sufficient forward visibility is provided for road users.

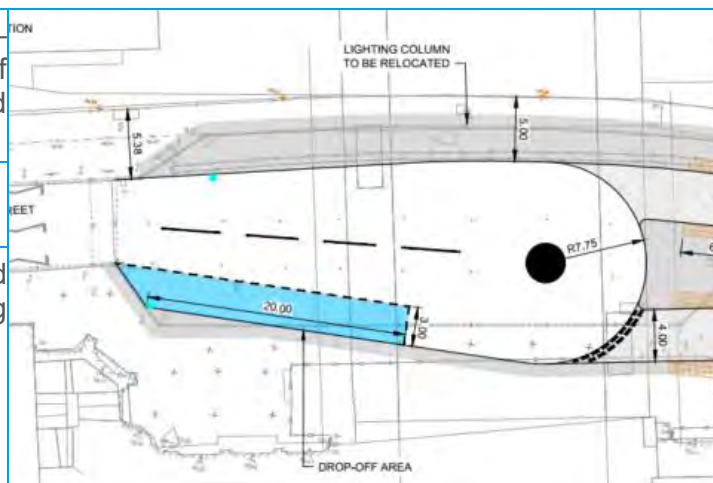
**Problem: 3.4**

**Summary:** Risk of parked vehicles obstructing the bus and taxi gate

A drop-off area is proposed southwest of the turning circle, east of Waverley Train Station. It is anticipated that during peak periods if the drop-off area is at capacity, that vehicles will undertake loading/unloading activities around the extents of the turning circle. This increases the likelihood of road user conflicts, including pedestrians, should stationary vehicles obstruct the bus and taxi gate and presents a collision risk between parked vehicles situated outside of the designated drop-off area and those attempting to utilise the turning circle.

It is recommended that parking restrictions are installed around the extents of the turning circle.

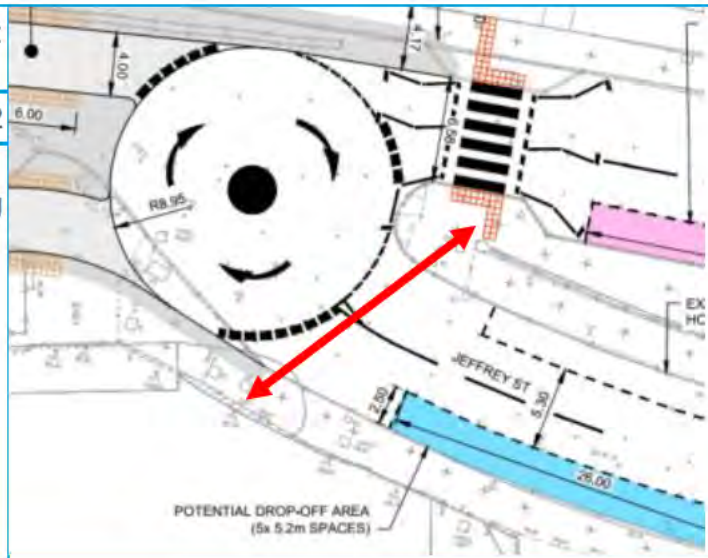
| <b>Problem:</b> | 3.5 |

| <b>Summary:</b> | Risk of pedestrians being struck by passing vehicles. |

The proposals do not indicate the provision of pedestrian crossing infrastructure at the junction of Jeffery Street at East Market Street. As this presents a direct route to/from the taxi rank and Jeffery Street, it is anticipated that there will be demand to cross this junction, as observed during the site visit.

Due to the geometry of the Jeffery Street and East Market Street junction, pedestrian visibility of oncoming vehicles is restricted. Visibility is impacted further by the railings that extend between the two streets and the on street parking on Jeffery Street. Insufficient visibility of other road users increases the likelihood of pedestrians being struck by vehicles when attempting to cross the carriageway.

There is a secondary risk that without crossing infrastructure in place, pedestrians may trip and fall over full height kerbs at this location.

It is recommended that a controlled pedestrian crossing facility is provided on Jeffery Street.

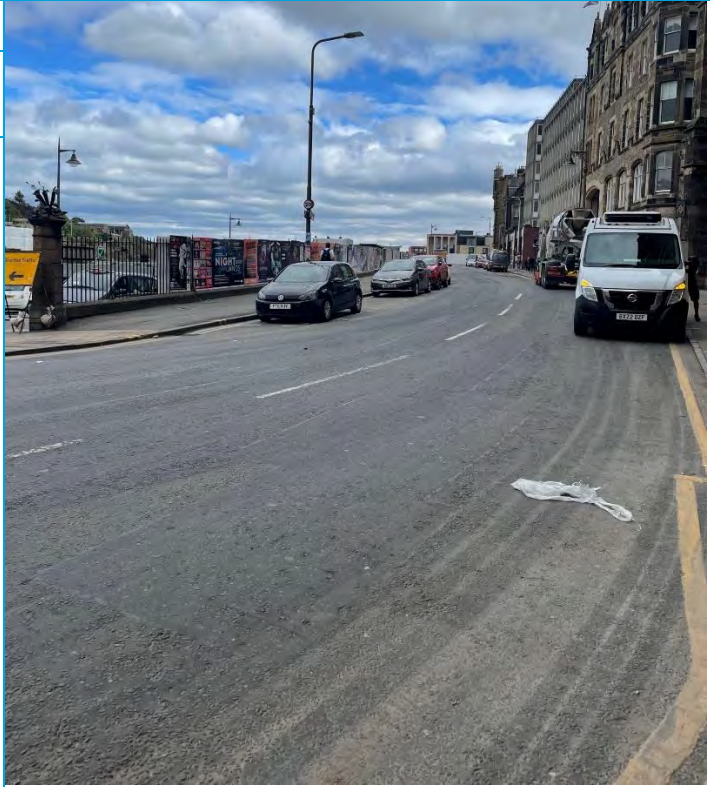
| <b>Problem:</b> | <b>3.6</b> | |

| <b>Summary:</b> | Risk of vehicles at Jeffery Street failing to give way due to restricted visibility and high vehicle speeds | |

There is limited visibility from Jeffery Street towards East Market Street due to the area's topography, railings (which during the site visit were covered in adverts) and stationary vehicles in the taxi rank on East Market Street. Traffic emerging from Jeffery Street must give-way to traffic from East Market Street but as a result of visibility limitations there is a risk that drivers inadvertently emerge from Jeffery Street and collide with oncoming vehicles.

This risk is exacerbated by the carriageway width and downhill gradient at Jeffery Street which may result in drivers approaching the mini roundabout at an inappropriate speed. This increases the likelihood of sudden braking leading to rear end shunt collisions and/or vehicles overshooting the roundabout.

The risk is increased as drivers from East Market Street are likely to be looking towards Market Street and less aware of vehicles emerging from Jeffery Street.

It is recommended that a sufficient visibility splay is provided between East Market Street and Jeffery Street and that measures are installed, such as advanced warning signage and/or traffic calming, to encourage drivers to moderate their speed on the Jeffery Street approach to the roundabout. Additionally, it is recommended that the proposed zebra crossing facility at East Market Street is located on a raised table to slow users entering the roundabout from this arm.

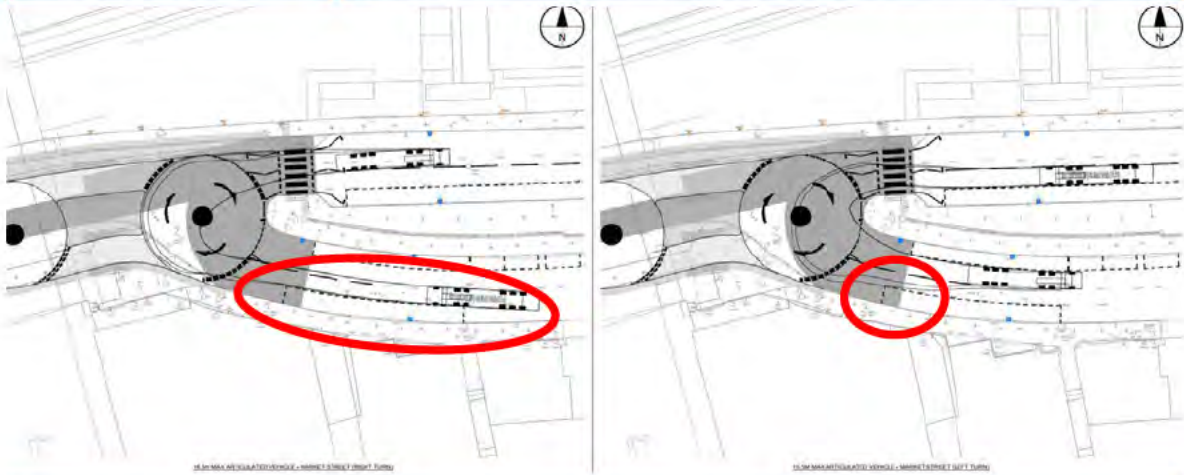
| <b>Problem:</b> | 3.7 |

| <b>Summary:</b> | Risk of head-on vehicle collisions resulting from large vehicles crossing into the opposing lane to complete turning manoeuvres. |

From the vehicle swept path plans provided, the turning manoeuvre of a 16.5m articulated vehicle involves crossing the centreline of both Jeffery Street and East Market Street when negotiating the junction. This increases the risk of head-on collision between vehicles which is exacerbated by the lack of intervisibility between Jeffery Street and East Market Street (see problem 3.7).

In addition, the swept path indicates that vehicles will encroach into the drop-off area proposed on Jeffery Street.

It is acknowledged that the geometry of the road layout is challenging, however, it is recommended that:

- Opposing traffic movements are subject to control to manage access to the junction space; and
- The drop-off area is relocated eastwards so that an articulated vehicle can manoeuvre into and out of Jeffery Street without encroaching into it.

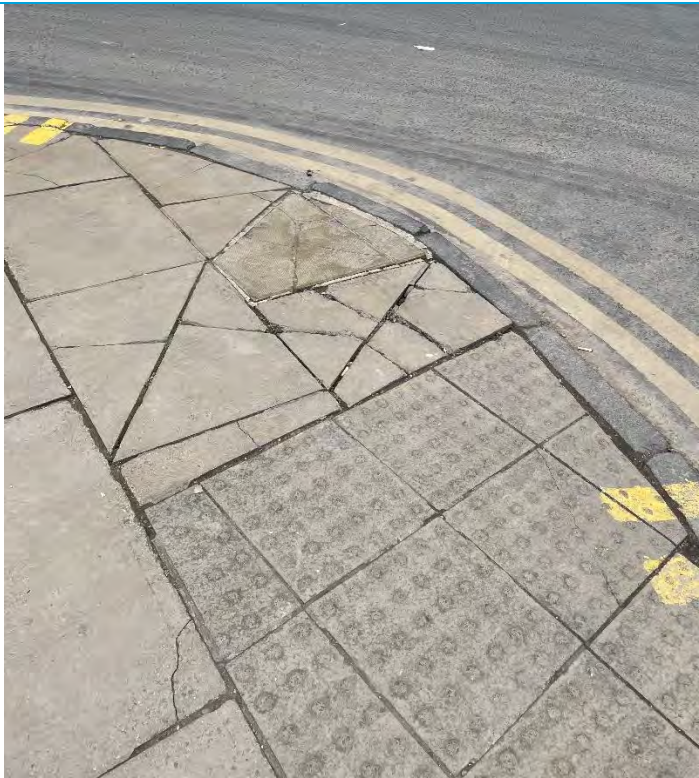
| <b>Problem:</b> | <b>3.8</b> | |

| <b>Summary:</b> | Risk of vehicles mounting the pavement whilst turning left into Jeffery Street | |

During the site visit, the RSA Team observed severe footway defects at the corner of Jeffery Street and East Market Street. The damaged footway is likely to result from vehicles mounting the footway whilst attempting to turn left onto Jeffery Street. This presents a risk to pedestrians who may be struck by turning vehicles inadvertently mounting the footway. The footway defects present a secondary risk to pedestrians who may trip and fall over the cracked and uneven slabs.

It is recommended that the junction layout is revised to ensure vehicles can turn into Jeffery Street without mounting the footway. Furthermore, it is recommended that the footway is resurfaced to remove any potential trip hazards.

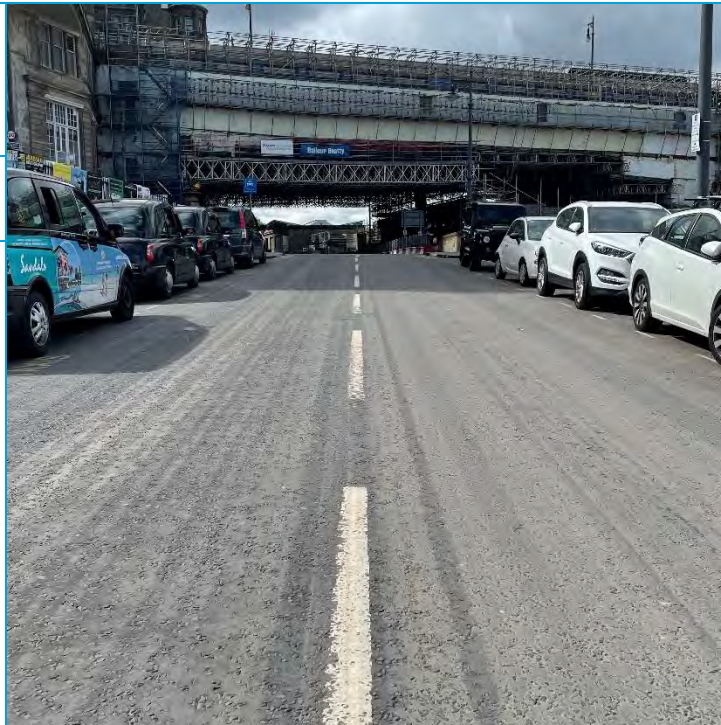
**Problem: 3.9**

**Summary:** Risk of loss of control collisions at the bus and taxi gate.

The East Market Street approach to the proposed mini roundabout is on an incline. Due to this gradient there is a risk that taxis and buses intending to travel ahead onto Market Street, do not have adequate forward visibility of the road layout ahead (see above image).

Drivers may be unaware of the give way or the change in alignment due to the roundabout. This increases the likelihood of vehicles approaching the roundabout at inappropriate speeds and / or failing to give way, subsequently losing control and colliding with other road users and/or the bus and taxi gate infrastructure.

This risk is exacerbated by the see-through effect observed for westbound traffic on East Market Street which is due to the incline, parked vehicles and the perception of a straight road alignment. These factors may also reduce driver visibility of pedestrians approaching/intending to use the proposed zebra crossing facility. This increases the likelihood of pedestrians being struck by vehicles failing to give way.

It is recommended that advanced warning of the roundabout and zebra crossing is provided and that measures are installed to slow vehicles approaching from East Market Street, such as raising the zebra crossing facility (see Problem 3.6).
