# Wall Inspections 25-26

**Revision** Queensferry Road - Orchard Drive 25-73

Wall name: Queensferry Road - Orchard Drive

Wall/No: 25-73

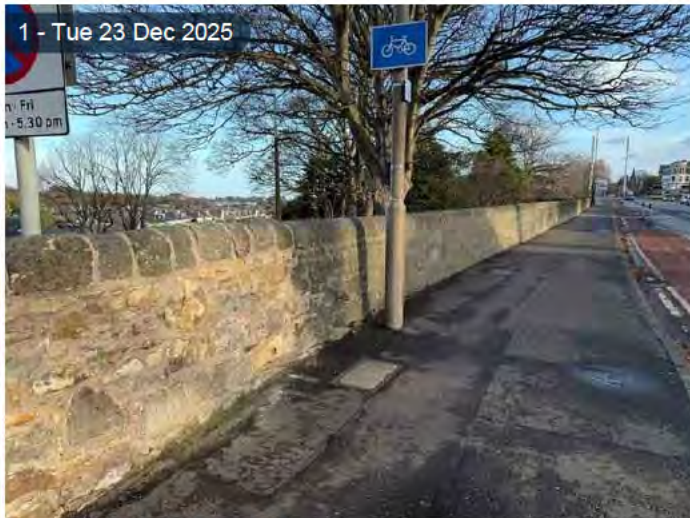
| Image comments | | User | Date |
|---|---|---|---|
| Image 1 | South face looking east | | Tue 23 Dec 2025 |

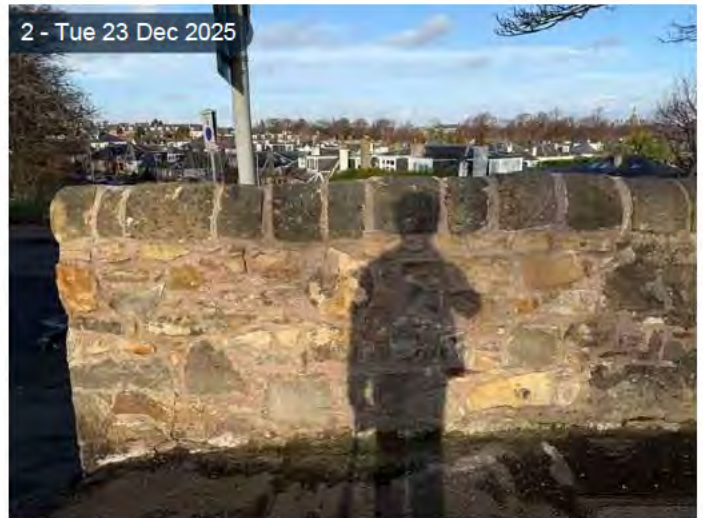
| Image comments | | User | Date |
|---|---|---|---|
| Image 2 | South face west end | | Tue 23 Dec 2025 |

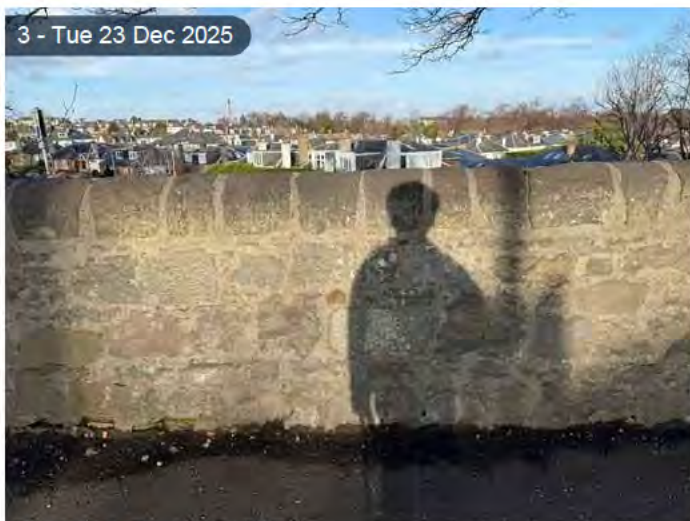
Between 10m and 25m, displacement of the wall was observed, therefore measurements were taken at closer intervals of 5m.

| Image comments | | User | Date |
|---|---|---|---|
| Image 3 | South face area of displacement | | Tue 23 Dec 2025 |

1. Repair the masonry and mortar to the west of the wall; and
2. Monitor the lean of the wall and reassess in 6 months.

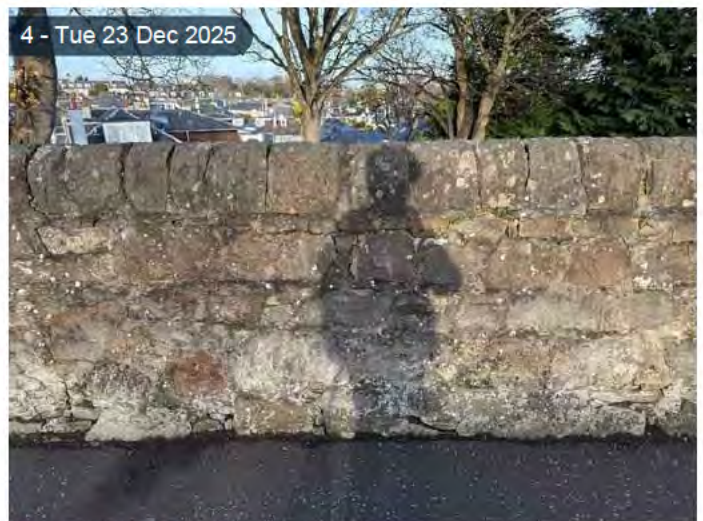
5 - Tue 23 Dec 2025

| Image comments | | User | Date |
|---|---|---|---|
| Image 4 | South face general wall condition (1) | | Tue 23 Dec 2025 |

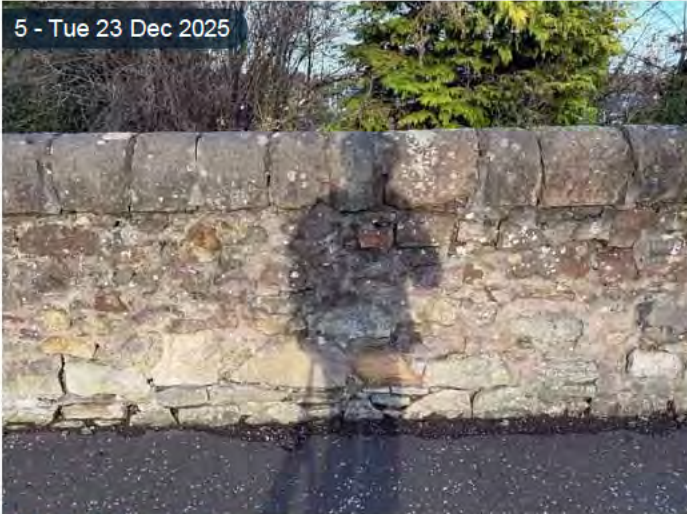
6 - Tue 23 Dec 2025

| Image comments | | User | Date |
|---|---|---|---|
| Image 5 | South face general wall condition (2) | | Tue 23 Dec 2025 |

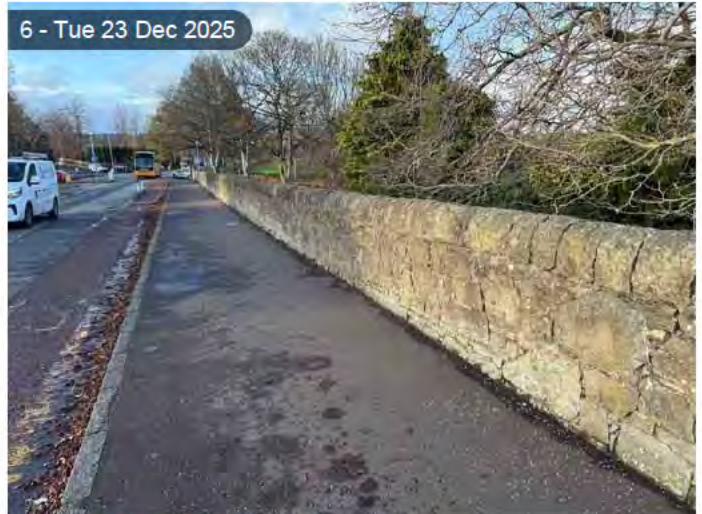
7 - Tue 23 Dec 2025

| Image comments | | User | Date |
|---|---|---|---|
| Image 6 | South face looking west | | Tue 23 Dec 2025 |

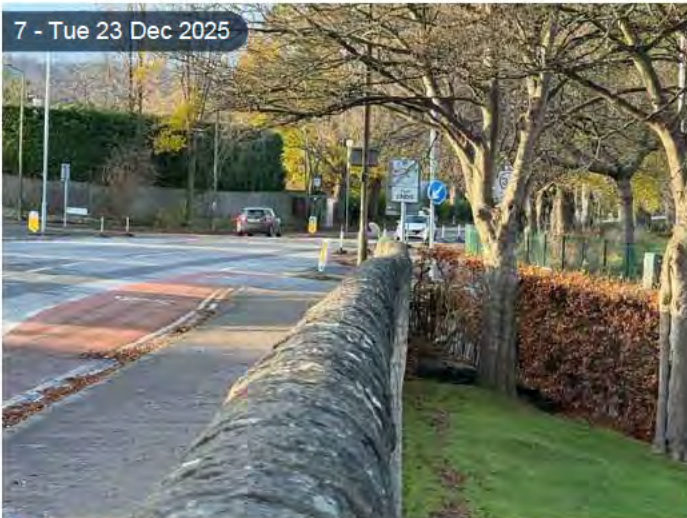
8 - Tue 23 Dec 2025

| Image comments | | User | Date |
|---|---|---|---|
| Image 7 | Looking west at the area of displacement | | Tue 23 Dec 2025 |

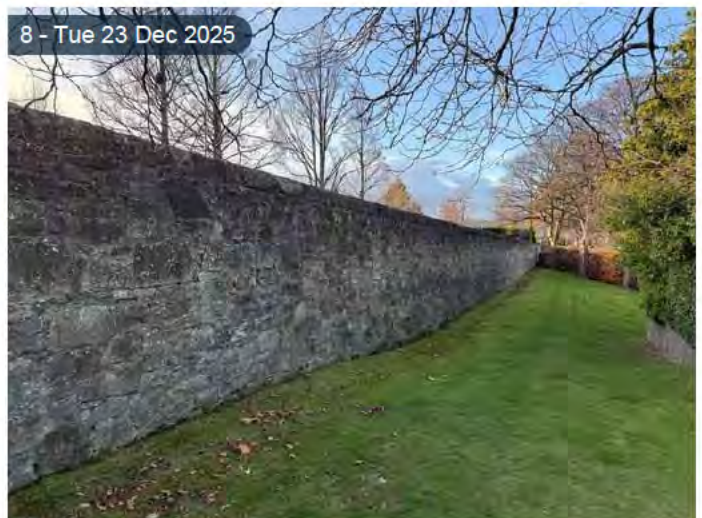
| Image comments | | User | Date |
|---|---|---|---|
| Image 8 | North face looking west | | Tue 23 Dec 2025 |

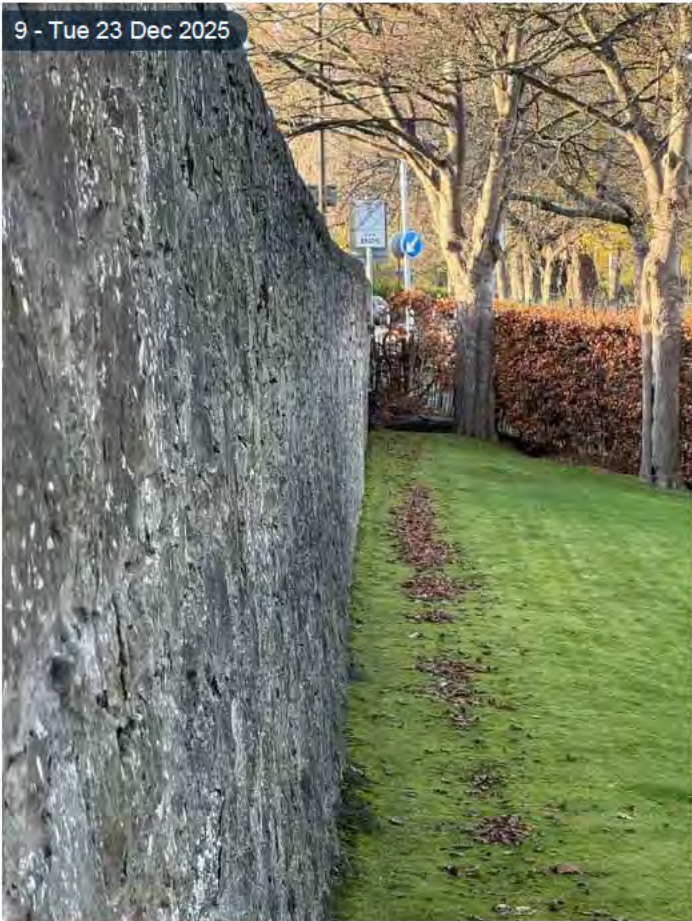
Between 10m to 25m, where the wall above the pavement had displaced, there appeared to be a distinct horizontal line along most the north face. This line appeared to mark the point from which the wall began to lean on the north face.

| Image comments | | User | Date |
|---|---|---|---|
| Image 9 | Nort face looking west at the area of displacement | | Tue 23 Dec 2025 |

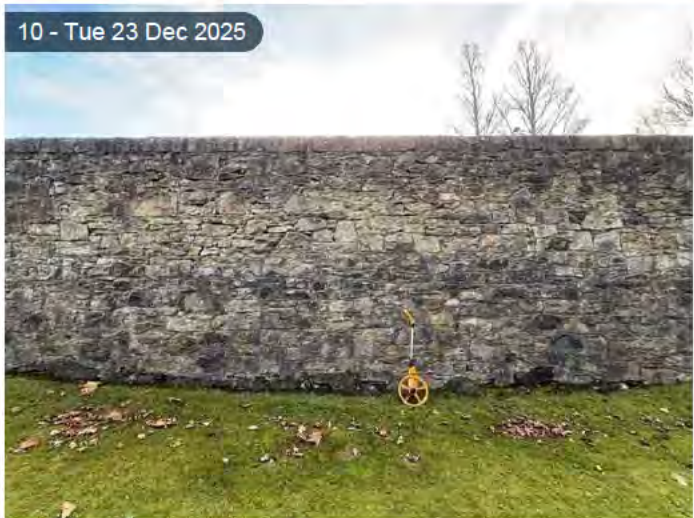
| Image comments | | User | Date |
|---|---|---|---|
| Image 10 | North face general condition | | Tue 23 Dec 2025 |

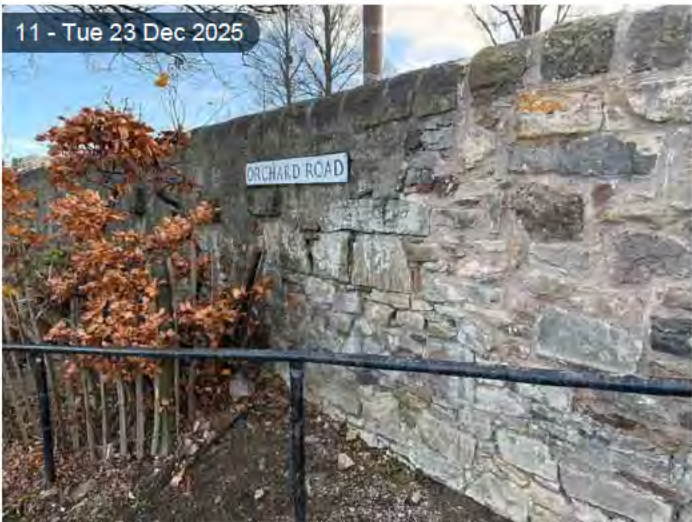
| Image comments | | User | Date |
|---|---|---|---|
| Image 11 | North face west end | | Tue 23 Dec 2025 |

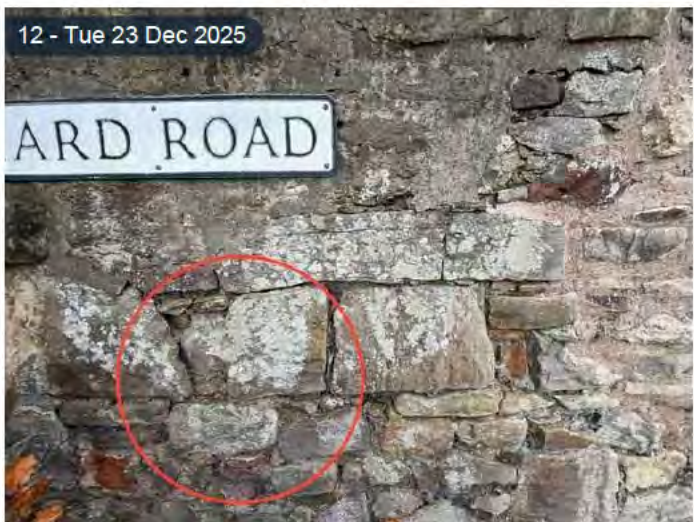
Overall, both sides of the wall appeared to be in relatively good condition, with only minor deterioration observed along most of its length. An exception was noted at the north face of the west end, where more significant mortar failure and loose masonry were present. The loose masonry measured approximately 42cm (L) x 29cm (H), and 27cm (L) x 20cm (H).

| Image comments | | User | Date |
|---|---|---|---|
| Image 12 | North face west end loose masonry | | Tue 23 Dec 2025 |
