**Phase 1 Environmental Assessment**  
**Former Corstorphine Station, off Station Road (The**  
**Paddockholm), Edinburgh, EH12 7XP**

**The City of Edinburgh Council**

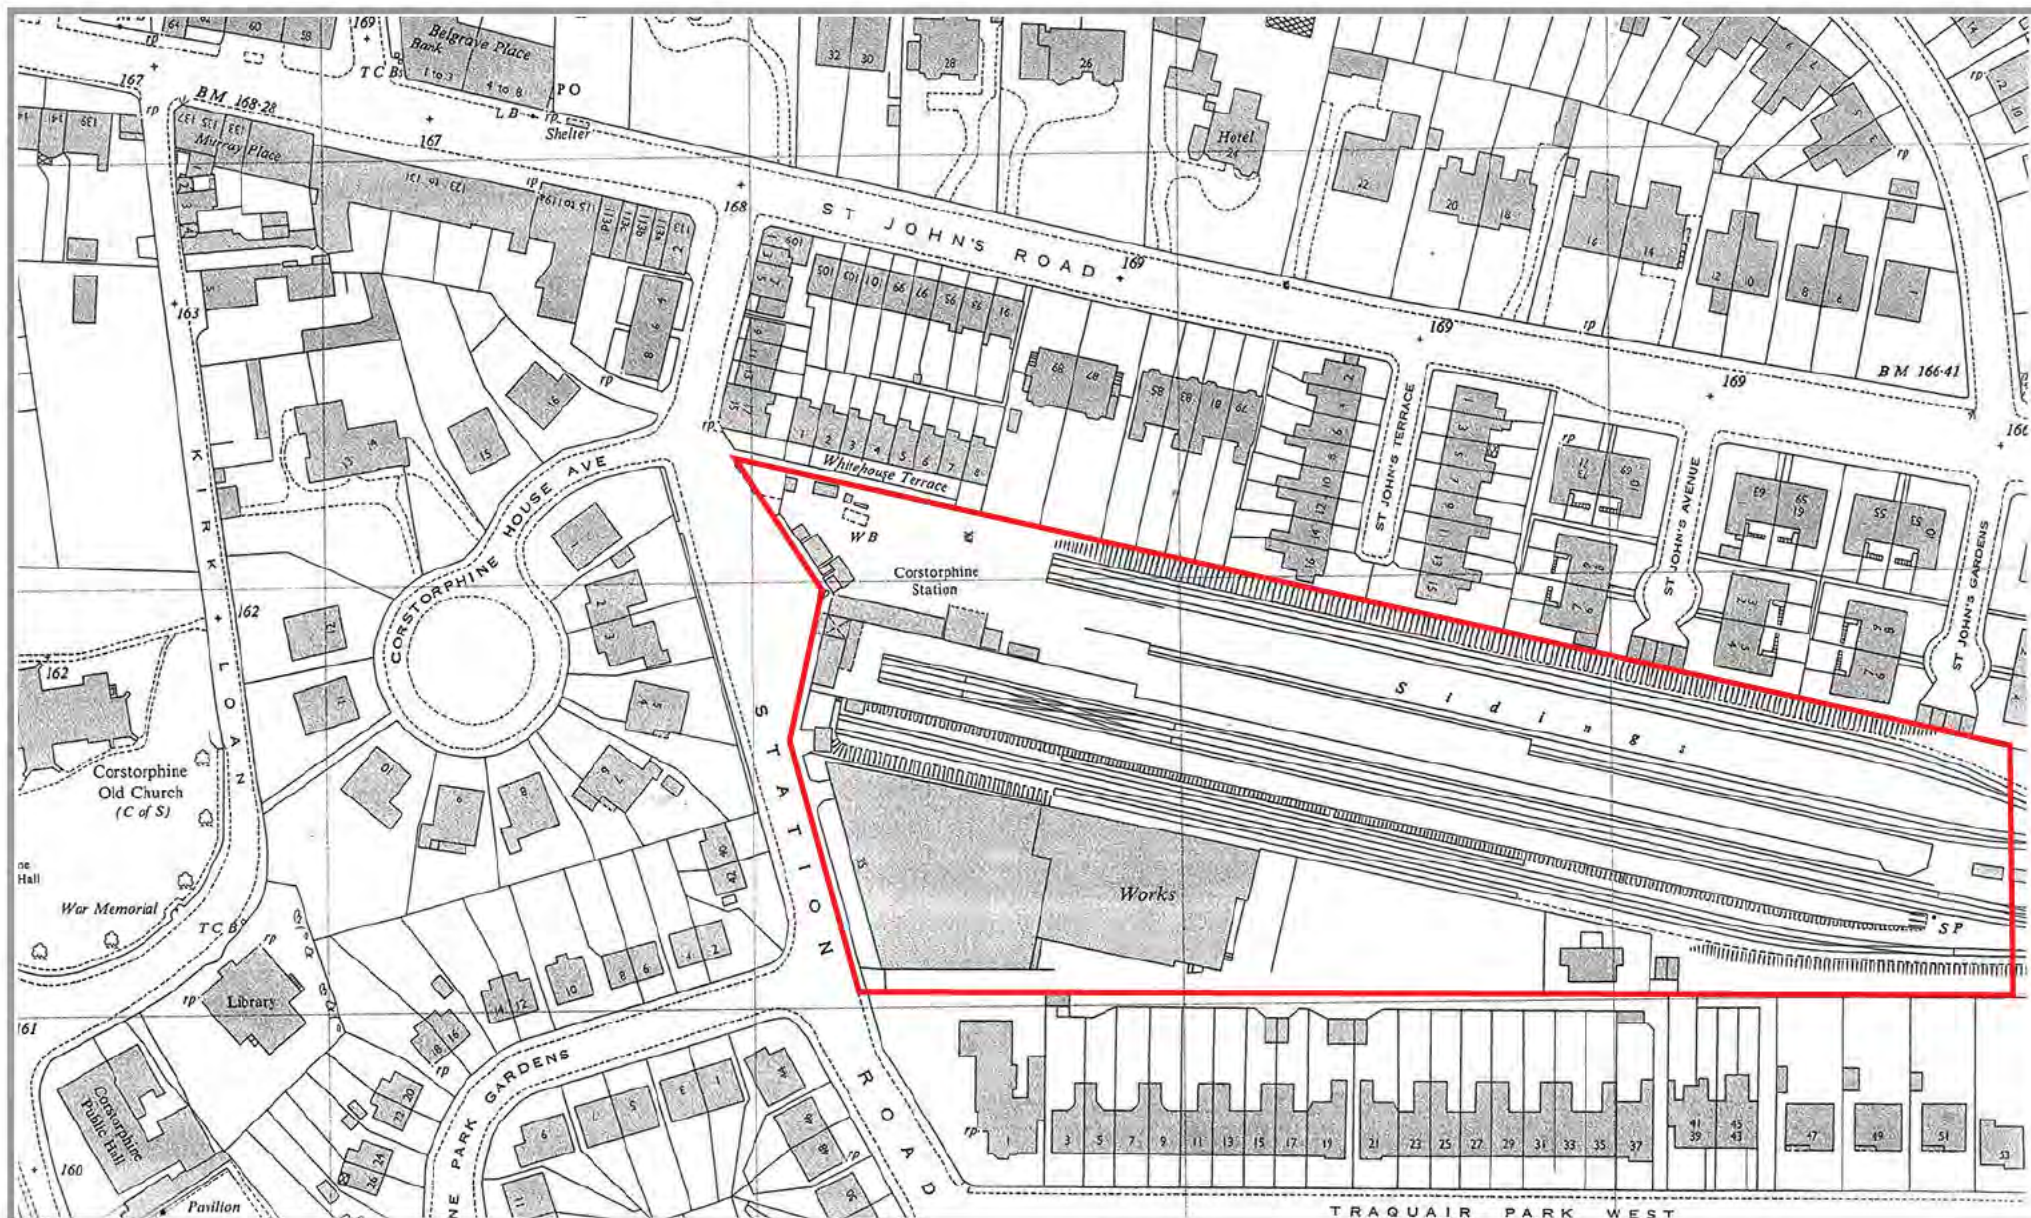
Figure 3  
Historical Plan of Corstorphine Station  
Dated 1965

The former Corstorphine Station is shown on an historical plan dated 1965 in Annex A (Figure 3).
