**Phase I Contaminated Land Assessment  
Site 369 – Roull Road Gasworks**

City of Edinburgh Council

December 2009

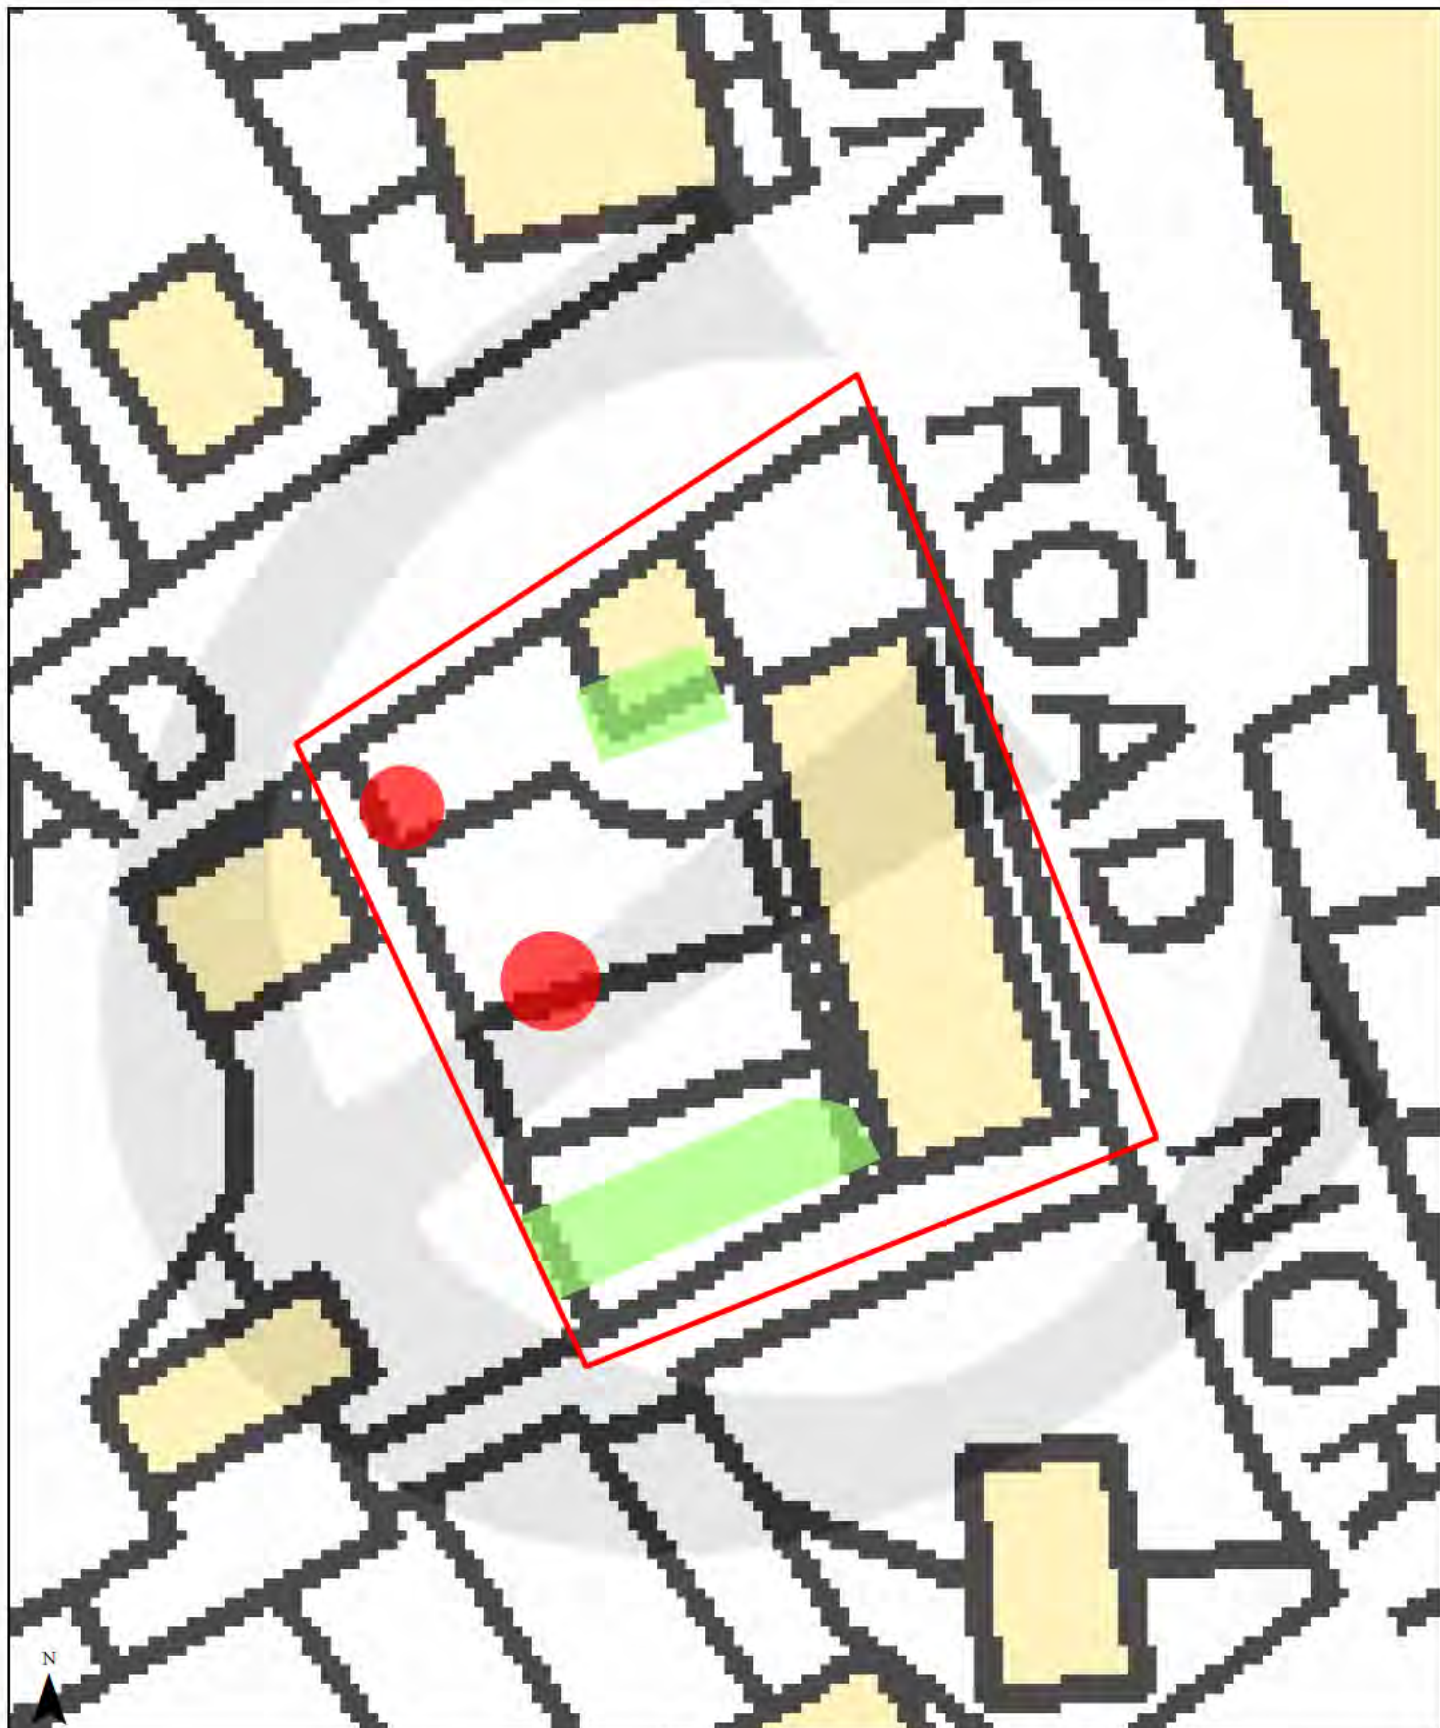
#### Site Location Plan & Sources 369 Roull Road Gas Works

#### Potential Sources of Contamination

Gas Holder

Gas Works Building

The locations of potential sources of contamination have been digitised from OS historical mapping.

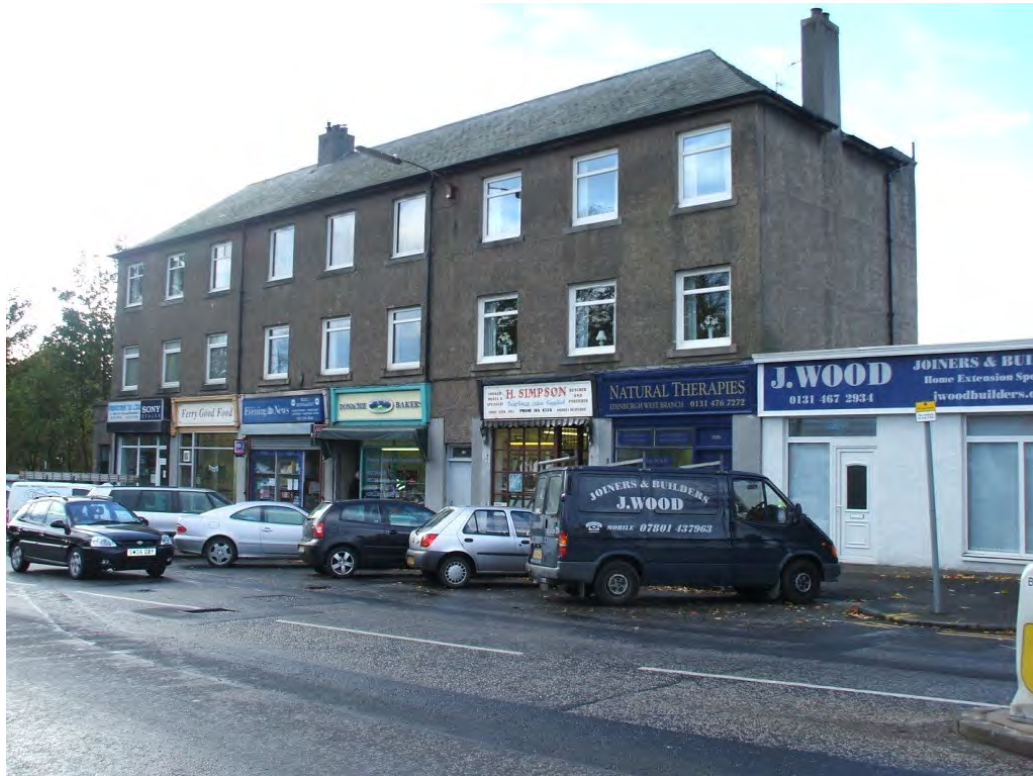
The site is currently in residential and retail use comprising a house with private garden, flats with shared gardens to the rear above retail properties, with car parking to the front. The retail properties on site are occupied by J Wood Builders (builders and joiners), Natural Therapies (acupuncture clinic), Harry Simpson (butchers), Donachie Bakers, Evening News (newsagents), Ferry Good Food (bakers) and Abercorn TV Ltd. (TV repairs and retail).

PLATE 1: East of the site comprising flats and retail properties

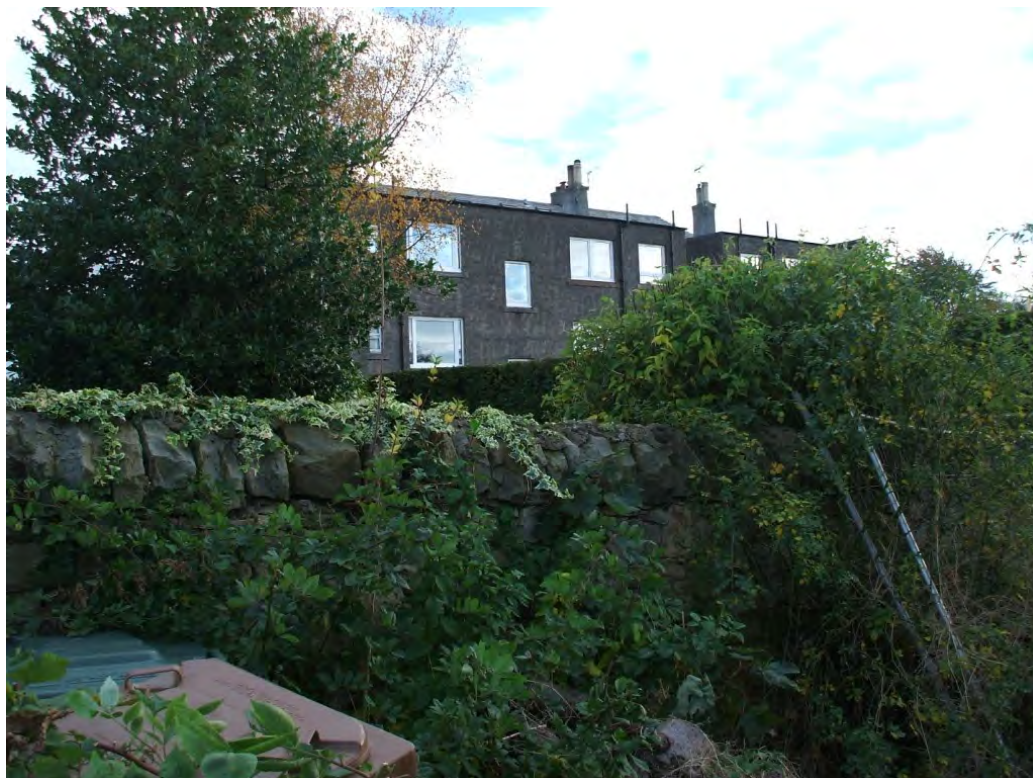
A single storey property is present on the northeast corner of the site, this property is connected to the other retail properties, however appears to have been constructed at a later date. This property is occupied by J Wood Builders. On the east of the site there are several car parking spaces with a long three-storey building adjacent. This building houses the remainder of the retail properties on the ground floor and residential flats are present on the upper floors. Communal yards and gardens are present to the west of this property. The north of the site is occupied by a residential property with private garden, the garden was observed to be mainly lawn with some flower beds.

PLATE 2: West of the site

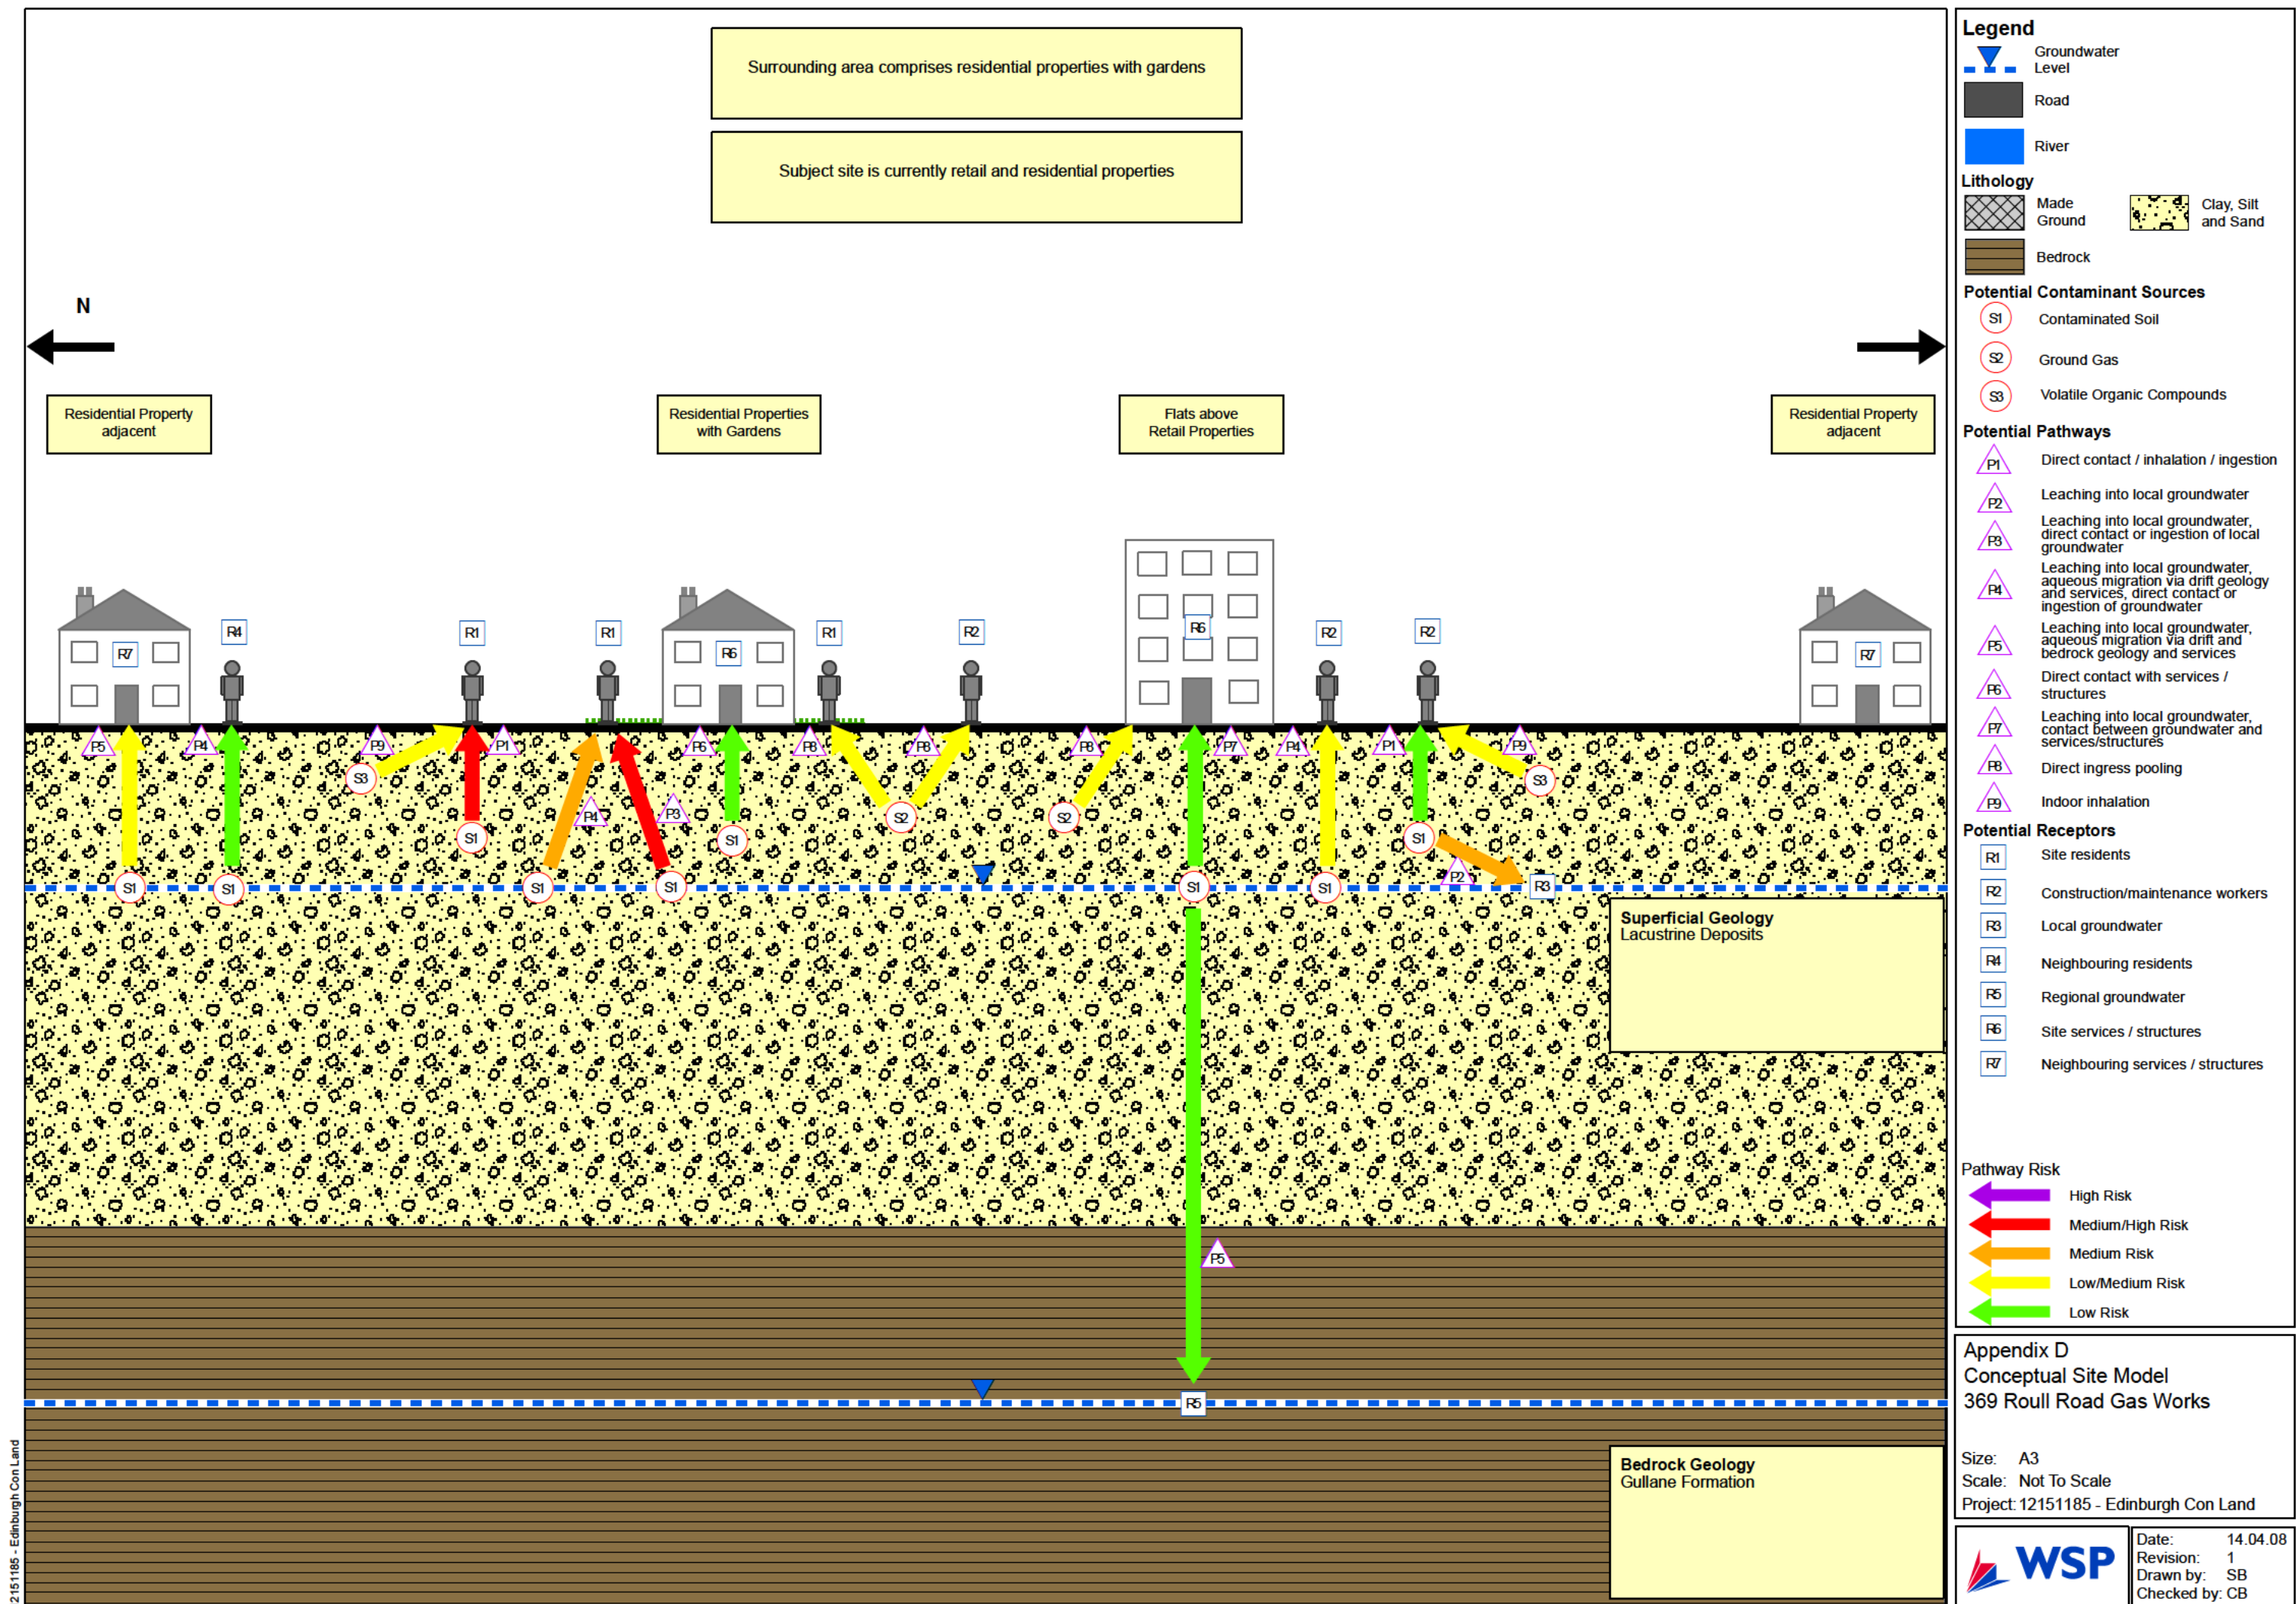
## Appendix D Source-Pathway-Receptor Model

Appendix D provides a graphical representation of the Source-Pathway-Receptor model.
