**Phase I Contaminated Land Assessment  
Site 289 – Saughton Goods Station**

City of Edinburgh Council

May 2010

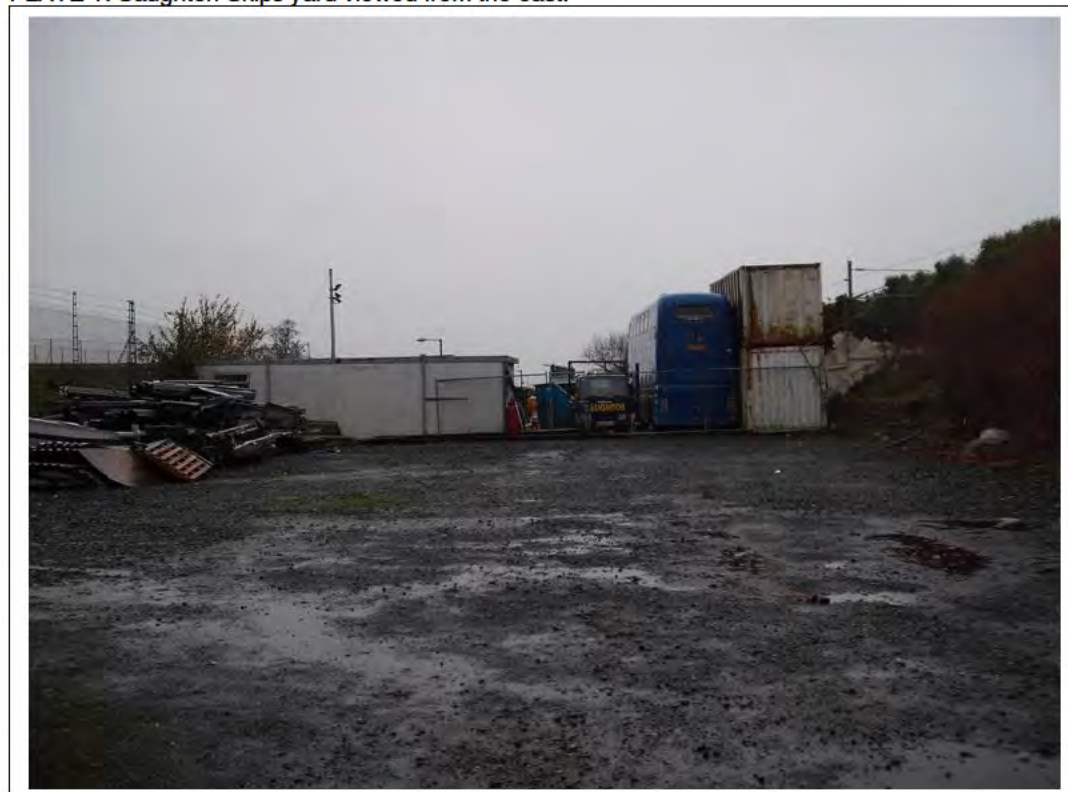
PLATE 1: Saughton Skips yard viewed from the east.

- On the south western part of the site Saughton Skips occupies a generally square slightly elevated piece of land with gated access, comprising a number of temporary cabins and a fenced skip storage area. The operation on the site comprises renting out, retrieving, storing and emptying skips containing building and general waste via collection from waste transfer companies. The site representative reported that there were no underground storage tanks (USTs) at the site, and no evidence of any above ground storage tanks (ASTs) was observed during the site visit. Surfacing was observed to comprise a mixture of tarmac hardstanding, loose gravel and exposed soils in some areas, with evidence of waste materials such as metals and wood scattered across the site. A JCB-type excavator was present on site during the time of the site visit and is reportedly used to empty out skips. A number of scrap motor vehicles, storage containers and a bus were observed to be stored on the eastern part of this area of the site.

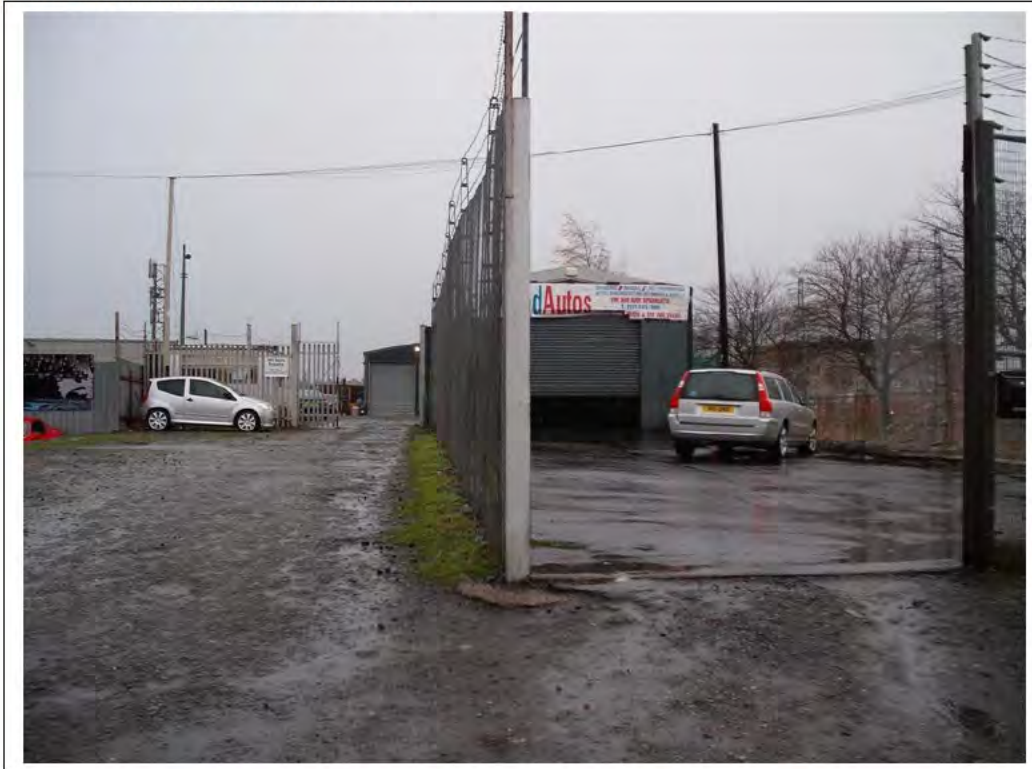
PLATE 3: External Advanced Autos area

- Advanced Autos and an access and parking area occupy the area adjacent to Saughton skips. This area is accessed by a gate and tarmac access area. Advanced Autos comprises one small warehouse style metal unit with roller doors and a temporary cabin used as office space. The site representative reported that site operation comprises undertaking MOT's on motor vehicles, and that there are no above ground or below ground storage tanks at the site. Small amounts of oil are reportedly stored within a locked cupboard at the back of the unit. Hardstanding, observed to be in satisfactory condition was observed to surface the site.

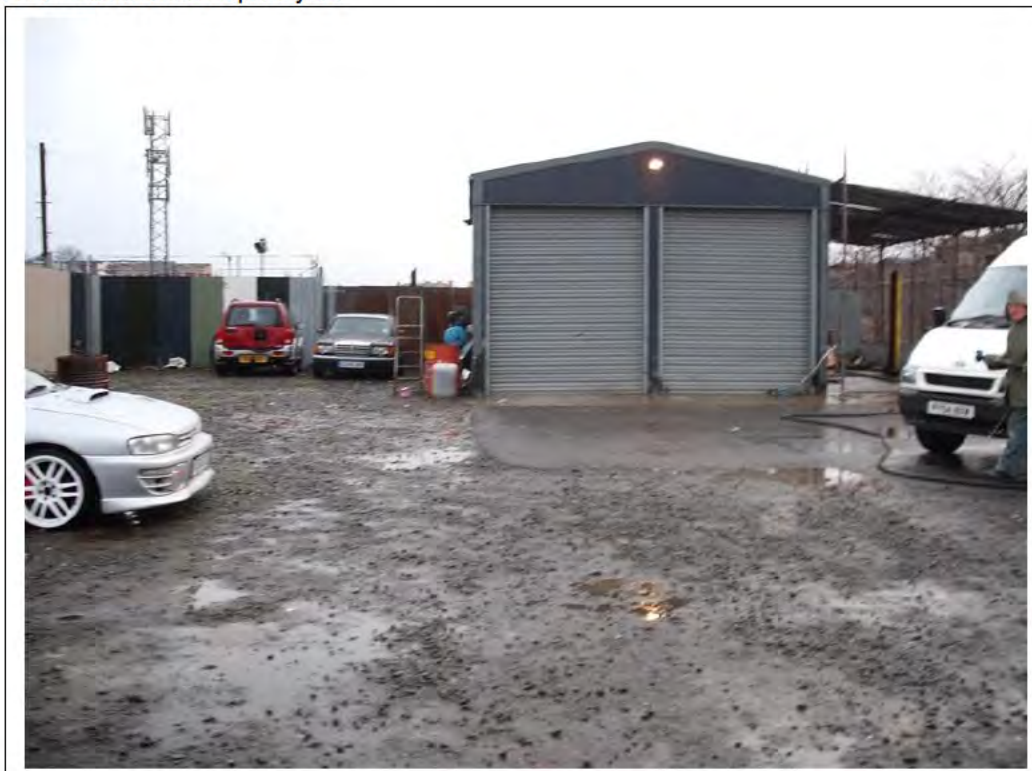
PLATE 4: MK Auto Repairs yard

- MK Auto Repairs occupies the area adjacent to Advanced Autos and comprises one temporary cabin, used as an office/reception, a small metal garage unit with roller doors and a tarmac and gravel surfaced rear area, used for washing vehicles after servicing. Drainage from this area was observed to be directly to ground as no grate or interceptor drains were observed. The site representative reported that there are no above ground or underground storage tanks onsite and that small quantities of oil are stored in a locked container at the rear of the unit. Three 45 gallon drums, labelled paint thinner and oil, were observed to be located within a gravel area adjacent to the unit. The drums were not contained within a bund. Access to this part of the site is via a tarmac ramp built upon a former railway platform, evident from platform stonework which is visible.

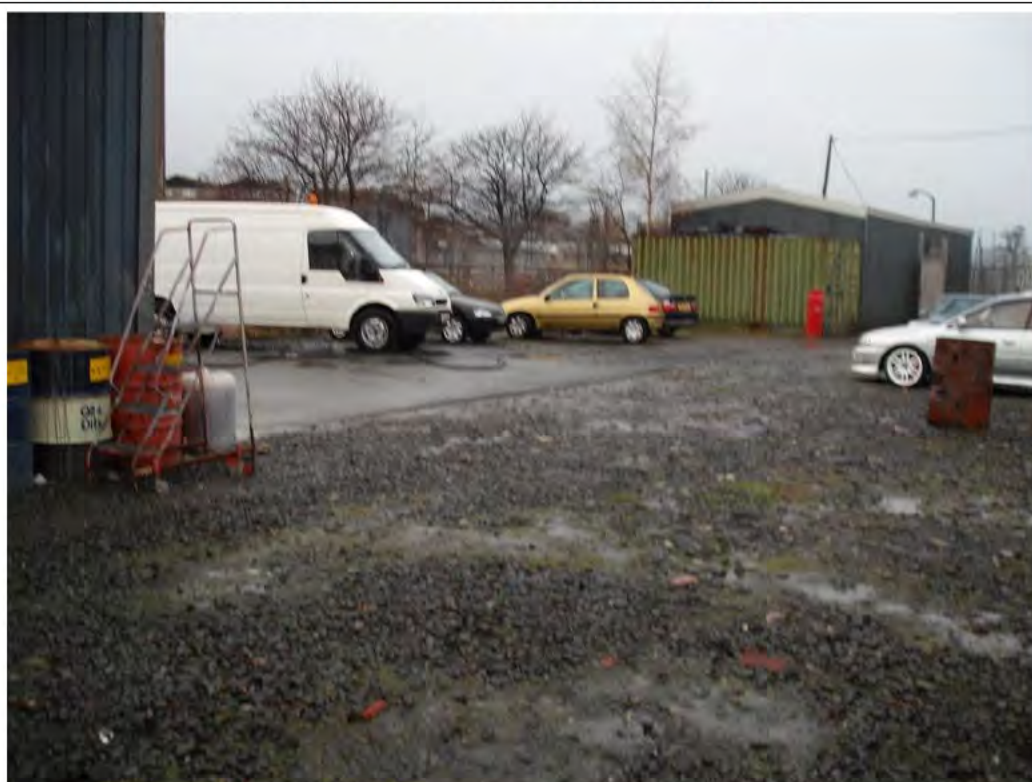
PLATE 5: Oil drums located on gravel surface at rear of MK Auto Repair yard.

Areas of fuel / chemical storage on the site include three 45 gallon drums labelled oil/paint thinner outside MK Auto Repairs. Other smaller containers of unknown liquids were also observed within this area. The drums were observed to be positioned on a gravel surface.

| Recommendation | Indicative Cost (£) | Timescale |
|---|---|---|
| Given that the status of any investigation / remedial action at the site is unknown, WSP would recommend an initial site investigation of minimal intrusion comprising window sampling and trial pits to obtain soil samples for chemical testing, and allow installation of groundwater monitoring wells, both to assess risks to human health and the water environment. | 12,000 to 18,000 | 8 to 12 weeks |

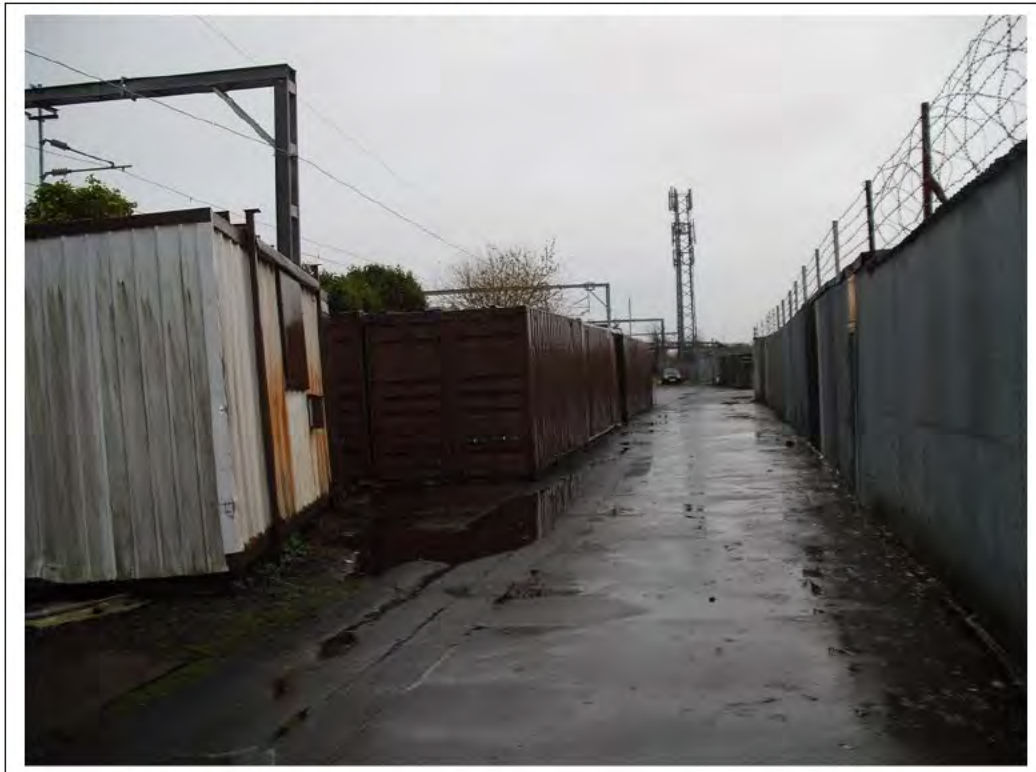
PLATE 7: Storage containers lining railway embankment in south

- The area to the south of the railway embankment was observed to comprise a row of metal storage containers. It is unclear what these are used for, however, a few appear to contain joiners' tools and are possibly lock-ups.

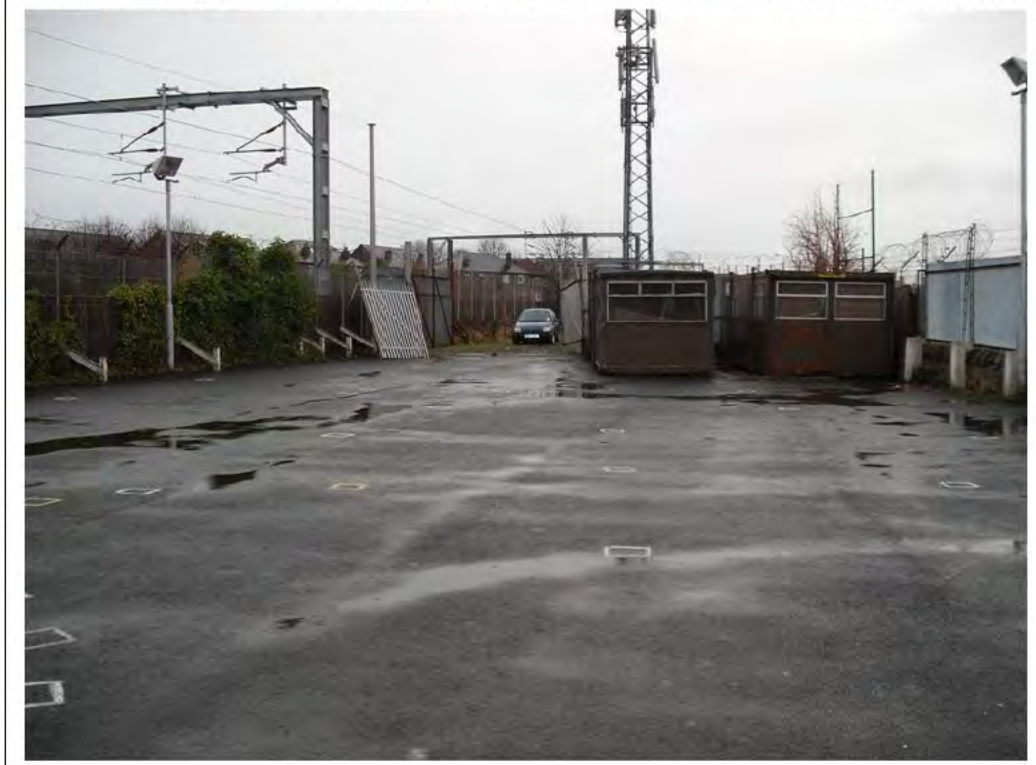
PLATE 8: Motorcycle training yard with temporary cabins, radio transmitter beyond and railway to north

- The eastern most part of the occupied site comprises an area which is used for motorcycle training. A temporary cabin used as an office, electric lighting and an area of tarmac hardstanding painted with "obstacles" occupies the area. No site representative was available to further report on activities undertaken in this area.

- A telecommunications mast with associated electronics is located beyond the motorcycle training yard. The transmitter was observed to serve Vodafone and O2.

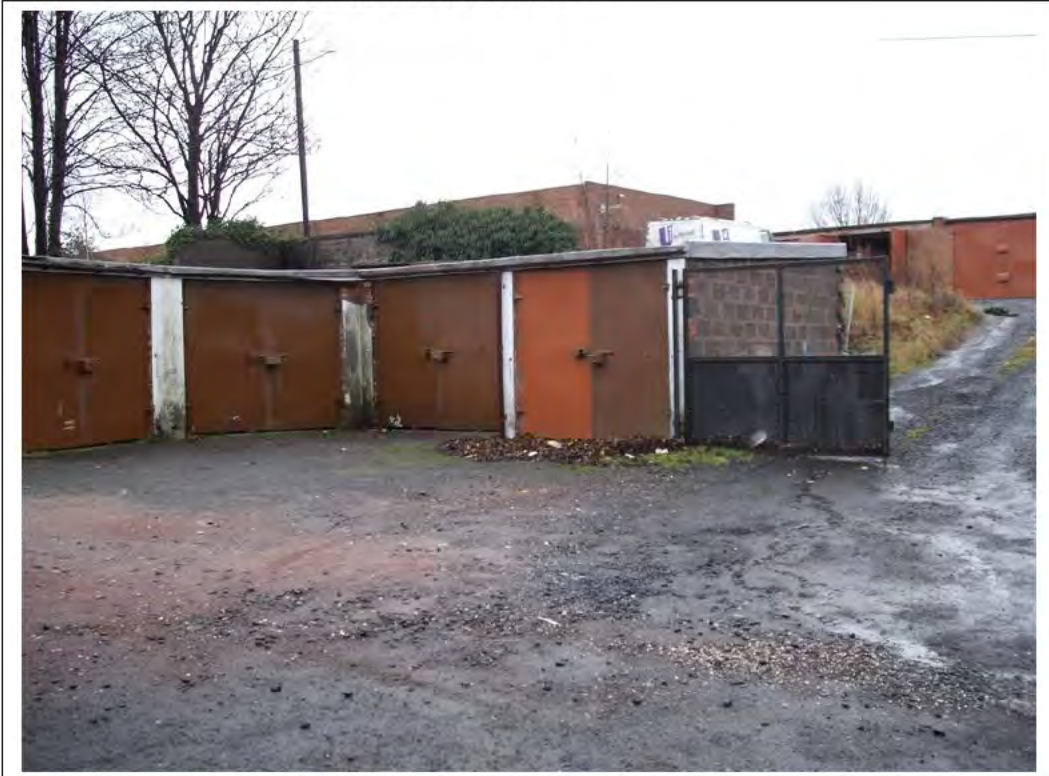
PLATE 9: Lock up garages on north western part of site

- A number of lock-up garages are located on the north western part of the site, to the north of the railway. Surfacing in this area was observed to comprise tarmac hardstanding. The garages have been constructed in two levels in a stepped design, sloping up towards the railway embankment. Access to this part of the site is via the road to the west.

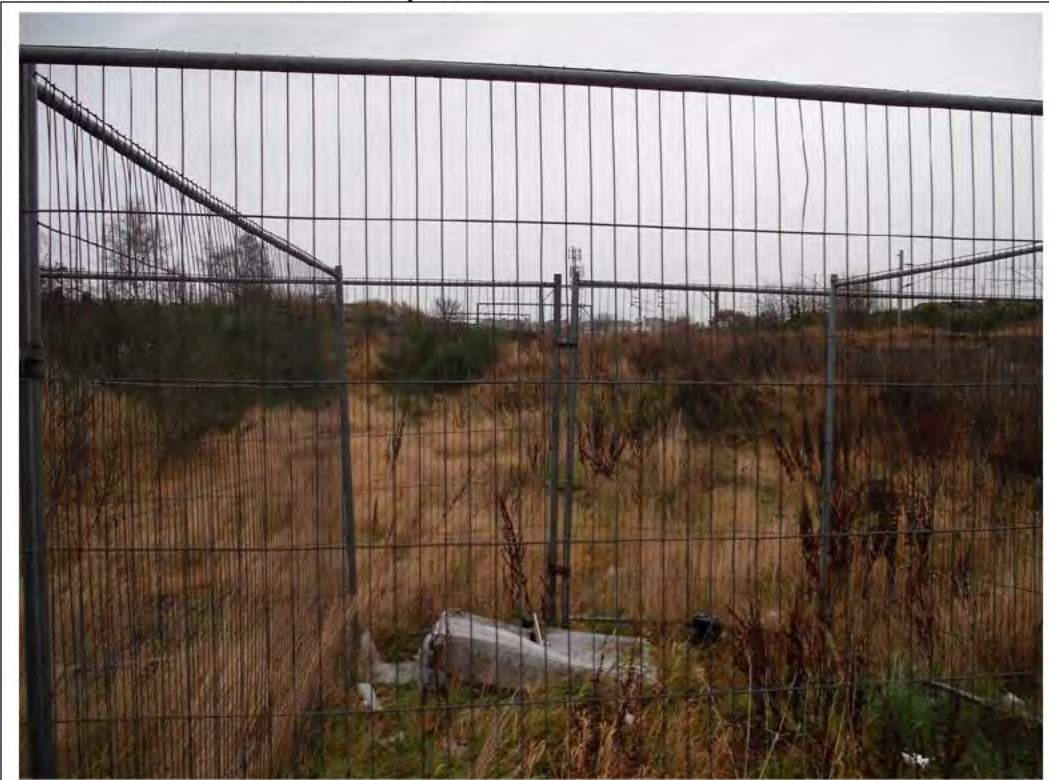
PLATE 10: Derelict land north of railway line

- Derelict land, comprising grass and shrubs, is located to the east of the lock up garages on the northern part of the site.
